Investigation of Voltage Notch on Waveform Leads to Saving 500kV PT

By Theo Laughner and Anthony Murphy

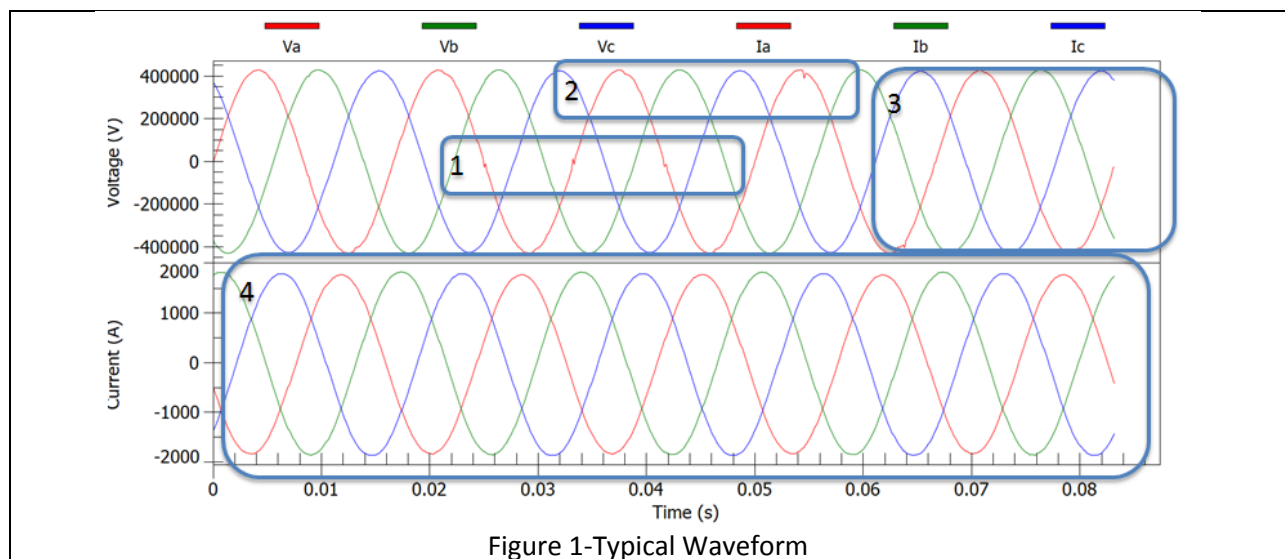
Between June 1st and August 1st, over 15,000 transient events were recorded by the PQ monitor connected to the 500kV Bus PT. The transient events all had the same characteristics. As can be seen in figure 1, the four characteristics were:

1. Notching at 0 crossing
2. Perturbation at Voltage Peak
3. A-Phase Voltage Only (Red Trace)
4. No corresponding response on the current channels.

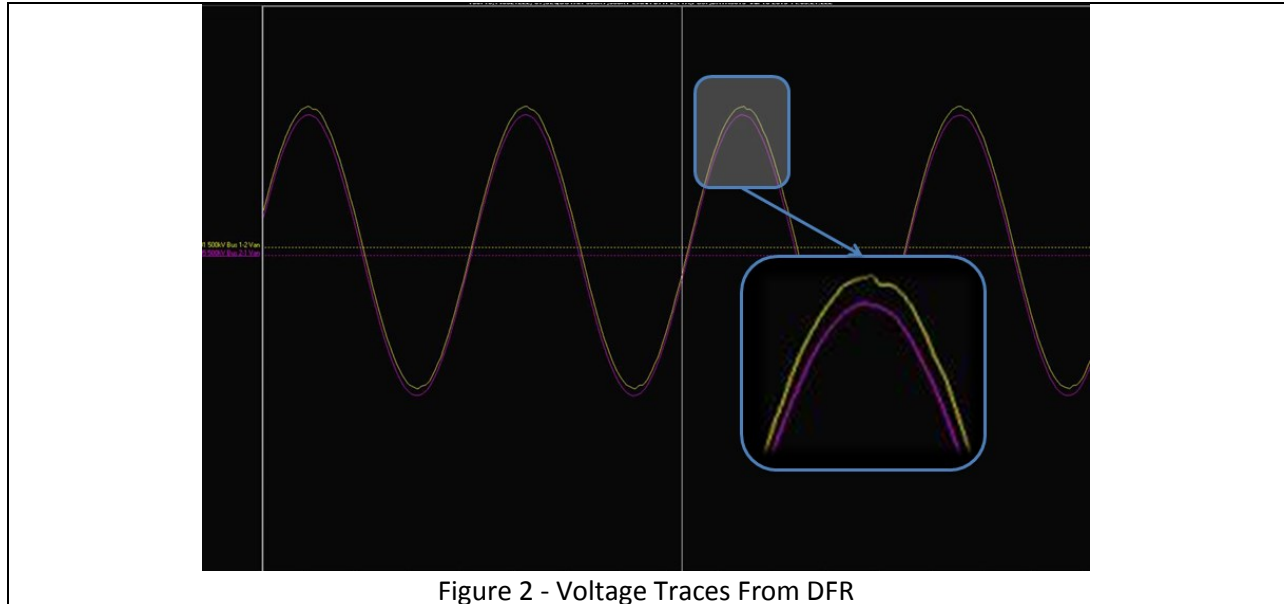
and the busses were tied together. On the DFR trace, the voltage notch appeared on one bus but not on the other bus. This eliminated the issue as a metering artifact since multiple devices were seeing the event. As can be seen in figure 2, the purple trace is the good PT, the yellow trace contains the voltage notch just like the PQ meter. The waveform suggests that the issue is on the VT or on the secondary side.

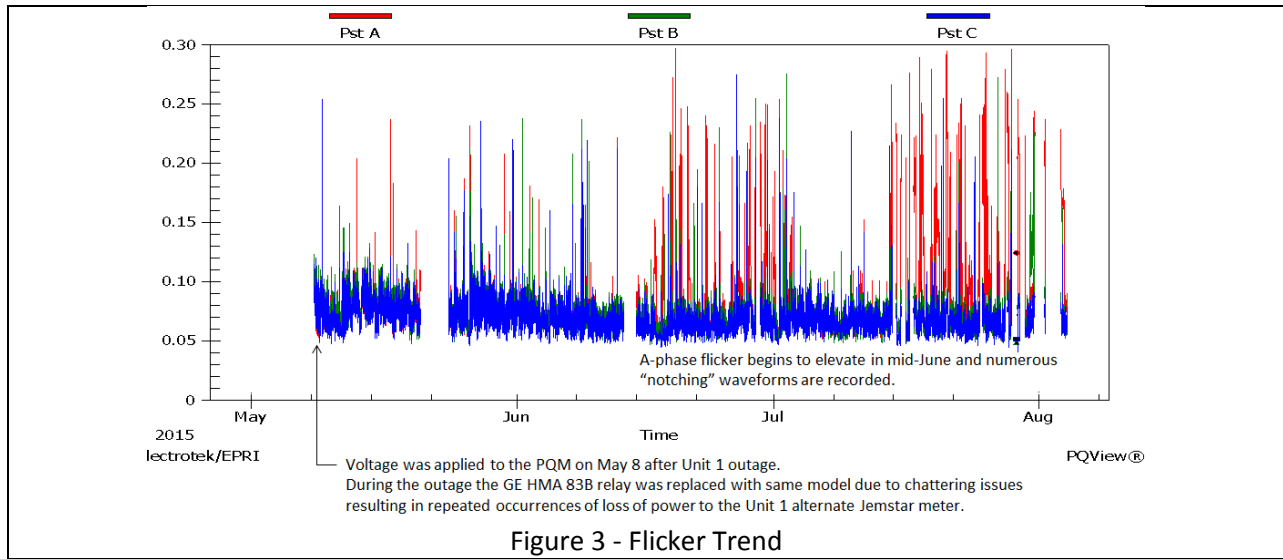
Figure 3 - Flicker Trend

The troubleshooting took several days to complete. Over the timeframe, it was clear that the issue was getting worse. The notching was severe enough to elevate flicker values on the PQ meter. As can be seen in figure 3.

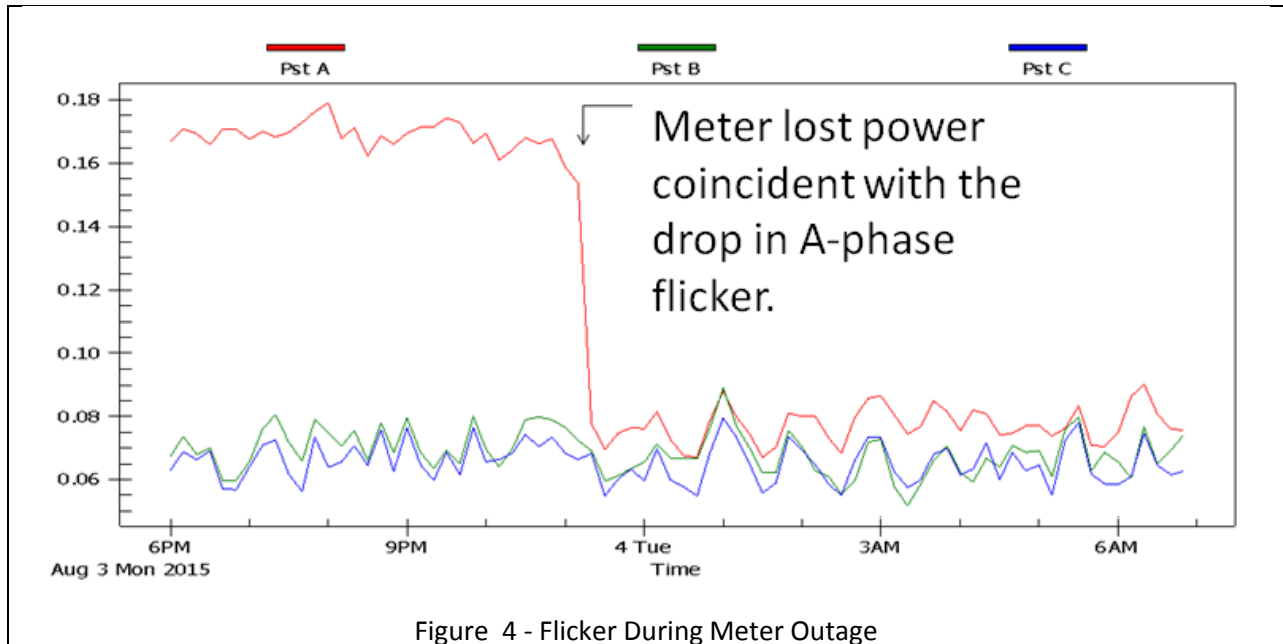
Figure 4 - Flicker During Meter Outage

On Monday, August 3rd, there was a complete loss of power to the meter and PQM fed from the PT secondary. Subsequent investigation revealed that all fuses tested good; however, an auxiliary relay in the meter cabinet was found to be chattering. When the meter lost power, a noticeable drop in the A-Phase flicker levels was observed as shown in figure 4.

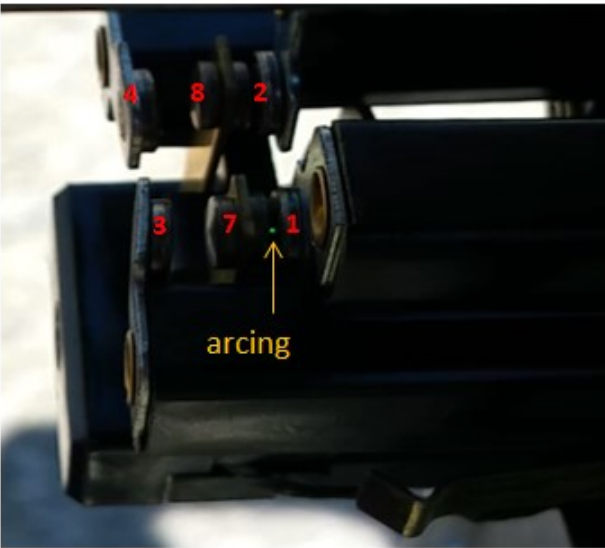
Figure 5 - Picture of Arcing in HMA Relay

The HMA relay is used to power the meter and power quality meter from the A-phase bus PT when there is an outage to the primary feed (station service). As can be seen in figure 5, an intermittent arc could be visually seen between contacts 1 and 7 of this relay. The arcing had pitted the contacts to the

point that it had resulted in an open condition and a loss of power to both the meter and PQM. Additionally, any slight vibration to the meter cabinet could cause the HMA contacts to make or break.

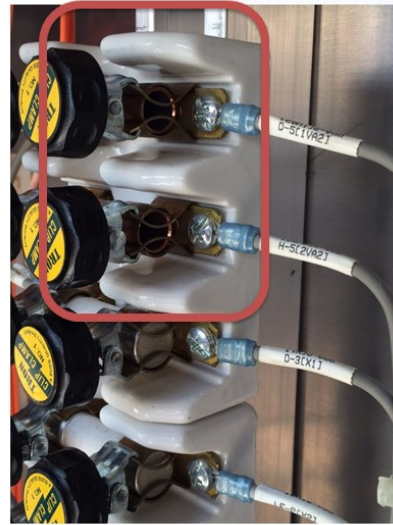
Figure 6 - Picture of Incorrect Shorting Slugs

Further investigation found that a copper tube with smaller diameter had been used in place of the copper slug that was to be in-line with the relay as can be seen in figure 6. This high impedance connection resulted in a lower voltage across the relay coil and the relay chattering. This is a known issue with this model relay and there is a replacement model. As a temporary fix, the relay was replaced with an identical model and the copper-tube was strapped over eliminating the notching waveforms. Ultimately, the relay was replaced with a new model.
