Analysis of a Transformer Neutral Resistor Damage on an 11kV Bus Fault at National Grid

By: Yujie Irene Lu & Song Ji (National Grid)

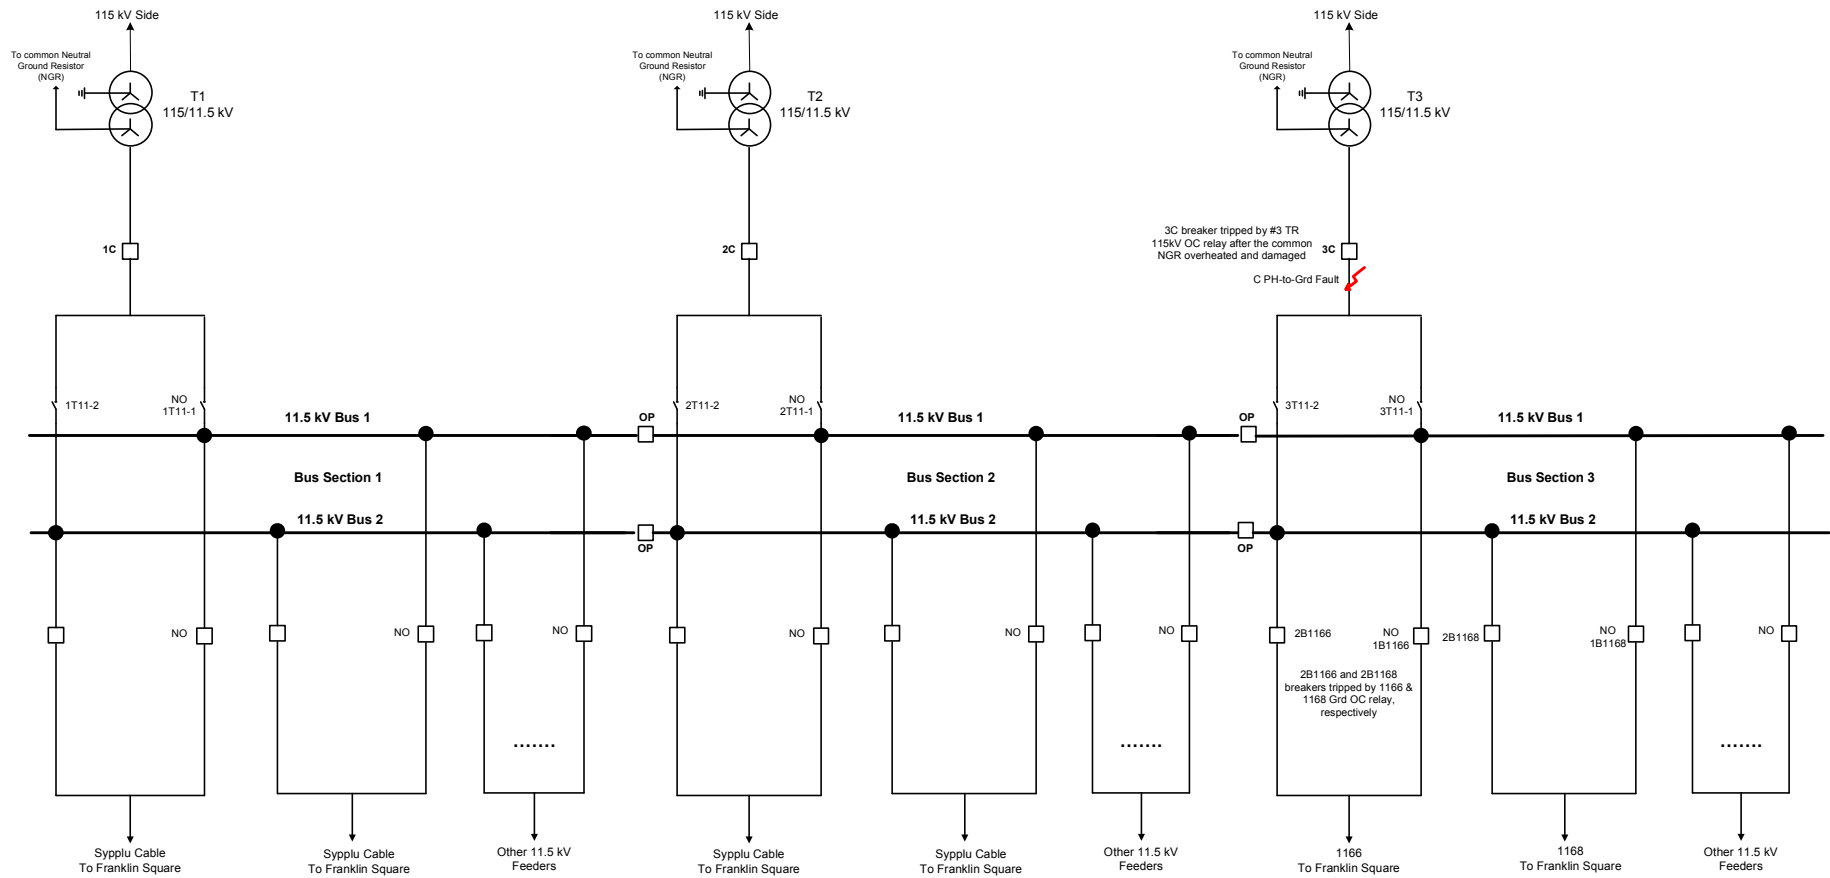
Figure 1. Simplified Substation One-Line Diagram and Fault Location

At 10:06:16, an animal contact caused a C-phase-to-ground fault outside the Section 3 of 11.5kV #2 Bus between #3 transformer 11.5kV side 3T11 breaker and 3T11-1 and 3T11-2 disconnects at S Street (See Figure 1). Based on relay targets, sequence of event (SOE), digital fault recorder (DFR) and relay records:

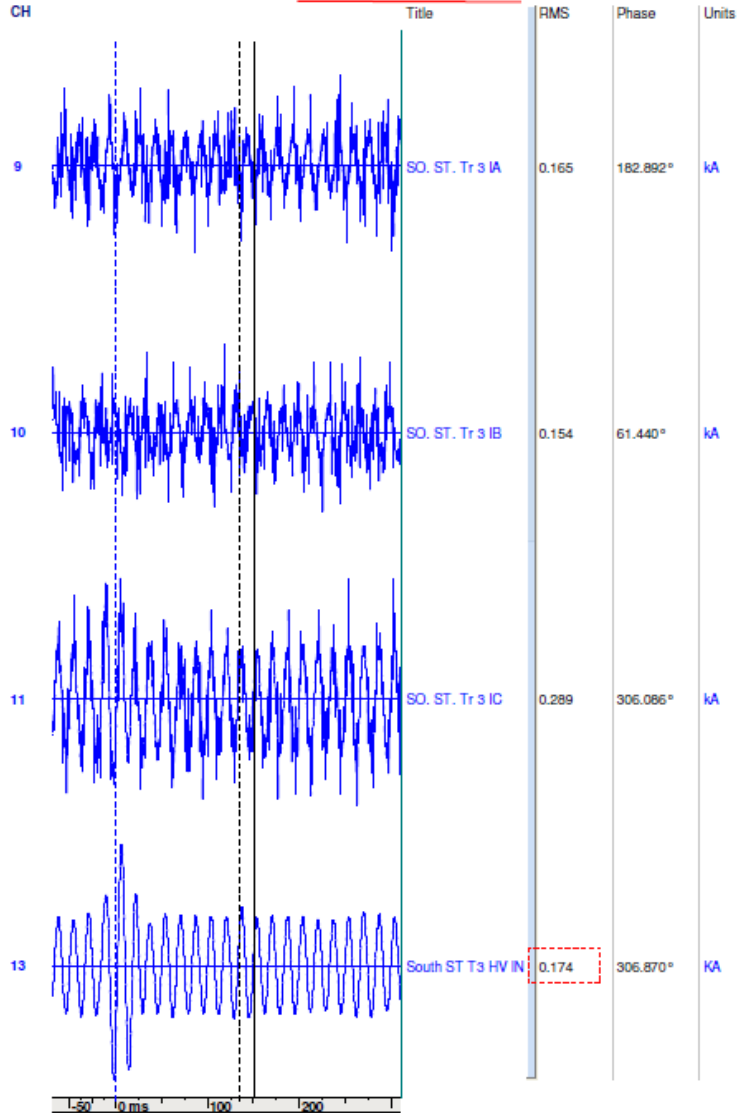
Figure 2. #3 115/11.5 kV Transformer DFR Records at S St. @ 10:06:18

- At the point of the DFR being triggered, current (both phase and ground) on the 115kV side of #3 transformer was about 100 amperes primary (CT Ratio = 400). 20 seconds later, the current jumped to over 1800 amperes primary, which matches the #3 transformer 115kV overcurrent (OC, 51) relay's record and short circuit simulation result without the common neutral resistor in service. The OC relay operated correctly in 6.5 cycles and the 11.5kV fault was finally isolated by tripping out the 115kV supply cable. By taking a close look at the SOE records, the fault lasted for over 41 seconds (See Table 1 in detail). How did the 115kV fault current increased in 18 times?

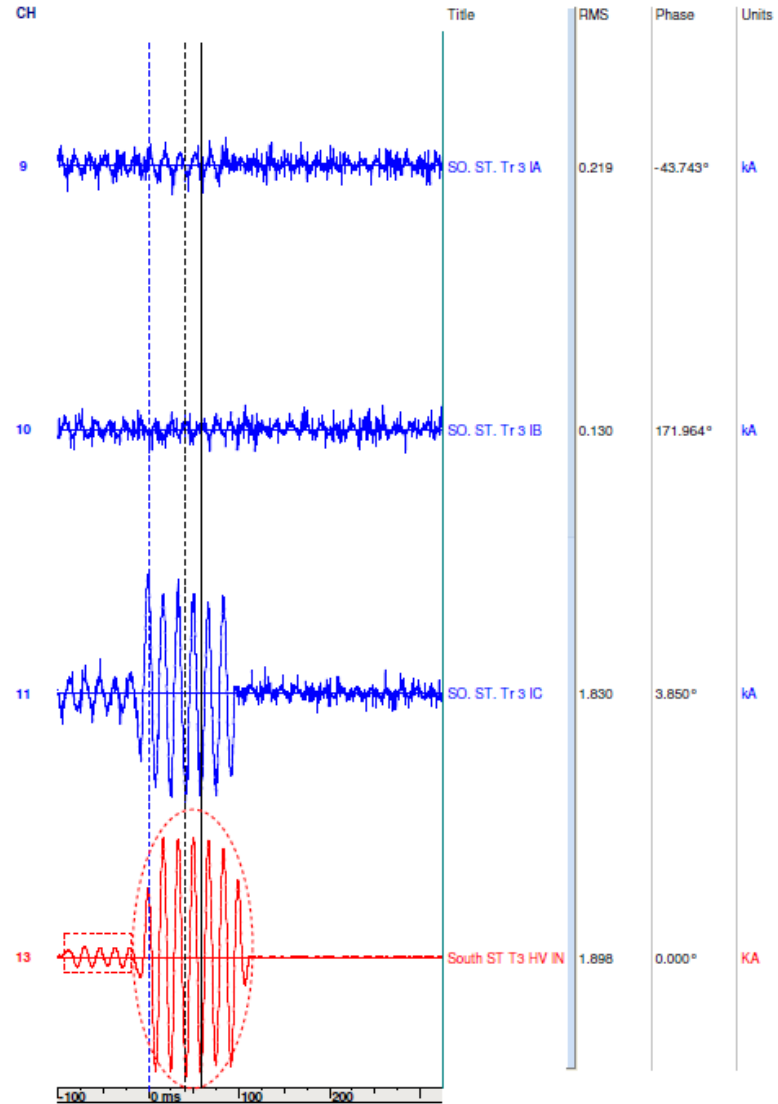
Figure 3. #3 115/11.5 kV Transformer DFR Records at S St @ 10:06:38

Per system design, the #3 transformer 115kV OC relay should not have sensed more than 100 – 150 amperes of fault current for an 11.5kV fault if the common neutral resistor on #1, #2 and #3 transformers at S Street connects and works as per design. Why did the fault current through the OC relay jump from 100 to 1800 amperes? The question was raised what was wrong with the neutral resistor? The short circuit simulation result confirmed that the fault current sensed by the #3 transformer 115kV OC relay matches the relay records if the common neutral resistor is by-passed. Based on this finding, it was suspected that the significant current jump was due to the slow fault clearing resulting in the neutral common resistor got damaged. Refer to Figure 2 and Figure3, the fault had been lasted for more than 20 seconds (10:06:18 – 10:06:38) and finally it evolved into a severe one. It was most likely the transformer 11.5kV common neutral resistor was bypassed and the zero-sequence fault current went through the earth directly.

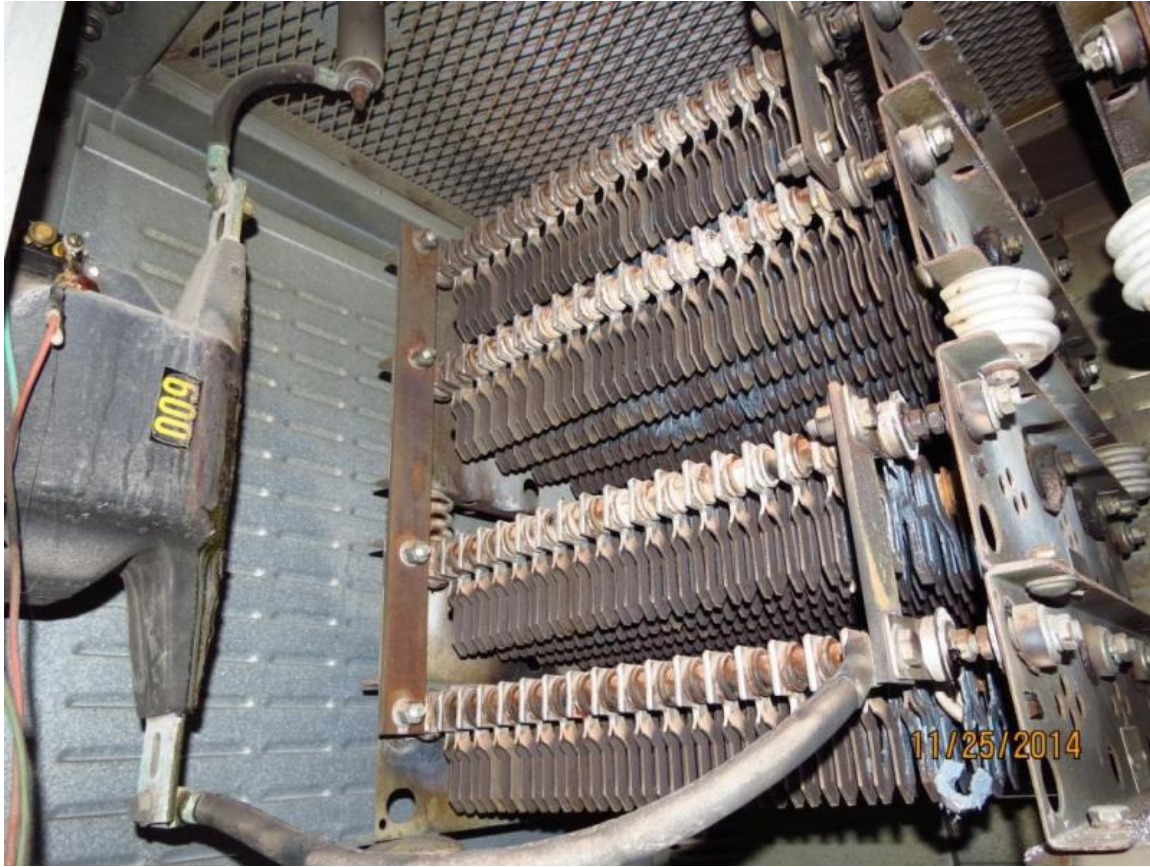
Figure 4. Damaged Common Neutral Resistor at S Street

Substation O&M inspected the common neutral resistor at S Street and confirmed that it was damaged due to over heat (see Figure 4), which explained why the current jump in 18 times after 40 seconds of the fault and, eventually resulted in the #3 transformer 115kV OC relay operated to isolate the fault from 115kV side.

- It was concluded that the significant through fault current jump was due to the slow fault clearing resulting in the neutral common resistor got damaged. From the area 11.5kV underground network design perspective, none of #1, #2 or #3 transformer at S Street shall be put in service if no neutral resistor is in service. The damaged resistor was replaced within a month.

1. The Damaged Common Neutral Resistor Issue: From the area 11.5kV underground network design perspective, none of #1, #2 or #3 transformer at S Street shall be put in service if no neutral resistor is in service. With the investigation team's support on specifying a new neutral resistor, the damaged resistor was replaced by Substation O&M within a month.

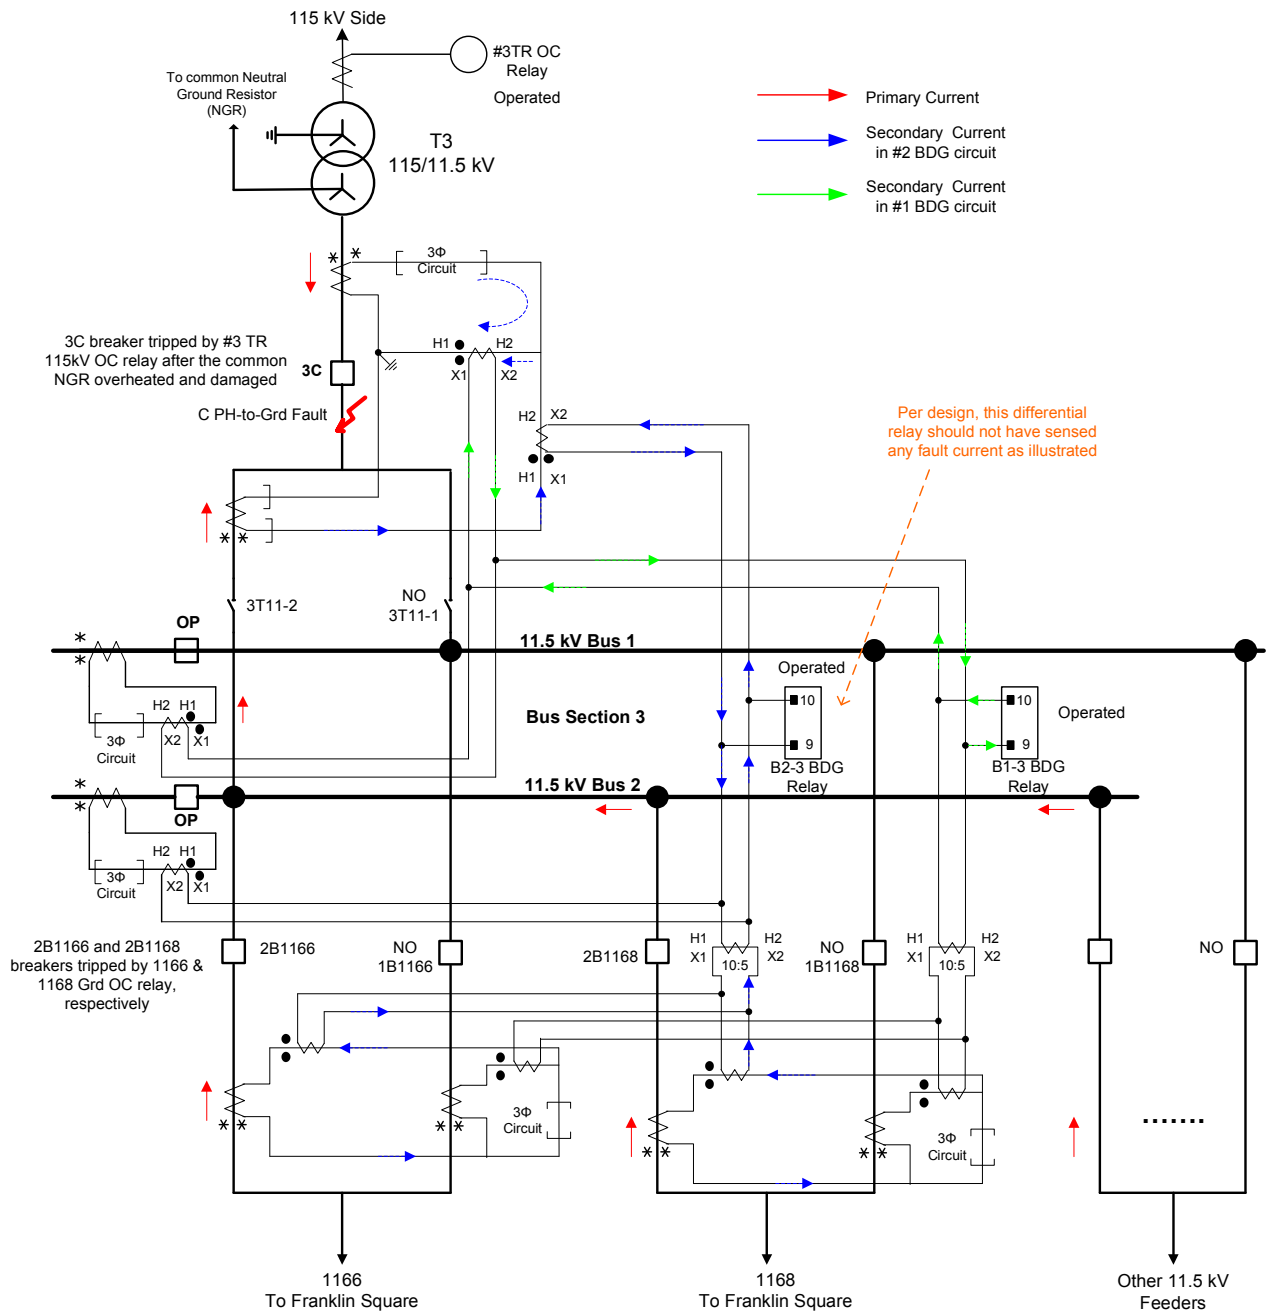
Figure 5. #1 & #2 Bus Section 3 BDG Relaying Current Circuit at S Street

Furthermore, according to the findings from this investigation, a design flaw on the #2 Bus Section 3 (apply to Section 1 and 2 as well) BDG was discovered. The CT for this BDG scheme is located on non #2 Bus side of the disconnect 3T11-2, which means the section between the 11.5kV breaker 3C and the CT is outside this BDG differential zone and so there is no BDG protection for this section under normal configuration at S Street. Although this section is covered by the #1 Bus Section 3 BDG scheme, nothing will trip via this scheme for faults within the section since #1 bus breakers are at normally open position. By the way, the #3 transformer differential zone ends up at the breaker 3C, therefore, there is no protection for the section between the 11.5kV breaker 3C and the CT located on non #2 Bus side of the disconnect 3T11-2 when the #2 Bus is in service. (See Figure 5 - Relay One-Line in detail) How to fix this problem?

- The #1 Bus Section 3 BDG operated per design, and the #2 Bus Section 3 BDG operation was because some of CT's accuracy in the BDG circuit is relatively low and very likely resulted in CT(s) saturation during this fault. This #2 Bus BDG operation was incorrect due to a design flaw in the BDG current circuit, but desirable for this fault. There is no protection for the zone between the 11.5kV breaker 3C and the CT located on non #2 Bus side of the disconnect 3T11-2 when the #2 Bus is in service. It is recommended to correct the design for all of six (6) Bus DBG schemes at S Street.
