# Shunt Capacitor Failure Investigation Using a Digital Fault Recorder

Douglas Selin, Wayne Perry, Baj Agrawal, John Demcko  
Arizona Public Service Co., Phoenix Arizona

2003 Fault and Disturbance Conference

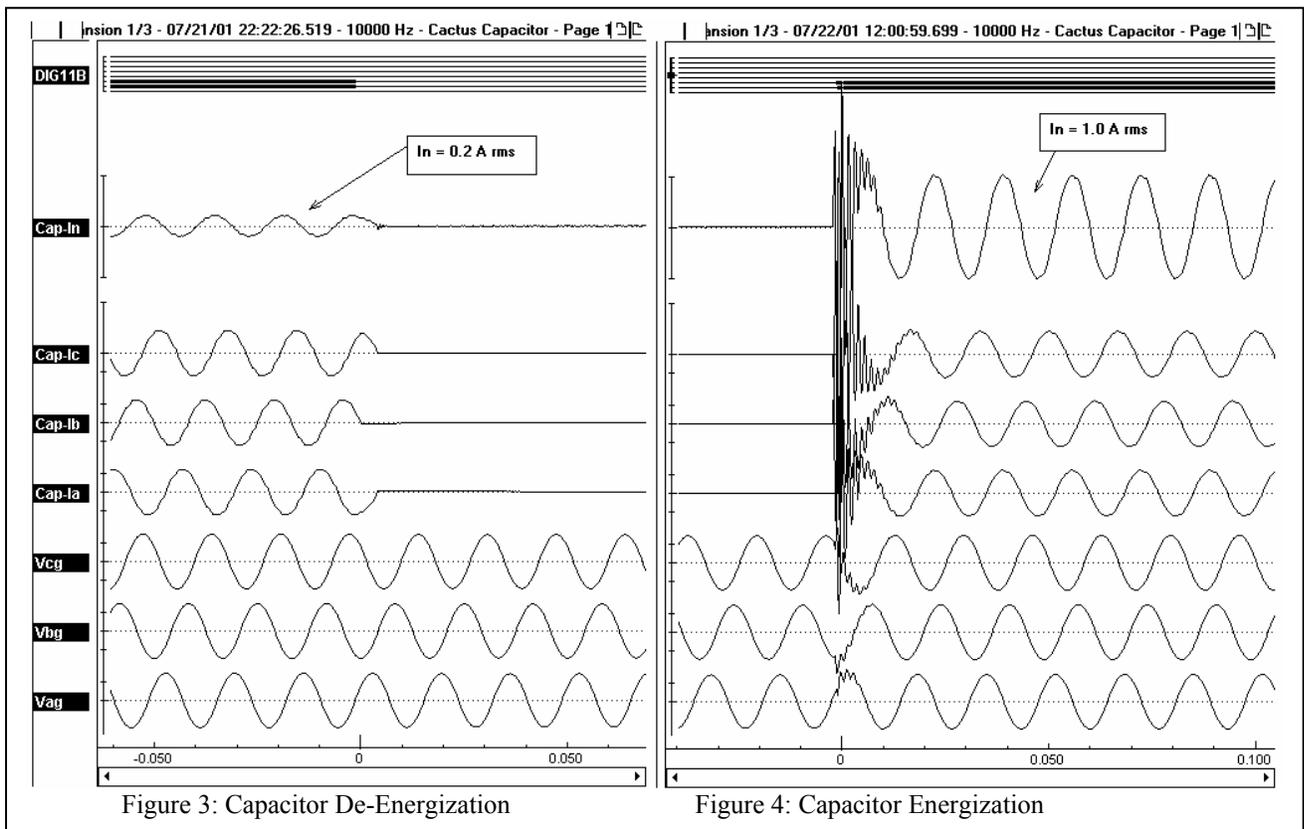
failures of capacitors were identified, but only after the fact. Figures 3 and 4 illustrate a failure where the steady state neutral current changes indicating a failure of one of the capacitor units. Note that in Figure 3, the steady state neutral current is approximately 0.2 A rms just prior to the capacitor bank switching off. The next time the capacitor bank switches on, the neutral current magnitude has increased to approximately 1 Arms. After observing several failures in this way the following observations were discussed with the capacitor manufacturer:

1. All of the capacitor failures were identified by an increase in the neutral current of a capacitor energization record which indicated that the failure did not occur while the bank was operating in steady state.
2. None of the energization cases showed excessive voltages or currents in the transients that were captured.
3. None of the de-energization cases showed any re-strikes.

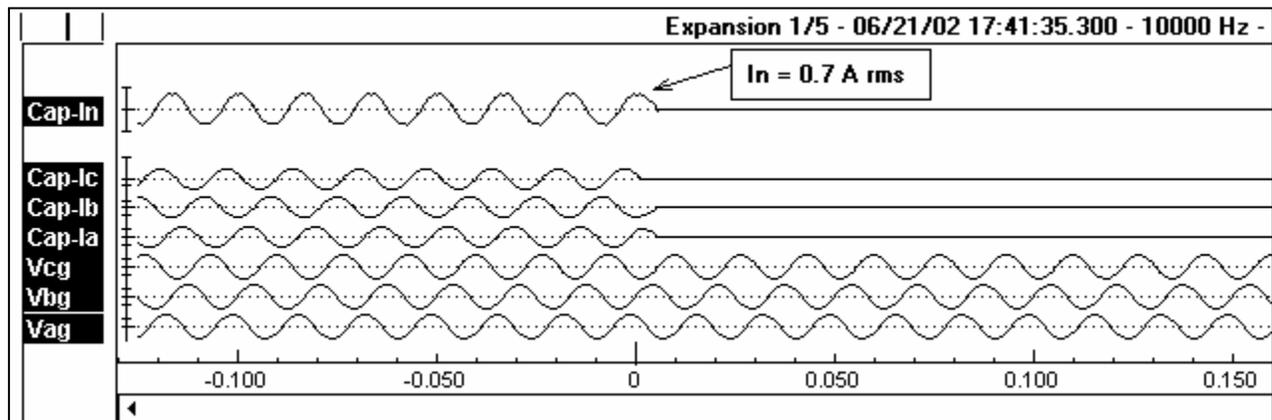
Figure 5: Capacitor De-energization Record

Figure 5 shows the normal de-energization of the capacitor bank. No restrikes occur and the steady state neutral current just prior to the de-energization is 0.7 Arms. Figure 6 shows the actual can failure. Note the following about this record:

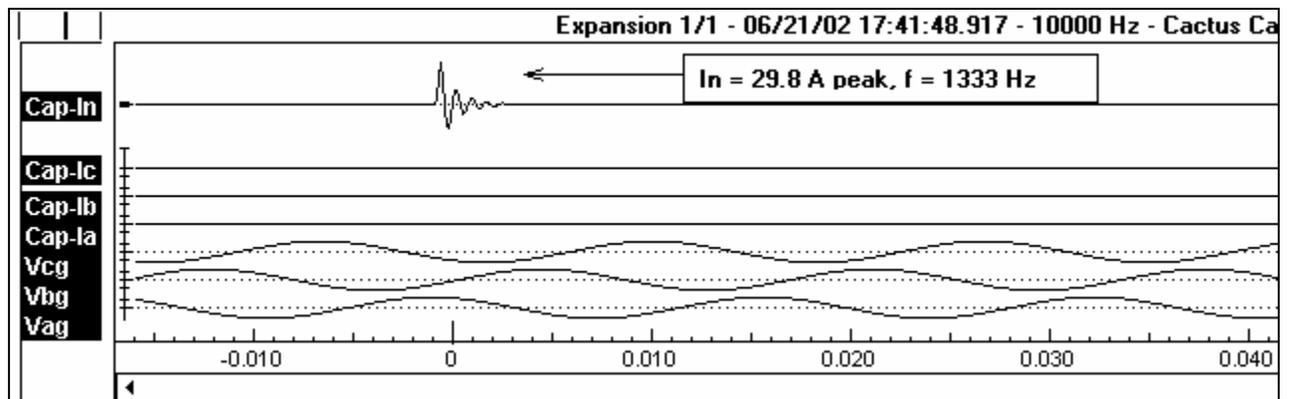
Figure 6: Capacitor Failure Record

1. No phase currents are seen for the entire record. This is because the breaker is open and remains open for the entire duration of the event.
2. Phase voltages are seen because the voltages are measured on the bus side of the breaker.
3. The neutral current trace shows a transient which has a peak magnitude of approximately 30 A and a natural frequency of around 1300 Hz. This neutral current flows as a result of the can imbalance between the two split – Y capacitor banks when the failure occurs.
4. Note the timing of the failure as documented by the events captured by the DFR. The capacitor failure occurs approximately 13 seconds following de-energization. This is a relatively long period of time following the de-energization and the capacitor voltages would have begun to discharge.

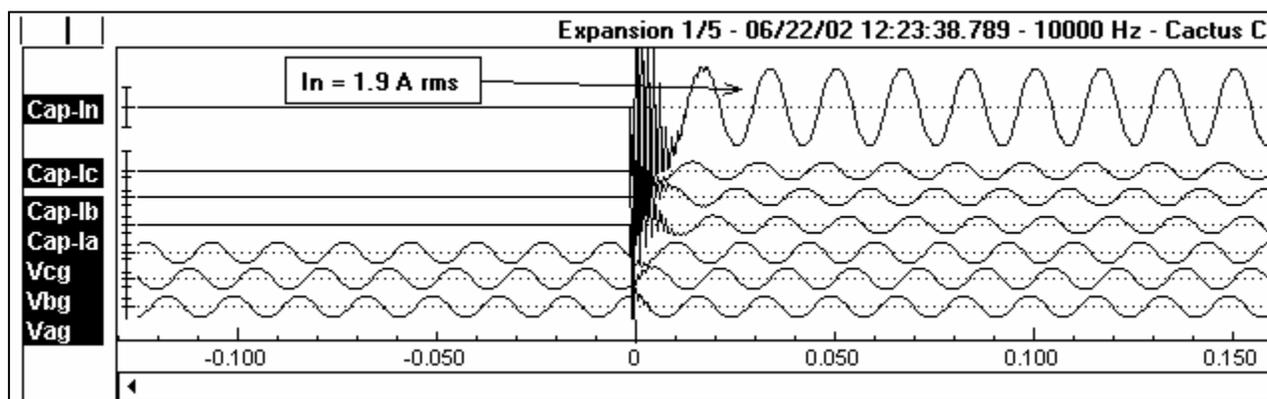
Figure 7: Capacitor Energization Following Failure

Figure 7 shows the captured record when the bank is re-energized. The neutral current has increased to approximately 1.9 Arms thus confirming that a capacitor failure had occurred. Because there was now direct evidence that the capacitors were failing with a DC trapped charge, we were able to approach the manufacturer and demonstrate that there was a problem with the capacitor design in withstanding a normal trapped DC charge. Based on the evidence captured by the DFR, the manufacturer reviewed their design and determined that a thicker mylar film was needed in the capacitor construction.

The capacitors were failing upon de-energization when exposed to the trapped DC voltage on the bank. The theoretical maximum DC voltage was in the range of 1.4 per unit spread across the series groups of capacitor cans and packs. While standards specify both an AC and a DC test for capacitors, when a manufacturer ships a capacitor, only one of these tests is usually performed on the capacitor cans. Generally, the AC withstand tests are done. Capacitor failure mechanisms are different for AC and DC applied voltage. The AC performance of the capacitor pack is limited by the voltage stress magnification at the edges of the foil. The DC performance is more a function of the thickness of the film as well as uniformity, purity, etc. Thus, while thinner films provide better AC performance, thicker films provide better DC performance. To eliminate the failures the manufacturer has proposed increasing the film thickness by 14% to 1.2 mils. Since the internal configuration of the capacitor still has 5 series groups, the resulting stress (in V/mil) reduces by 12.5%. This is illustrated in Table 1. Although Table 1 values are based on AC voltage magnitudes, this stress reduction applies to both the AC and DC stress experienced by the capacitors.

APS and the manufacturer are now in the midst of a change out program wherein the original cans are being replaced with the new thicker film design capacitors.
