Analyzing Transmission Capacitor Bank Events

Robert M. Orndorff
Dominion Virginia Power

Presented to the
Georgia Tech
Fault and Disturbance Analysis
May 5-6, 2003

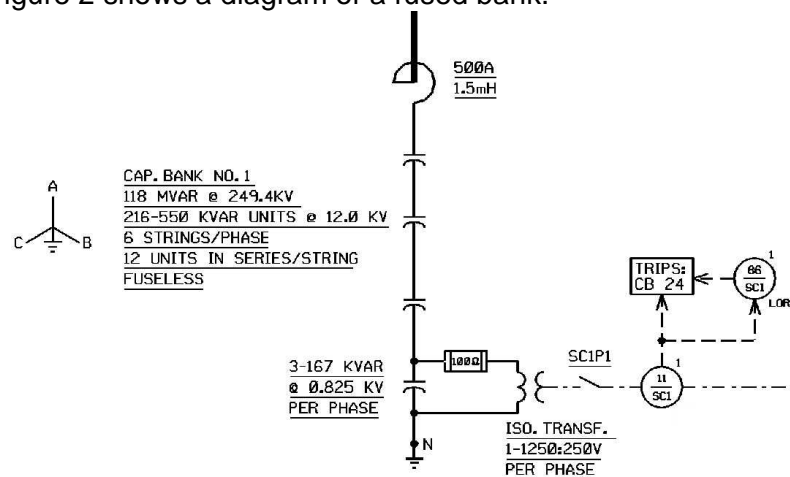
Figure 1 - Fuseless Capacitor Bank Diagram - 230 KV

The Whealton capacitor bank is a fuseless bank. The tap voltage comes from a potential transformer paralleled across the large capacitor near the bank neutral. (See Figure 1) On September 10th the bank tripped with B and C differential targets. The differential voltage changed from +0.75 on B phase and +1.25 on C phase to +1.6 and +2.2, respectively, at the time of the trip. We compared the differential voltage change to the calculations spreadsheet and conveyed the number of cans to look for to the substation department. All the cans were tested on B and C phases and no bad cans were found. Here are excerpts of event reports from the September 10th event. These events are 10 seconds apart and there are four other event reports between these two that show an increasing differential voltage. Notice the difference in the differential voltage on B and C phases.

On September 17th the bank tripped again with the same targets and roughly the same differential voltages. This time we took a more critical look at the voltage change and realized that for failure of any cans above the tap (where most of the bank is) the differential voltage should change in a negative direction, not a positive direction as was found. This led us to look more closely at the large capacitors at the center of the Y and also at the potential transformer. The transformer and capacitors tested good. We then “discovered” that there is a 100 ohm resistor in series with the primary of the transformer. We were blissfully unaware of the existence of the resistor in fuseless banks before this event. The substation department then took a closer look at that resistor. When they did, a considerable amount of corrosion was found on the connections to that resistor. The connections were taken apart, cleaned and reconnected. When the bank went back in service, the differential voltages were -0.09 and +0.13, much better than the previous in service readings!

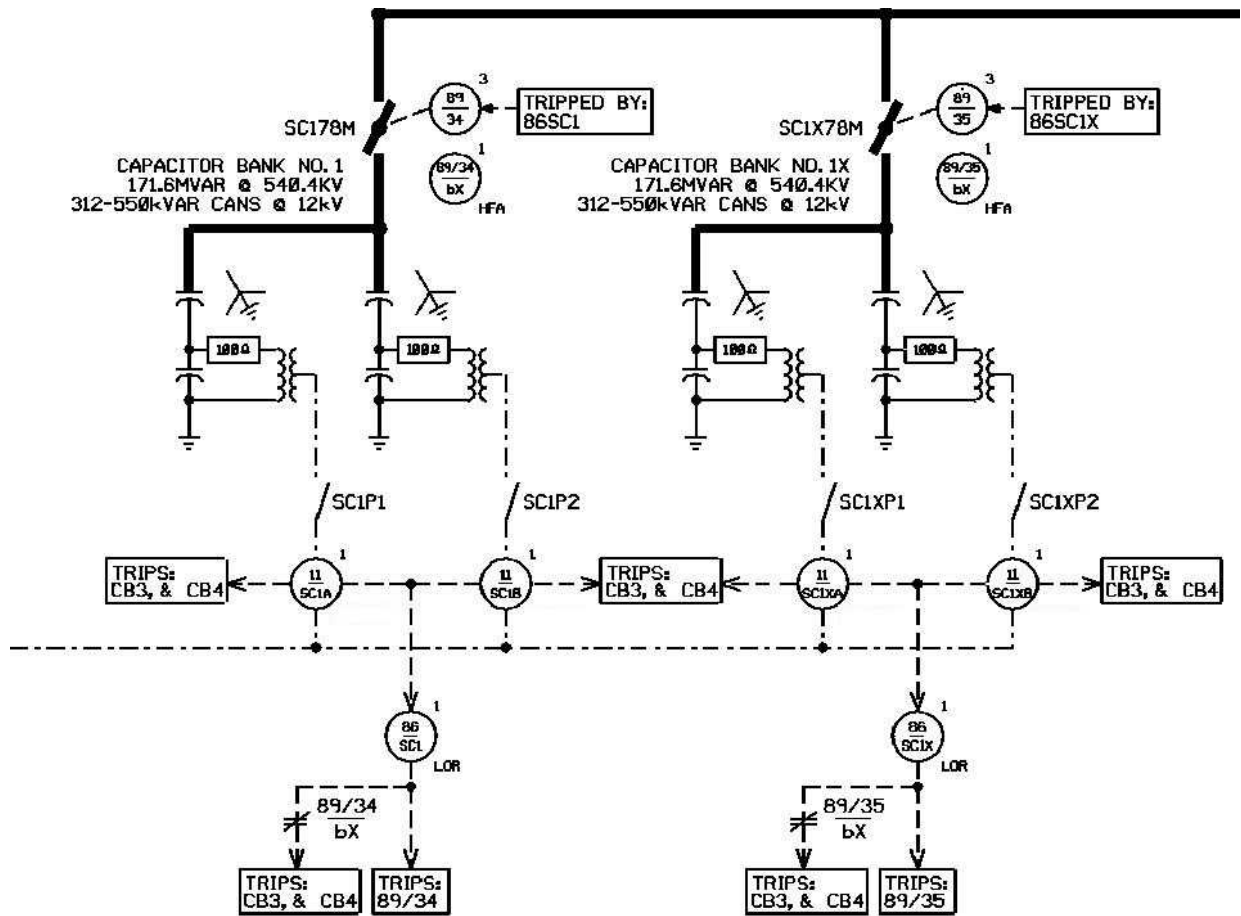
Figure 5 - Mount Storm Capacitor Bank One Line

This bank is actually four fuseless banks operated in parallel. Each of the four banks has its own differential relay. The banks are connected in such a way that there are two sets of two banks, and if needed, only half the bank can be switched in service. The banks are named SC1A, SC1B, SC1XA, and SC1XB. Total rating of the bank is 343.4 MVARs. This bank is critical in providing voltage control in the northwestern part of our system.

When the alleged good half of the bank was switched in (from the previous trip), it stayed energized for 20 minutes and then also tripped with a C phase differential target on the SC1XA portion of the bank. Examination of the differential voltages leading up to the trip showed the same differential voltage, around -1.8 volts.

The immediate fix to the bank was to increase the trip setting to 2.06 volts until we could figure out what was causing the bank to trip. Again, one questionable can was found on the C phase section of the bank. Heat scans were performed on the bank after it went back in service. The scans did show some heating of cans, especially in C phase. The hot cans were replaced and sent to the manufacturer for testing. The manufacturer found that there was a problem with the way the crimping was performed inside the cans, which resulted in the heating.

Because of the critical nature of this bank, it was decided to start monitoring the differential voltages as soon as possible. We already had a relay autopoll in place that we used periodically to automatically dial relays and retrieve status and also to set the time. That polling was modified to dial the Mount Storm differential relays and retrieve the meter information every two hours. This was intended to be a temporary system until something could be worked out to gather the differential voltages without making long distance calls a dozen times a day. We eventually were able to get the data automatically sent to SCADA, and we now have the differential voltage readings taken every 30 minutes and archived.

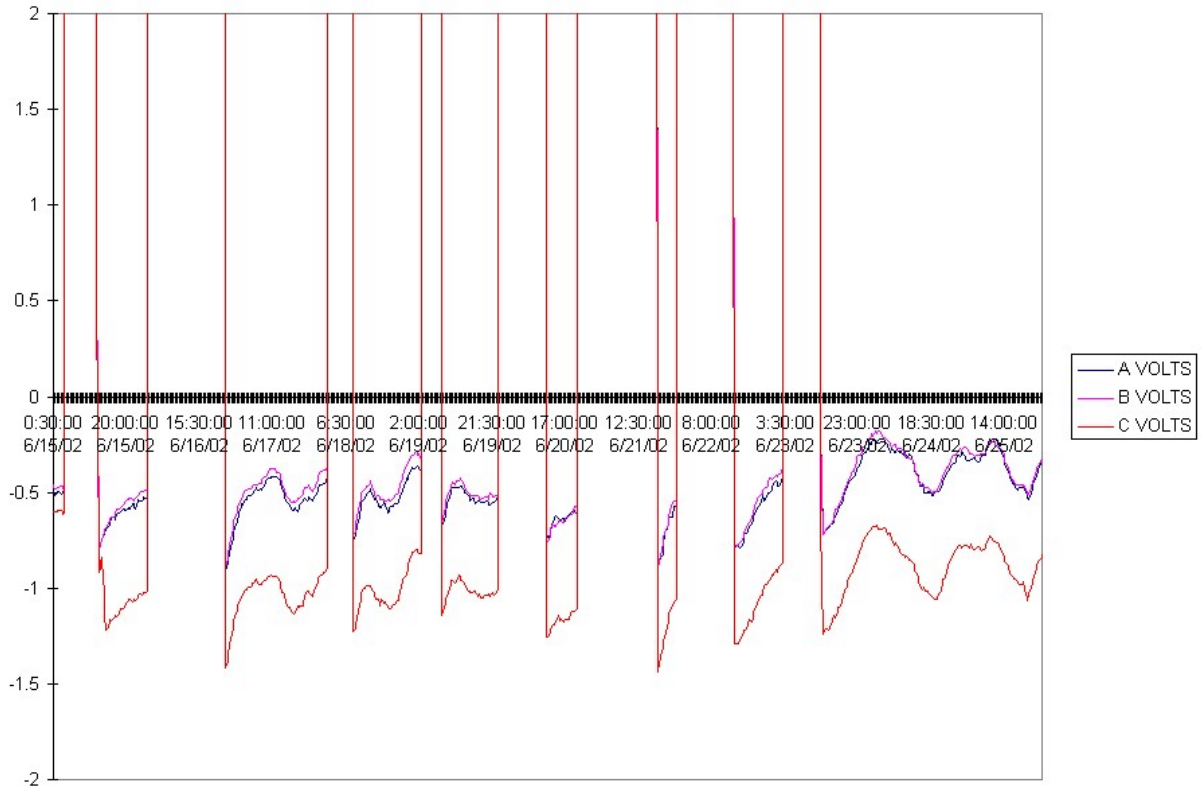
Figure 6 - Differential Voltage over a 10 day period

We are now able to get the SCADA differential voltage data imported into a spreadsheet and then graph the differential voltage over time. The graph showed some trends that were useful in discovering what was going on. The differential voltage spikes in a negative direction shortly after energizing and then settles out. Heating by sunlight also causes a noticeable change in the differential voltage. We are currently watching these trends to see if they affect the relay trip point enough for us to take action. Figure 6 is a graph of the differential voltage of the “1A” portion of the bank for a ten day period in the summer of 2002. The negative dips after energizing are very noticeable, and you can also see the change due to heating and cooling at the end of the graph. The very high voltages are when the bank was not in service.

We also saw that the capacitors change their capacitance over the first few months of service. As a result of this, we are starting a program to re-null some banks on a periodic basis by resetting the K factor.
