Analysis of a Cascading Operation for Two Line Faults at National Grid

By: Yujie Irene Lu and Song Ji, National Grid

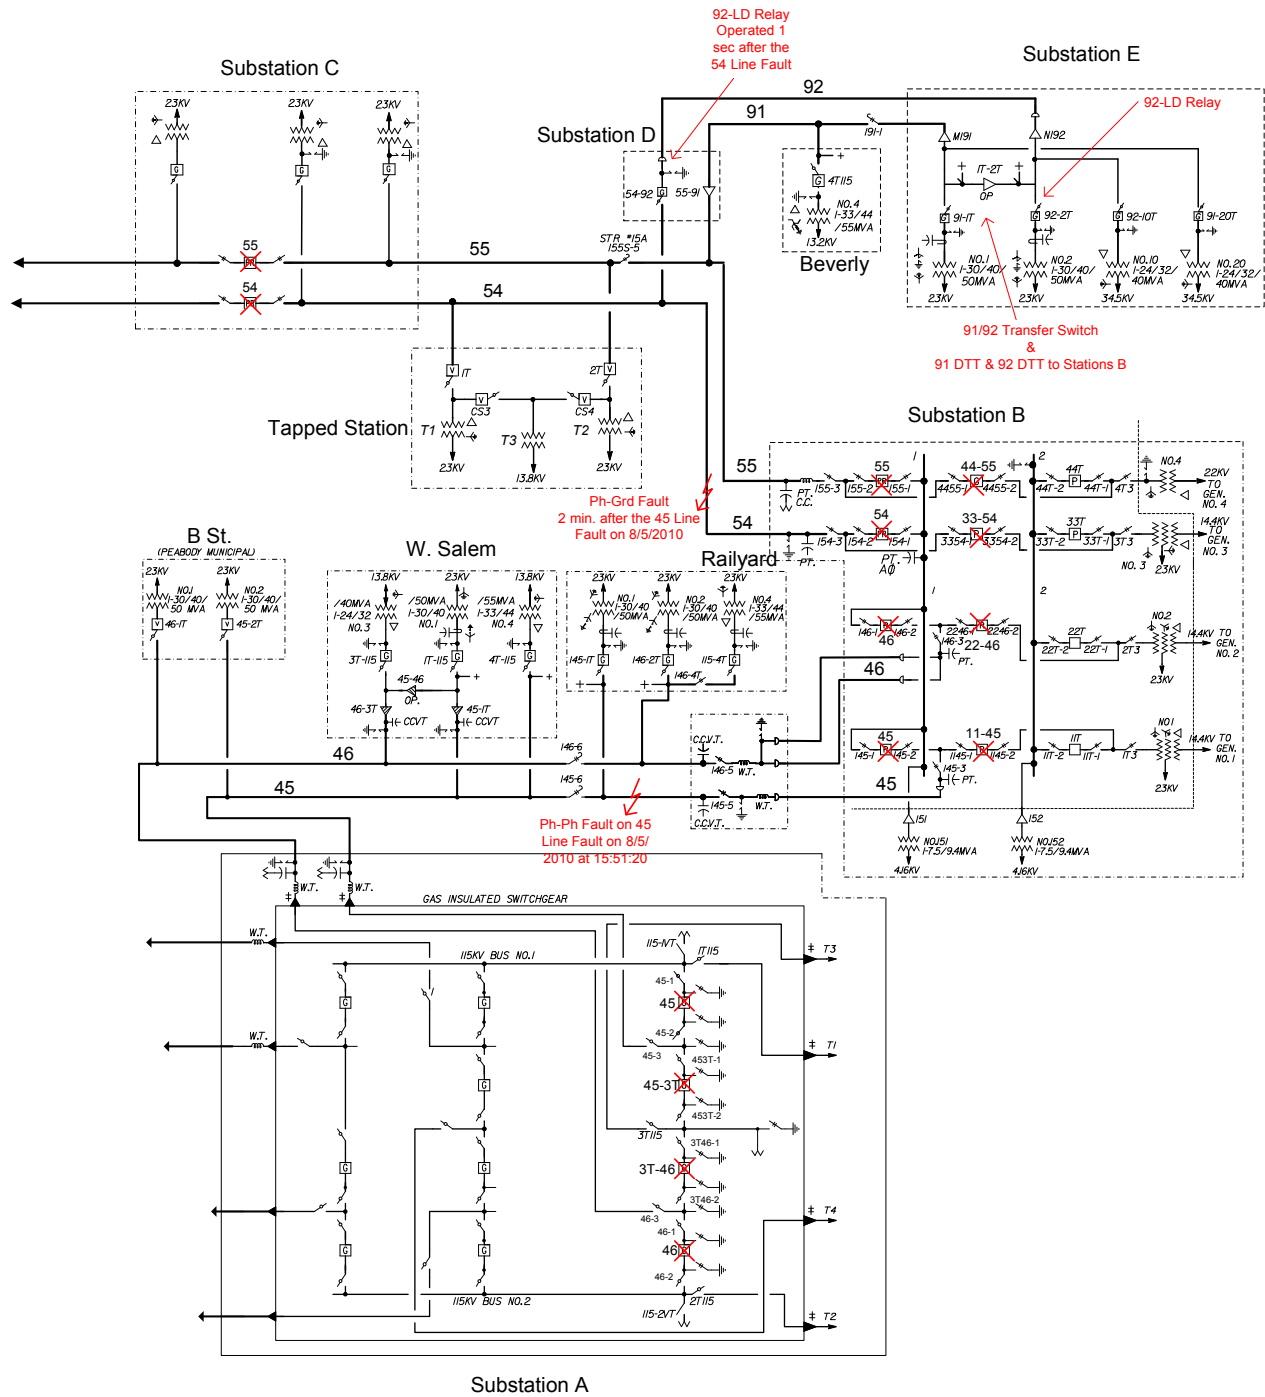
Figure 1. System One-Line Diagram with the 45 and 54 Line Faults

1. The voltage angle across the 45 or 46 open breaker at Station B should not exceed 10 degrees as long as all other lines in the area (e.g. 45 or 46, 54 and 55) are closed in. However, the angle does get close to 10 degrees (the simulation shown 9.1 degrees at shoulder peak load) with all generators running at Station. No shaft torque problems at Station B were seen from the switching event on August 05, 2010. However, if the 46 line is open at the same time as the 45 breaker opens and closes, then the angle across the 45 open breaker approaches 25 degrees. This subjects one of the generators at Station B to an 81% of shaft torque (i.e. % of MVA nameplate). The IEEE recommended maximum is 50% of nameplate MVA. Note however that this constitutes an

2. The voltage angle across the 54 or 55 open breaker at Station B can exceed 10 degrees, even when the parallel line is in-service and closed through. When the parallel line is out of service, the angle can approach 25 degrees. However, in both cases, the Shaft Torque does not come close to 50% of nameplate for any of Station B units. Therefore, it is recommended to open up the synchronism check setting to 30 degrees for the 54 and 55 breakers (Figure 1).

Why did the 92 cable differential (LD) scheme between Stations E and D operate on the 54 fault? Based on the manufacturer’s recommendation, this 92 LD phase bias had been set at 1.0 Ampere since 1996. While, a revised application note from the manufacturer was received in 2007, in which it was suggested to reset the phase bias at 2.0 Amperes or higher to insure that the line differential relay provides the optimum level of security without sacrificing dependability. Too low phase bias setting may compromise security for CT errors during external fault with high fault current as per the manufacturer. Give that it is very likely that the 92 LD relay operated on the through 54 fault because of the sensitive phase bias setting (Figure 1).

“unplanned” switching event (opening and closing the breaker 45 while the breaker 46 is open); therefore, this is not in opposition to the IEEE recommendation. It is recommended to open up the synchronism check setting to 20 degrees that should provide enough margins to close the 45 breaker with the 46 line in-service, while at the same time providing a level of safety when the 46 line is out of service and the 45 breaker trips and attempts to auto-close (Figure 1).

1. Based on the National Grid Transmission Planning's recommendation, reset the synchronism check angle from 10 to 20 degrees for the breakers 45, 11-45, 46 and 22-46 and to 30 degrees for the breakers 54, 33-54, 55 and 44-55 at Station B.

2. Based on the manufacturer's recommendation, reset the phase bias from 1.0 to 2.5 Amperes for the 92 cable differential relays at both of Station D and E.

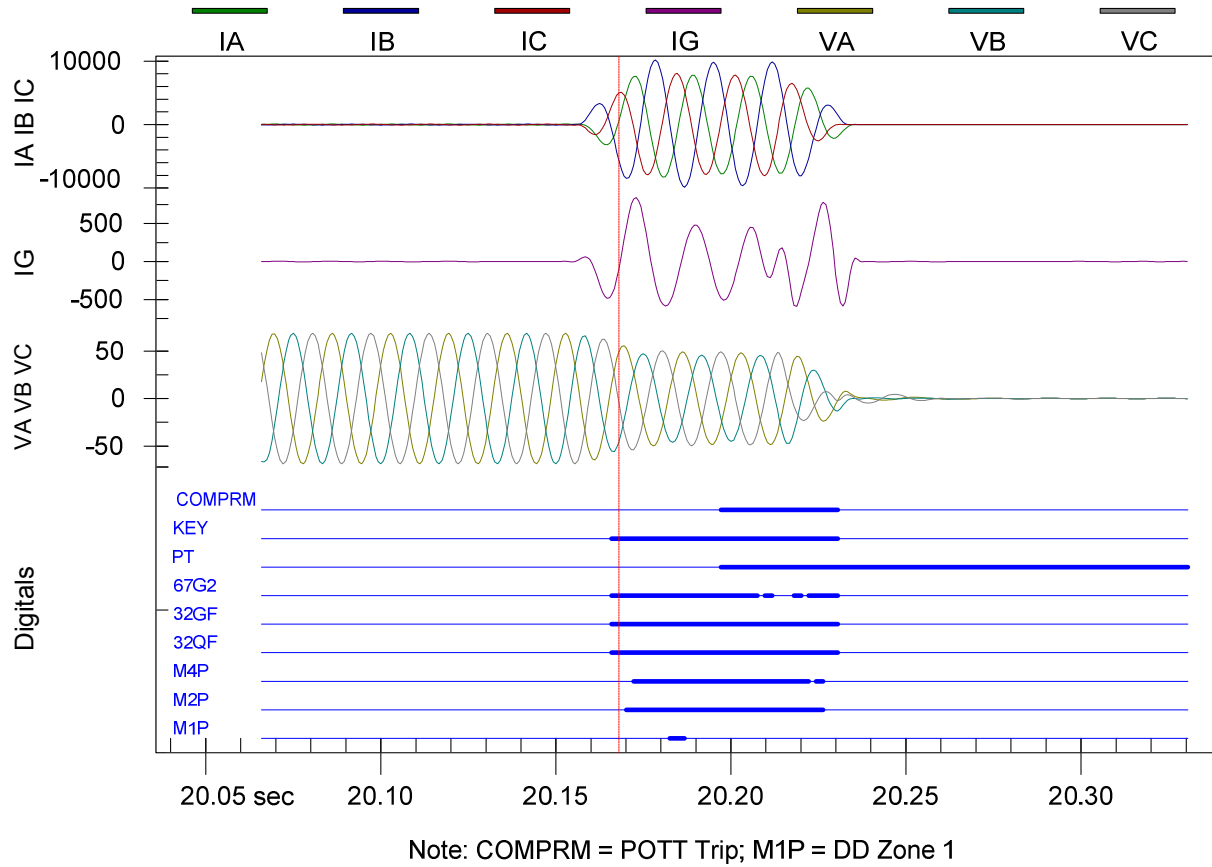
Figure 2. 45 Line Relay Waveforms at Station A on 08/05/2010 @ 15:51:20

1. A phase fault occurred on the 45 line and the 45 line Permissive Overreaching Transfer Trip (POTT) scheme operated and isolated the fault correctly (Figure 2). The 45 line was successfully auto-closed at Station A, but failed to auto-close at Station B.

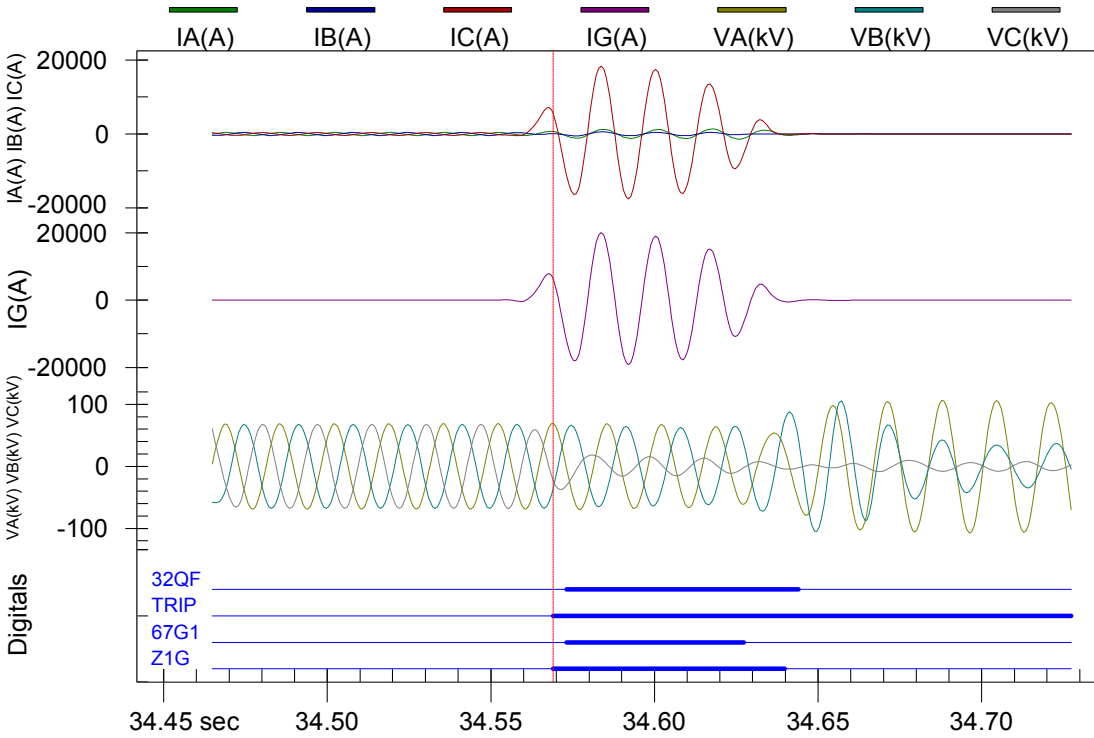
Figure 3A. 54 Line Relay Waveforms at Station B on 08/05/2010 @ 15:53:34

2. Two minutes and 14 seconds after the 45 line fault, later (at 15:53:34), a C-phase-to-ground fault occurred on the line 54 near Station B and the line 54 directional ground instantaneous (DG Inst) and the directional distance ground zone 1 (DDG Zone 1) relays at Stations C and B, respectively, operated and isolated the 54 line fault correctly (Figure 3B). As per design, the 54 line protection also keyed a Direct Transfer Trip (DTT) signal to Station E correctly. Simultaneously, the line 46 directional ground instantaneous (DG Inst) relay at Station A sensed this 54 fault and sent a Direct Transfer Trip (DTT) signal to Station B. As a result, the line 46 over tripped on this close-in 54 fault at both A and B terminals (Figure 3A and 3C). The A terminal auto-closed successfully but the B terminal did not auto-close.

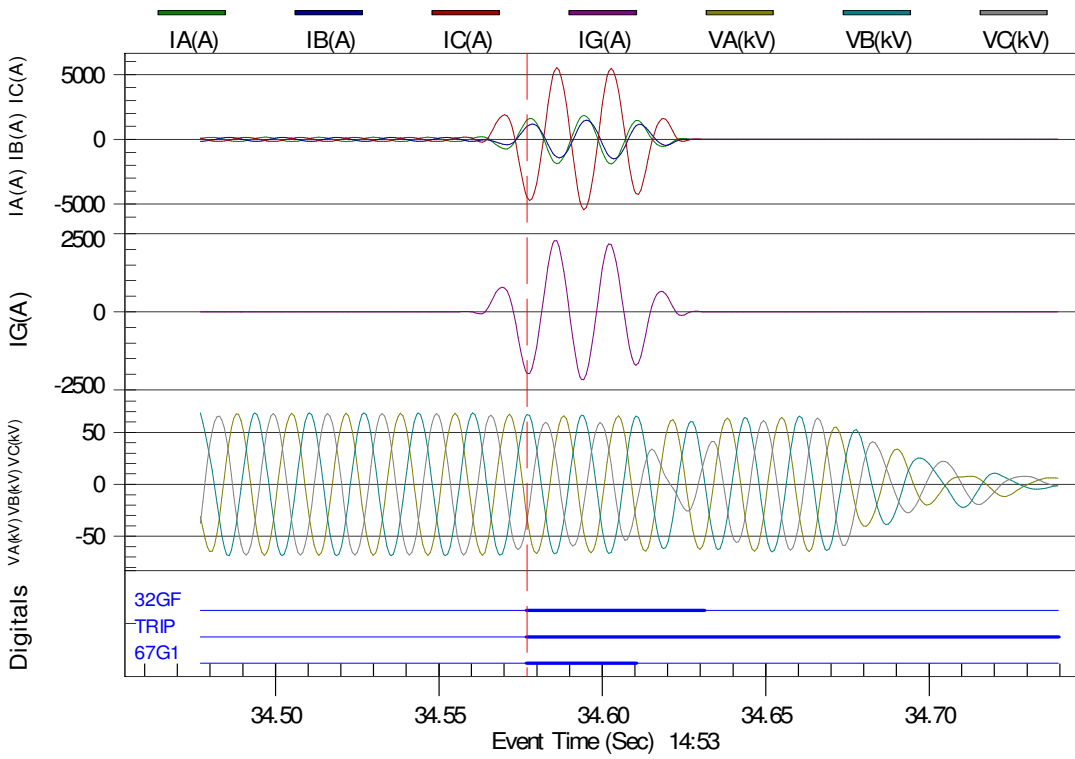
Figure 3B. 46 Line Relay Waveforms at Station A on 08/05/2010 @ 15:53:34

1. The 46 DG Inst relay would not see external faults if only any one component out. In another word, if the system is under the N-1 condition. That implied that the pickup setting of the relay was proper as per the company protection application philosophy.
2. Due to both of an unit and the line 45 out of service at the time, the 46 DG Inst relay sensed the fault current was about 25% higher than only one component was out and it was just above the pickup value. As a result, the relay over tripped the line 46 at Station A and initiated a direct transfer trip (DTT) signal to Station B and tripped the 46 terminal over there. Given that the 46 DG Inst operation was correct but undesired.

4. Although National Grid does not normally set relay with considering N-2 condition, to be more secure, it is suggested to raise Station A line 45 and 46 directional ground instantaneous pickup value with considering two components out of service to prevent from over tripping for any external faults since one of the generation unit is off for most of time as confirmed with the owner.

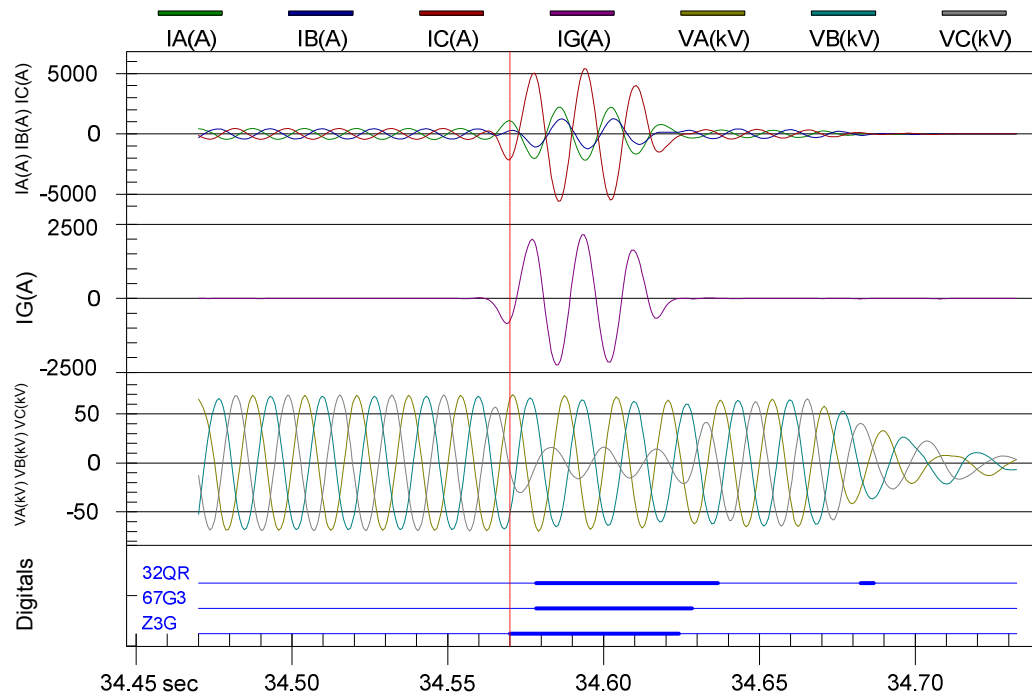
Figure 3C 46 Line Relay Waveforms at Station B on 08/05/2010 @ 15:53:34

46 Line tripped at Sation B by 46 DTT from Station A
