Analysis of Selected Motor Event and Starting Reports

Derrick Haas, Jason Young, and Ryan McDaniel, *Schweitzer Engineering Laboratories, Inc.*

This paper investigates several real-world events with data from both motor starting reports and event records. The data demonstrate the value of having devices capable of recording motor data during starts and fault events and of capturing and reviewing such data for the purpose of determining root cause. Lessons learned are shared to help in troubleshooting motor problems and to avoid potential misoperations in motor protection.

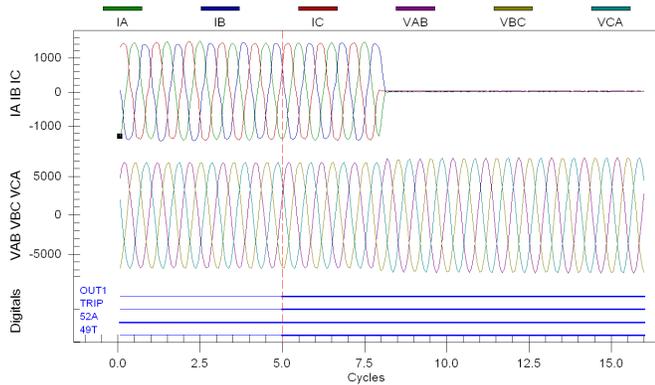
Fig. 1. Event report from a microprocessor-based relay showing a trip on thermal overload

We can see from the oscillograph that the currents appear to be balanced. This machine has a rated full-load amperes of 333 A. The current magnitude shown in Fig. 1 is approximately 4.4 times the rated current. In addition, the 49T bit is an indication that the relay thermal overload protection called for the trip.

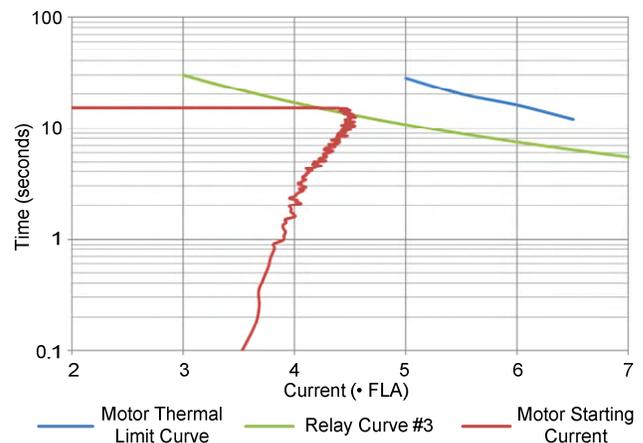
Fig. 3. Motor starting current, relay trip characteristic, and hot thermal damage curve on the plot of time versus current

Based on (1), (2), and Fig. 3, we can assert that the relay operated consistently with the published trip characteristic and the settings. So why did the relay trip? Were the curve settings set too fast? Could an adjustment to the relay curve setting be the solution?

We noticed in Fig. 3 that there was ample room between the motor manufacturer thermal limit curve and the relay tripping characteristic. The decision was made to adjust the curve setting from 3 to 4. This would not compromise the

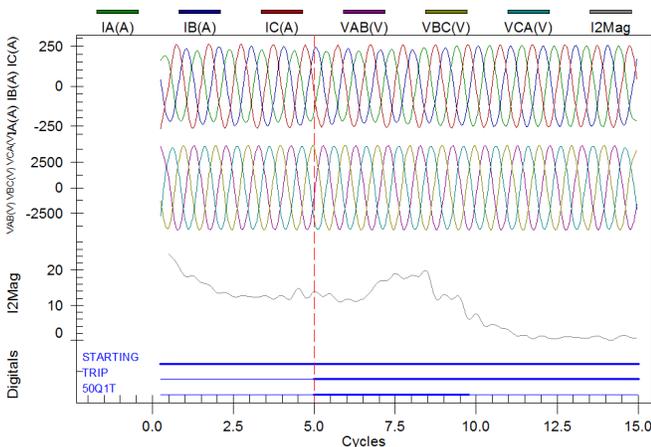
Fig. 7. Initial unbalance trip

From the relay event report shown in Fig. 7, we can see that the 50Q1T element caused the trip. From the previous settings, we know that this element is set to operate when the negative-sequence current (3I2) is greater than half of the full-load amperes (FLA1), or 19.5 A primary.

Fig. 7 shows that the I2 magnitude at the time of the trip was approximately 12 A primary. This means that 3I2 was approximately 36 A primary and well above the pickup threshold of 19.5 A primary. However, the event report also shows that less than 5 cycles after the trip was issued, the

Because a motor draws approximately six times its full-load amperes during a start, it is common for the CTs to experience some saturation. Therefore, unbalance elements should not be set to operate instantaneously because they can operate on false unbalance quantities that result from CT saturation. It is important to remember that the threat of damage posed by negative-sequence currents is thermal in nature. Therefore, equipment will not be damaged instantaneously.

One reference recommends that a definite-time element operating on negative-sequence current be set at 1.5 A secondary with a 4-second delay to ride through the saturation that can occur during a start. This setting ensures the security of the element [5].

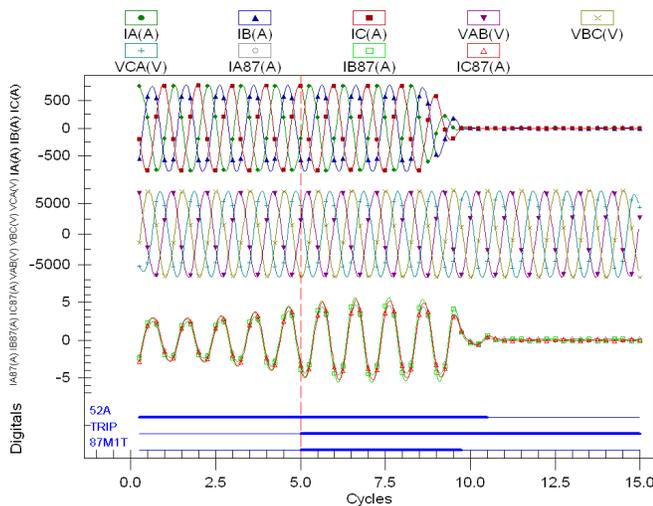
Fig. 9. Filtered event report of a differential trip

There is no set time delay; however, the pickup is larger than some of the settings recommendations discussed in the previous paragraph. The microprocessor-based relay event report data for the trip are shown in Fig. 9. We can see that the currents and voltages appear very balanced and below the full-load ampere rating of the motor. In addition, we see approximately 5 A secondary of differential current just as the relay tripped. Also noteworthy is that all three differential currents (87A, 87B, and 87C) are almost perfectly in phase with roughly equal magnitudes, indicative of zero-sequence current.

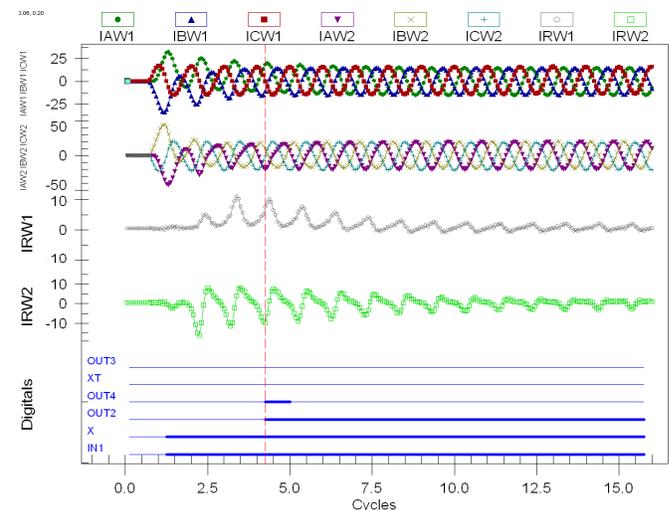
Fig. 14. Filtered event report of the phase differential trip

The oscillograph from the filtered event report is shown in Fig. 14. Notice how the ground currents are not sinusoidal and decay throughout the event report. Whenever we see ground current that decays, it is an indication that CTs may be saturating.

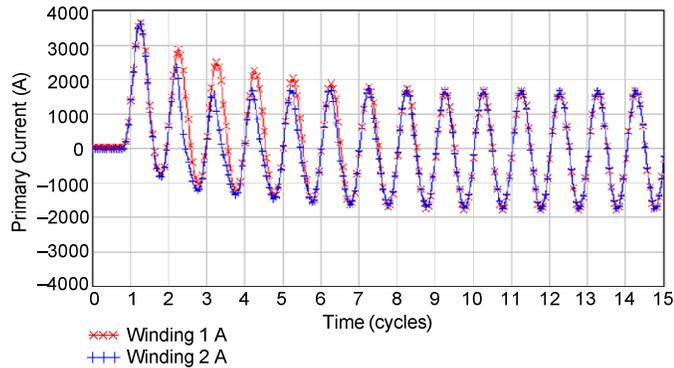
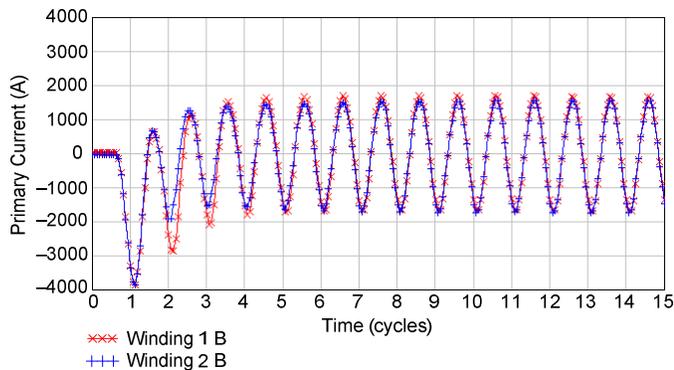
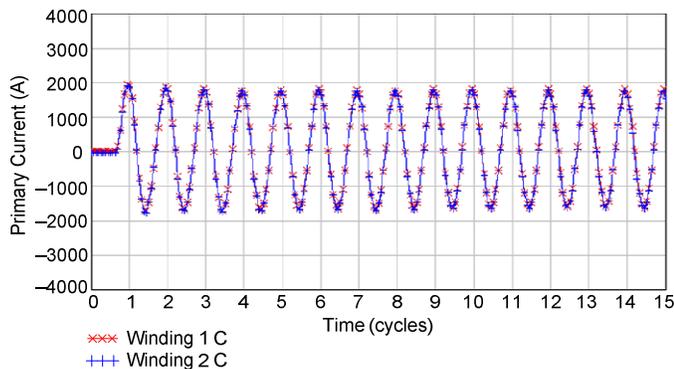
Note that for the C-phase currents, the Winding 1 current and Winding 2 current in Fig. 17 almost match. However, for A-phase and B-phase in Fig. 15 and Fig. 16, we notice that the Winding 2 currents experience saturation. The two sets of CTs

The ultimate solution for this particular problem is to replace both CTs during the next scheduled outage so that they have identical CT ratios, ANSI ratings, and saturation characteristics. In the meantime, the slope settings were adjusted to ensure security during starting and to avoid the nuisance targeting that was a result of the previous timer scheme.

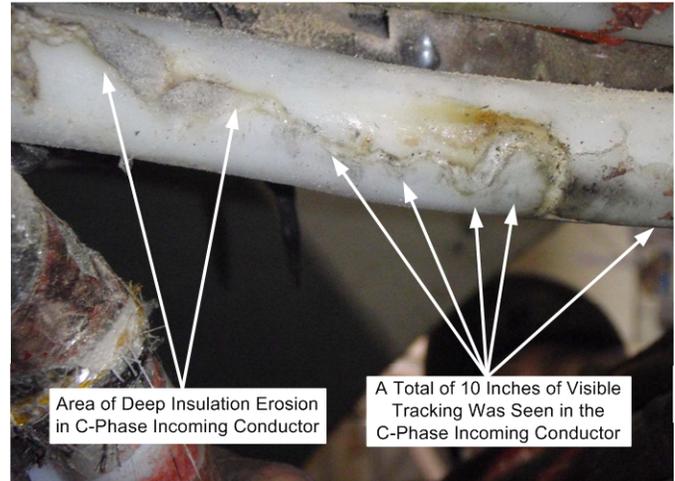
Fig. 31. C-phase incoming conductor damage

Once the external arcing was seen on the neutral, the wrapping around the incoming C-phase conductors was removed to reveal the silicon jacket. This revealed apparent tracking from a fault and showed the silicon jacket eroding. Based on the length and trajectory of the marks, it is apparent that moisture ingress led to the breakdown of insulating material. Fig. 31 shows the tracking marks in the incoming C-phase line.

At this point, we have clearly found an insulation breakdown on the C-phase incoming conductors and tracking on the neutral conductor. However, a connection between the incoming C-phase and neutral would not produce fault currents but a motor unbalance condition. What about that burn mark that was found on-site?

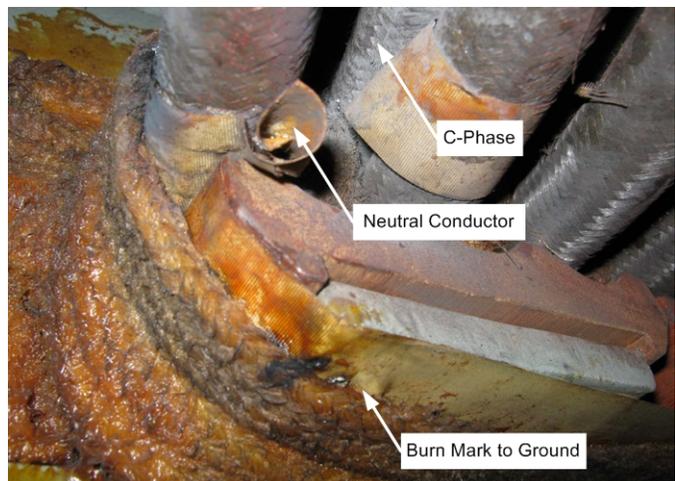
Fig. 32. Ground point

Fig. 32 shows a very tiny burn mark that is very close to the neutral and C-phase tracking. This is the path for C-phase to ground and led to the large amount of current seen.

This particular fan was located between two areas with large temperature differences that led to condensation forming in the motor. This condensation gathered at the bottom of the motor housing and found a way to seep into the conductors, which eventually broke down the insulation. With the insulation breakdown and a supply of water running near the C-phase conductor, the dielectric strength between C-phase and ground broke down and allowed a temporary flashover. Fig. 33 shows an electrical diagram of the fault.
