# Analysis of the Plant Gorgas Breaker Failure

By: Jerrod B. Moll, Alabama Power

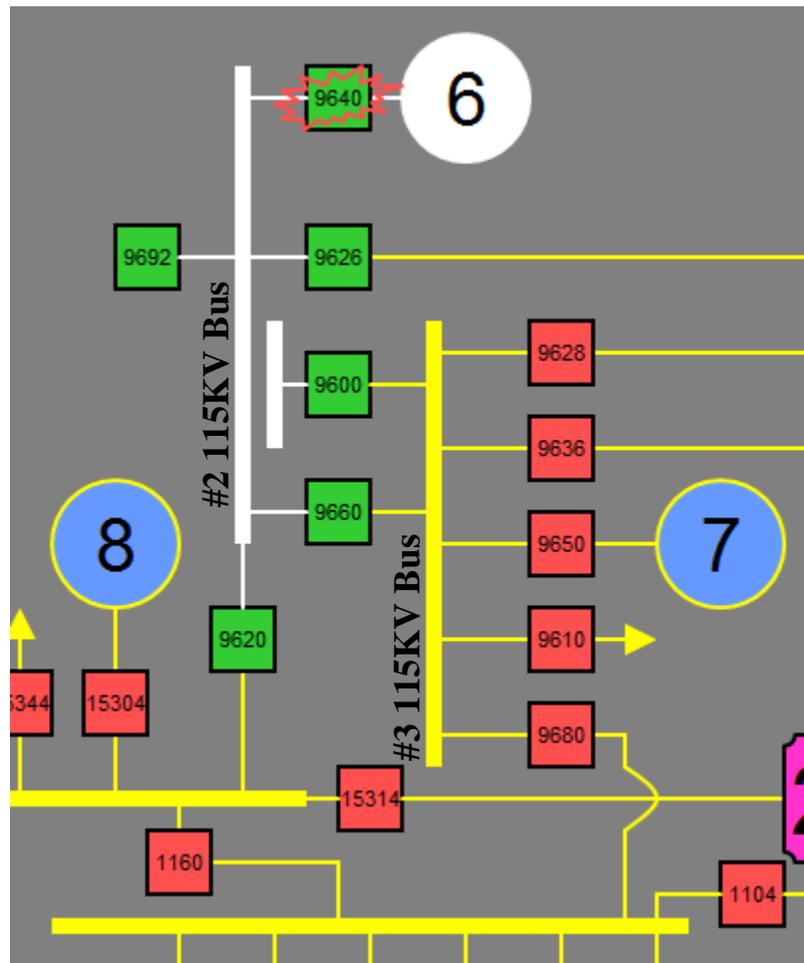
On June 18<sup>th</sup>, 2008, Plant Gorgas was operating normally except for Unit #6 which was coming back online from a maintenance outage. Breaker 9640 was closed to bring Unit #6 online at approximately 12:50 AM. When Breaker 9640 is closed it fails catastrophically and trips the #2 115KV Bus differential which will isolate the faulted breaker. The fault is *not* isolated and it now includes the #3 115KV Bus. The #3 115KV Bus differential operated but it does not open the breakers. This starts the operation of several lines feeding Plant Gorgas. Units #7, #8 and #9 also trip offline as well. After three seconds there is a pause in operations and then one second after the pause it starts up again. This time Unit #10 trips offline and starts the operation of numerous lines feeding and around Plant Gorgas. The whole event lasts for thirty six seconds from the closing of Breaker 9640 until the #2 and #3 115KV Buses are isolated. Within another 49 seconds all the breakers are reclosed and operational, except for one at USX

Figure 2: Plant Gorgas #2 and #3 115KV Buses - Shortly after Breaker 9640 fails

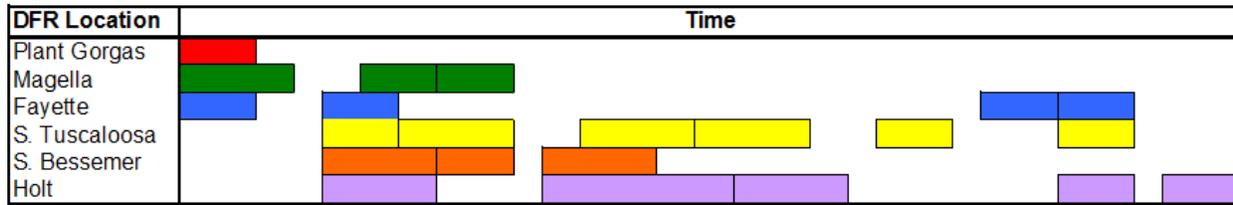
Figure 4: DFR Event Record Timing Diagram

It was also discovered that the event actually contained two faults. The first one was a three phase fault, which was the failing of Breaker 9640. The second fault started as a phase 2-3 but soon turned into a three phase fault like the first one. The magnitude for a three phase fault on Plant Gorgas's #2 115KV Bus was approximately 48,000 amps.

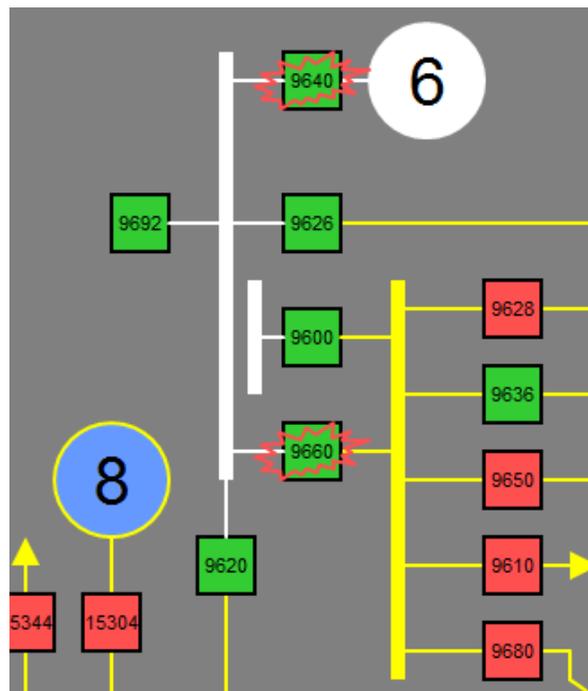
It was confirmed that the #2 115KV Bus differential operated for the failure of Breaker 9640, but why didn't that isolate the fault? After field personnel examined the switchyard it was discovered that when Breaker 9640 failed it sprayed oil onto a neighboring breaker. That breaker was Breaker 9660, the #2 and #3 115KV Bus Tie Breaker. The oil then caught fire and the fault that started out on the #2 115KV Bus now included the #3 115KV Bus.

Figure 5: Plant Gorgas #2 and #3 115KV Buses - Shortly After the Fault Included Both Buses

The #3 115KV Bus differential operated but the LOR did not trip any of the breakers on the #3 115KV Bus. Breaker 9636 tripped when the fault included the #3 115KV Bus because the fault magnitude was so high and it had old electromechanical relays. It was later discovered that the Lockout Relay (LOR) for the #3 115KV Bus had failed before the event took place but we had no way of monitoring these coils. Since the differential couldn't trip the bus breakers lines feeding Plant Gorgas began to trip out for Zone 2 and reclose. Unit's #7, #8, and #9 trip off as well for Out of Step, this was a loss of 421 MW's. We now had the answer to why the fault was not isolated to the #2 115KV Bus and when is spread to the #3 115KV Bus. We also learned why the lines around Plant Gorgas began tripping.

We took away quite a few action items from the event to help prevent similar types of events in the future. Alabama Power has started to install monitoring devices on all LOR coils at all critical locations which included Plant Gorgas. Inspect a random sampling of similar breakers for any signs of problems to help determine if this was an isolated case or if new measures need to be taken for breaker inspections.

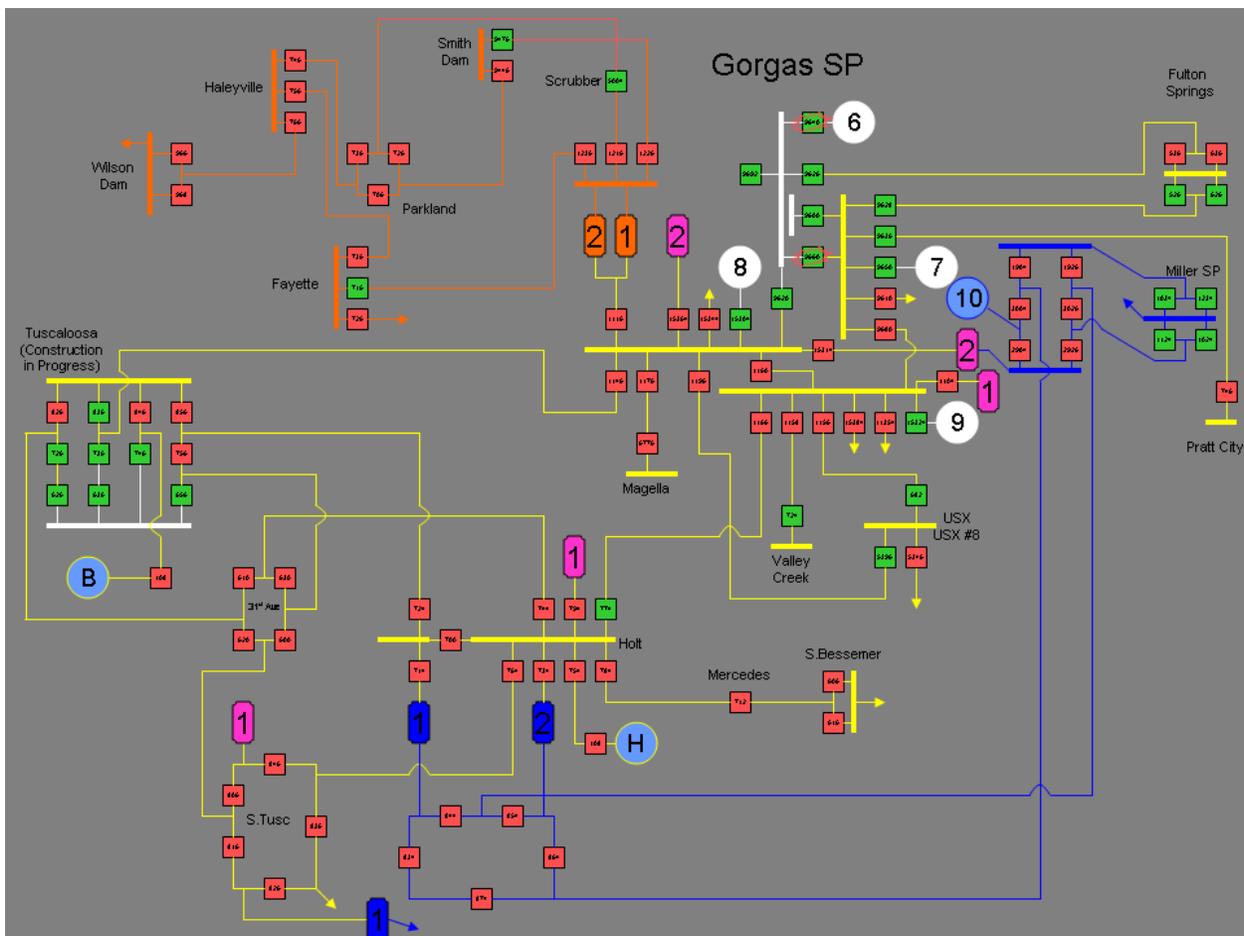
Figure 6: Event Area Single Line Diagram - Shortly After the 1<sup>st</sup> Fault Disappears

The second fault appears and Unit #10 soon tripped offline which accounted for 700 MW's. This significant loss in generation causes more lines to trip out for Zone 3 and reclose. One hydro facility is also tripped offline during the second fault, which accounts for another 45

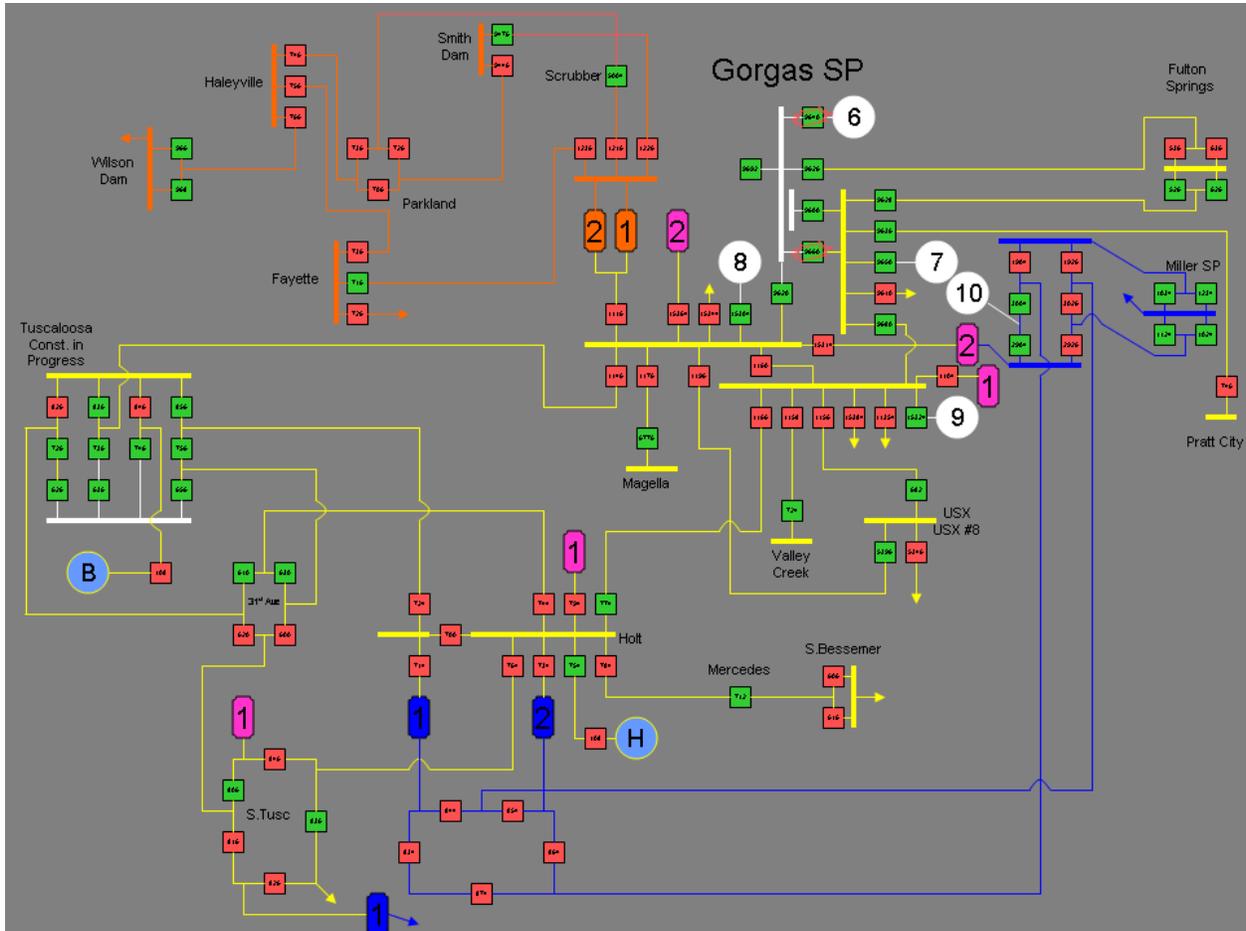
MW's. Eventually all lines feeding the #2 and #3 115KV Buses trip out and the fault is isolated. The second fault was discovered, on site, to have been a huge fireball of burning oil that engulfed most of the #3 115KV Bus from the failing of Breaker 9640.

Figure 7: Event Area Single Line Diagram - Shortly After the 2<sup>nd</sup> Fault is Isolated

After reviewing all event records it was determined that everything that operated, operated as it was designed and installed to do.
