# Electrical Characterization of Vegetation Faults on Distribution Feeders

**Abstract--** Vegetation management is the single largest maintenance expense on distribution feeders. Vegetation intrusion causes a loss of reliability, reduction in power quality and safety issues. This paper describes the nature of vegetation-induced faults, including low-current events that do not trip protection devices and recurring high-current events that cause interruptions and outages. Actual field data and fault waveforms are included from staged vegetation faults at the Downed Conductor Test Facility at Texas A&M University.

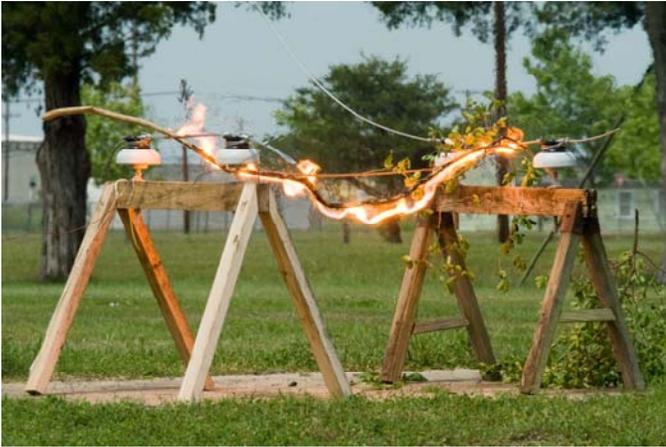
Fig. 1 shows one of the power arcs from Experiment 1 in progress. The arc had just formed and was still quite close to the branch. Hot arc plasma rose by convection and caused the arc to rise away from the branch. Arcs typically lengthened substantially before extinguishing. Researchers visually estimated the length of many of the elongated arc paths to be two to three meters (six to nine feet) in a generally semicircular shape terminating at the contact points between the branch and the conductors. Most of the arcs persisted for approximately fifteen cycles, but the final burst was significantly longer. Researchers believe this burst was of extended length primarily due to a large gust of coincident wind. Rapid dispersion of the plasma prevented longer arcs from forming, resulting in more continuous arcing closer to the surface of the limb. This extended burst caused the fuse to operate, de-energizing the conductor.

Fig. 1. Arcing crape myrtle

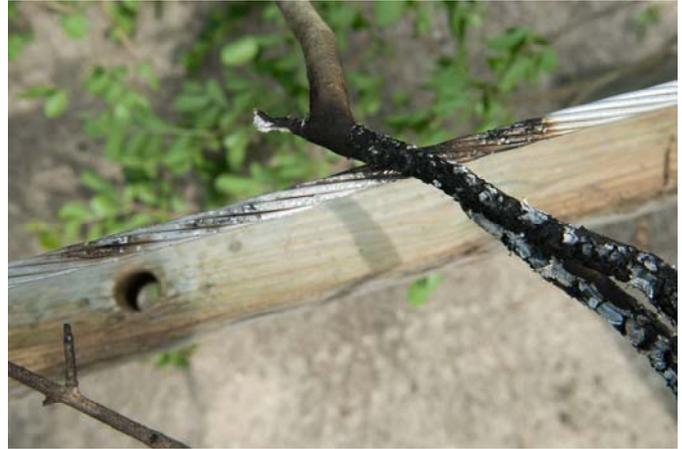
Following the experiment, researchers inspected the conductors and the branch for physical damage. Not surprisingly, the branch suffered significant physical damage. Fig. 2 shows a picture of the branch contact point with the phase conductor. As can be seen in the photograph, there was significant damage to the conductor as well as the heavy damage to the branch. While it is likely that a small tree branch will fail sooner than the conductor, the high-current arcs clearly damaged the conductors, potentially impacting their mechanical integrity.

Fig. 2. Damage to branch and phase conductor after Experiment 1.

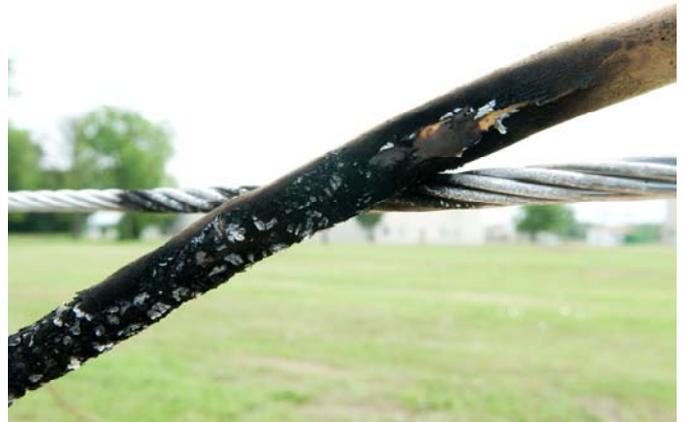
Fig. 3 shows the branch contact point with the neutral conductor. Again there is clear and significant damage to both the branch and conductors. Fig. 4 shows clear damage along the branch mid-section, particularly near the point where the carbonized paths met. Bark can clearly be seen peeled back from the wood in the photograph.

Fig. 3. Damage to branch and neutral conductor after Experiment 1.

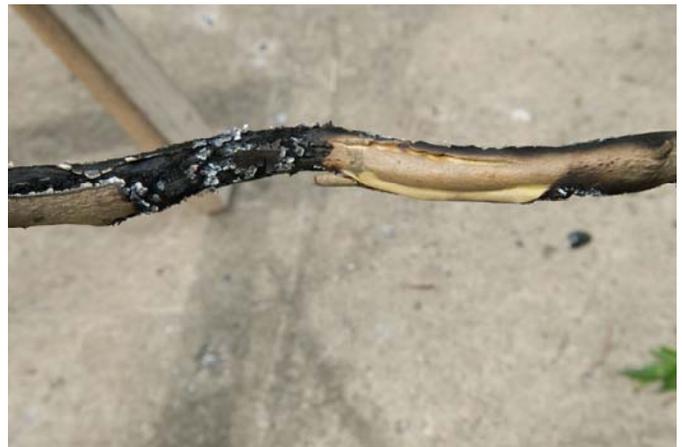
Fig. 4. Damage to branch, mid-branch after Experiment 1.

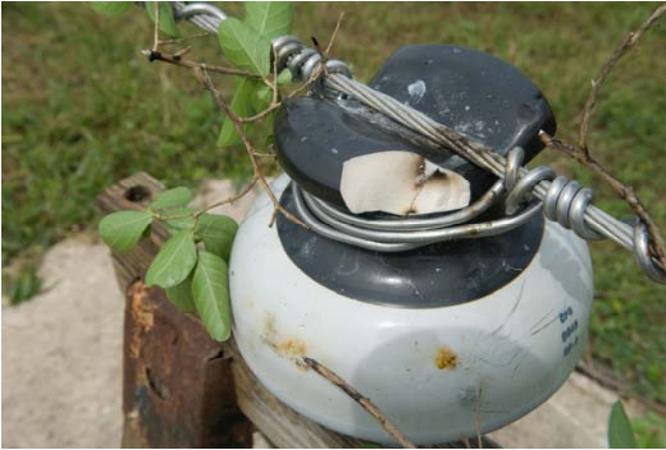
Finally Fig. 5 shows damage to one of the insulators supporting one of the conductors. Photographs prior to the experiment show a small stem from the branch making incidental

contact with the insulator. The insulator was not new, but had only minor damage from previous use. During the experiment, arcing through the branch cracked the porcelain, further damaging the insulator and ultimately causing a large porcelain chip to separate.

Fig. 5. Damage to insulator after Experiment 1.

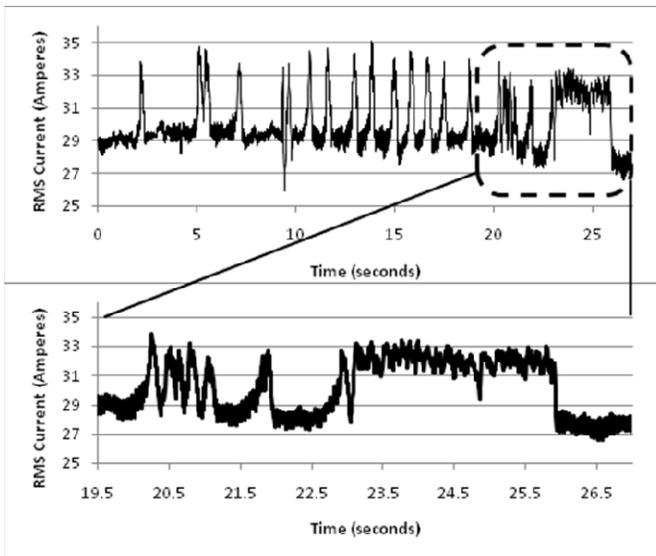
Fig. 6 shows recorded data from a 27-second period during the fault recorded in Experiment 1. The figure shows RMS neutral current calculated at two points per cycle. Each peak on the graph corresponds to one burst of the higher current. The final extended burst can also be seen. As observed from the graph, load levels for the recorded period are nominally 30 amperes, with bursts up to approximately 35 amperes. Because of normal imbalances between phases of the feeder, this does not mean that the fault current was five amperes. Observations from the clamp-on ammeter were erratic and difficult to judge, but it is believed that actual fault current during these bursts was closer to its maximum available value of 14.4 amperes.

Fig. 6. RMS neutral current, Experiment 1.

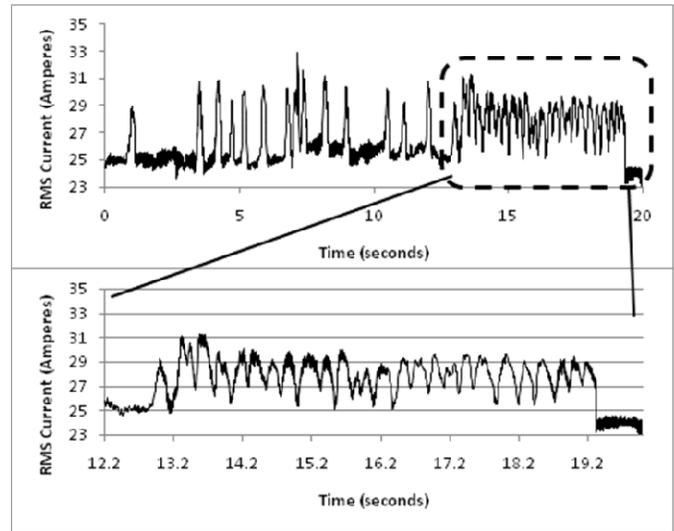
RMS neutral current for a 20-second period is shown in Fig. 7. As with Experiment 1, arc bursts during Experiment 3 increase the substation-measured neutral current by approximately five amperes.

Fig. 7. RMS neutral current, Experiment 3

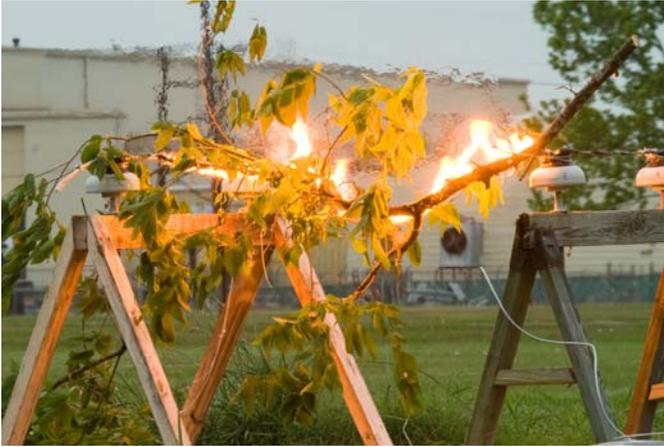
Fig. 8 - Fig. 11 are photographs taken during and after Experiment 3. Fig. 8 shows the branch during the eighteen-second interval of power arcs before the branch first moved. Fig. 9 shows the branch immediately after the final arc burst in that period. It can be seen from the photograph that it has dropped from its original position and is no longer arcing.

Fig. 8. Arcing branch, Experiment 3.

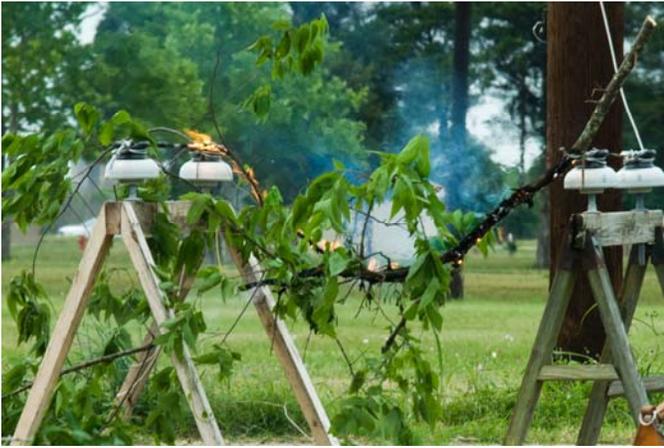
The final 6.5-second arc burst did not blow the 2T fuse. Rather the contact point at the neutral conductor burned through so that the carbonized path was not physically present to reestablish another arc. The branch did not fall clear of the conductors, but its mechanical configuration was altered such that there were new points of contact between the conductors and the branch. The branch remained in contact with the conductors for an additional one minute, 45 seconds, and a new carbonized path began to form along the branch. At this time, the new contact point burned through, causing the branch to fall clear of the neutral conductor and come to rest on the concrete slab on which the tests were performed. Researchers allowed the branch to remain in contact with the concrete and energized primary phase conductor for approximately one minute, but no additional activity resulted.

Fig. 9. Burned-through branch immediately after final arc burst, Experiment 3

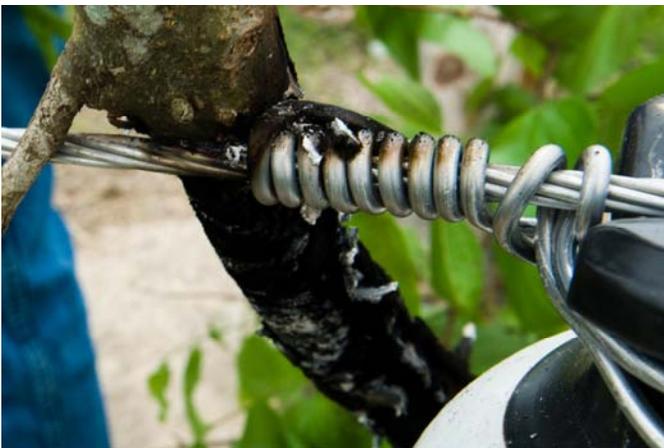
Fig. 10 shows the end of the branch contacting the phase conductor, which remained attached by means of a small offshoot branch, visible in the photograph. Fig. 11 shows a larger portion of the same section of conductor with the branch moved to show the damage. As with Experiment 1, the conductor remains intact, but it has sustained damage which may adversely affect its mechanical strength and structural properties.

Fig. 10. Main branch remains on conductor, Experiment 3.

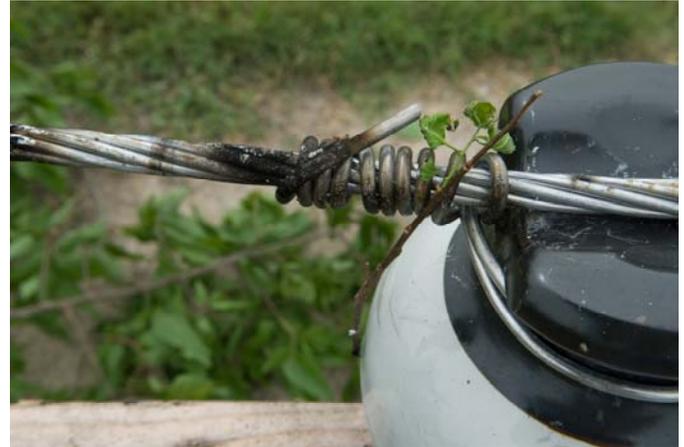
Fig. 11. Damage to Conductor, Experiment 3.

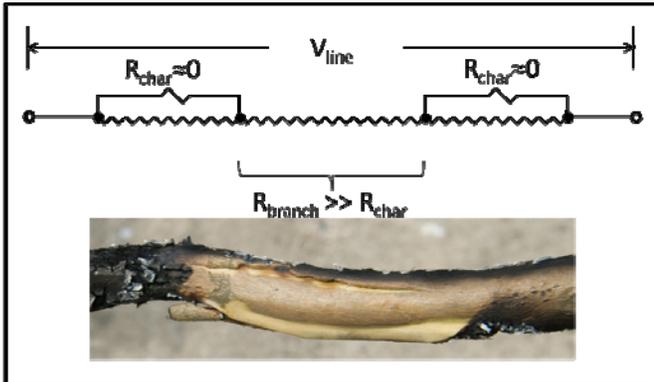
Experimental observations suggest a model for the phenomenon of vegetation spanning two conductors on a medium-voltage circuit. The branch initially can be thought of as a continuous high-resistance path between the contact points, as shown in Fig. 12. Shortly after contact occurs, current concentration at the point of contact causes significant localized heating. Scintillation begins and causes the organic wood products to carbonize, or char. The resistance of char is quite low, so it acts as an effective short circuit across the much higher resistance of the underlying wood. Resistance of the overall path therefore decreases. The area immediately adjacent to the char then becomes the point of current concentration and scintillation and burning begin at this point. This extends the charred path and further reduces the overall resistance. The process continues and the charred path progresses preferentially in the direction of the other contact point. As the charred paths lengthen, the overall branch resistance decreases, as more of the

“high-resistance” wood is short-circuited by the much lower-resistance carbonized path. This continues until the two paths meet and form a continuous, charred, low-resistance path, enabling a high-current event.

Fig. 12. First-order electrical model of tree branch spanning two conductors
