# Event Analysis of a Fault Disturbance in the Colombian Power System Caused by a Light Aircraft Crash

Pedro Lozada and Sadul Urbáez, ISA Colombia.

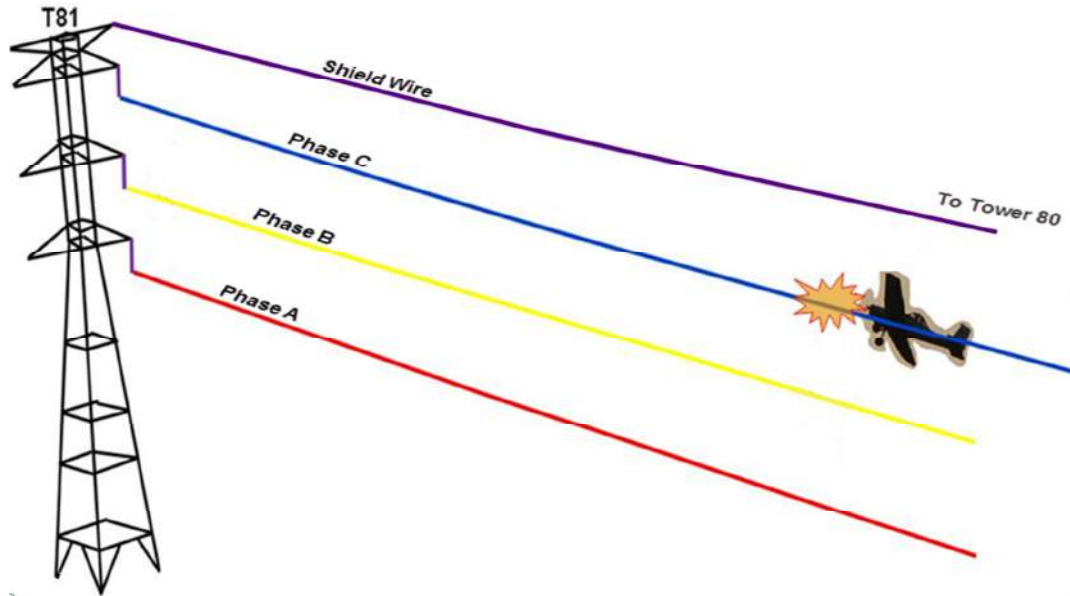
Figure 1. Aircraft crash into the double circuit structures of LN-814 (not shown) and LN-815.

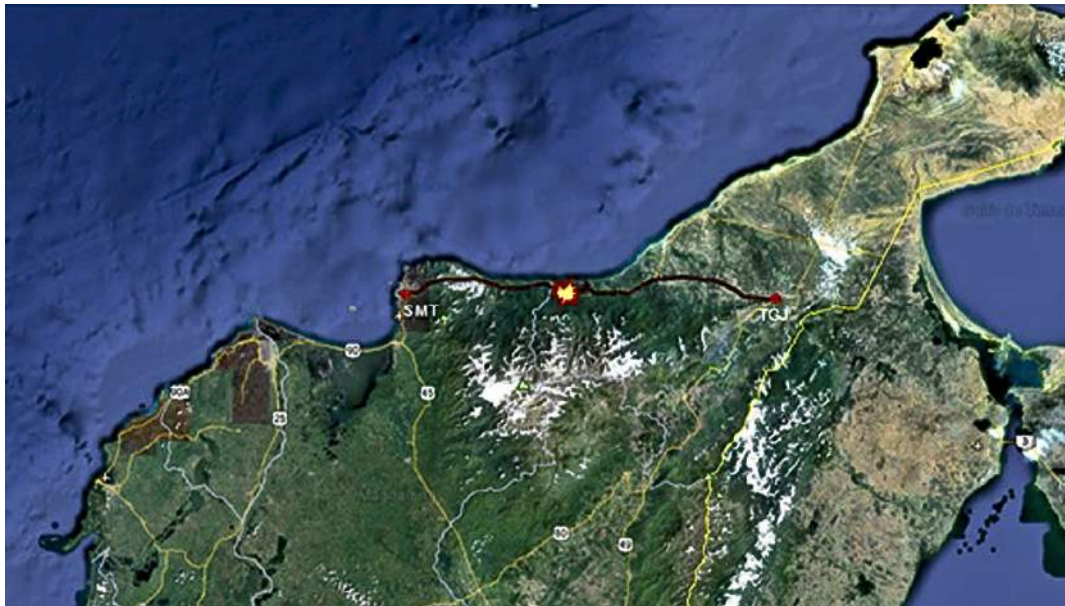
Figure 2. 220kV double circuit overhead transmission line between SMT and TGJ (LN-814/LN-815) and crash site at approximately 42km from SMT.

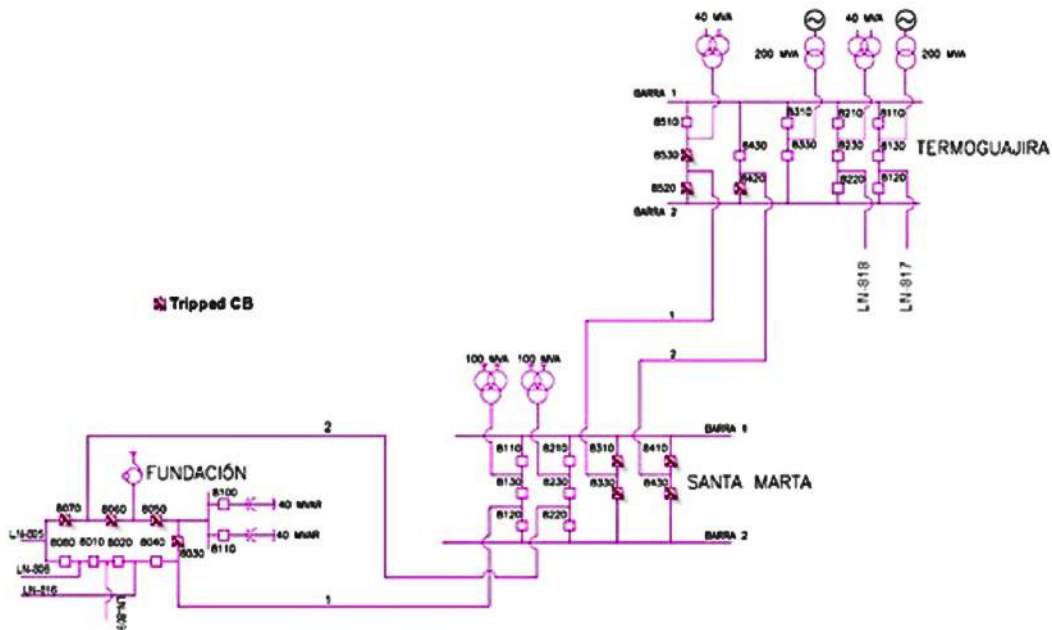
Figure 3. Disconnected bays at FUN, SMT and TGJ.

Along with the disconnection of the capacitor bank bay, the 220kV autotransformer bay of AT-FUN01 was also disconnected, not because any of its protections operated, but because of the tripping of CBs 8060 and 8050, which belong to this bay and were tripped with the disconnections of line bay LN-808 and the capacitor bank bay, respectively, as seen in figure 3. A summary of the sequence is presented in the next table.

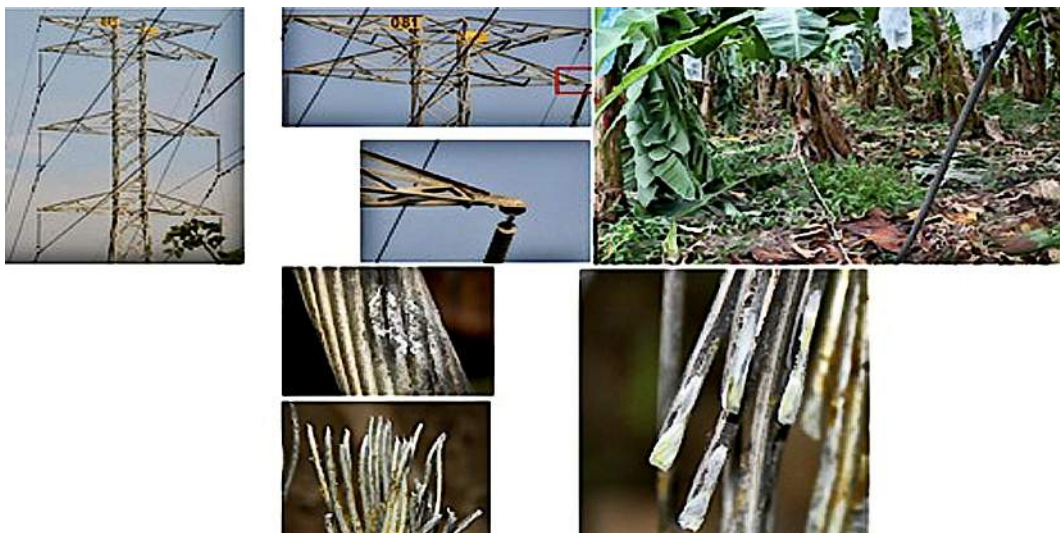
Given the multiples disconnections in this event, an aerial inspection of the two overhead transmission lines between SMT and TGJ substations was conducted. The aerial patrol found that phase C conductor and cross arm were affected in the line span between towers 80 and 81 of LN-815 and for that reason LN-815 was out of service for 36 hours while the corrective maintenance activities were made. It was not until the aerial patrol arrived at the crash site and confirmed the permanent nature of the fault that it was known that an aerial fumigation light aircraft had caused the disturbance when crashing into the circuits. Evidence found at the crash site is presented in figures 4 and 5.

Figure 4. Evidence found at the crash site.

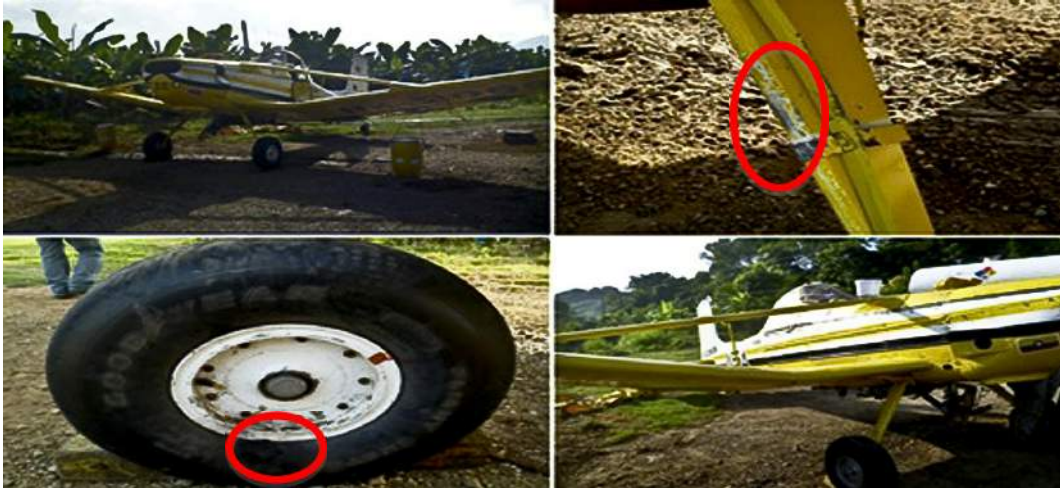
Figure 5. Light aircraft used for aerial fumigation that caused the fault in circuits LN-814 and LN-815.

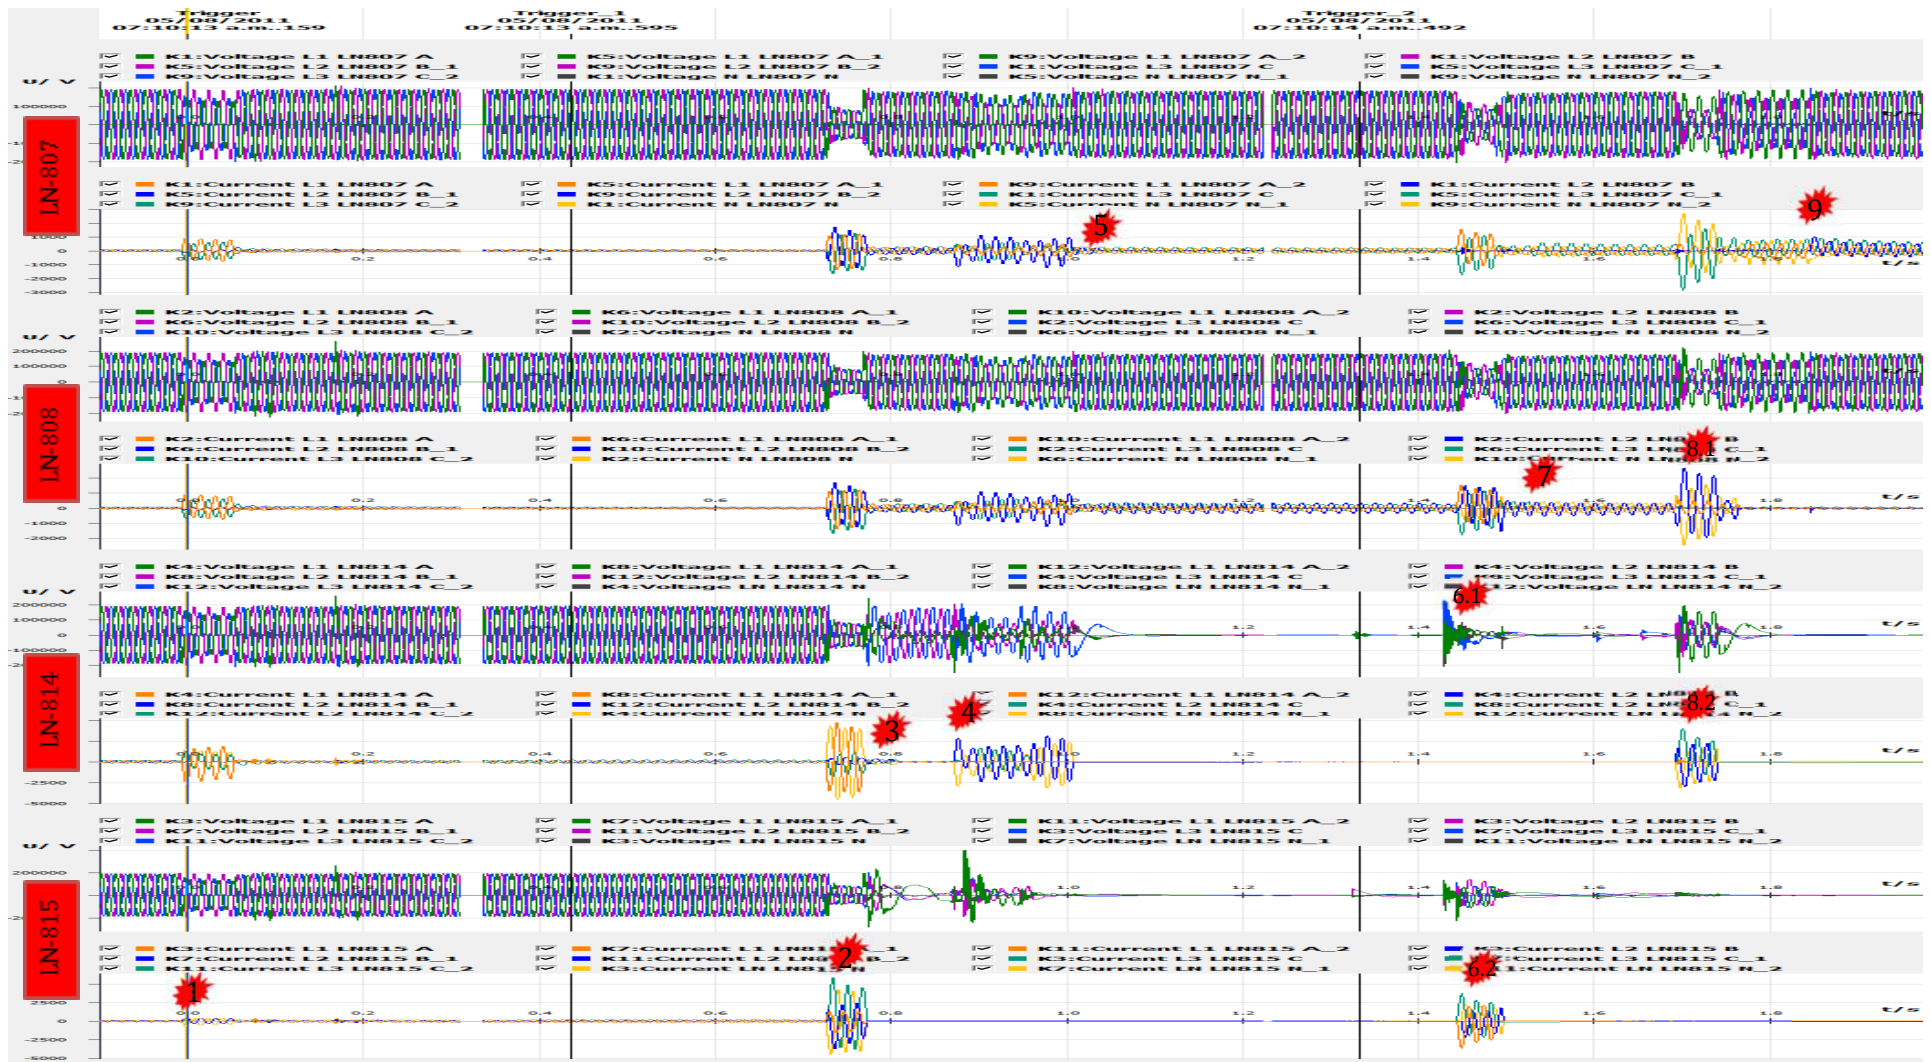
Figure 6. Complete disturbance data from the DFR at SMT.

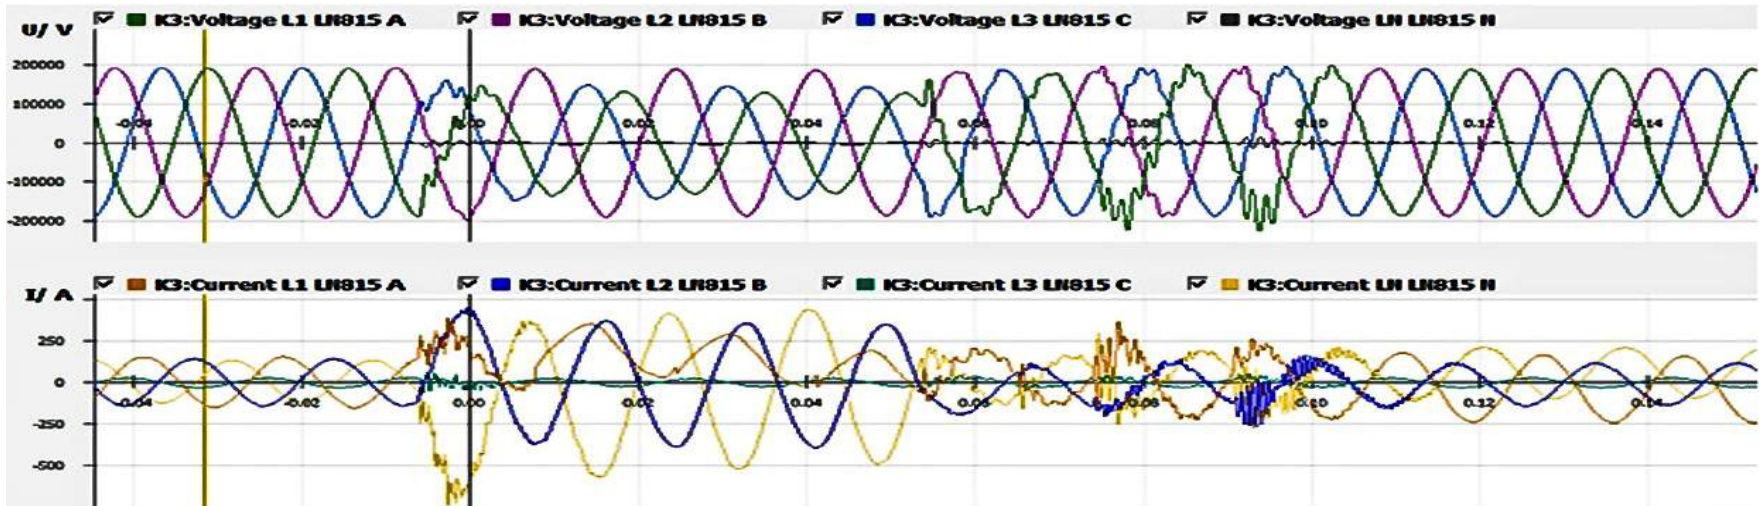
1. There was a condition of open conductor before the intercircuit fault of phases C and A of LN-815 and LN-814 took place in moment 1, as shown in figure 7. The intercircuit fault was first cleared at TGJ LN-815 and approximately one cycle after at TGJ LN-814 by the distance protections. Further details are provided through figures 8 to 10.

Seen from SMT LN-815, the phase C conductor was broken and therefore the fault condition was not clearly detected. After the fault in LN-815 was cleared, voltages for phases A and C are the same for 59mS, which also indicates that the phase C conductor of this circuit came into contact with the phase A conductor of the parallel line. At SMT LN-814 there was no tripping since the distance element that picked up was the zone 2 and no teleprotection signal was received while the fault was present.

Figure 7. Condition of broken conductor seen from SMT at pre-fault (yellow line). (a) Voltages and currents of LN-815. (b) Values measured at SMT.

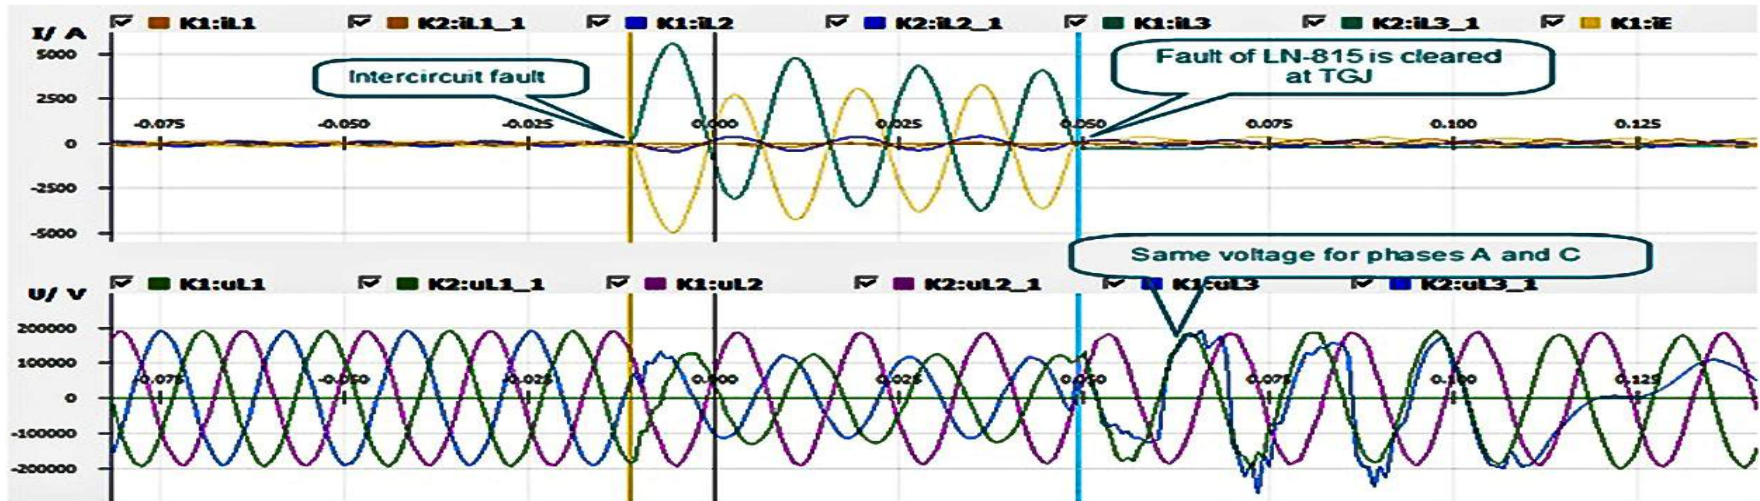
Figure 8. Event record at TGJ LN-815 for the intercircuit fault.

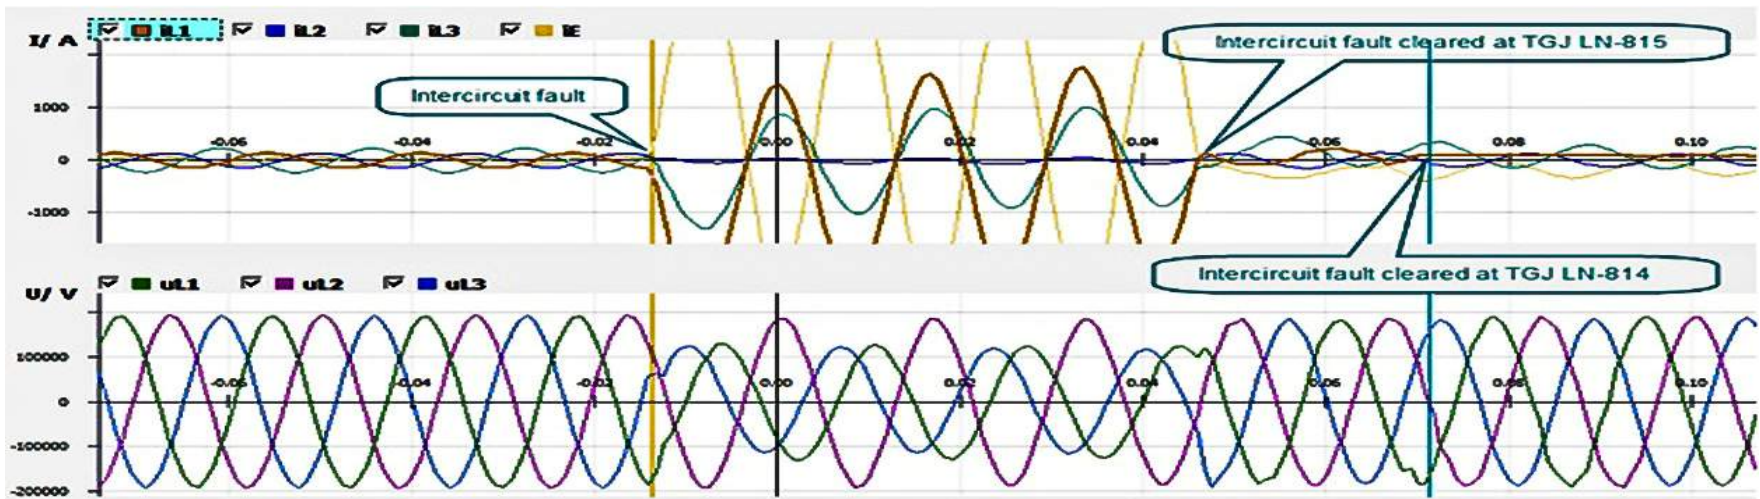
Figure 9. Event record at TGJ LN-814 for the intercircuit fault, which was first cleared by CB at TGJ LN-815 and one cycle after at TGJ LN-814.

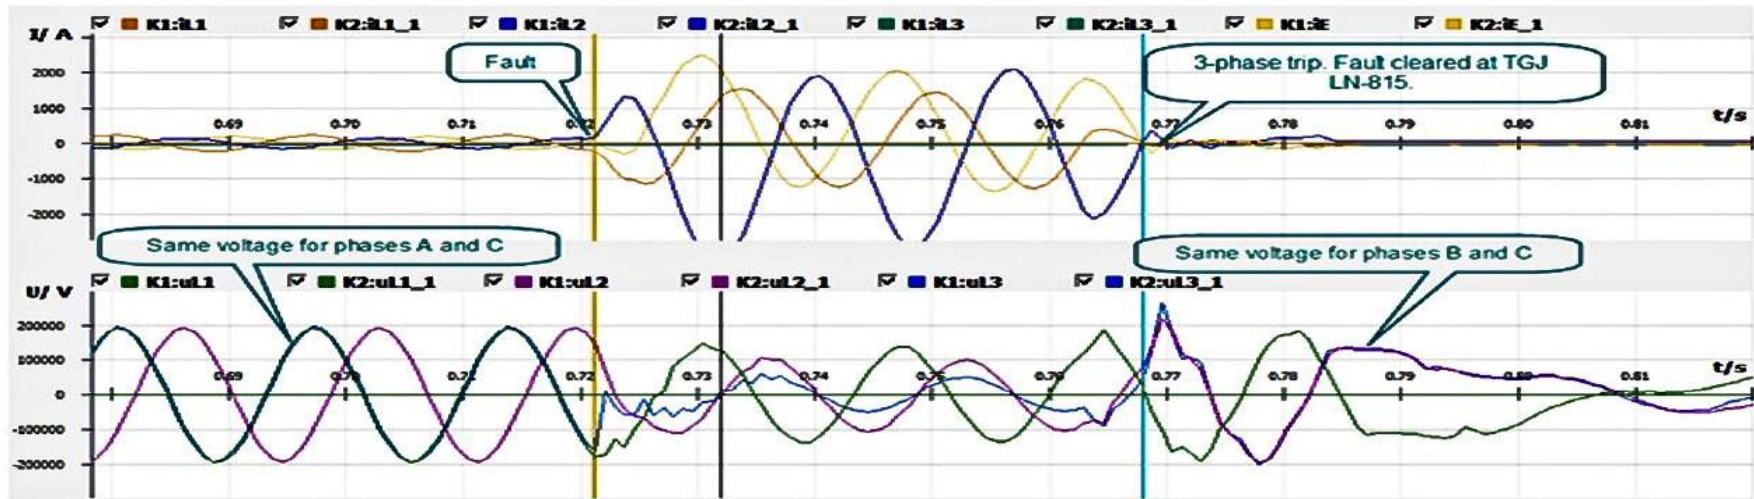
2. As the phase C conductor of LN-815 was broken, the part strung on tower 80 fell across phase B causing a new fault that was detected by the distance protections in zone 1 which tripped all three phases at both substations, CBs 8410 and 8430 at SMT and 8420 at TGJ. This new fault is depicted in figures 11 and 12 and was produced 733mS from the previous one and during the dead time of the single-pole auto-reclosing of phase C of line bay TGJ LB-815. Voltage signals of phases A and C are the same in figure 11 before the second fault which happens because conductors are in contact as in the first fault. After the three-phase trip, voltage signals for phases B and C are the same, just in the same way as in figure 12 and it confirms that phase C fell across phase B in LN-815 seen from SMT to TGJ.

Figure 11. 3-phase trip at TGJ LN-815 during the dead time of the single-pole auto-reclosing of phase C. Before the fault, voltages for phases A and C are the same. After the trip, voltages for phases B and C are equal.

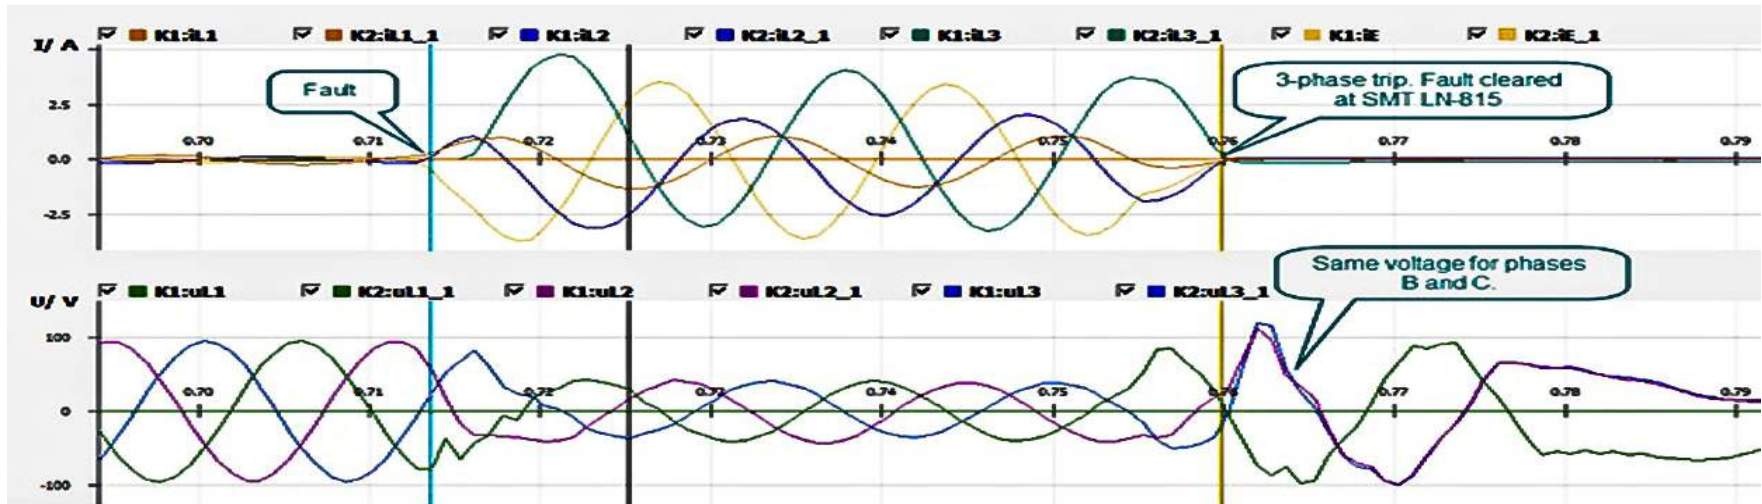
Figure 12. 3-phase trip at SMT LN-815. After the trip, voltages for phases B and C are equal.

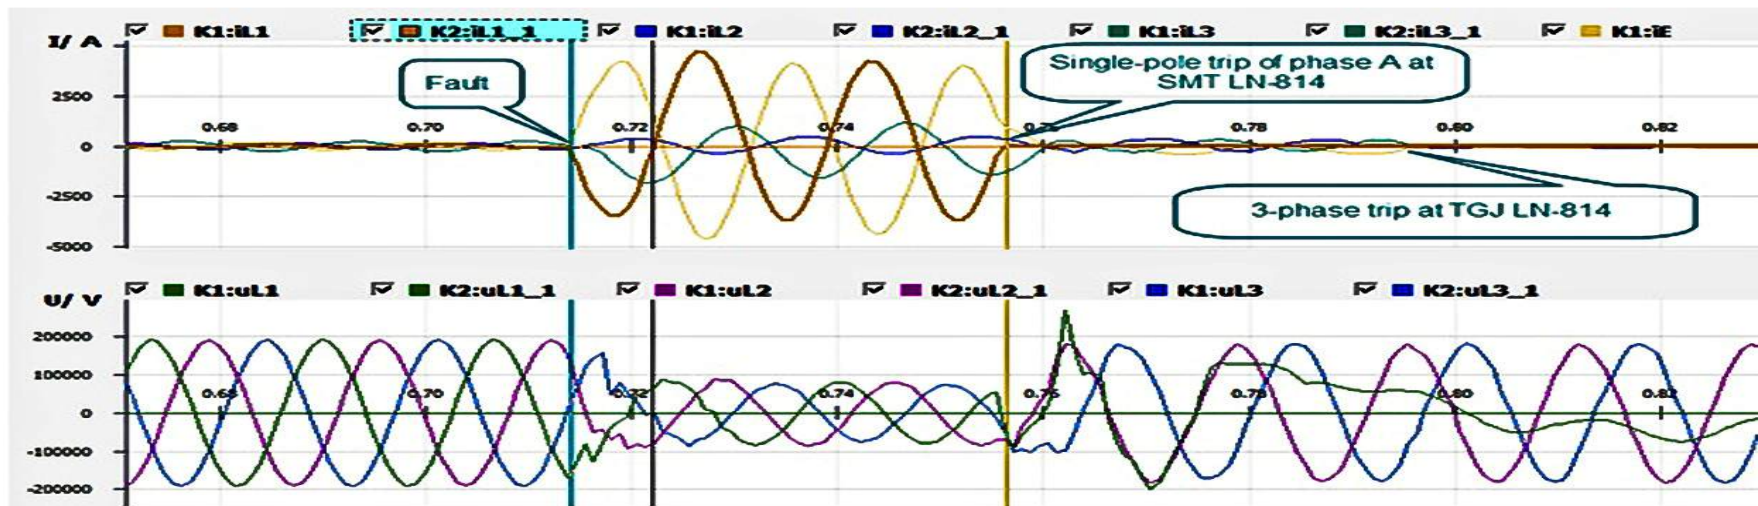
On the other hand, at the same time for LN-814, CBs 8310 and 8330 of line bay SMT LN-814 effected a single pole operation for phase A after a trip issued by distance protection in zone 1 as plotted in figures 13 and 14. At TGJ it was still running the dead time for the single-pole auto-reclosing of phase A.

Figure 13. Single-pole trip of phase A at SMT LN-814 after distance element zone 1 operated.

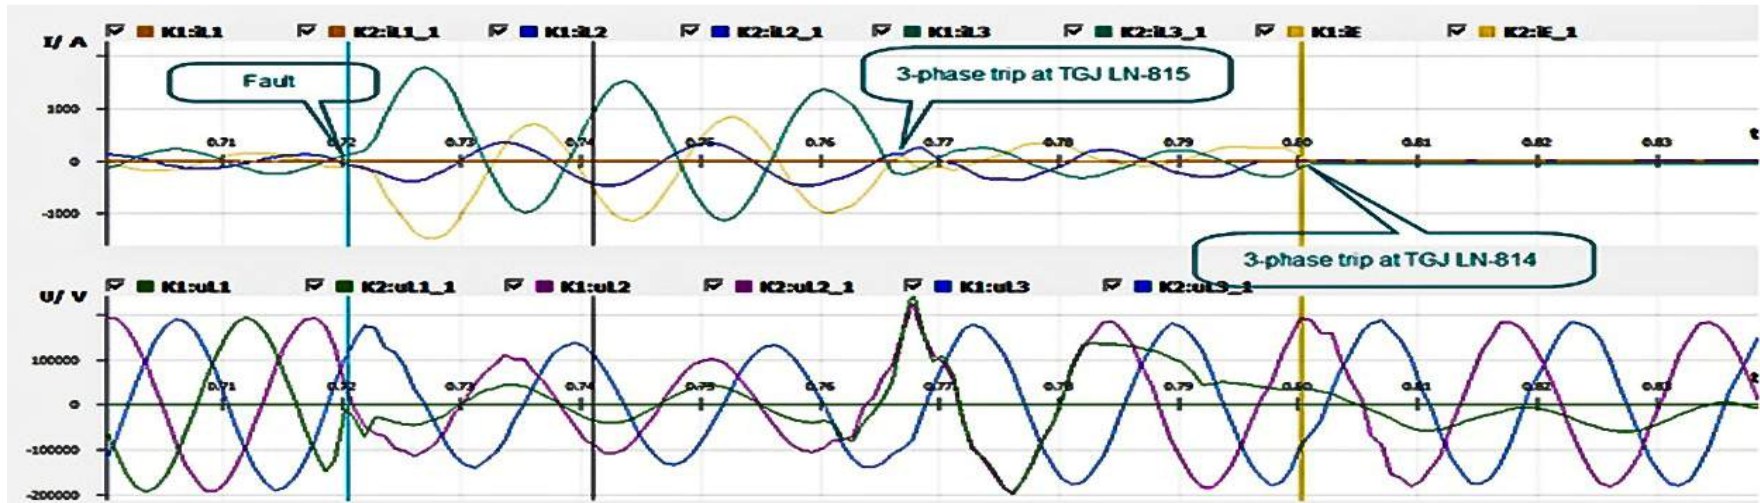
Figure 14. Three-phase trip at TGJ LN-815 in moment 2 and at TGJLN-814 in moment 3.

3. The third moment of the sequence is at 814mS, where CBs 8520 and 8530 of line bay of circuit LN-814 at TGJ are tripped after relay SEL-321 issued a three-phase trip command once a teleprotection signal was received with its distance element zone 2 picked up during the dead time after the previous tripping of phase A by Siemens 7SA522 at moment 1. Event records illustrated in figures 13 and 14 also show the moment when line bay of LN-814 at TGJ is tripped.

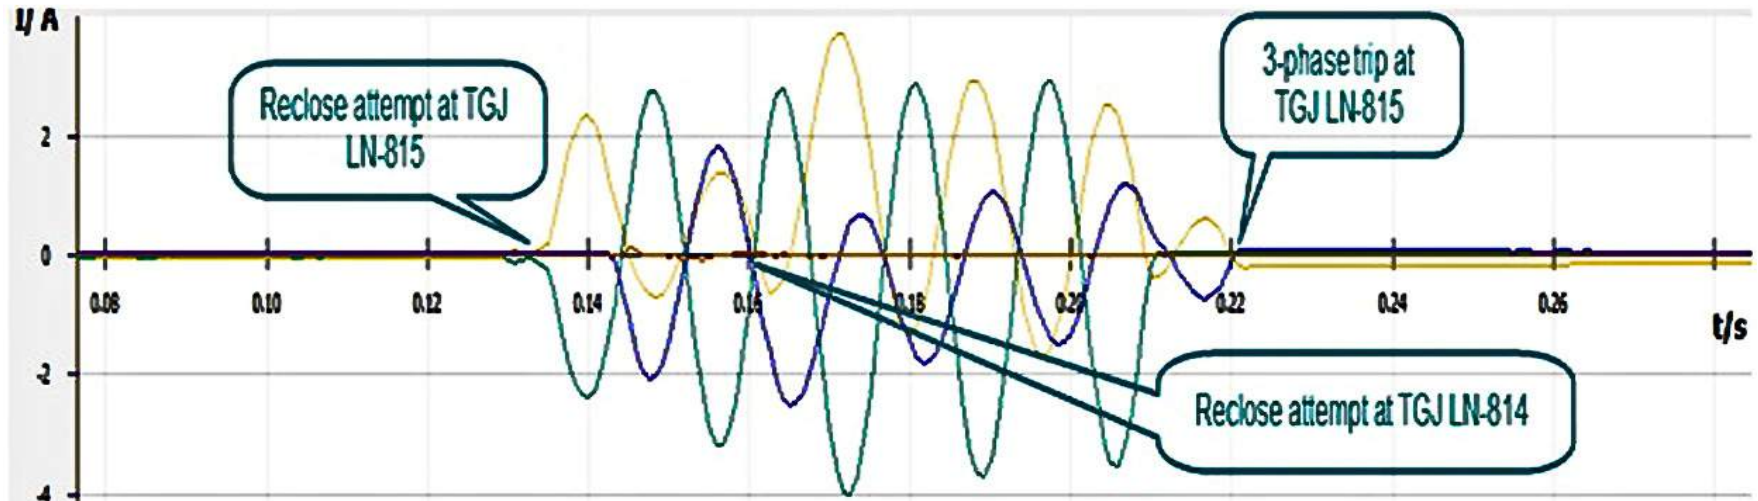
4. After the three-phase trip of CB 8420 of line bay LN-815 at TGJ, it reclosed into the line at 878mS, but as the fault was still present, all the poles tripped again at 963mS after the operation of distance protection and no further reclosing took place. During this failed reclose attempt, CB 8520 of LN-814 at TGJ also reclosed three poles on to the permanent fault at 903mS and tripped again at 973mS. Immediately afterward at 1014mS, CBs 8310 and 8330 at SMT LN-814 tripped when line protections issued a three-phase trip command during the reclose attempt at TGJ LN-814. This part of the sequence is represented through figures 15 to 17.

Figure 15. Reclose attempt and subsequent tripping of CB 8420 at TGJ LN-815.

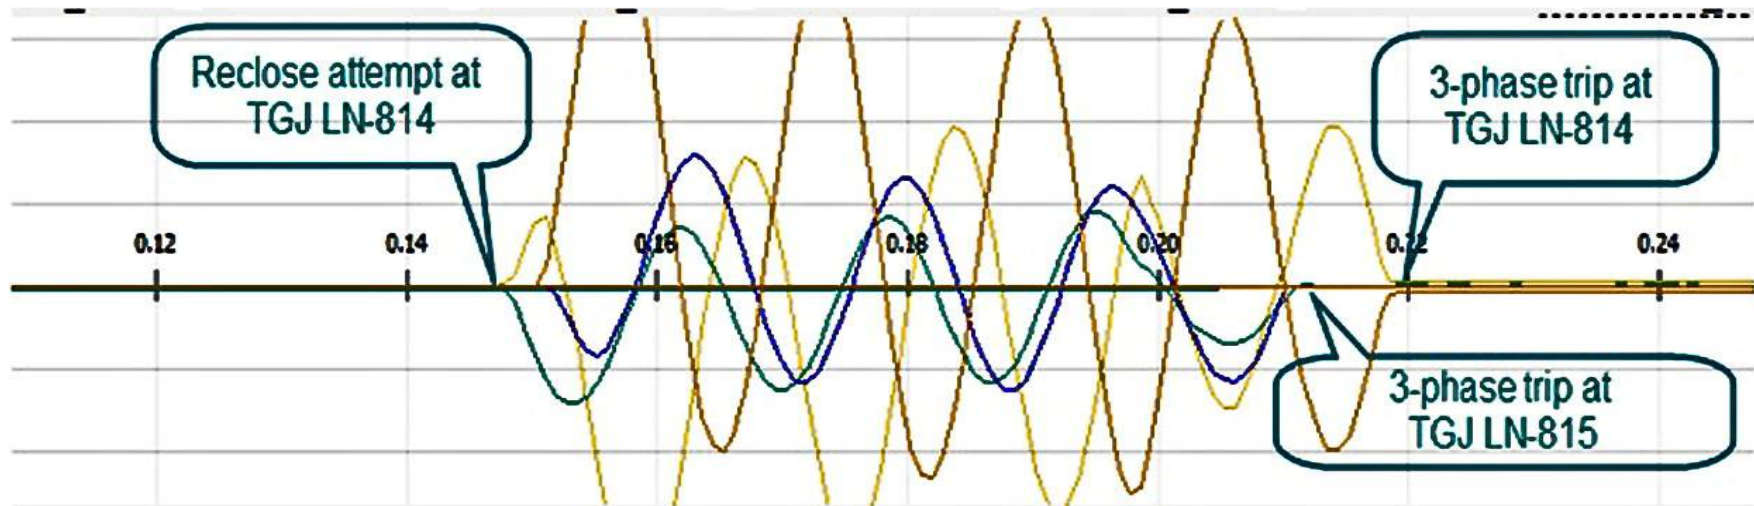
Figure 16. Reclose attempt and subsequent tripping of CB 8520 at TGJ LN-814.

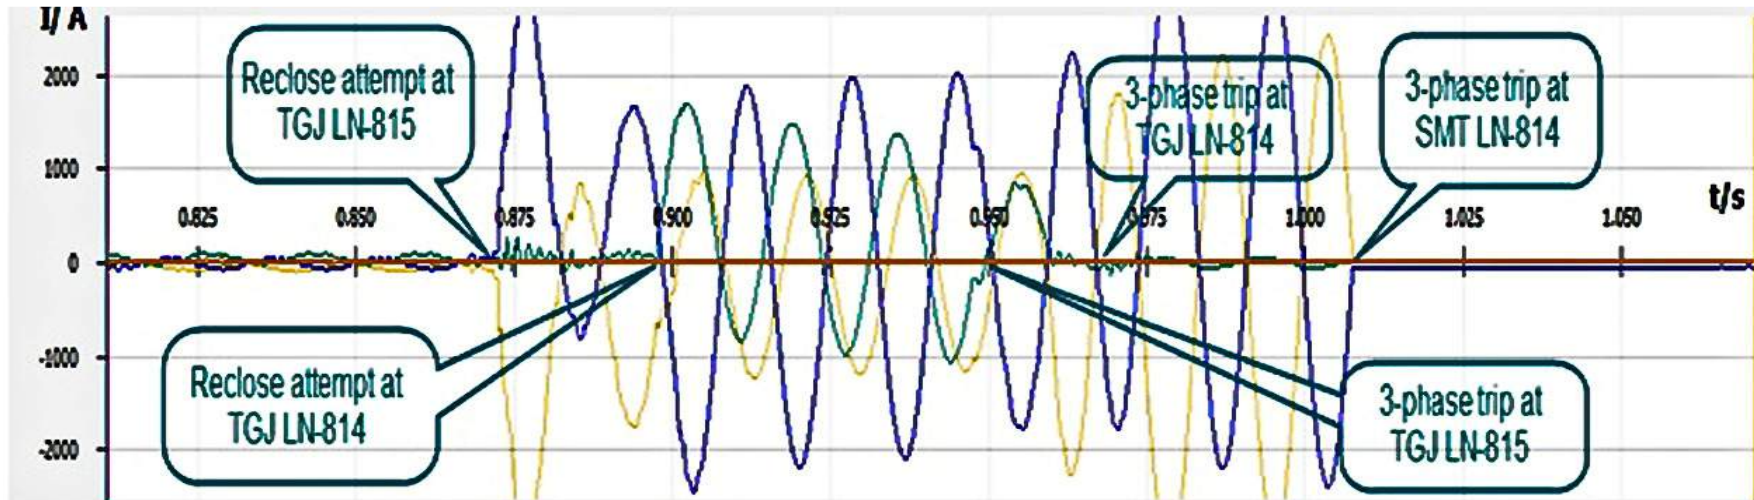
Figure 17. Reclose attempts and tripping of line bays LN-815, LN-814 at TGJ and three-phase trip at SMT LN-814 as recorded on DFR at SMT.

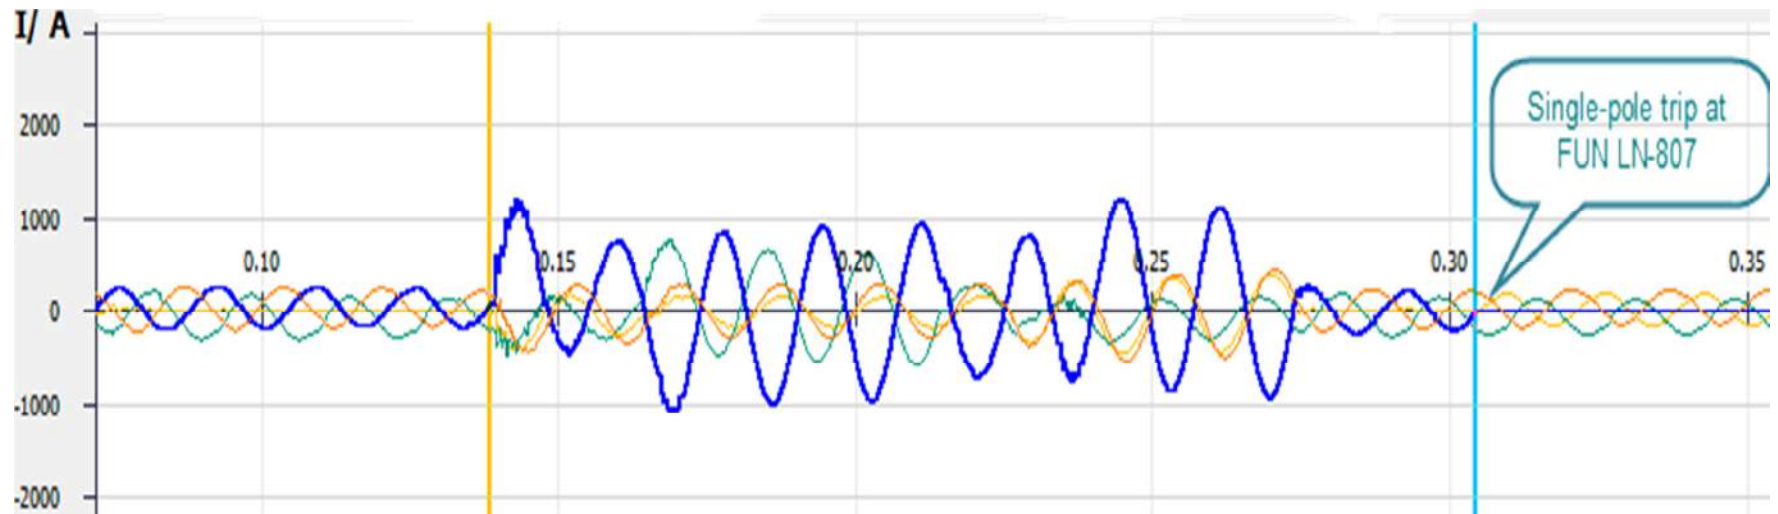
5. In this part of the sequence at 1044mS, CBs 8030 and 8040 of line bay LN-807 at FUN tripped the pole corresponding to phase B, as seen in figure 18. FUN and SMT substations are interconnected by power lines LN-807 and LN-808. This was an undesired operation of the distance relay SEL-321 (MP1) at this bay line, which overreached for an external fault. No event records from relay SEL-321 at this bay were available and from the Trip Log of Siemens 7SA522 (MP2) it was confirmed this second relay did not trip. The misoperation of MP1 was stamped on the SOE and also recorded on the DFR when the signal "TR21PL1-LN807" went high.

Figure 18. Single-pole trip at FUN of LN-807.

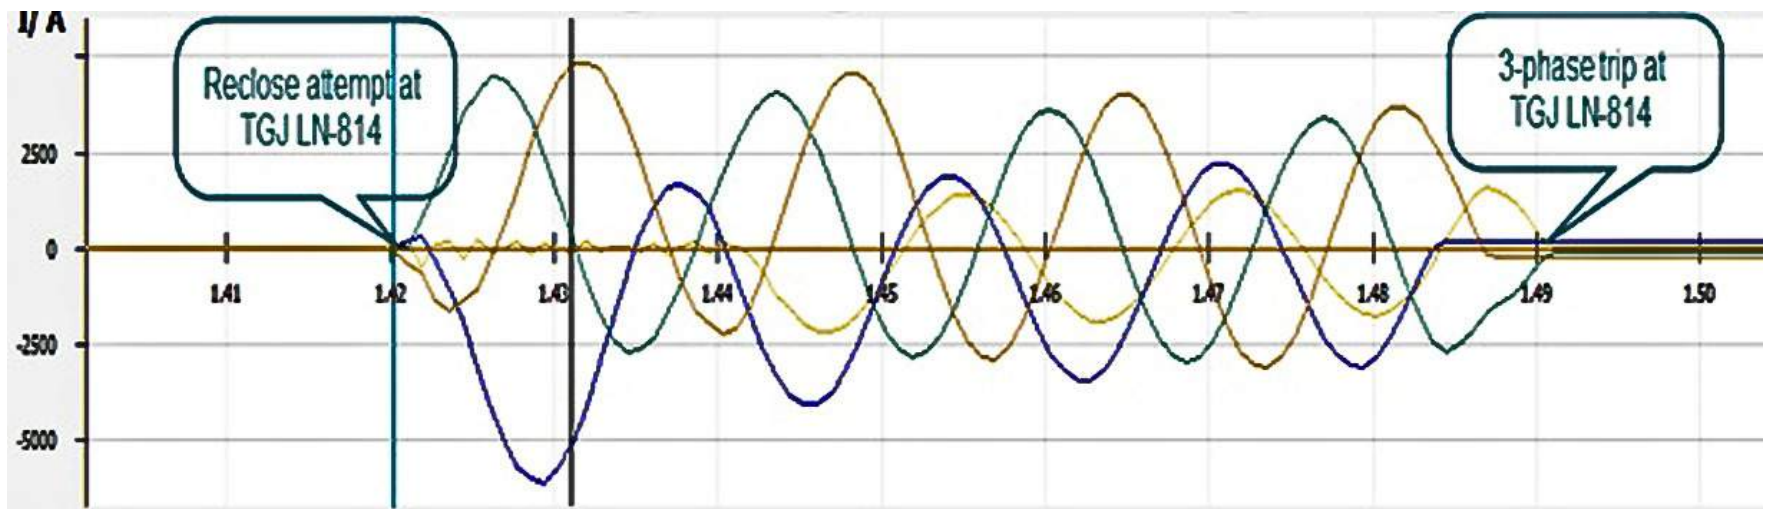
6. A second reclose attempt happened at TGJ LN -814 at 1434mS when CB 8520 reclosed three poles on to the permanent fault and so did CB 8410 of LN-815 at SMT 16mS after. The fault was once more cleared by distance protections at this line bays and those CBs tripped again and locked out at 1504mS. For line bay TGJ LN-814, it was a maloperation of the reclosing scheme, since this second reclosing attempt of CB 8520 was not conceived considering it must have locked out after the previous trip. Concerning the reclosing at SMT LN-815, it was 670mS after the three-phase trip at moment 2 and it was expected to occur. This moment of the sequence is detailed in figures 19 and 20.

Figure 19. Reclose attempt and subsequent tripping at TGJ LN-814.

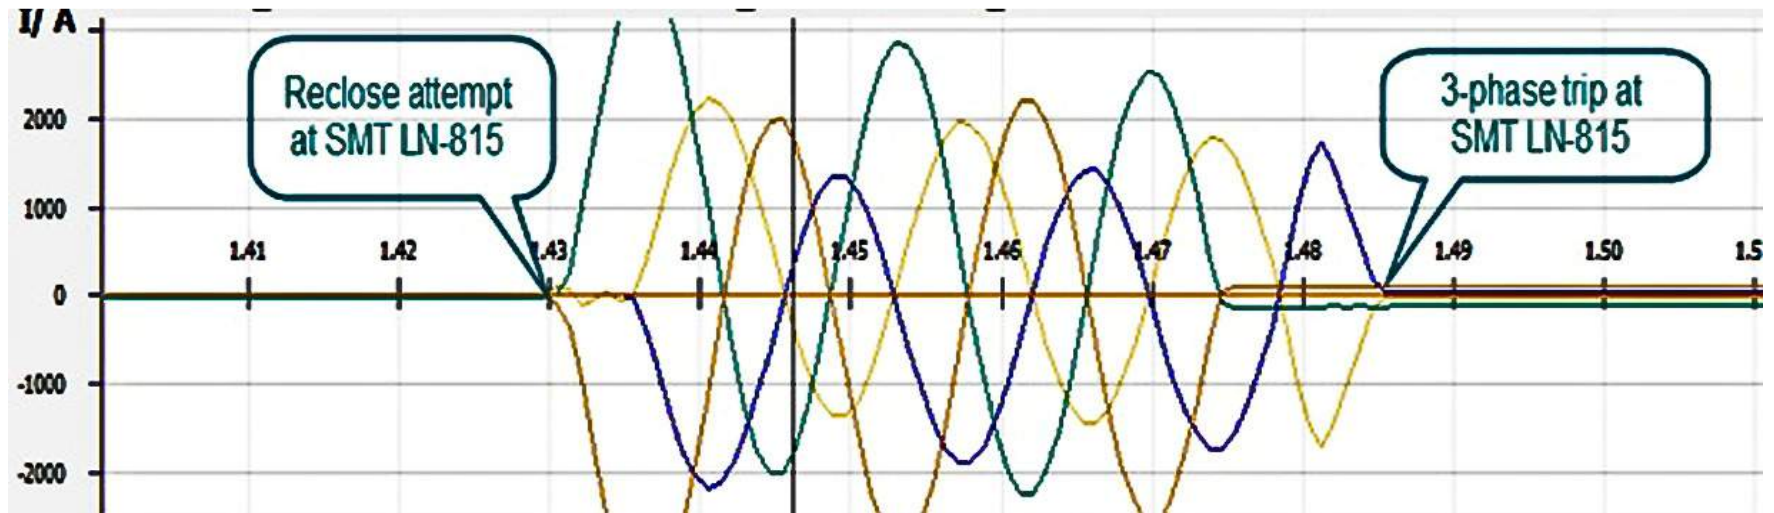
Figure 20. Reclose attempt and subsequent tripping at SMT LN-815.

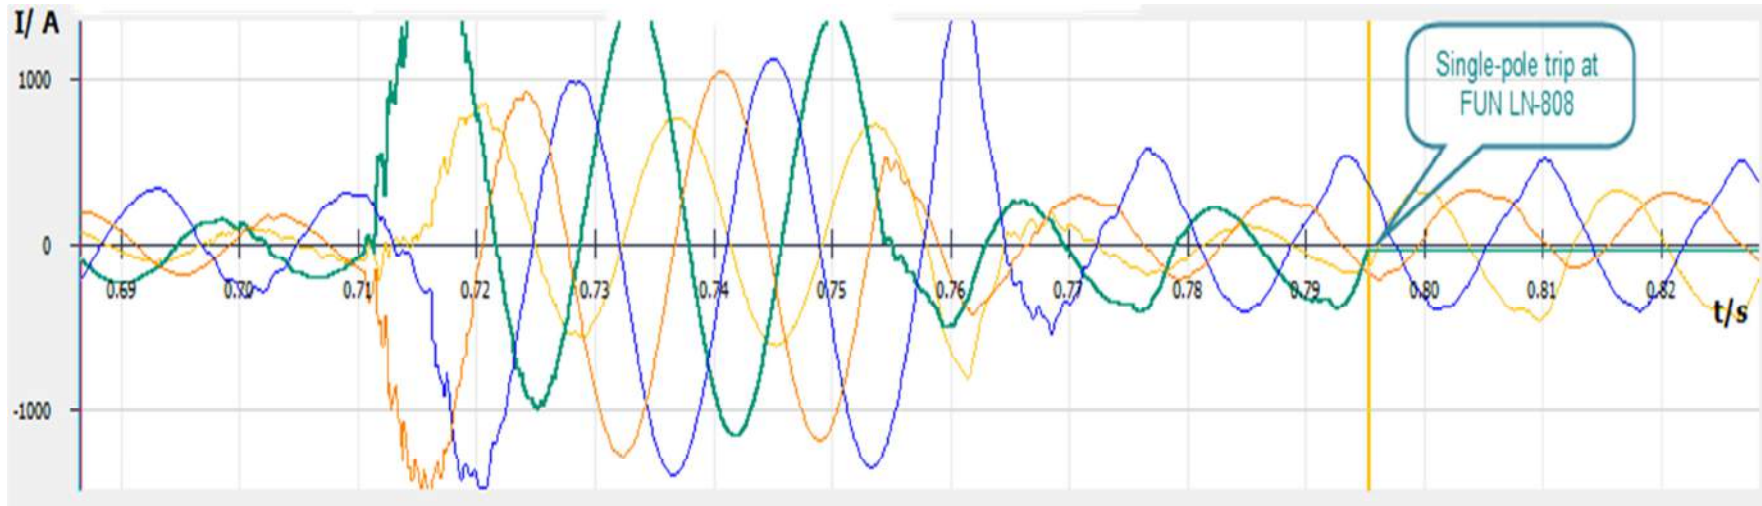
7. During the fault presented in moment 6, relay Siemens 7SA522 (MP2) of line bay LN-808 at FUN issued a single-pole trip after the operation of the distance element zone 1 and CBs 8060 and 8070 tripped phase C poles at 1535mS, as illustrated in figure 21. Here there was another maloperation of the protection schemes at FUN after overreaching for an external fault.

Figure 21. Single-pole trip at FUN of LN-808.

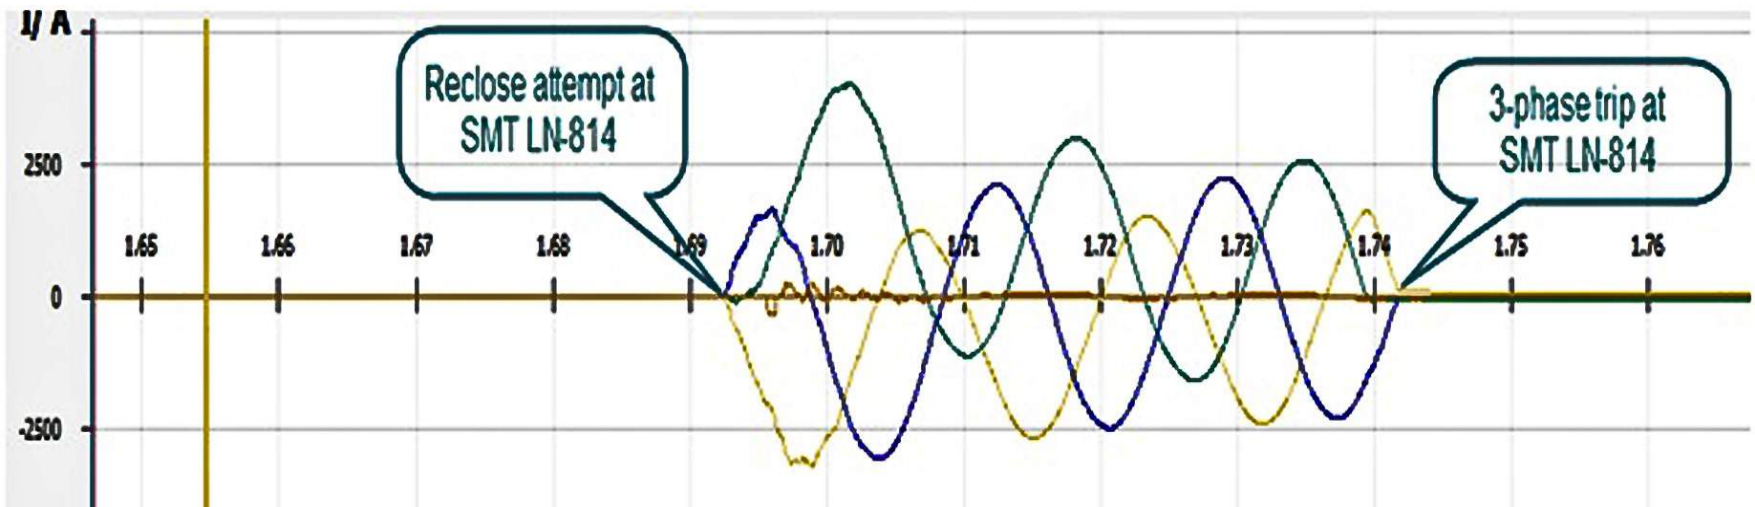
8. Over the dead time of the two single-phase auto-reclosings at FUN (moments 5 and 7), CB 8310 of LN-814 at SMT also reclosed on to the fault at 1699mS and tripped again at 1748mS as a result of the operations of the distance protections. This fault caused the line protection MP1 of LN-808 at FUN to trip all the poles of CBs 8060 and 8070 after detecting a developing fault during the dead time. This time relay Siemens 7SA522 did not issue any trip and, in this case, relay SEL-321 was the one that misoperated. The operation of MP1 was confirmed on the SOE and on the DFR records as no event data from the relay was found. Three-phase reclosing is out of service for this bay line. These two trippings that took place in this moment are presented in figures 22 and 23.

Figure 22. Reclose attempt and subsequent tripping at SMT LN-814.

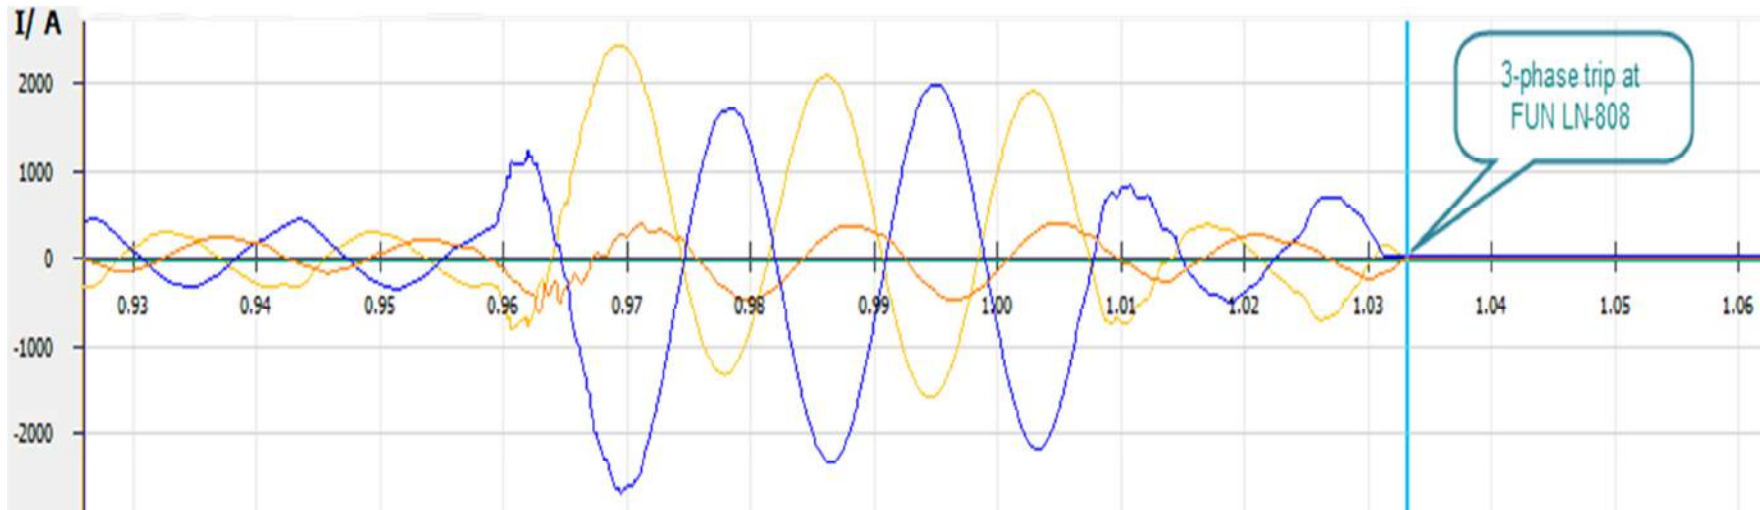
Figure 23. Three-pole trip at FUN of LN-808.

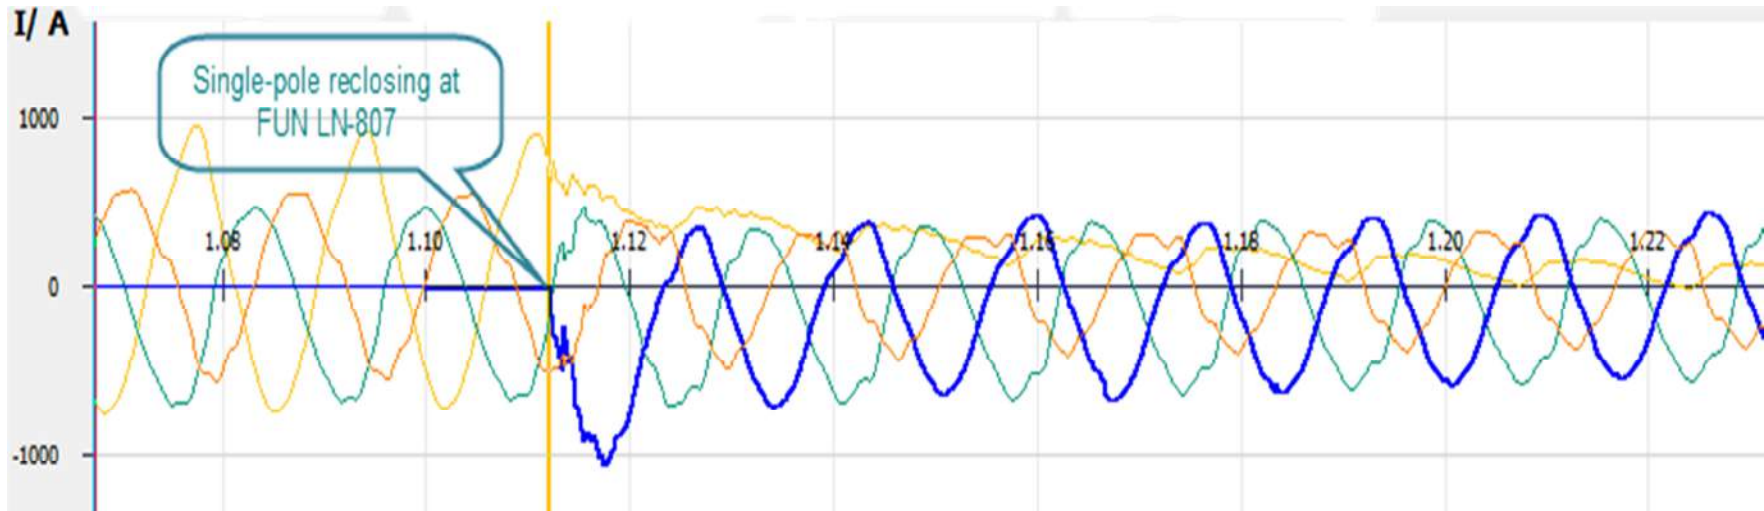
9. Successful single-pole reclosing of CB 8040 at FUN occurred at 1851mS. Nevertheless, as there had been an unbalance condition in the system with phases B (bay line LN-807 single-pole trip) and C (bay line LN-808 3-phase trip) tripped and taking into account the ring bus configuration at FUN the overcurrent relay of the capacitor bank operated. The capacitor bank bay is in the middle of the line bays corresponding to LN-807 and LN-808 and due to this topology the overcurrent relay tripped CBs 8030 and 8050.

Figure 24. Single-pole reclosing of CB 8040 at FUN.

Concerning the settings for the overcurrent relay of the capacitor bank, they were also modified so unbalance conditions do not make the relay maloperate again.
