# Event Analysis of a Fault Disturbance in the Colombian Power System Caused by a Light Aircraft Crash

Pedro Lozada and Sadul Urbáez, ISA Colombia.

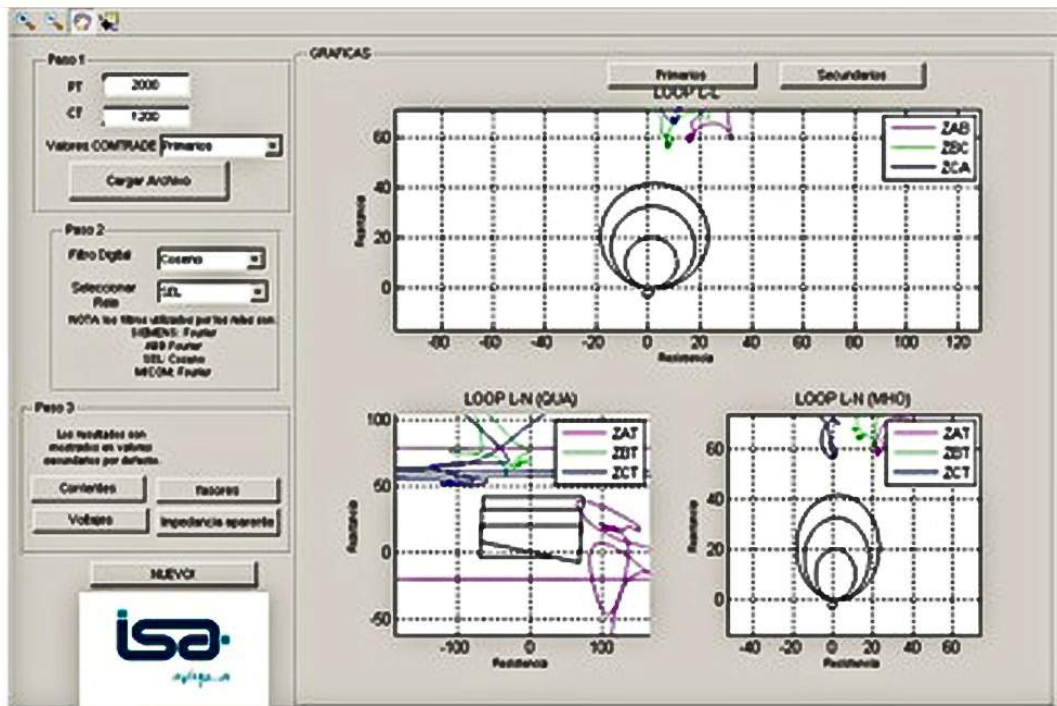
Relay SEL-321 (MP1) of line bay LN-807 at FUN misoperated after it issued a single-pole trip for an external fault at moment 5 of the sequence. To assess the operation of the MP1 the IMPAP (software used to simulate the apparent impedance seen by relays developed by ISA) was used. The apparent impedance for phase B seen by MP1 did not enter the distance relay zone 1 characteristics, as depicted in figure 25, hence this relay did not trip for this reason and it is unknown what made the relay operate. However, it is believed that the relay might have tripped because of capacitive voltage transformer (CVT) transients due to overreach problems of distance elements of this type of relay in the past. The evaluation of the apparent impedance for this relay was performed with the event data recorded on MP2, relay Siemens 7SA522, and the DFR, because no event record from SEL-321 was available.

Figure 25. Apparent impedance trajectories on IMPAP for SEL-321 of LN-807 at FUN.

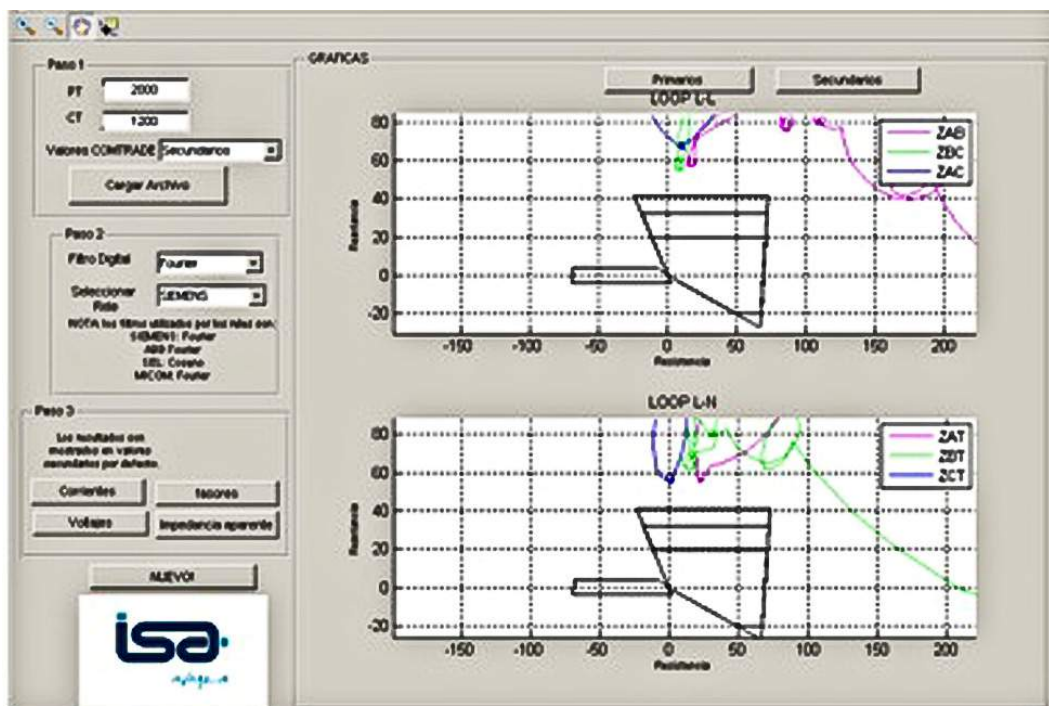
Figure 26. Apparent impedance trajectories on IMPAP for Siemens 7SA522 of LN-807 at FUN.

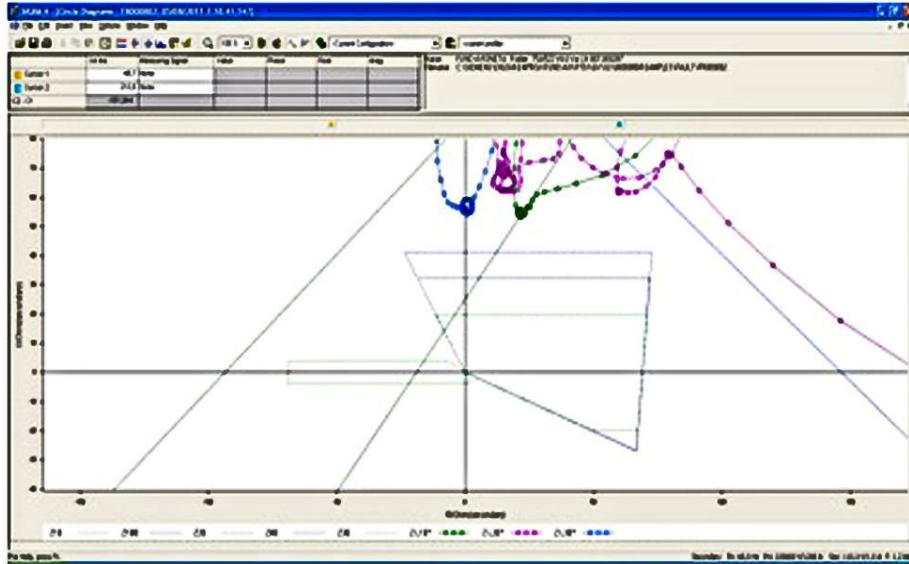
Figure 27. Apparent impedance trajectories as seen from Siemens 7SA522 of LN-807at FUN.

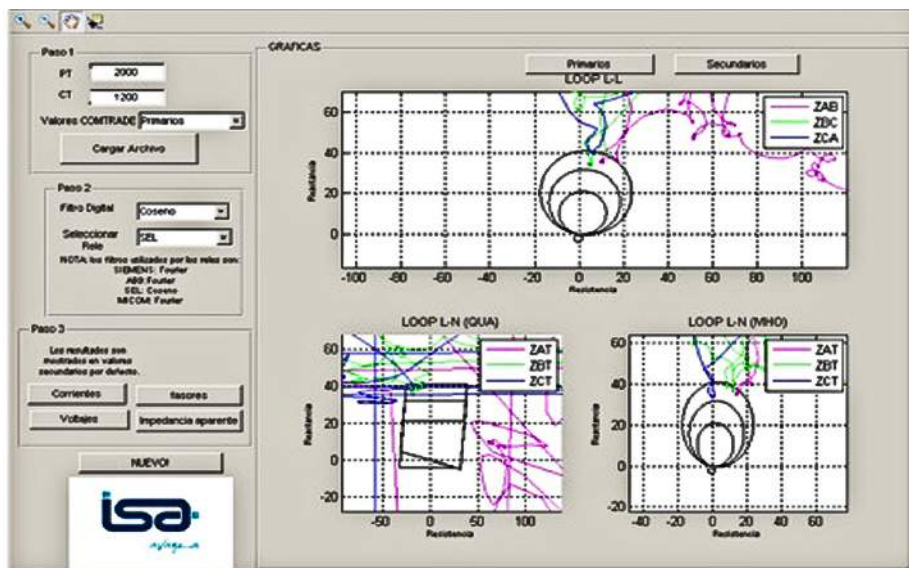
Figure 28. Apparent impedance trajectories estimated with new settings for SEL-321 of LN-807at FUN.

To correct the misoperations detected, new settings were recommended for MPs of this line bay. To assure no future maloperations will occur for external faults, apparent impedance trajectories were estimated and the outcome is shown in figures 28 and 29.

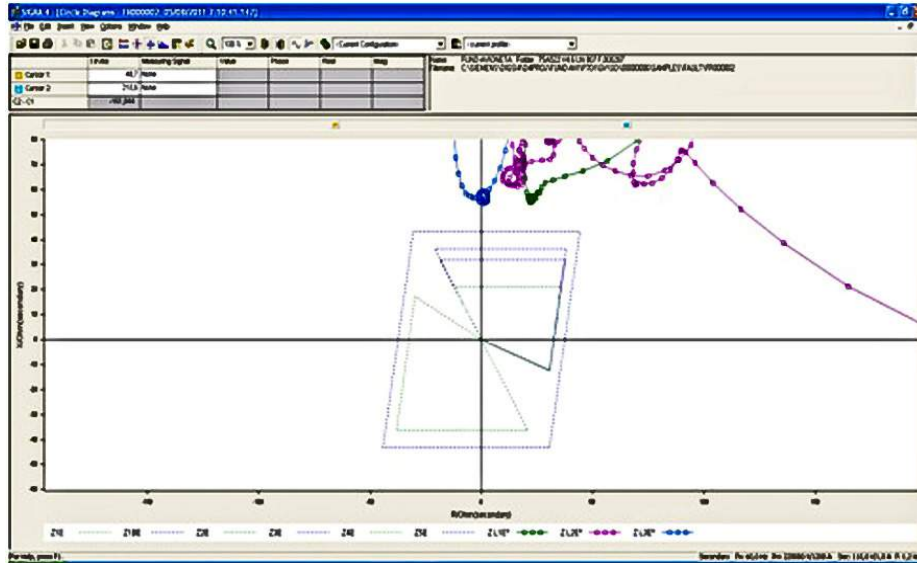
Figure 29. Apparent impedance trajectories estimated with new settings for Siemens 7SA522 of LN-807 at FUN.

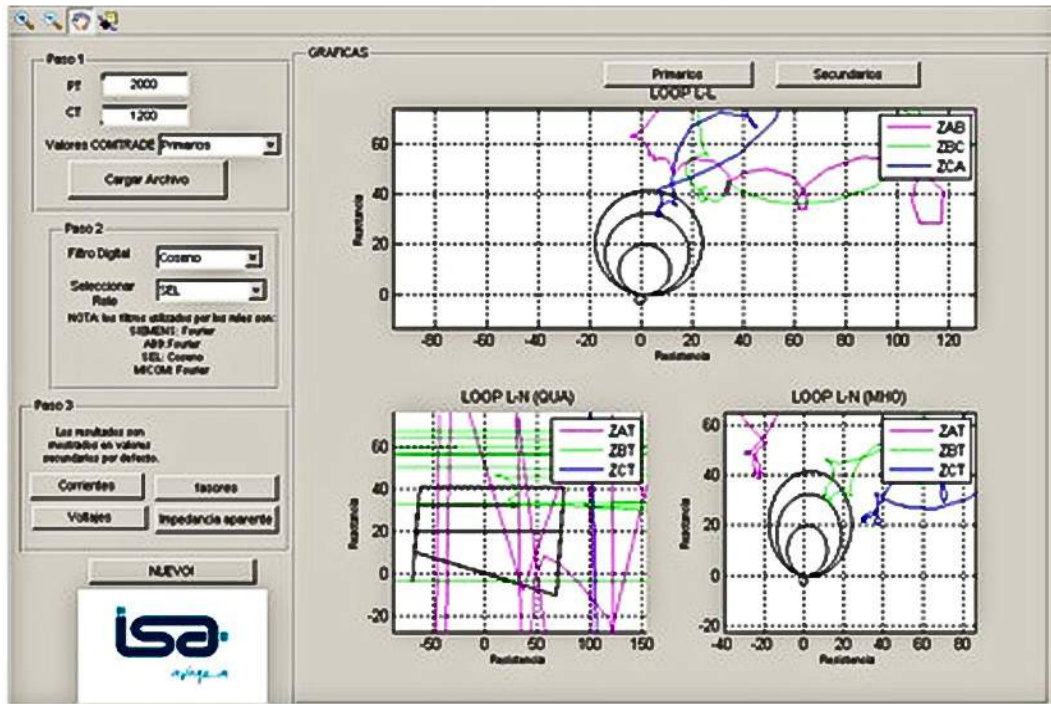
For this bay relay Siemens 7SA522 (MP2) of circuit LN-808 at FUN also misoperated after it issued a single-pole trip for an external fault at moment 7 of the sequence. In this case, after the assessment of the apparent impedance on IMPAP it was found that the apparent impedance for phase C encroached under the relay zone 1 characteristic. For solving this problem the setting of the resistive reach of the quadrilateral ground distance characteristic adapted a value of 45% of the lowest load impedance of the transmission line.

Figure 30. Apparent impedance trajectories on IMPAP for SEL-321 of LN-808 at FUN.

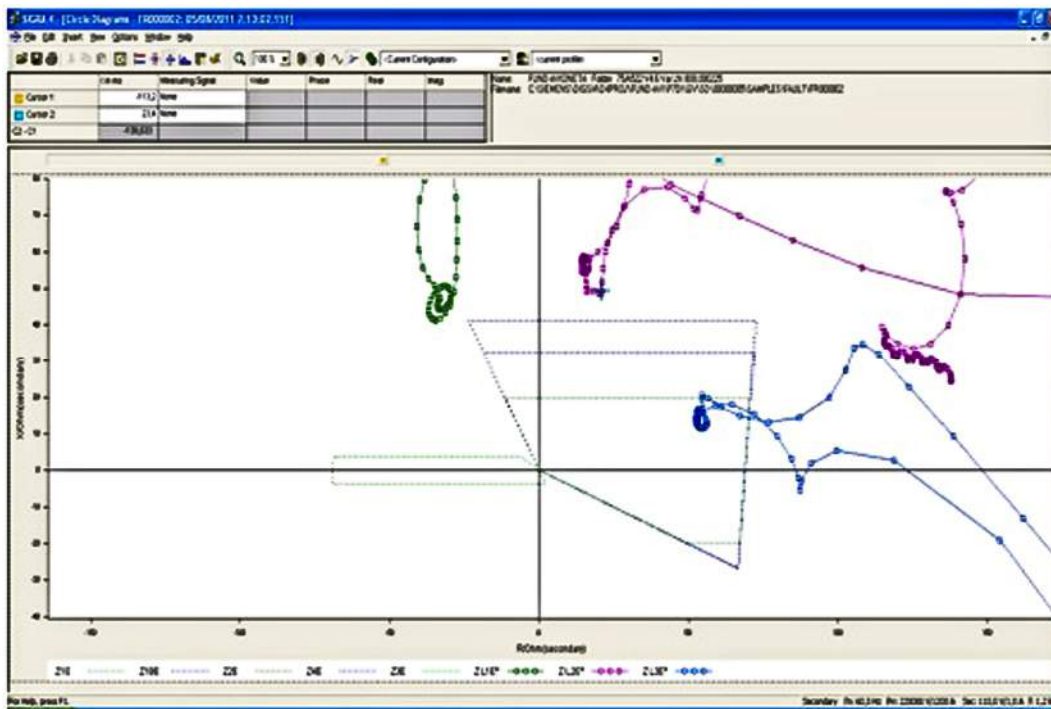
Figure 31. Apparent impedance trajectories seen by relay Siemens 7SA522 of LN-808 at FUN.

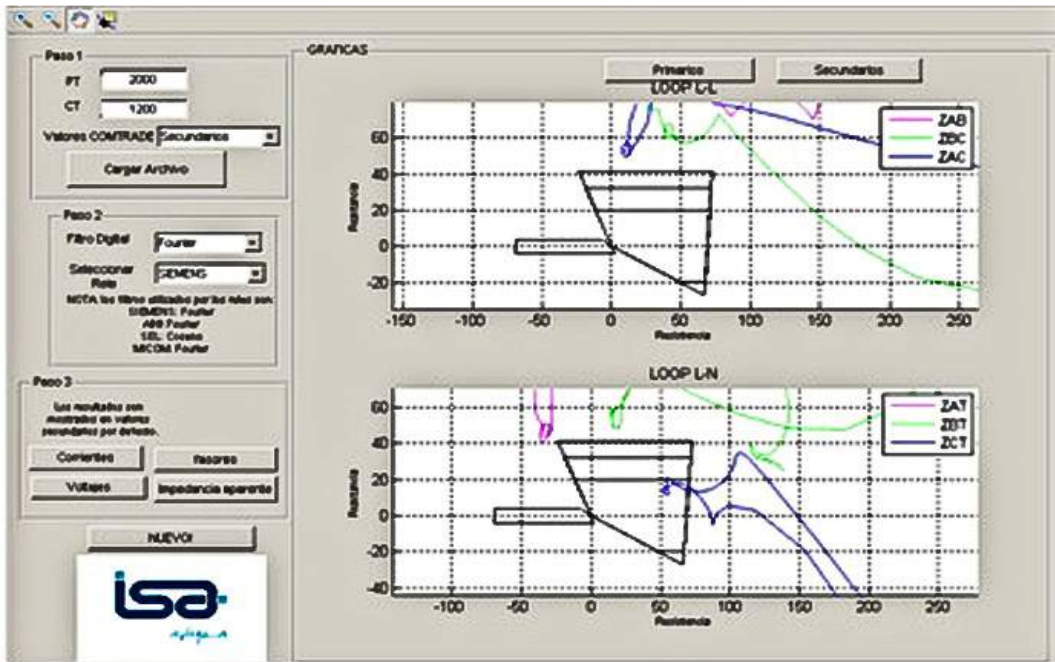
Figure 32. Apparent impedance trajectories on IMPAP for relay Siemens 7SA522 of LN-808 at FUN.

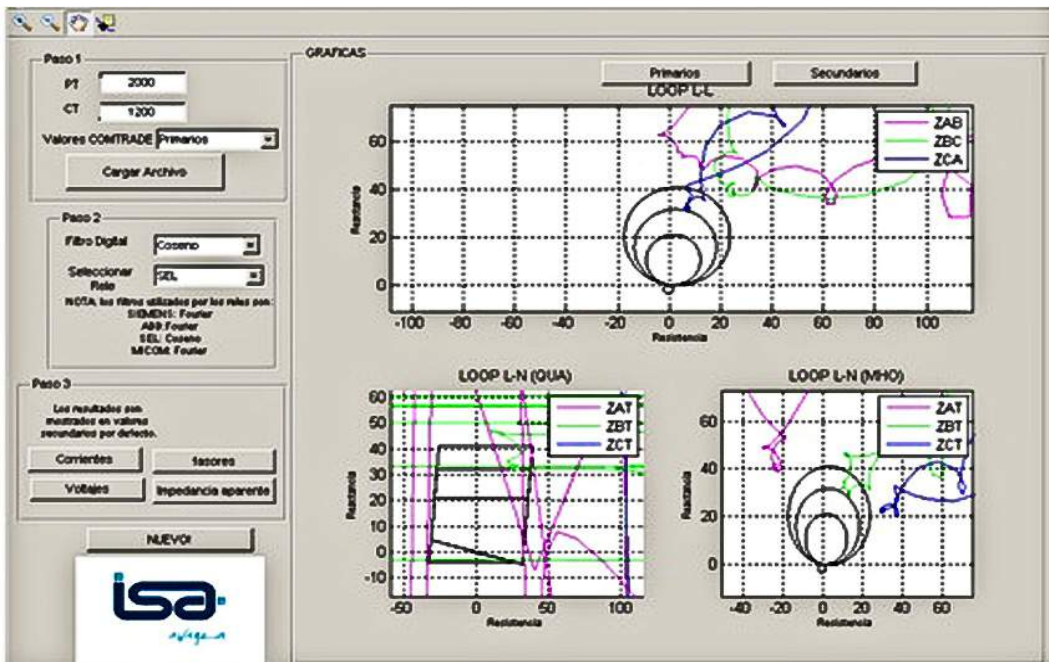
Figure 33. Apparent impedance trajectories estimated with new settings for SEL-321 of LN-808 at FUN.

New settings for the relays of this line bay were calculated as well. The results of the apparent impedance trajectories on the IMPAP are as described in figures 33 and 34 for SEL-321 and Siemens 7SA522.

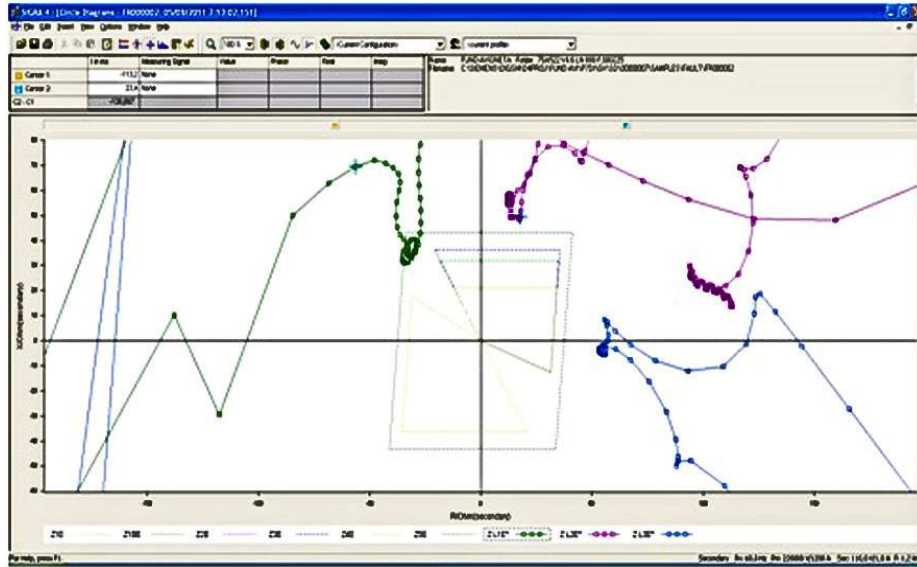
Figure 34. Apparent impedance trajectories estimated with new settings for Siemens 7SA522 of LN-808 at FUN.
