**Widows Creek Disturbance
June 22, 2002 @1115**

Problems and Near-Misses

**Gary L. Kobet, P.E.
Tennessee Valley Authority**

**Presented at the
Georgia Tech
Fault and Disturbance Analysis Conference
April 25-26, 2005**

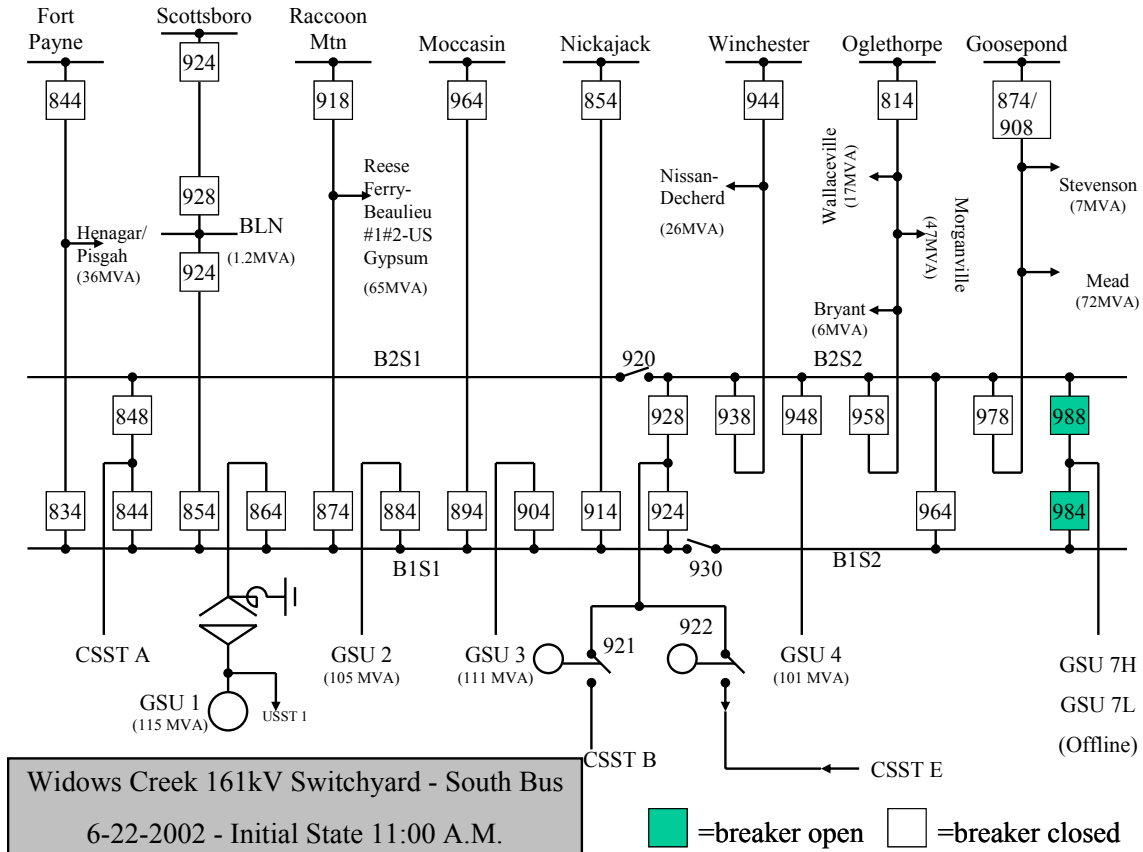
Figure 1: Widows Creek 161kV Switchyard - South Bus

As shown in Figure 1, PCBs 924/928 feed Common Station Service Transformers B (Units 4,5,6 start boards) and E (Unit 7 Scrubber). This feeder is protected by differential overcurrent relays (figure 2). This protection was removed from service while 922 was being operated, supposedly to avoid a misoperation of the protection during switching, which would have resulted in a loss of CSST B. This indicates a misunderstanding of differential protection and its importance during primary switching.

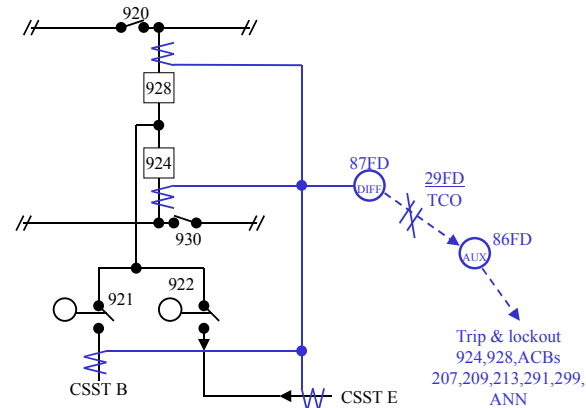
Figure 2: CSST B/E Feeder Differential Protection

On June 22, 2002, those involved in preparing the switching, including plant personnel and ESO system operators, made a conscious decision to remove the feeder differential protection from service by opening 29FD, thus disabling local primary protection for MOD 922. To be fair, it should be noted that at least a contributing factor in this decision is the fact that both CSST B and CSST E are fed from the same switchyard bay. If breakers 924 and 928 were used to deenergize CSST E, CSST B would be deenergized (and vice versa). Due to known problems in the transferring (both automatic and manual) of the common boards, this has caused the loss of control air and other significant loads (e.g., Raw Water Board #2, ignition systems) and has even resulted in unit trips. This is a known issue and is being worked on by site engineers.

In any event, the resulting disturbance lasted over 150 cycles (almost three seconds), taking 83.5 cycles to clear 16kA (initial) phase-to-ground bus fault. Backup protection at all eight remote terminals, plus backup protection on all four 125MVA generators, necessarily had to operate to clear this fault.

Disabling the feeder differential protection was the major cause of the extended duration of the disturbance and the resulting threats to TVA generators (described below). It is crucial that plant personnel and system operators recognize the importance of primary protection and be extremely careful in evaluating its removal from service, giving careful thought to the consequences should a fault occur in the primary zone of protection. As a guideline, primary protection should remain in service at all times except during secondary switching (e.g., switching bank differential CTs) or for relay testing. If there are any questions regarding the principles behind a relaying scheme, ESO/System Protection & Analysis should be contacted.

ESO/Transmission Operations dispatchers have issued new guidelines for Fossil Plant Switching (see attached).

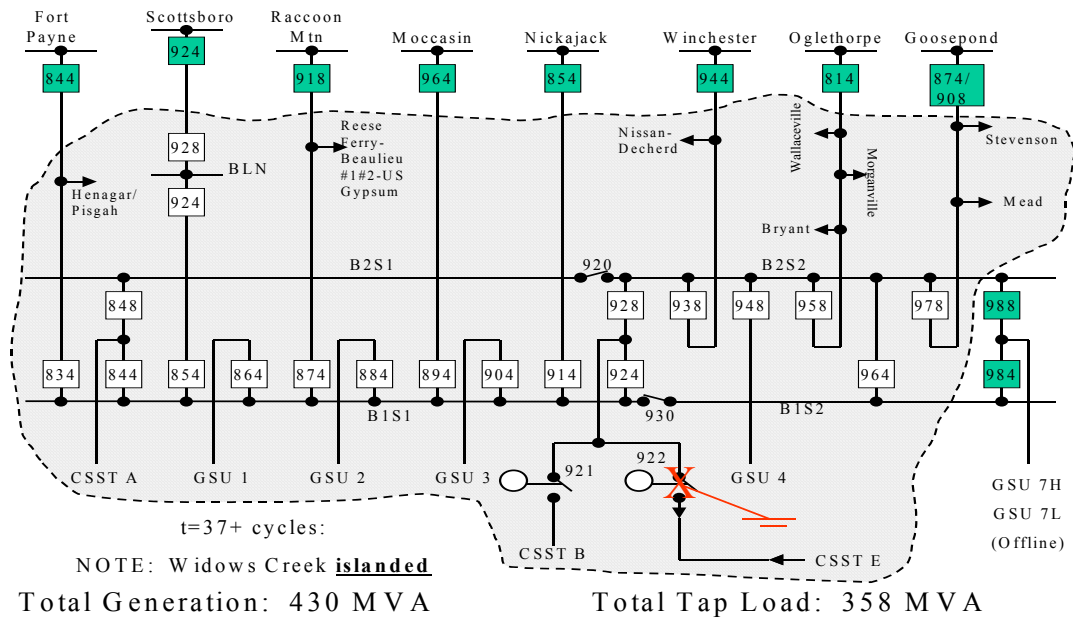
Figure 3: Widows Creek South Bus - Islanded

Regarding abnormal frequency protection of fossil-power generators, the timeline shows that after the last remote terminal cleared (Fort Payne 844 at t=37 cycles), an island was formed (figure 3), with the Widows Creek generators 1, 2, 3, and 4 along with loads tapped off the eight 161kV lines and the Widows Creek station service loads. Total available generation was 4*125 MVA=500 MVA, matched against total pre-fault three-

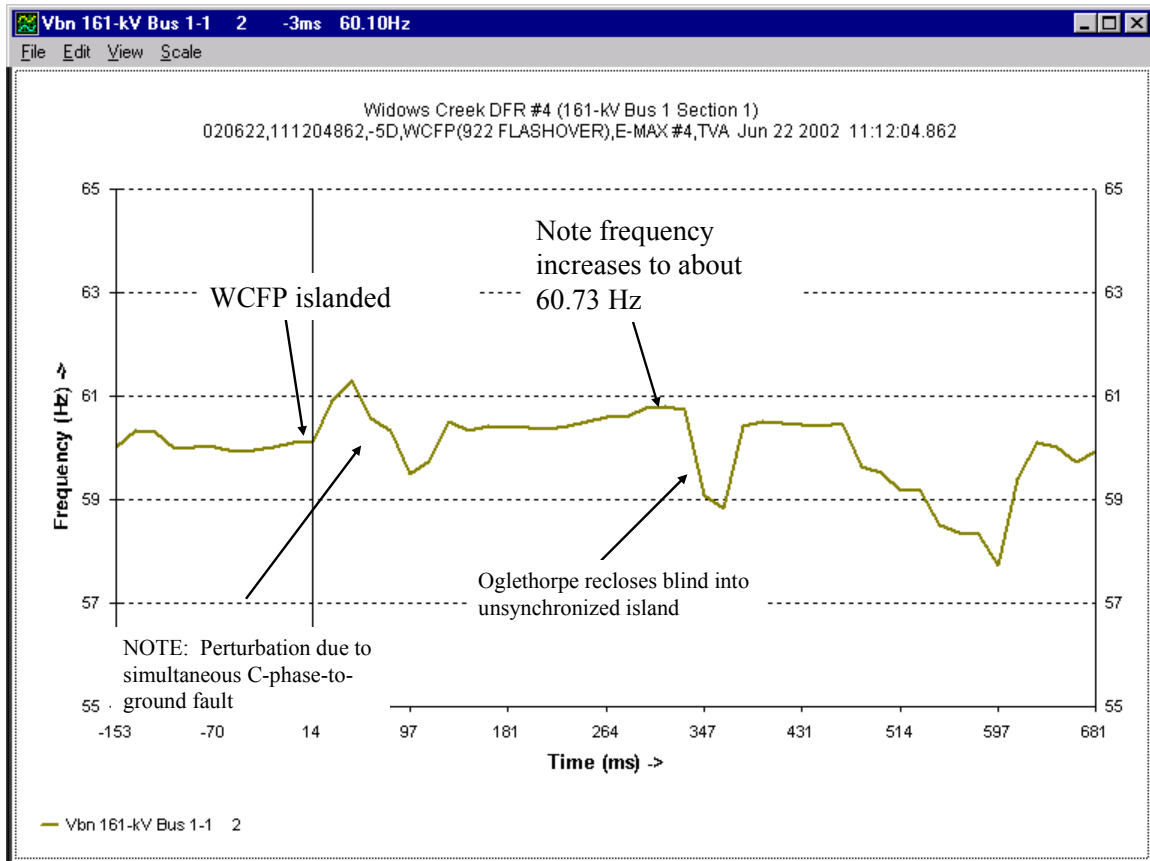
Figure 4: Widows Creek South Bus - Frequency

phase load of 358 MVA. As expected, then, the frequency of the island increased to about 60.73 Hz in about 16 cycles (267 msec) (figure 4).

It should be noted that this event occurred on a Saturday at 11:00 A.M. Had the event occurred on a weekday during an extreme summer peak, the load of the island would have approached 487 MVA. If only three Widows Creek units had been online (a reasonable system configuration), the available generation would have been about 375 MVA, and the frequency of the island would have decreased. Underfrequency load shedding is installed at three of the tap stations, but it was in service at only two, so that the total load shed would have been only about 55 MVA, leaving 432 MVA of load against 375 MVA of generation. Under this scenario, the frequency of the island most likely would have dropped to the point that damage would have occurred to the Widows Creek steam turbines. This is because TVA steam turbine/generator units do not currently have underfrequency protection as prescribed by IEEE standards. A proposal is currently under development to upgrade TVA's generator protection on larger units to include underfrequency protection.

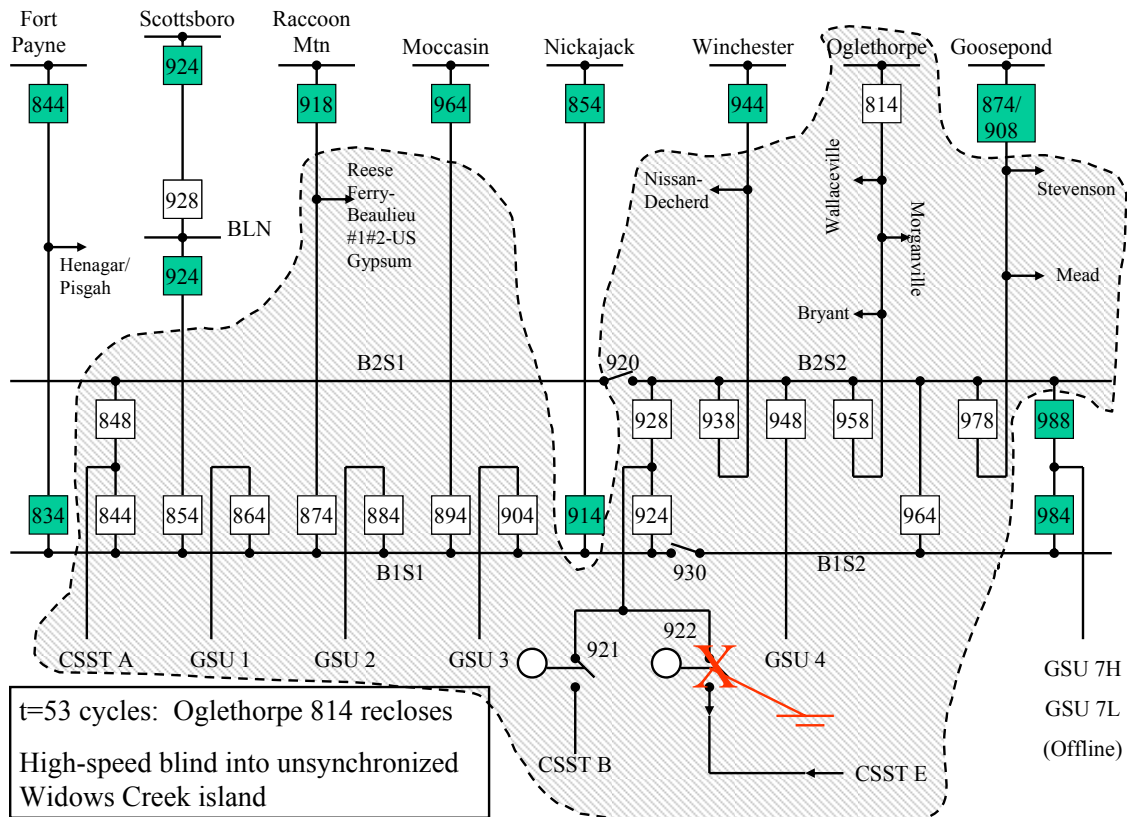
Figure 5: Widows Creek South Bus - Oglethorpe 814 reclosing into island

DESIGN DEFICIENCY: MDAR RB contact not wired to cancel first reclose

With regard to blind reclosing into an island which has changed frequency relative to the remainder of the power system: According to the attached timeline, at t=53 cycles, Oglethorpe PCB 814 reclosed high-speed “blind” (unsupervised) into the island (figure 5), due to a problem with the reclosing circuits at Oglethorpe. Calculations show that the island was approximately 30 degrees out of phase with the TVA system (figure 6), but, as noted above, the island was operating at about 60.73 Hz, with the TVA system still operating at 60 Hz. Had the reclose occurred with the two systems 180 degrees out of phase, it likely would have resulted in some degree of damage or at best loss-of-life to the shafts of all four Widows Creek generators (the effects of such events were studied in the 60’s and 70’s, resulting in the decision to eliminate high speed reclosing on the 500kV transmission system).

TVA reclosing standard design calls for the first reclose shot to be canceled for a time delayed trip on 161kV lines with carrier. This was not the case on this breaker and has been rectified by modifying the circuit per the present TVA standard¹. (NOTE: Bellefonte PCB 924 is wired per the standard, but it failed to operate, which resulted in a

¹ It is recommended that the RB-1 contact of both MDAR relays (8121/67G-A and -B) at Oglethorpe be connected to operate the 79H/O coil (in parallel with 79RCT contact 6/8), canceling the first reclose on any time delay trip.

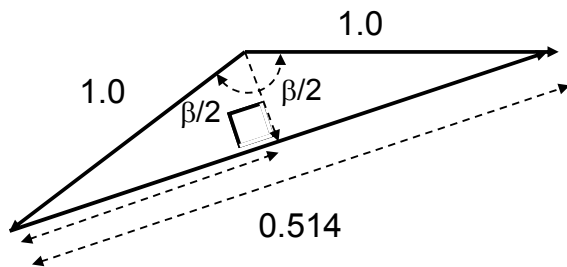
Figure 6: Approximate calculation of angle across open Oglethorpe 814 just before blind reclose

$$I = \frac{dV}{X} = \frac{|1\angle 0 - 1\angle \beta|}{X_S + X_L + X_D''} = \frac{|1\angle 0 - 1\angle \beta|}{0.0172 + 0.0922 + 0.0447} = \frac{|1\angle 0 - 1\angle \beta|}{0.1541} = 3.33$$

$$|1\angle 0 - 1\angle \beta| = 0.514$$

$$\therefore \beta = 2 * \sin^{-1}(0.514/2) = 30^\circ$$
