# **Using Synchronized Disturbance Recorders to Dissect a Complex, Short Duration Event**

Dean Ellis, P.E. and Jim Ingleson, P.E.  
New York Independent System Operator, Inc., Schenectady, NY

For Presentation at the 2005 Georgia Tech Fault and Disturbance Analysis Conference

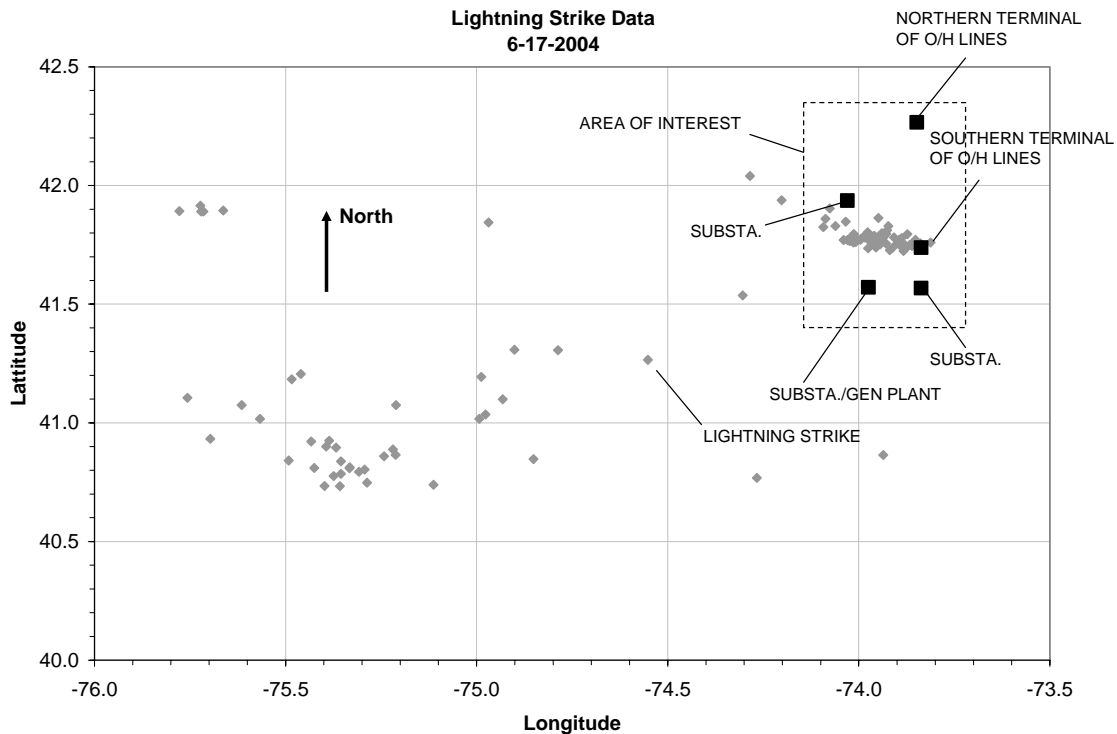
*Figure 2*  
Location of Lightning Strikes on June 17, 2004

The lightning detection system revealed that a 68 kA magnitude cloud-to-ground strike occurred in at the location of the unshielded tower at 19:00:21.700 EDT. Figure 2 below illustrates graphically the location of lightning strikes throughout the day relative to the facilities in question.

The DFRs located at the northern and southern terminals of the overhead lines revealed a trigger time of 19:00:21.706 and 19:00:21.707, respectively. These trigger times are consistent with the time of the strike as recorded by the lightning detection system. The lines were cleared at 19:00:21.773 and 19:00:21.819, respectively (4.4 and 7.1 cycles after the lightning strike). All of these facts showed that the overhead lines were most likely struck by lightning.

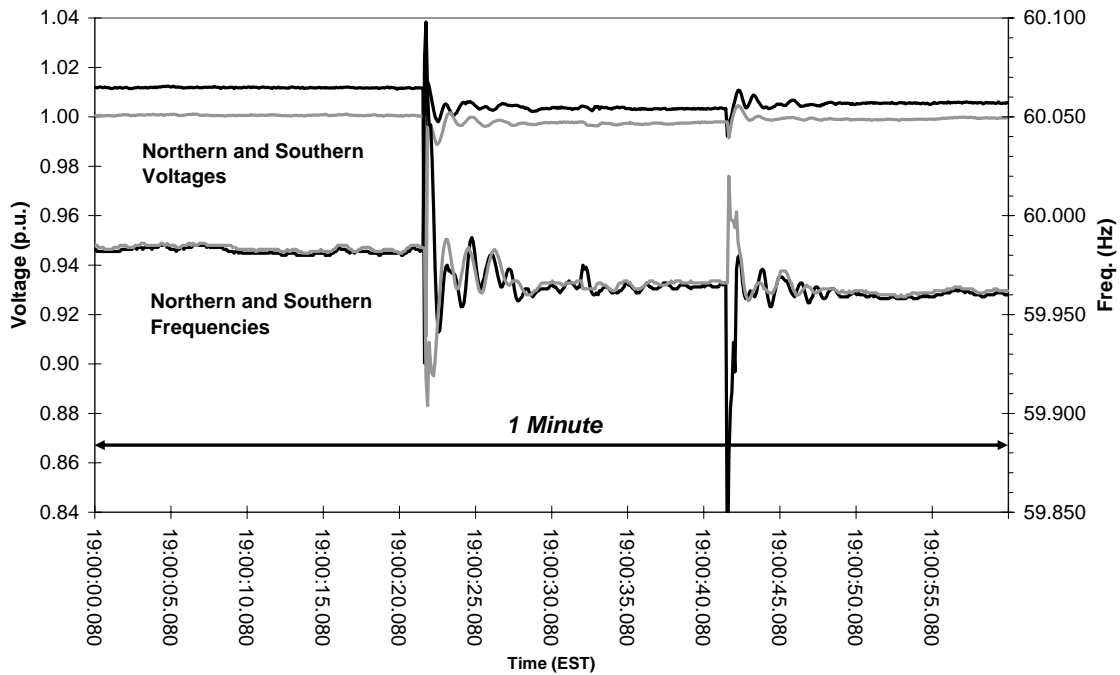
*Figure 3*

The NYISO owns several Dynamic Data Recorders (DDRs) which are installed at Transmission Owner substations throughout the State. These DDRs primarily record system frequency during events, but also record bus voltages. These DDRs are time-synchronized, and provided an additional level of detail for the investigation. Figure 3 below shows the voltage and frequency as recorded to the north and south of the incident.

*Northern and Southern System Frequency and Voltage Response*
