Knoxville 161-kV Substation Bus Insulator Failures and Corresponding Ground Problems

Timothy L. Burgess
Chattanooga Transmission

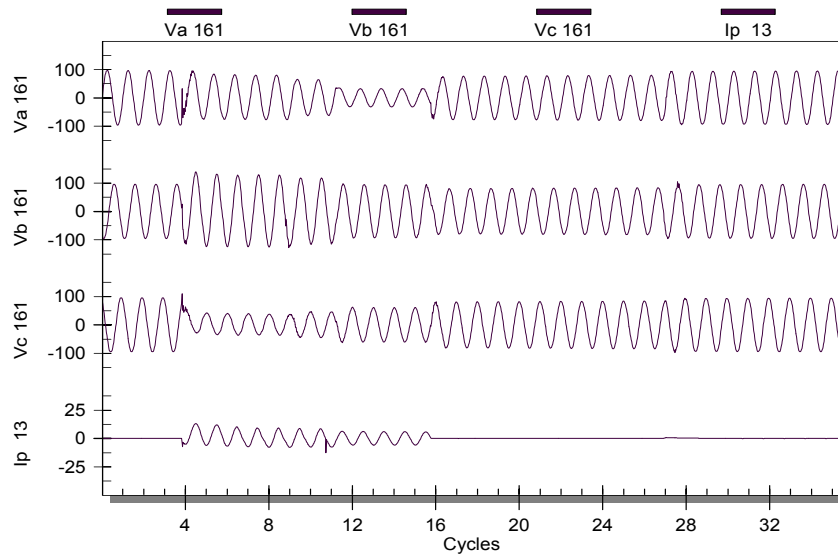
Figure 2: Bus Voltages and Polarizing Current for 9/14/2000 Bus Fault

The review of the oscillography for the event was complicated by apparent problems with the RIS 1630. While the Volunteer #1 A-phase current trace (laVOL1) and the Nixon Road A-phase current trace (laALC) seemed to indicate an A-phase fault (Figure 3), the bus potential traces (Figure 2) indicated that the fault originated on C-phase and migrated to A-phase coincident with the tripping of the Volunteer #1 161-kV line. A review of both digital and paper oscillography from surrounding stations substantiated the theory that the fault was caused by an A-phase insulator flash to ground and no C-phase involvement was observed.

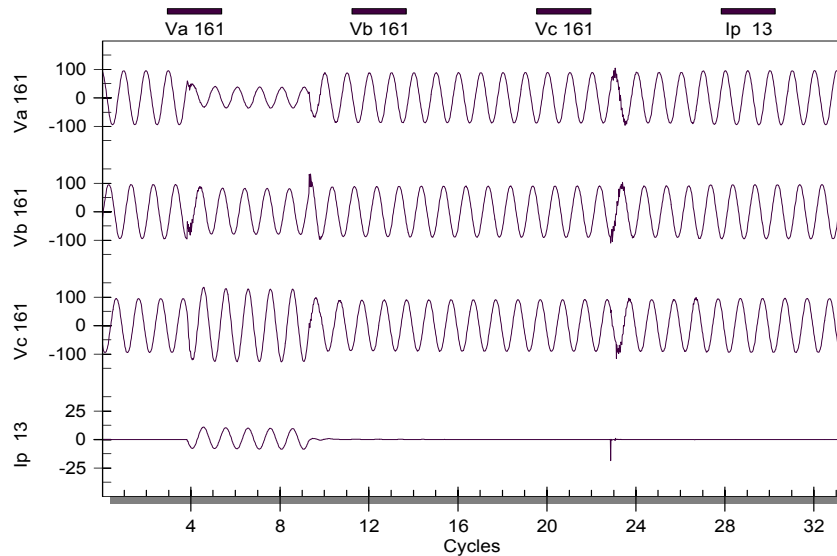
Figure 4: Bus Voltages and Polarizing Current for 9/18/2000 Bus Fault

While Figure 4 showed a definite collapse in A-phase voltage and a smaller decrease in B-phase voltage, the currents, shown in Figure 5, seemed to indicate a B-phase fault.

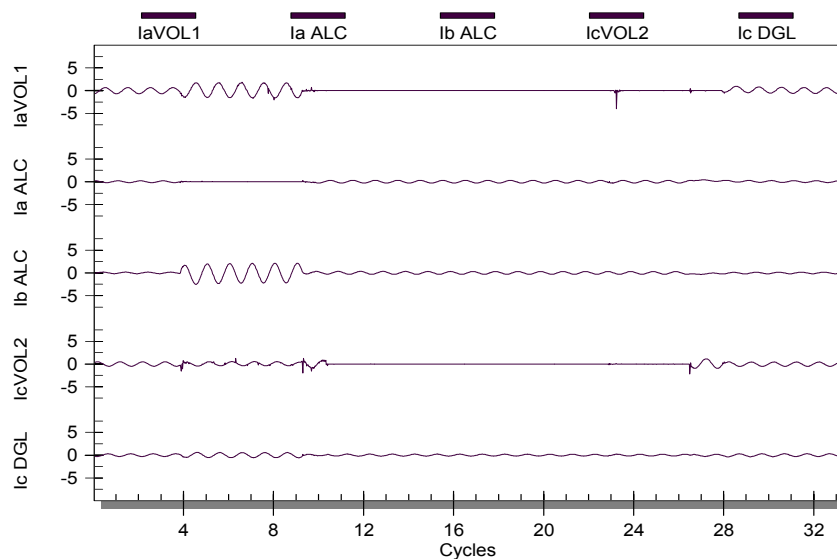
Figure 5: Line Currents for 9/18/2000 Bus Fault

A review of oscillography from neighboring stations confirmed the existence of a B-phase fault. Further, a fault location study indicated that the fault was less than 5% of the distance from Knoxville Primary to Volunteer on the #1 Line.

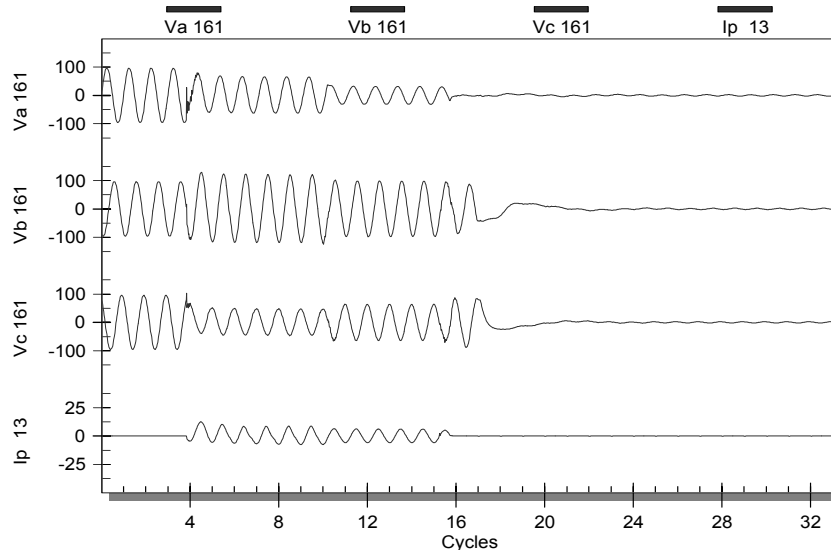
Figure 6: Bus Voltages and Polarizing Current for 10/2/2000 Bus Fault

With the exception that this fault involved Bus 1 and therefore the monitored Bus 1 voltage traces went to zero with the clearing of the fault, the voltage oscillography (figure 6) for the fault on October 2nd looked identical to that for the September 14th event (figure 2). Again, oscillography from surrounding stations showed the fault to be A-phase to ground with no other phase involvement.

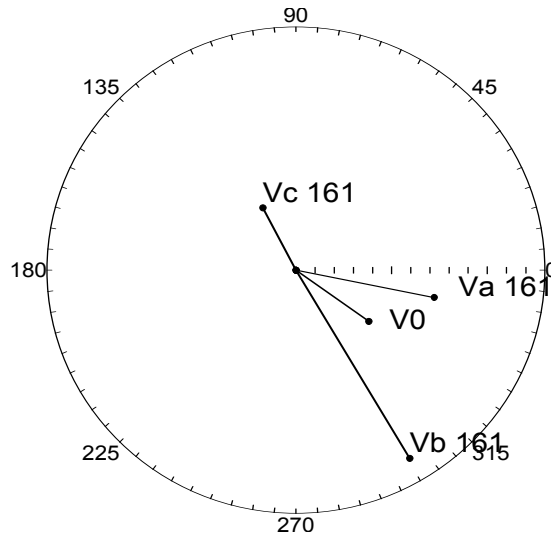
Figure 10: Voltage vectors on 9/14/2000 at $t = 6$ cycles with the calculated V_0

$$\begin{aligned} V_0 &= (78.6 \angle 348.5^\circ + 124.7 \angle 300.5^\circ + 40.0 \angle 117.4^\circ) / 3 \\ &= 50.0 \angle 324.3^\circ \text{ kV} \end{aligned}$$

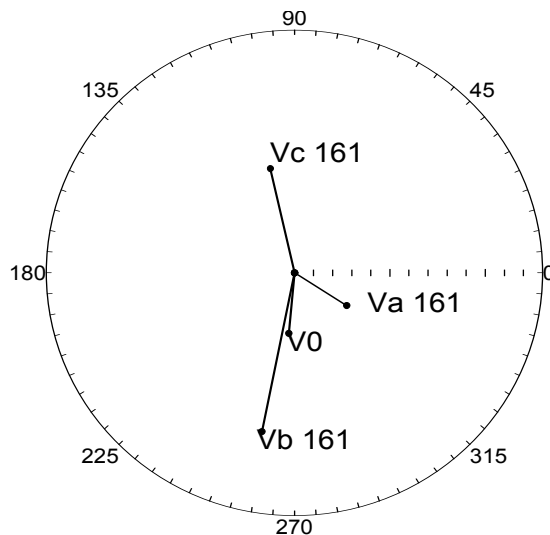
Figure 11: Voltage vectors on 9/14/2000 at $t = 14$ cycles with the calculated V_0

Similarly Figure 11 illustrates the V_0 (equal to $16.3 \angle 297.6^\circ$ kV) at $t = 14$ cycles.

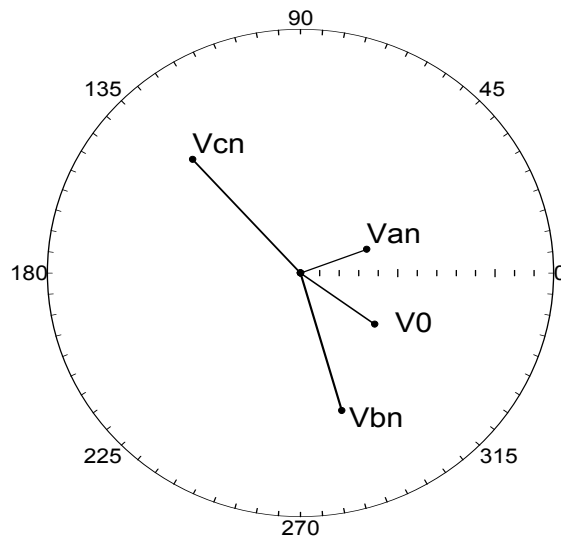
Figure 12: Voltages for 9/14/2000 fault after compensation at $t = 6$ cycles

$$\begin{aligned}
 V_{an} &= V_{ag} - V_{ng} \\
 &= 78.6\angle 348.5^\circ - 50.0\angle 324.3^\circ \\
 &= 38.8\angle 20.4^\circ \text{ kV}
 \end{aligned}$$

V_{an} , V_{bn} and V_{cn} were then plotted, again using COMTRADE, by removing the V_0 component from the observed phase to ground voltages. This led to the more recognizable vectors of a single-phase to ground fault shown in Figure 12.

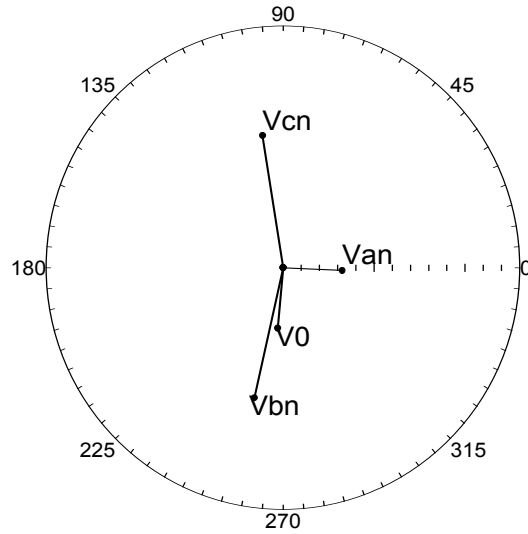
Figure 13: Voltages for 9/14/2000 fault after compensation at $t = 14$ cycles

These vectors, again indicating the A-phase to ground fault are shown in Figure 13.

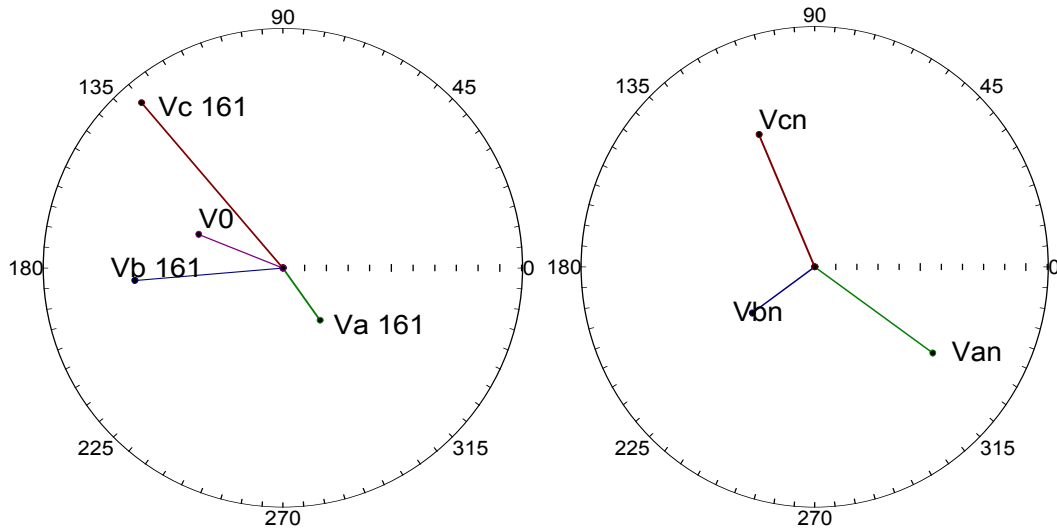
Figure 14: Uncompensated and compensated bus voltages for fault on 9/18/2000

The uncompensated and compensated phasor diagrams for this fault are shown in Figure 14. These verify that the fault was B-phase to ground as suspected from surrounding oscillography.

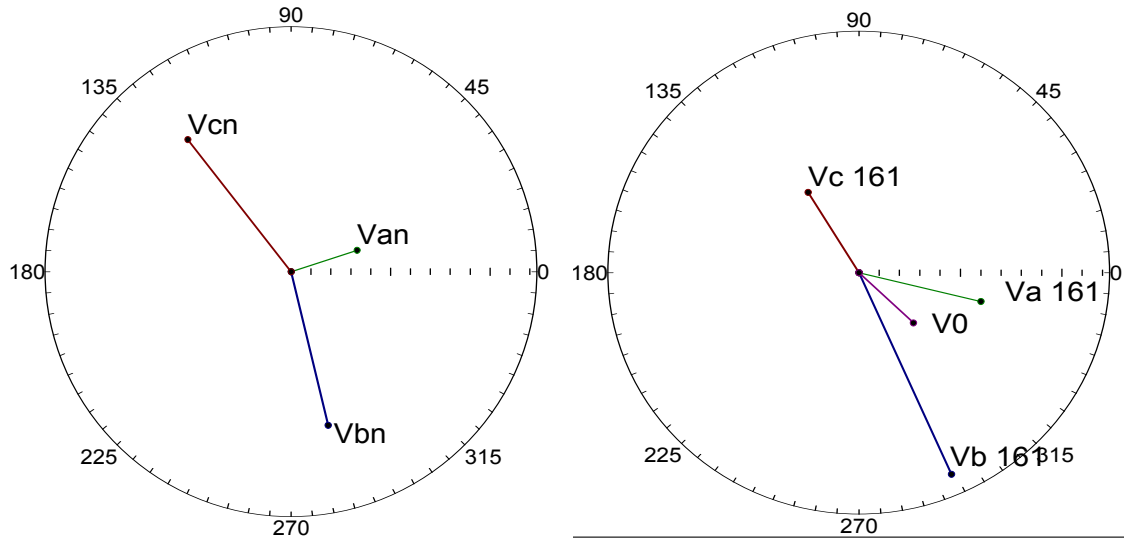
Figure 15: Uncompensated and compensated bus voltages for 10/2 fault at t = 6 cycles

$$\begin{aligned} V_A &= 64.5 \angle 346.2^\circ \text{ kV} \\ V_B &= 117.6 \angle 293.8^\circ \text{ kV} \\ V_C &= 50.2 \angle 121.3^\circ \text{ kV} \\ V_0 &= 38.7 \angle 316.4^\circ \text{ kV} \end{aligned}$$

$$\begin{aligned} V_{an} &= 36.4 \angle 18.1^\circ \text{ kV} \\ V_{bn} &= 83.2 \angle 283.6^\circ \text{ kV} \\ V_{cn} &= 88.1 \angle 127.9^\circ \text{ kV} \end{aligned}$$
