Why record trends and oscillography at the distribution level?
(A Case Study)

Bryan Gehringer
Alexander Apostolov, PhD.

Ninth Annual Fault and Disturbance Analysis Conference, Georgia Tech
May 1, 2006, Atlanta, Georgia

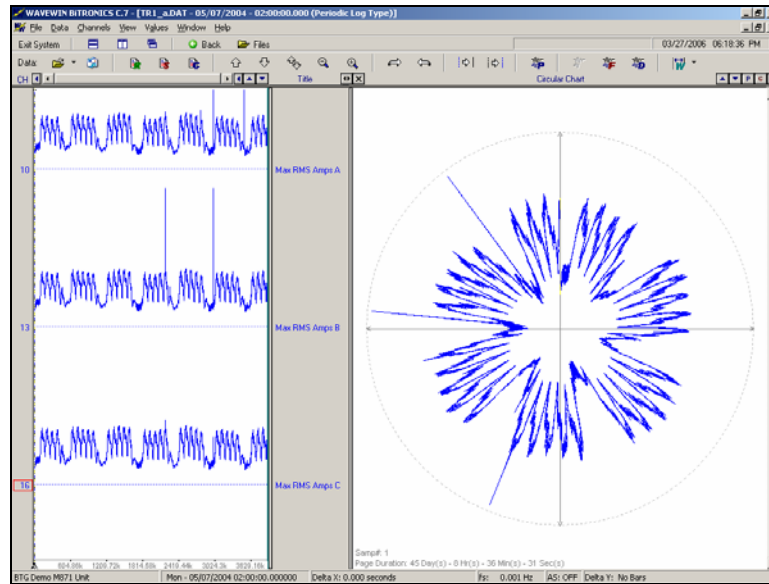
Figure 1. Seven week trend showing evidence of disturbances

The trend recording in Figure 1 illustrates a seven week long pattern of on and off-peak daily load current variation typical of the Summer season at this location, with significant spikes occurring on July 30, August 8 and August 14. A smaller spike appears on August 6, but was below the 900A threshold used to trigger oscillography. Oscillography was captured for the major spikes which helped to characterize the kind of transients that were being observed.

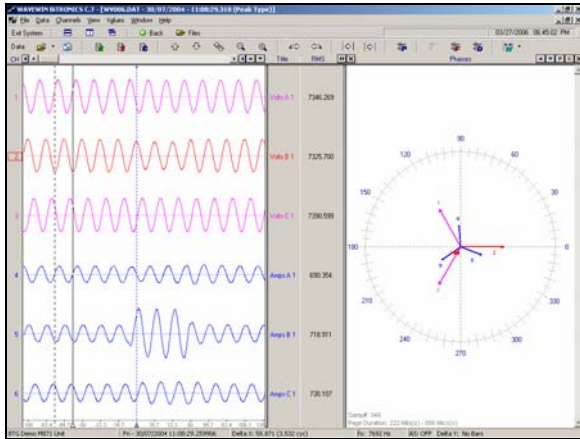
Figure 2. July 30, 2004

Figure 2 is the July 30 fault. It happened at on a Friday at 11:00AM. It was on B-phase only. The normal prefault load was 720A on that day. Fault current was 2025A, only about three times normal load and lasted for just 3 cycles. It was inductive, didn't saturate the CT and had no appreciable harmonics.

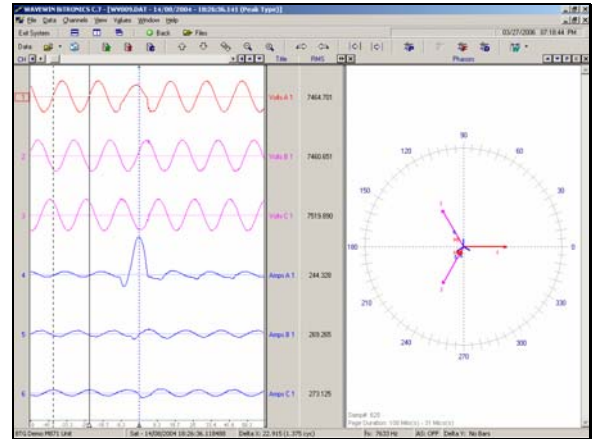
Figure 3. August 14, 2004

This fault occurred on a weekend when the normal load was just under 250A. It was on the A-phase and lasted only about 12 milliseconds. The fault current exceeded 2500A RMS, or ten times normal, (over 4700A peak). In this case there were obvious significant harmonics, much more in the current than on the voltage. The current harmonics (particularly the even components) actually increased after the fault cleared. See Figure 4.

Interesting as these recordings are, it was concluded that both faults were self clearing, neither indicated any threat of damage to substation equipment or suggested anything (such as a relay) might be misoperating. There were no customer complaints on those dates that the recordings might have corroborated or helped to explain. After ruling out likely explanations like tree strikes and wildlife, it was decided that whatever the cause, it was not worth committing scarce resources to further investigation. The middle spike on the trend recorder was more interesting however.

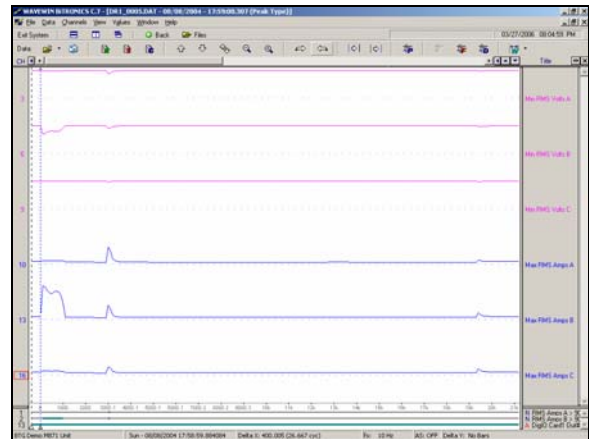
Figure 5. Slow disturbance record showing August 8, 2004 fault

Figure 5 shows an RMS recording of a 3000A B-phase fault that occurred downstream of the substation. This fault was cleared by a customer's protective relay in about one second. Notably, there appear to be two transformer inrush signatures at three seconds and fifteen seconds following the fault, possibly indicating some kind of automatic load restoration after the fault was isolated. The slow disturbance recorder places this entire sequence of events on a common time-scale making the cause/effect relationship between the incipient fault and the two resulting transients easier to visualize. See Figures 6 and 7 for oscillography recordings of the fault and the subsequent inrush.

Why was this more interesting than the others? Because a prolonged 3000A fault could potentially trip the feeder breaker in the substation if downstream protection was set improperly or failed to operate. An alarm in SCADA is justified, and may be significant if the fault not an isolated incident but seems to repeat periodically, as this one did. As it turns out this customer's protection worked correctly and the feeder breaker never needed to trip. The utility is legitimately concerned when interruption of service to other customers is possible. When alarms occur, having the tools to be able to characterize abnormal conditions quickly and efficiently reduces cost and frees up limited maintenance resources for other work.

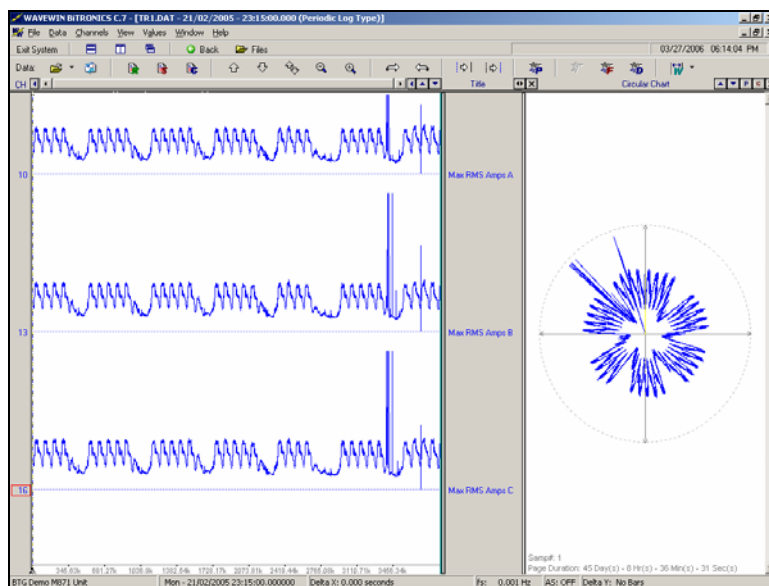
Figure 8. Trend record indicating where the 250HP motor failed

Upon removing the recorder in April 2005, the final download revealed twenty-eight spikes between 7:00 AM and 2:00 PM on Saturday, April 2 and a total outage of approximately one hour duration in the middle of the night on April 6. The cause of the outage was already known and was not related to the other disturbances. The twenty-eight spikes on April 2, however, coincided with a report of a 250 horsepower motor that failed at a manufacturing facility supplied by the station.
