Analysis of Mutual Coupling Effect on DCB Scheme Operation for an External Fault

By: Yujie Irene Lu, National Grid

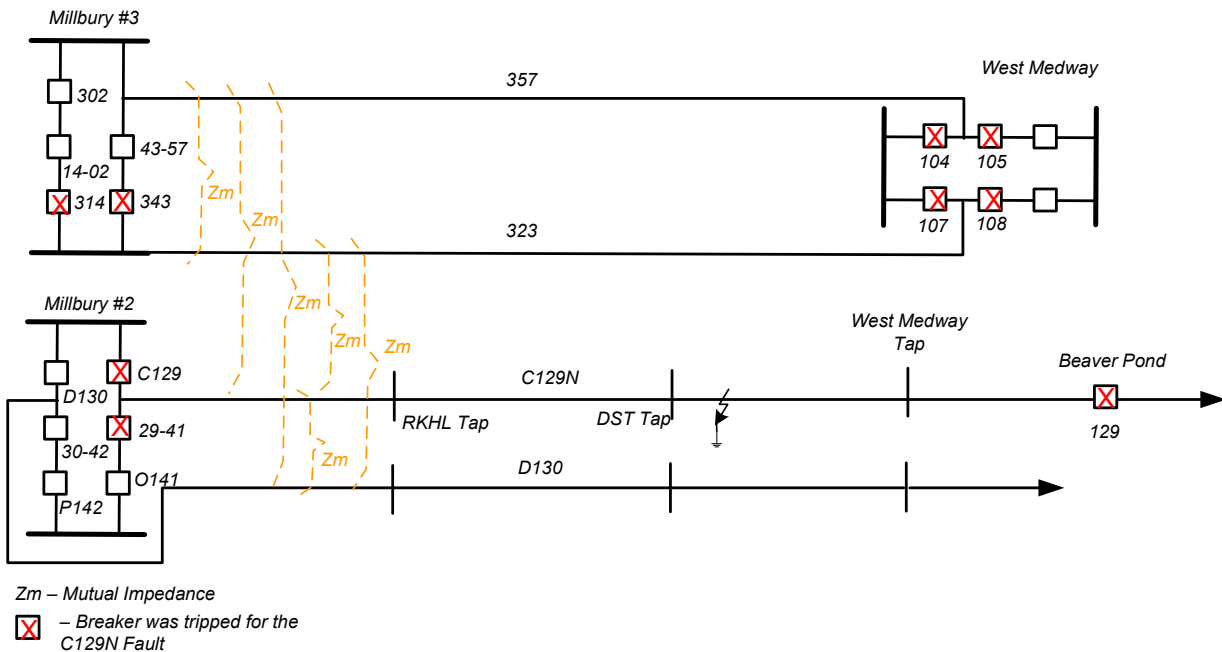
Figure 1. System One Line Diagram with the C129N Line Fault

Refer to the system one-line configuration (Figure 1), it is noted that the 115kV C129N and D130 lines are mutual coupled and tied together on the same bus at the Millbury #2 substation, and the 345kV 323 and 357 lines are mutual coupled and tied together on the same bus at both Millbury #3 and West Medway substations. However, the two pairs of the lines are not connected together through transformers, i.e. with zero sequence isolation, except mutual coupling. This fact implies that, during this fault, the directional ground relays on the 323 and 357 lines might challenger to sense direction correctly. Besides the possible directional sensing issue, it is believed that the increasing magnitude of ground fault current, i.e. 3I₀, on the two 345kV lines contribute to the CDG false operations.

1. Due to the physical arrangement between the lines and the different voltage level of the lines (Figure 1), the mutual coupling effect was more significant on the 323 lines than on the 357 and D130 lines during the original C129N fault. In other words, the magnitude of the ground fault current 3I₀ on the 323 Line increased more significantly than on the other two lines. In addition, the level of magnitude increase of 3I₀ also depended on the fault locations. For the C129 faults located between the Rocky Hill (RKHL) tap and West Medway tap, the ground current 3I₀ on the 323 Line might exceed the pickup setting of 360 amperes on the 323 CDG relays at the Millbury #3 and West Medway. See Table 2 in detail.

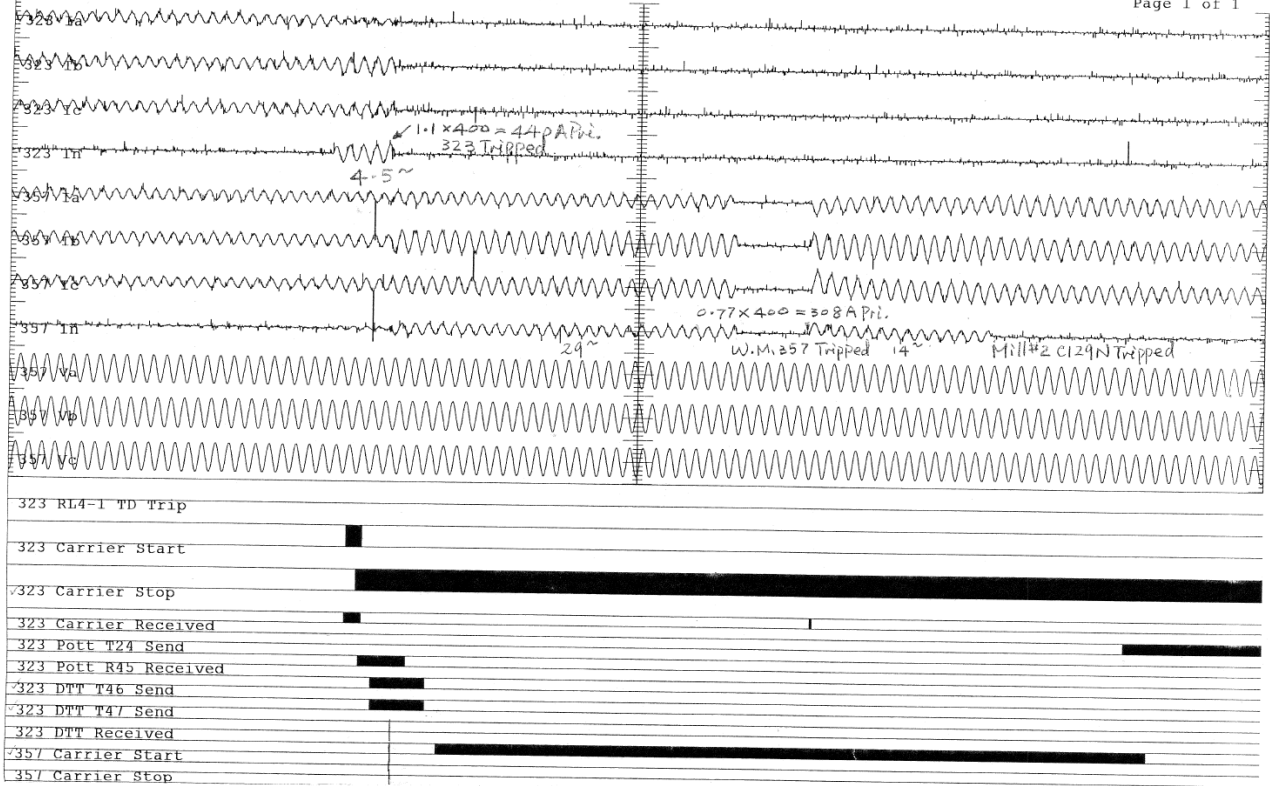
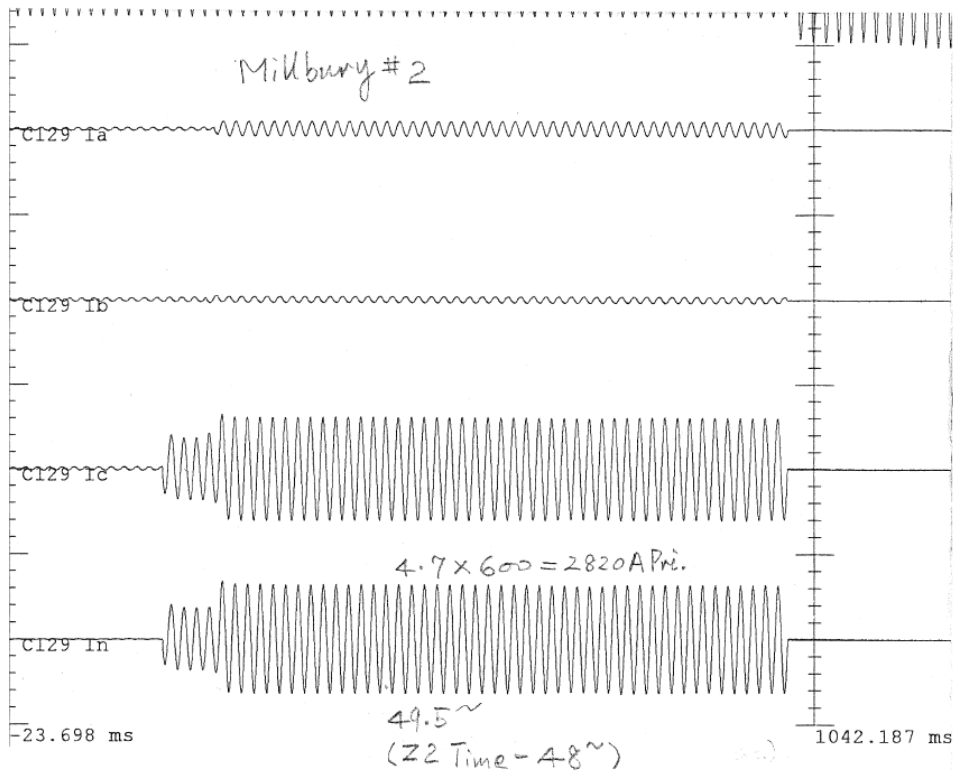
Figure 2. C129N, 323 and 357 Line DFR Records at Millbury Substation at 06:21:32:00

2. During the C129N fault, the 323 Line opened at both the Millbury #3 and West Medway (NStar) terminals. The line tripped at both terminals within 4.5 cycles. The current flow through 323 Line during the C129N fault for 3I0 was from the West Medway to Millbury #3. The 3I0 magnitude on the 323 Line at the Millbury #3 end was approximately 440 to 460 amperes, which is above the carrier directional ground trip (CDG) relay pickup of 360 ampere. (Note: The CDG function is a part of the 323 Carrier Comparison Blocking, DCB, scheme and the relay's directional control is zero-sequence voltage polarized.) As a fact, the 323 Line CDG relay at the Millbury #3 picked up and cleared the local terminal and sent a direct transfer tripping (DTT) signal to the West Medway resulting in the opening of the breakers 107 and 108 on the 323 Line. Since the breakers at the West Medway opened by the DTT, there was no auto-close on the 107 and 108 breakers at the time. It was most likely that the 323 CDG relay at the Millbury #3 misoperated due to the mutual coupling effects between the D130, C129N, 323 and 357 lines.

3. After the loss of the 323 Line and the Beaver Pond end of the C129N, the 357 Line became a main supply to the fault. It is important to keep in mind that the Millbury #2 end of the C129 Line had not yet cleared the fault. The 3I0 ground current, flowing from West Medway to Millbury, sensed by the 357 CDG start relay at the Millbury #3 was exceeded the pickup point of 200 amperes, therefore, the reverse-looking CDG start relay picked up and sent a carrier blocking signal to the West Medway. The 3I0 also exceeded the pickup setting of the 357 CDG trip relays at the West Medway. While, the 357 Line was correctly restrained from tripping due to the receipt of carrier blocking signal from the Millbury #3. As per further finding from NStar, for some unknown reason, approximately 29 cycles into the fault, there was a two (2) cycle interruption of the carrier blocking signal (i.e. a carrier hole) on the 357 Line at the West Medway terminal. This resulted in a single-end trip of the 357 Line at the West Medway only. It appeared that there were some problems on the 357 power line carrier system at this terminal.
