# **ANALYSIS of a CASCADING EVENT at NATIONAL GRID**

By Jeffrey Pond, National Grid and Dave Bertagnolli, ISO-New England

On November 16, 2007 a shield wire failure within National Grid's Sandy Pond substation initiated an event that cascaded, resulting in the failure of a 345/115 kV transformer and the loss of the nearby HVDC Converter Terminal supply. Cascading events are of concern to utilities and the Regional Transmission Organizations (RTO). For the utility, the protection schemes need to work properly to isolate faults quickly, minimizing the impact on transmission system. Isolation of faulted components quickly is necessary in order to maintain system reliability and stability. For the RTO if the failed components are not isolated the impact on power system stability could potentially cause a wide-area event.

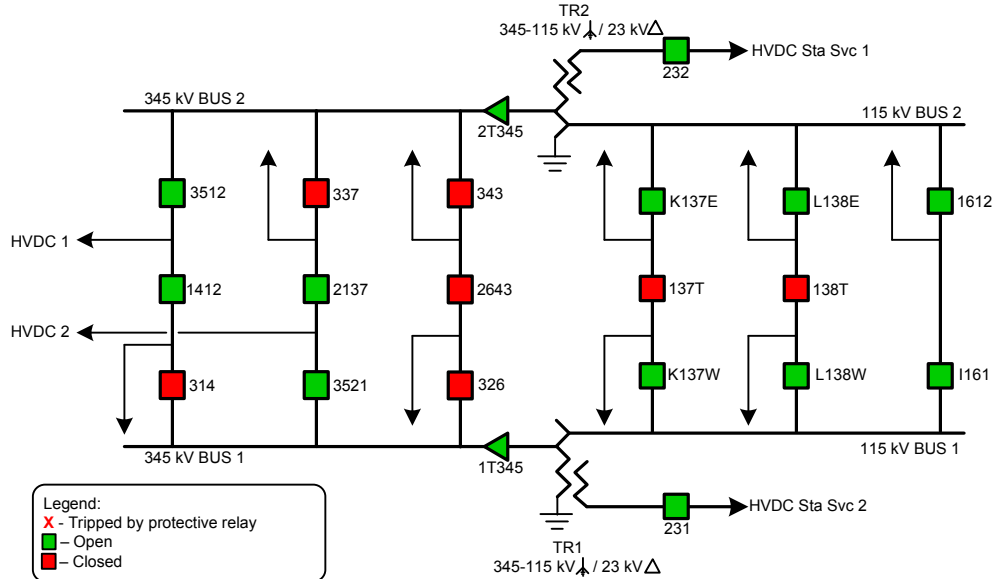
Figure 1 – One-line Station Configuration at End of Cascade Event

On 11/16/2007 the System Control Center reported that at 14:54:38 the I-161 Line shield wire failed and fell across the 1612 circuit breaker (CB) causing a fault tripping the I161 and 1612 CBs. The fault caused Transformer 1 to fail. The 314, 3521, 326, K-137W, L-138W, and 231 CBs tripped and locked out. At the same time the 3512, 337, 343, K-137E, L-138E and, 232 CBs on Bus 2 tripped and locked out. The 1412 and 2137 CBs then tripped. Figure 1 shows the position of the circuit breakers and disconnects at Sandy Pond after all faults were cleared.

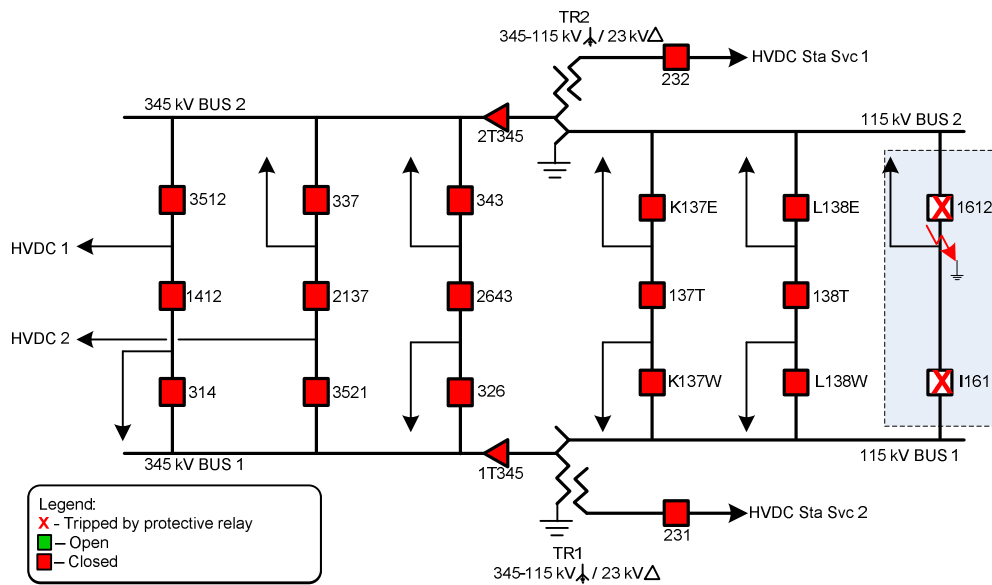
Figure 2 – Initial I161 fault

The initial fault was caused when the shield wire broke free of the structure and fell coming in contact with the I-161 Line section of the bus as depicted in the one-line in Figure 2. The fault record captured for this event (Figure 3) shows a C-phase to ground fault exceeding 15,000 Amps that cleared in approximately three cycles when the I161 and 1612 circuit breakers (CB) tripped. The circuit breaker change-of-state in Figure 3 agrees with the sequence-of-events for Event 1 in Table 1. The I161 system one and two Directional Distance Zone 1 targets reported by the System Control Center align with this operation based on the protection zone of the relays, which is identified by the highlighted area shown in Figure 2.

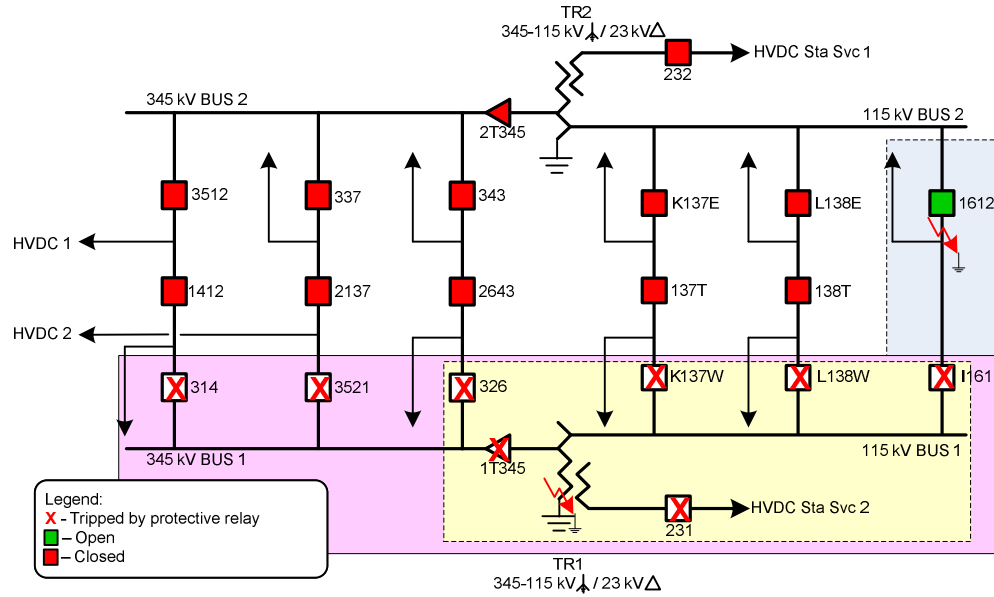
Figure 4 – I161 CB Auto-Close and TR1 Failure

The second event occurs approximately five seconds after the initial fault, as can be seen in Table 1. During this event the TR1 Overall Differential protection and Transformer Differential protection operated tripping the Bus 1 345kV and 115kV circuit breakers to lockout as depicted in Figure 4. The 1T345 motor operated disconnects on the 345kV side of TR1 also tripped. The protection zones of the Overall Differential protection and Transformer Differential protection are highlighted in red and yellow respectively for reference in Figure 4. Review of the fault record (Figure 5) captured for this event shows that the I161 CB closed into a fault caused by the failed shield wire. The fault record shows TR1 supplying fault current for the I161 fault. The I161 circuit breaker trips in approximately three-cycles at which point the C-phase and neutral current supplied by TR1 increases. It is possible that the transformer fails at the point where the I-161 fault clears because of the increase in fault current supplied by the transformer. The transformer fault clears approximately two and one-half -cycles after the I161 CB opens clearing the I161 fault. No targets were assigned for the I161 CB operation in Event 2 of Table 1. It is possible that the trip was initiated by the I-161 Line Directional Distance protection, however, it is more likely that the I161 CB tripped on Instantaneous Over-Current (IOC) protection of which no target was reported. The IOC protection is designed to trip its associated circuit breaker if it is closed into a permanent fault, similar to Switch-on-to-Fault protection today.

A review of the protective relay and control settings identified that for an I-161 line fault the I161 CB will auto-close in five (5) seconds. This five second auto-close matches the time that lapsed between the first and second event. As discussed above it was confirmed in the fault record that the I161 CB attempted to

close into a permanent fault caused by the failed shield wire. The sequence-of-events table does not show this auto-close.

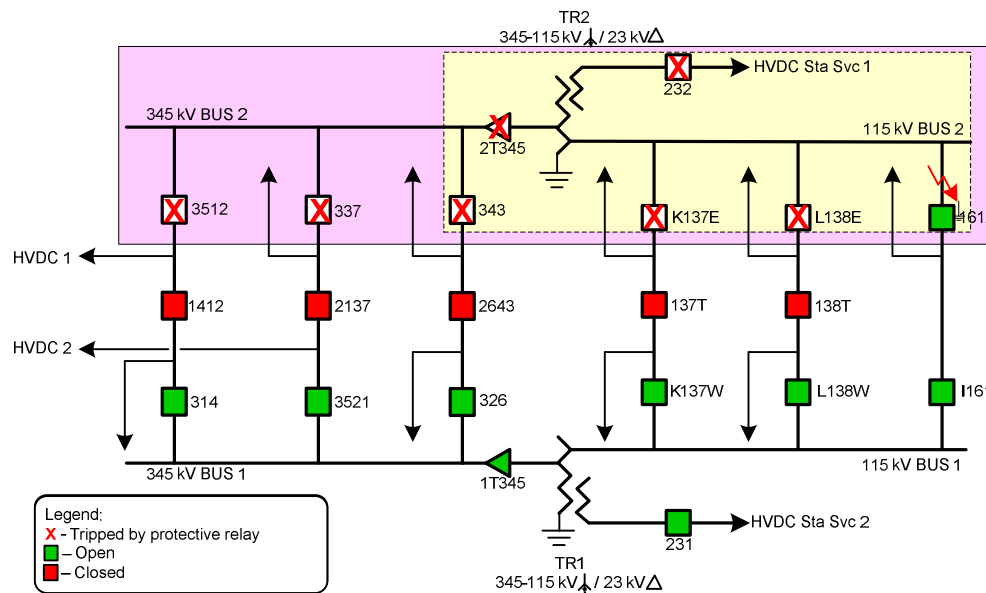
Figure 6 – TR2 Overall Differential Operation

The third event occurs approximately two and one-half seconds after the second event began, as can be seen in Table 1, tripping the Bus 2 345kV and 115kV circuit breakers to lockout. The 2T345kV motor operated disconnects also tripped. The Bus 2 Overall Differential (OD) relay targets reported align with the CBs and MOD that operated for this event (Figure 6). Unfortunately there were no fault records captured for this event. Therefore, it is not clear if TR2 Overall Differential protection system operation was correct. However, at this point in the analysis it was assumed that the shield wire had jumped across to the Bus 2 side of the 1612 CB as a result of the flash created when the I161 CB reclosed into the fault resulting in the TR2 Overall Differential relay operation. This appears to be a valid assumption as it matched the sequence-of-events in Table 1. If the shield wire did jump across the 1612 CB as assumed the TR2 OD protective relay operation is proper.

Of concern for this event was the fact that the TR2 Overall Differential protection operated but the TR2 Transformer Differential protection did not operate as had occurred during event 2 when TR1 failed. The protection zones of the Overall Differential protection and Transformer Differential protection are highlighted in red and yellow respectively for reference in Figure 6. Another consideration is that the TR2 OD protection is an older solid state relay that may be susceptible to harmonics or a transient surge that resulted in the trip contacts being bridged causing the static protective relay to operate. Therefore,

additional follow-up is required as it is still possible that this TR2 Overall Differential protection operation was improper.

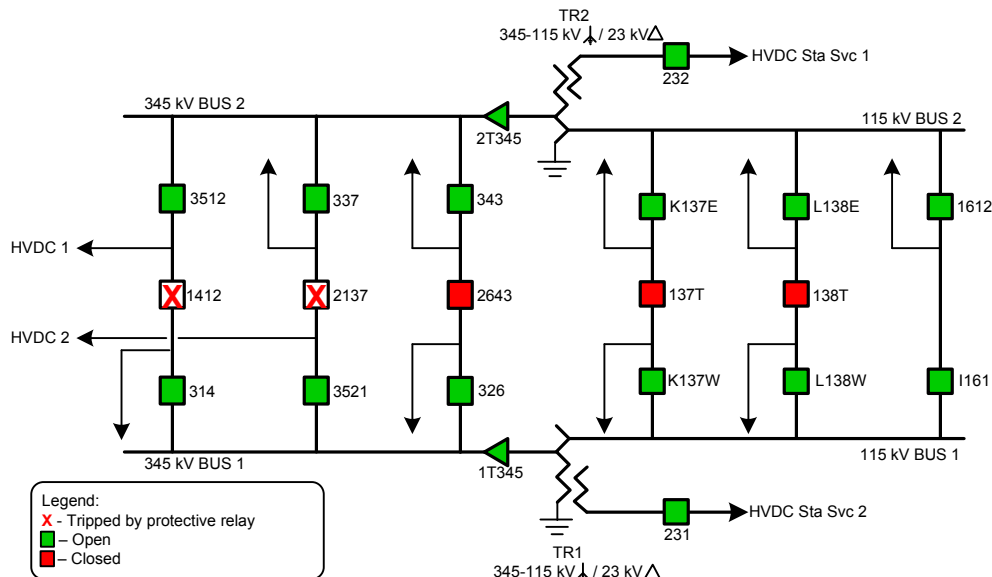
Figure 7 – Direct Transfer Trip Operation from HVDC

The fourth event occurred as a result of the loss of HVDC station service from Sandy Pond. The loss of station service caused the HVDC Converter cooling pumps to shut down. The loss of the cooling pumps and the voltage rise of the DC filter capacitors caused a Bus 1 and 2 overvoltage condition initiating a Direct Transfer Trip (DTT) signal to Sandy Pond tripping the 1412 and 2137 CBs (Figure 7). The 3512 and 3521 CBs would normally trip when DTT is received, however, they were already open from the associated differential protection operations from the second and third event.

The design of the Transformer protection, which includes the Overall Differential and Transformer Differential relays, allows the 345kV Bus circuit breakers to reclose after the TR MOD opens. The fifth event in Table 1 is the auto-close of the 345kV breakers. As shown in Figure 1 the 326 and 314 CBs on Bus 1, and the 337 and 343 CBs on Bus 2 reclosed successfully and as can be seen in Table 1, Event 5 the change-of-state was detected by the RTU sequence-of-events recorder. The 3512 and 3521 CBs were driven to lockout when the DTT signal was received and could not reclose.

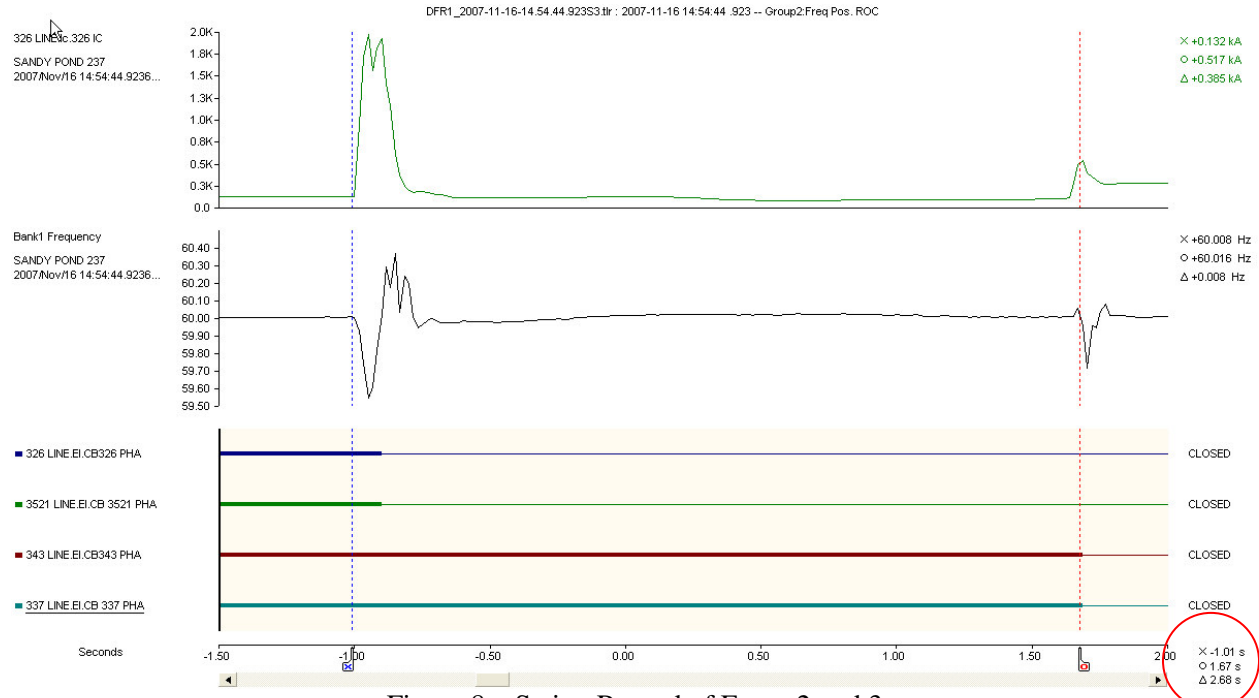
Figure 8 – Swing Record of Event 2 and 3

When reviewing the retrieved records, a swing record captured by one of the Sandy Pond DFRs during the event was found. Figure 8 is a view of the swing record showing the I161 reclose event and the Bus 2 trip event. Comparing the digital inputs with the C-Phase current a time line can be determined. The 326 and 3521 CBs change state with the first magnitude increase, which is when Transformer 1 failed. Measuring the time between the first and second magnitude increase, shown by the cursors, it can be seen in the lower right corner of Figure 8 the next event occurs 2.68 seconds later, at which time the 343 and 337 CBs, connected to Bus 2 trip. The 2.68 second time between the events is close to the difference in time between Event 2 and 3 in Table 1. The magnitude of the C-phase current for the second event in the swing record below is close to the 600-amp primary pick-up setting of the TR2 OD relay. This explains

the OD operation, but why did the TR2 Differential protection not operate? A review of the relay setting records identified that the TR2 OD is set more sensitive than the TR2 differential relay. It was determined that there was not sufficient fault current to operate the TR2 Differential protection, therefore, the TR2 OD operation was proper.

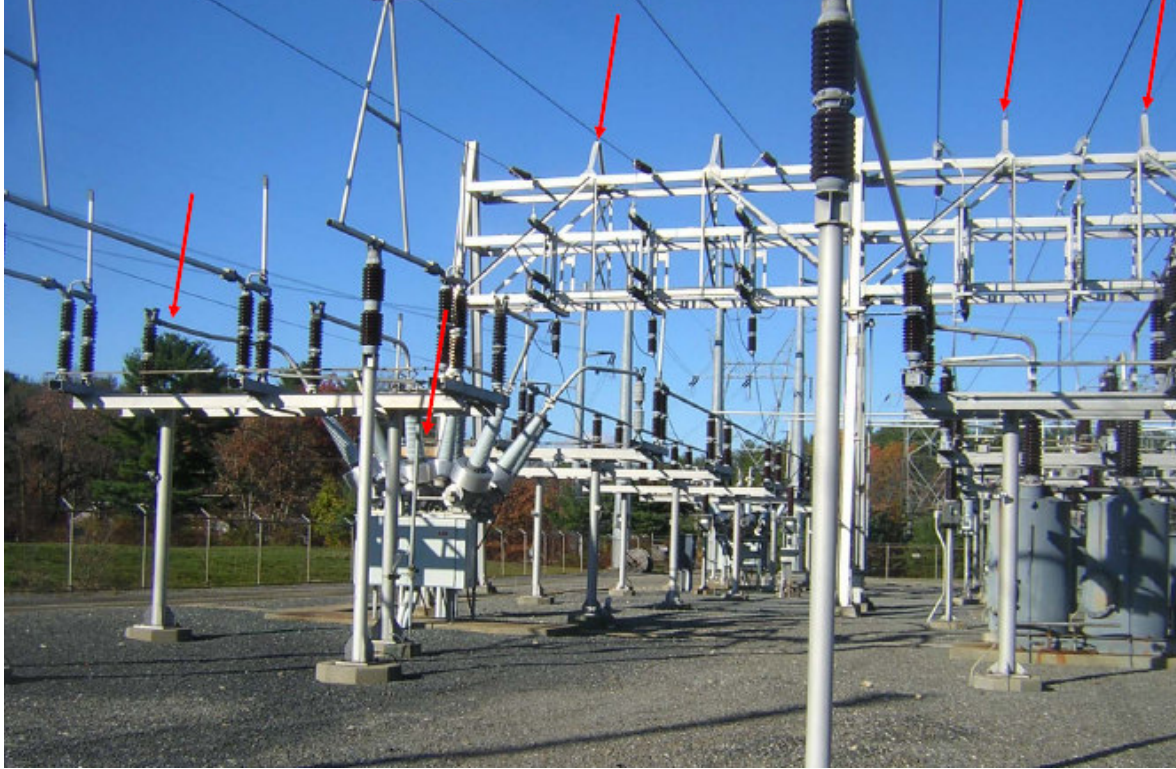
Figure 9 – I161 Line Bay (1612 CB foreground)

A physical inspection was performed concurrently with the fault analysis. Flash burns were found on the Bus 2 side of the 1612 circuit breaker to support the assumption that the shield wire jumped to the Bus 2 side of the 1612 CB when the I161 CB closed into the permanent fault. The arrows shown at the top of Figure 9 indicate the location of the shield wires and the arrows on the left side indicate where evidence of flash burns were found on the 1612 CB and the motor-operated-disconnects on the Bus 2 side of the 1612 CB. The results of the inspection confirmed the TR2 Overall Differential protection operated properly because the physical evidence and the data in the swing record agreed.

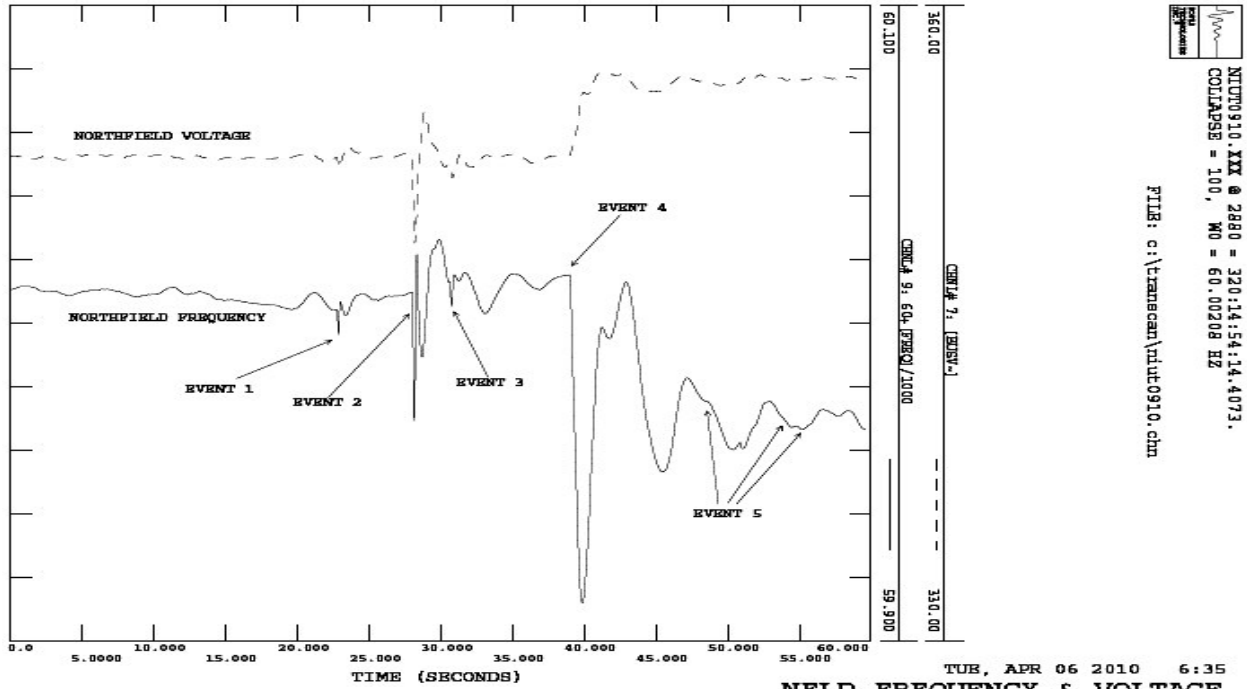
Figure 10 – Northfield Frequency and Voltage

The Northfield 345kV substation dynamic disturbance record data is plotted for 60 seconds, from approximately 20 seconds before initial fault (Event 1) through the automatic reclosing of the 345kV circuit breakers (Event 5). Figure 10 shows RMS voltage and frequency as calculated from the captured record at Northfield. The first four Events can be identified in the RMS voltage trace with a total voltage deviation of approximately 8 kV. These Events are more easily identified in the frequency trace, with frequency deviation caused by Event 4 dominating those caused by the fault during Events 1, 2 and 3. Event 5 cannot be identified in either voltage or frequency but was identified from the relative time after Event 4.

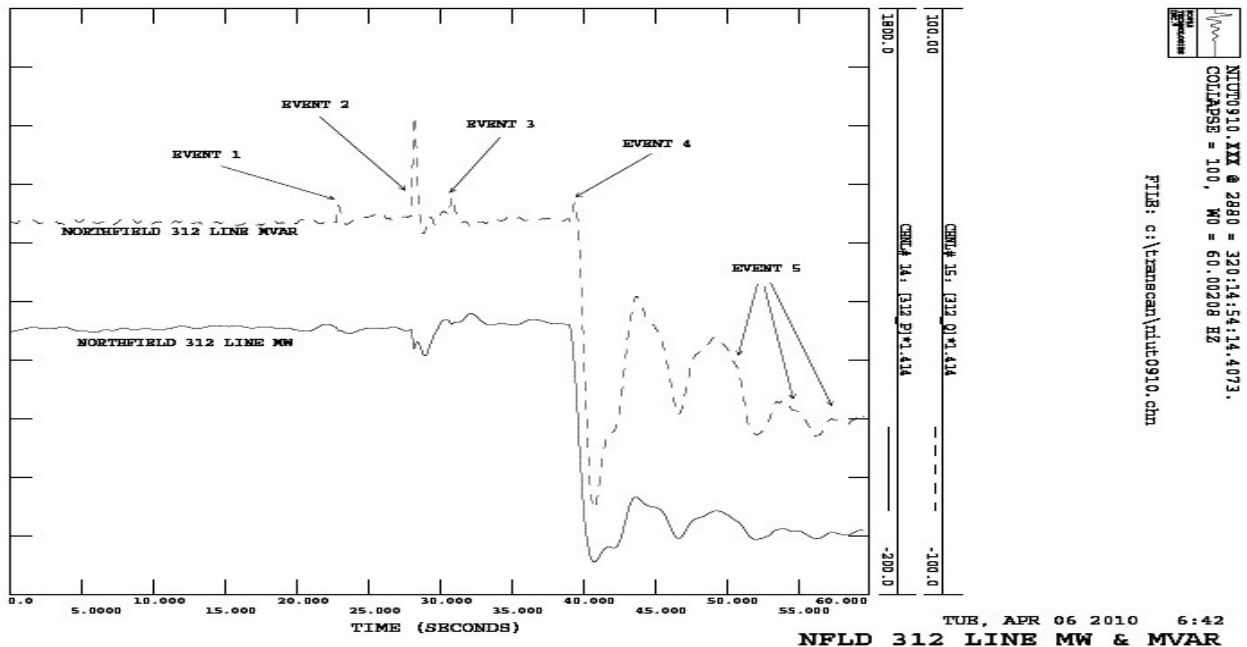
Figure 11 – Northfield 312 Line MW & MVAR Flow

Figure 11 shows MW and MVAR flow on the 345 kV line connecting New England to New York. The first four Events are readily identifiable in MW & MVAR flows, but not Event 5. While all power system quantities were affected, frequency and MVAR flow shows the events most distinctly.

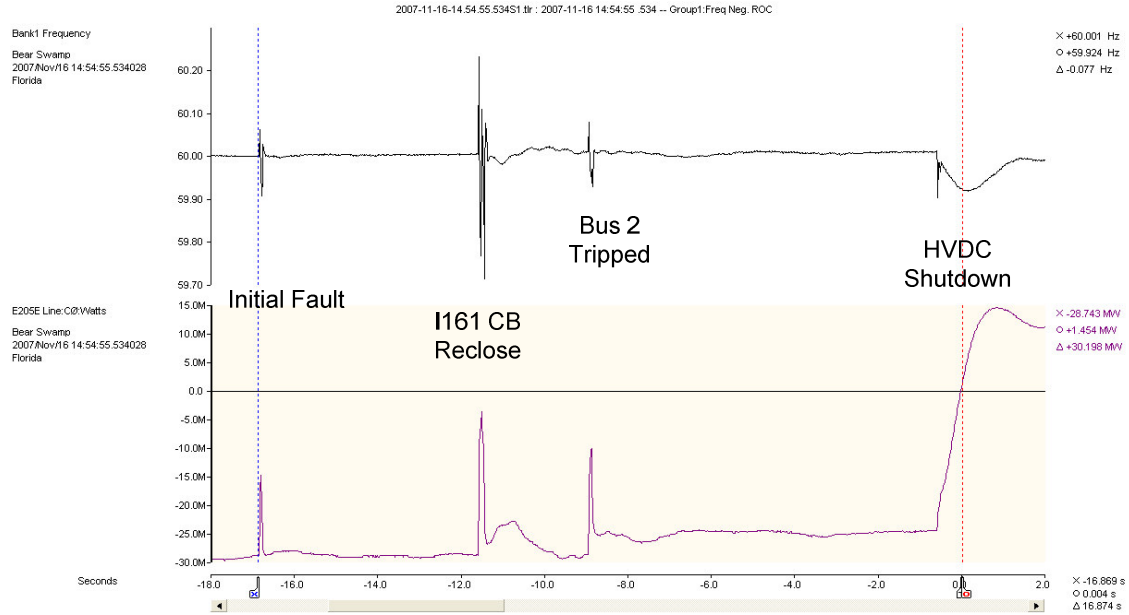
Figure 12 - Bear Swamp – Cascading Event Capture; Frequency and MW

The cascade event at Sandy Pond can also be analyzed with the Bear Swamp swing record shown in Figure 12 above. Referring to Figure 12 it can be seen that the initial fault caused a switching transient that momentarily impacted frequency and power flow. When the I161 circuit breaker (CB) reclosed a larger switching transient occurs and the system began to oscillate, as can be seen in the frequency plot. When Bus 2 tripped there was a smaller switching transient, and the oscillation continued but was damped. The oscillation continues to damp until the HVDC Terminal shuts down, when a new oscillation occurs and power flow changes direction, where New York is now importing power to New England.

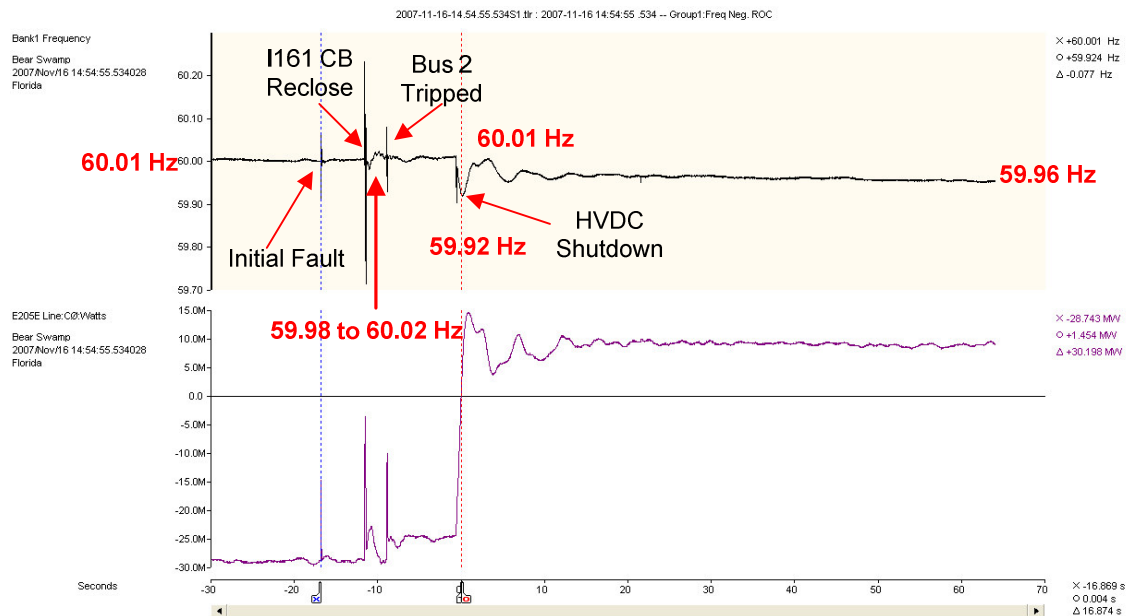
Figure 13 - Bear Swamp Inertie Swing Record

As discussed above the initial event did not have a significant impact on the system. The first oscillation occurred when the I161 CB closed into the permanent fault (Event 2). Referring to Figure 13 it can be seen the system frequency was stable at 60.01 Hz prior to the I161 CB reclose, with the exception of the switching transient which occurred during the initial fault. The system started to oscillate when the I161 CB reclosed. The initial oscillation ranged between 59.98 and 60.02 Hz and was damped through the Sandy Pond Bus 2 trip (Event 3). The second oscillation occurs when the HVDC Terminal shut down. The frequency oscillation ranges from 59.92 to 60.01 Hz and damps. The frequency then continues to decrease to 59.96 Hz at the end of the record.

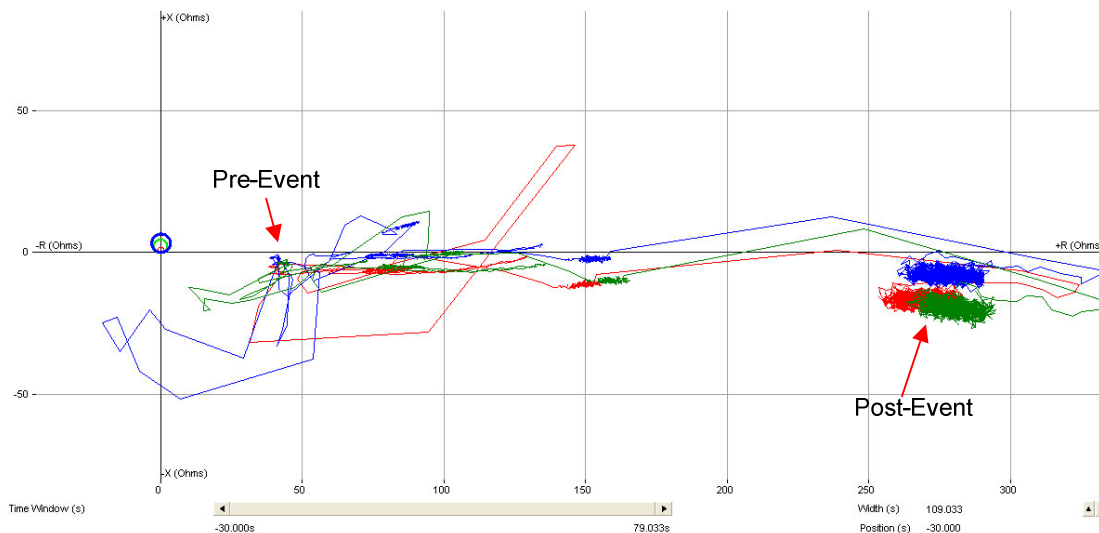
Figure 15 - Sandy Pond Swing Record – 343 Line Impedance Plot

The 343 Line remained in service through the entire event and plotting the apparent line impedance on an R-X diagram in relation to the protection system zones shown in Figure 15 allowed the 343 protection performance to be measured. Through the event the current magnitude on the 343 Line decreased to 103 Amps primary from 638 Amps primary and the voltage increased an average of 2 kV per phase. When reviewing the R-X diagram in Figure 15 it can be seen that the pre-fault load impedance was approximately 45 ohms primary and increased as the current on the line decreased. The quantities plotted are the same quantities measured by the relay. Based on this it was determined that the 343 Line Directional Distance protection responded properly for this event.

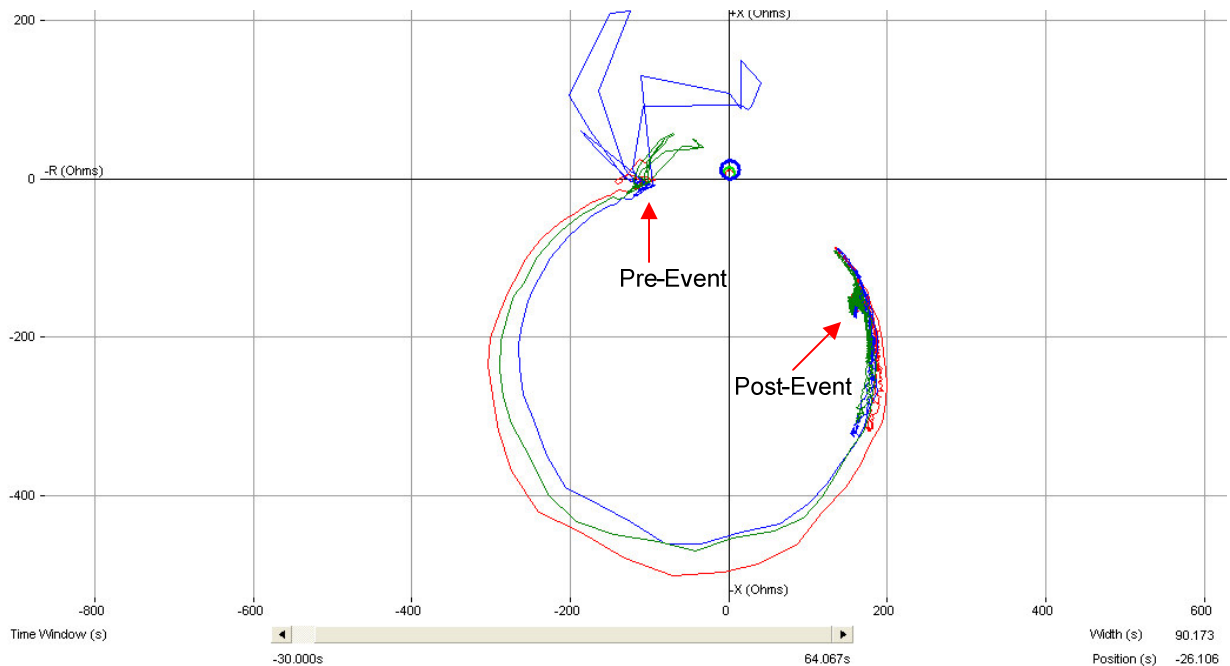
Figure 16 - Bear Swamp Swing Record – E205E Line Impedance Plot

The E205E protection system at Bear Swamp was measured in the same manner as the 343 line protection system. The plot shown in Figure 16 shows the pre-fault load in quadrant III near the  $-R$  axis, with an apparent impedance close to 150 ohms. The post fault impedance moves into quadrant IV and is near 150 ohms but more reactive than the pre-fault impedance. Based on the impedance plot it can be determined that the E205E Line Directional Distance protection system performed properly for this event.
