Investigation of Fault Activity on a 132KV Teed Circuit in Scotland and how Travelling Wave Technology is Locating the Fault Site

Ron Garrett – Scottish and Southern Electricity and David Cole – Qualitrol LLC

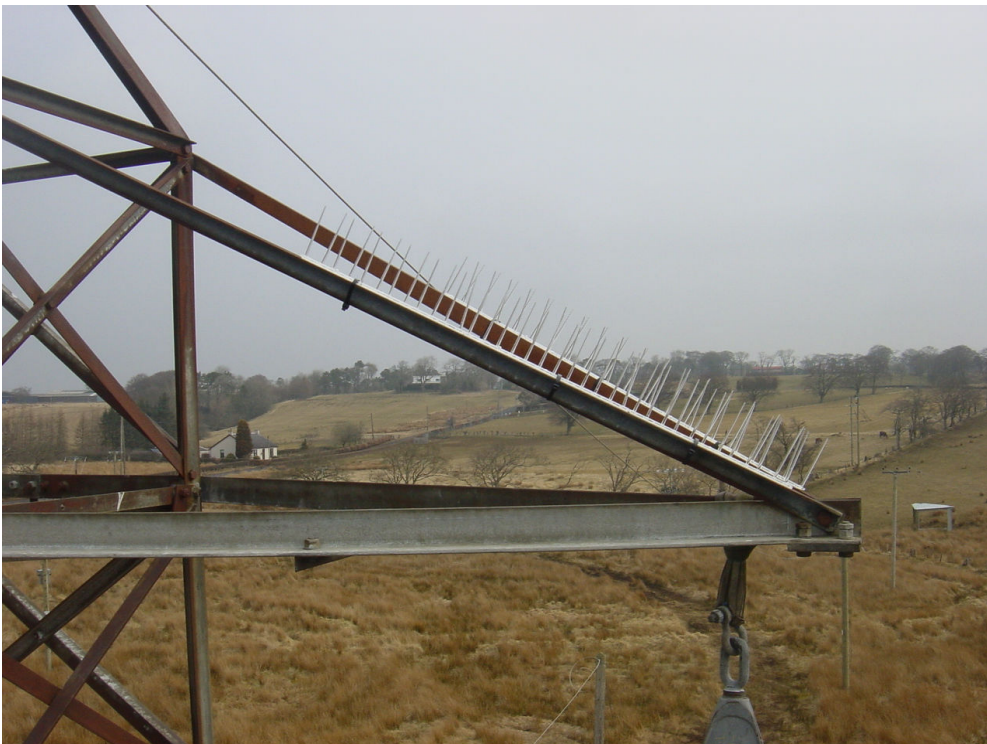
Fig 7 Bird Deflectors Fitted to a Tower near the Landfill Site

There is some evidence to indicate that birds are no longer roosting on the towers as a result of the deflectors but there is a suggestion that the bird deflectors have captured some wind borne debris. On balance the results of installing bird deflectors since March 2013 to date have been more positive than negative.

- In 2013 it was decided to install bird deflectors on 7 towers close to the landfill area. This was a difficult decision as although birds were considered a probable cause of faults at the landfill site the spikes on the deflectors can snag windblown debris, especially plastic bags, and cause other problems.

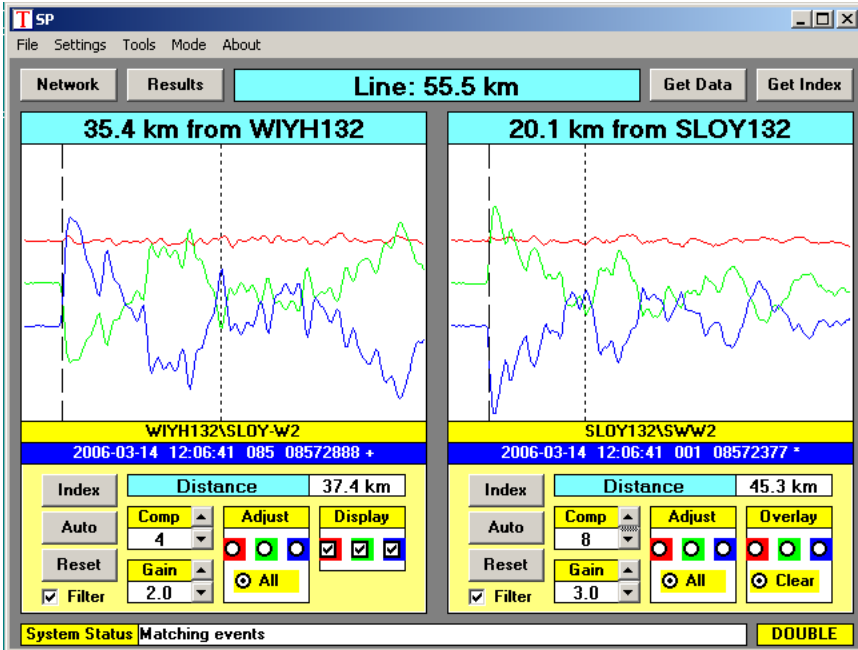
Fig 8 Travelling Wave Result for Phase to phase fault in March 2006

The TW waveforms indicate a phase to phase fault confirmed by the fault recorder trace from Windyhill for the same incident shown in Fig 9.

Corrected result is 19.38Km from Sloy and 34.5KM from Windyhill when a corrected line length of 53.9Km is used

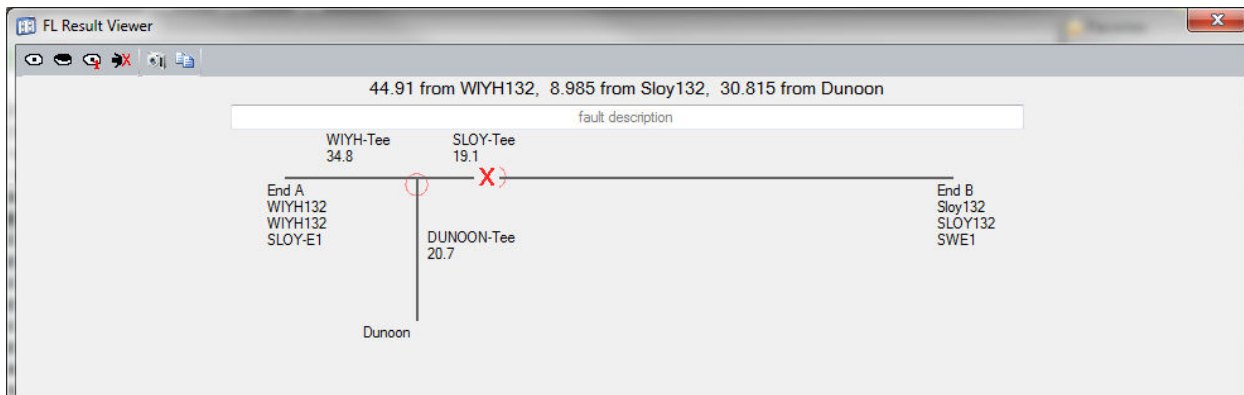
Fig 12 Results from Trip on 5th December 2013

The first trip after commissioning was on 5th December 2013 on the GL1 circuit and was located 9Km from Sloy on the main line. Figure 12 shows the graphical result from the analysis software. In this view all the different 2 ended possible results are marked with the X showing the actual fault position.

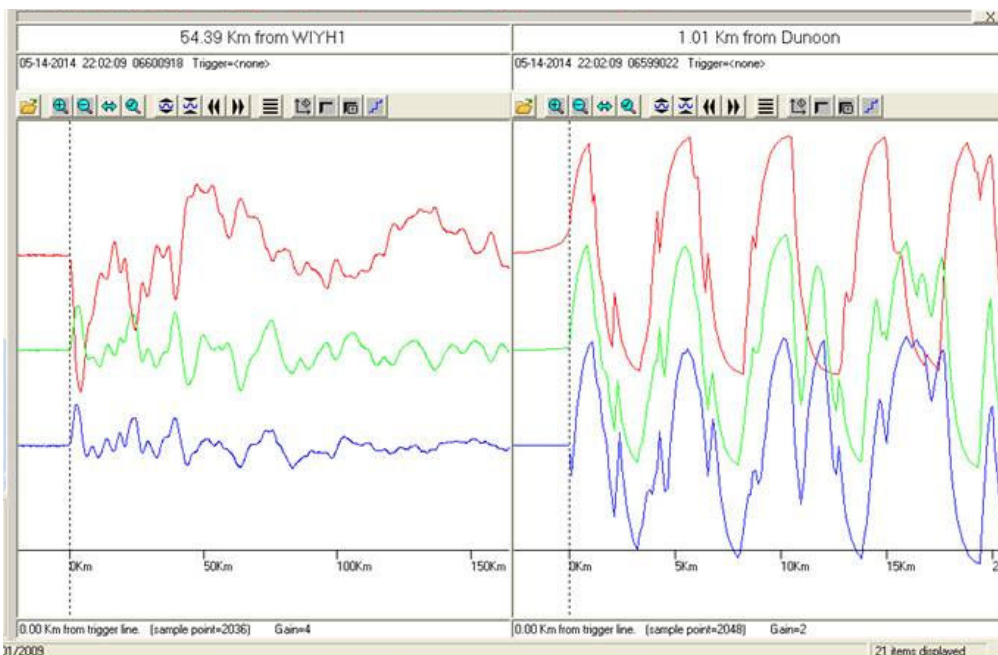
Fig 13 Fault Location from Trip on 14th May 2014

Two other trips occurred in 2014 both of which were on the Dunoon tee section and both of unknown origin. The first was on the 14th May at 23.02. It occurred on the top phase (red) of the GL1 circuit and the TW system located the fault at 1Km from Dunoon as shown in the double ended measurement from Windyhill to Dunoon in Fig 13.

Note that the time shown is 1 hour early as the daylight saving function was not enabled

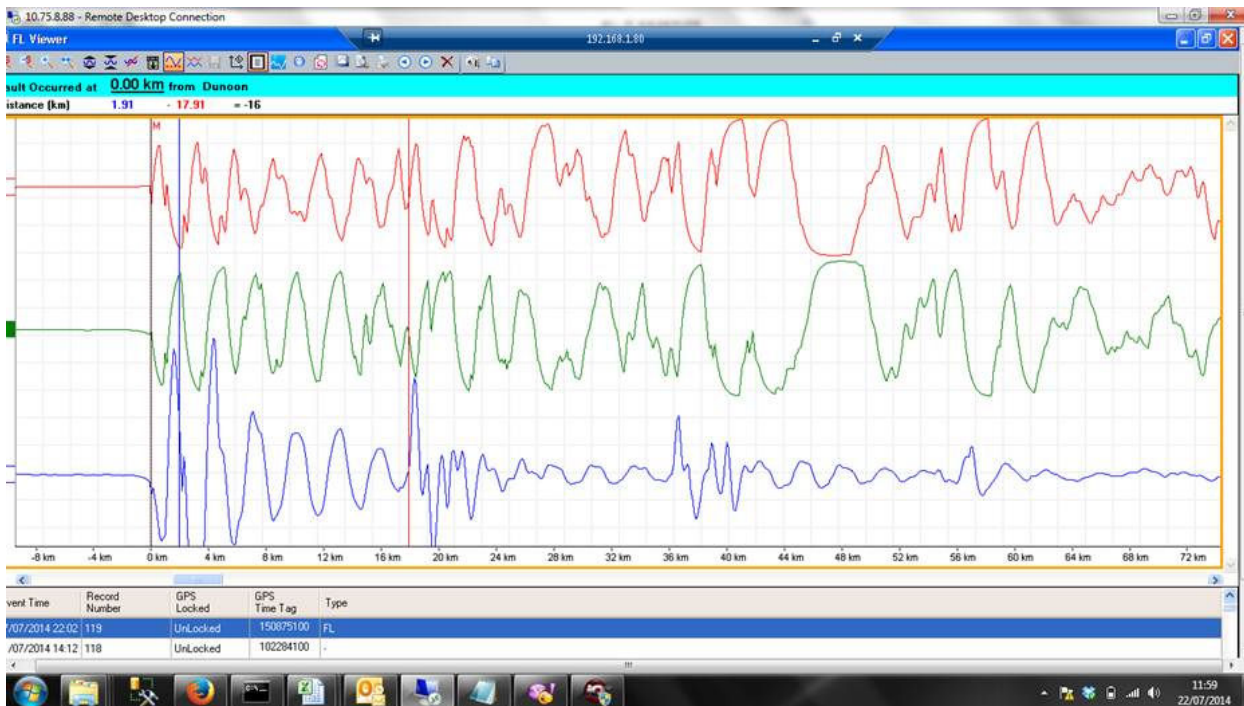
The second fault occurred on the 17th July at 23.02 on the top phase (blue) of the GL2 circuit. The Windyhill section of the circuit was out of service for maintenance and the TW device at Sloy had been taken off line meaning only a manual single ended analysis of fault location was possible from Dunoon. The single ended manual analysis puts the fault close to Dunoon, less than 2Km. The clear reflection of opposite polarity that can be identified (where the red vertical cursor is placed) is 17.91Km out. If the fault was high impedance then this could be the reflection of the fault generated transient from Whistlefield meaning 17.91Km is the distance back from Whistlefield. This would place the fault about 1Km from Dunoon.

Both faults were in the same vicinity just outside the area protected by the bird deflectors and work is now concentrated in this small area to try to identify the cause. The occurrence of the faults at the same time is also interesting.
