# Cascading disturbance caused 1,800 MW generation lost in Colombian Power System

Nolasco Orrego, María N. Arboleda, Jaime A. Zapata, XM S.A. E.S.P.

The aim of this article is to briefly describe a disturbance event which caused a 1,800 MW generation lost in Colombia's Interconnected Power System (CIPS) on March 9<sup>th</sup> 2011. That event represented a 20% of total peak load in maximum demand and it was made up of two disturbances occurred at the same hour.

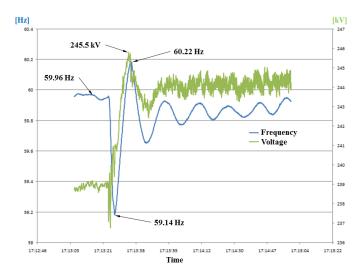
Fig. 5 Voltage in Bt substation at 230 kV Vs CIPS Frequency

- Due to the tripping of ANSI 59G Function, included into the generator's multifunctional protection, the only unit of **Bt**'s<sup>7</sup> hydroelectric power plant was wrongly disconnected. The setting for ANSI 59G Function was mistaken. Table 3 shows the Trip Log relay. Figure 5 explains the reason for the pickup of ANSI 24G Function.

After the fall of Colombia's frequency, the recovery of **CIPS** frequency and the voltage at **Bt** substation at 230 kV increased at the same time. These combined phenomena caused the pickup of ANSI 24 Function.

- Has been replaced all MCB related to secondary voltage transformer at **G** substation at 230 kV and has been implemented a supervision of all **MCB**'s position.
- Has been reviewed all generators' protection settings at G, Ch, PA and Bt power plants.
- Conducting AGC assignment study (benefit-cost). Answer this question, ¿All the AGC in one only power plant or distributing the AGC between CIPS's electrical areas?
