Analysis of Simultaneous Faults Using Short Circuit Simulations And Fault Records

By: Yujie. I. Lu and Jeffrey Pond, National Grid

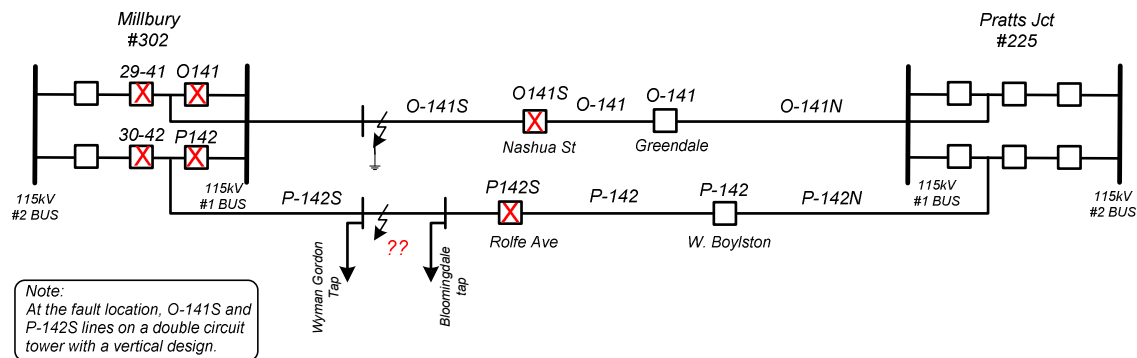
Figure 1. One Line Diagram for O-141 & P-142 Lines

On August 14th, 2005, the National Grid System Control Center reported that at 16:01:30 a lightning stroke caused a fault on the 115kV O-141S line near the company's Millbury #302 substation. The substation and faulted line configuration are shown in Figure 1. The circuit breakers O141 and 29-41 at Millbury #302 and O141S at Nashua St tripped correctly by the line protection relays. As per the report, at the time of the O-141S operation, the 115kV P-142S line, one of the parallel lines with the faulted O-141S line, tripped by their line protection relays at Millbury #302 and Rolfe Avenue substations for the O-141S fault. Targets reported for these two operations are as follows:

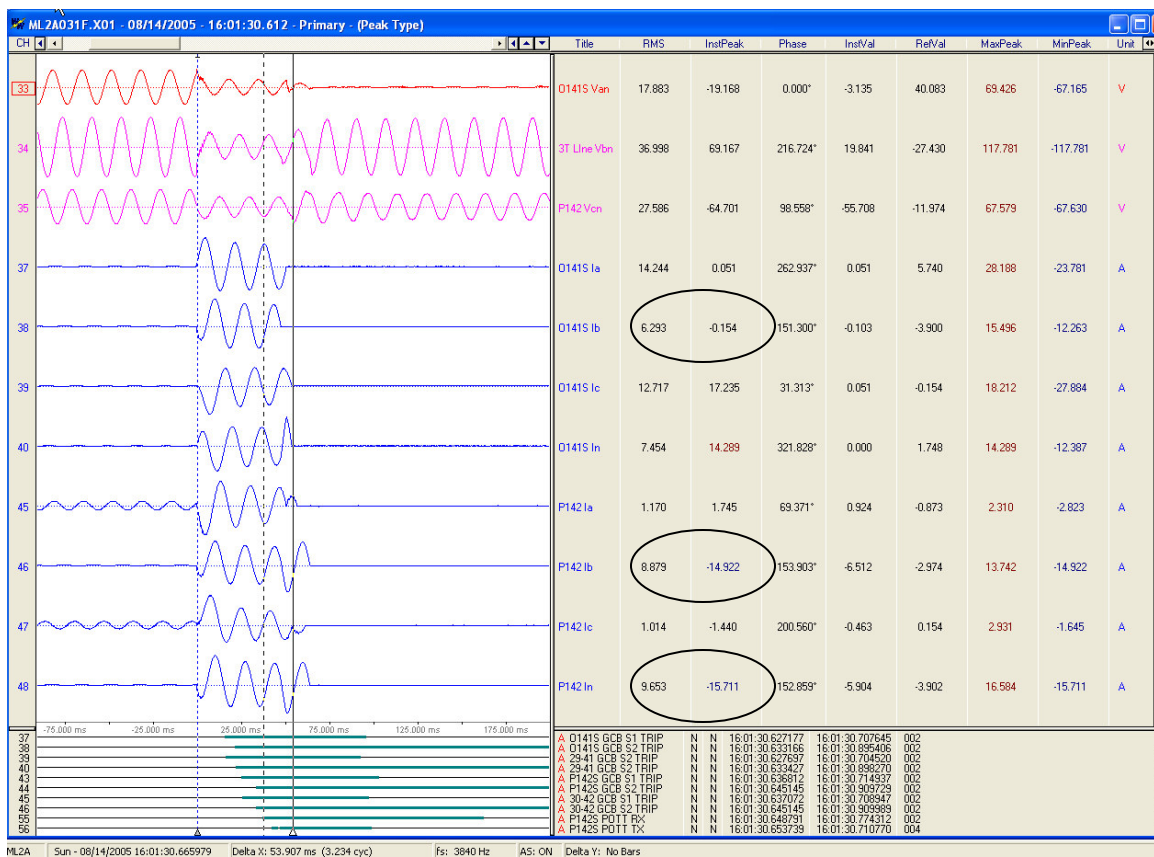
Figure 2. O-141S and P-142S Line DFR Records at Millbury #302

142S lines at 3.06 miles from Millbury #302. Based on the records, the fault involved A-phase-, B-phase- and C-phase-to-ground on the O-141S line and B-phase-to-ground on the P-142S line with fault impedance (Figure 2). It was then further noticed that:

1. The B-phase fault current flowed through the O-141S and P-142S from Millbury #302 were almost in phase, which implies that it was indeed a simultaneous fault. At the cursor (or trigger) point of Figure 2, $I_{b-O-141S}$ was 6.29 @ 151.3⁰ and $I_{b-P-142S}$ was 8.88 @ 153.9⁰ in secondary amperes.
2. The B-phase and the ground (the zero-sequence current, 3I0) fault current flowed on P-142S from Millbury #302 were in phase, which implies that the fault on the P-142S was B-phase-to-ground. At the cursor (or trigger) point of Figure 2, $I_{b-P-142S}$ was 8.88 @ 153.9⁰ and $3I0_{P-142S}$ was 9.65 @ 152.9⁰ in secondary amperes.

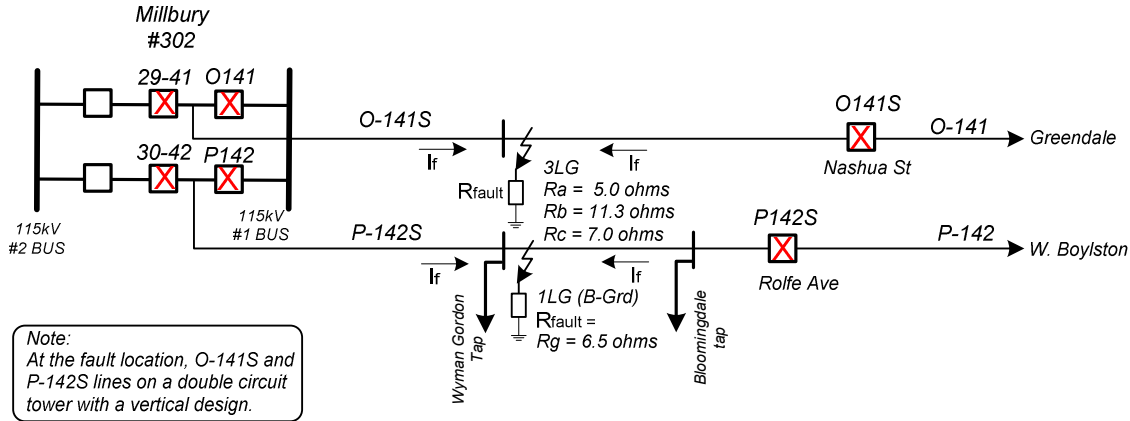
Figure 3. O-141S & P-142S Line Fault

1. The fault did involve A-, B- and C-phase on the O-141S lines and B-phase-to-ground on the P-142S line simultaneously, and
2. It was a non-bolted fault with phase-to-phase and B-phase-to-ground resistance involved on the O-141S and P-142S line, respectively.

Furthermore, to quantitatively match the fault records captured by the DFR at Millbury 302, more simulations were conducted with a different fault resistance on each phase. Finally, the results concluded that the fault resistance for the O-141S three-phase-to-ground fault was approximately as follows: $R_a = 5.0$ primary-ohms, $R_b = 11.3$ primary-ohms and $R_c = 7.0$ primary-ohms, and the fault resistance for the P-142S B-phase-to-ground fault, R_g , was around 6.5 primary-ohms. (Figure 3 & Table 1)

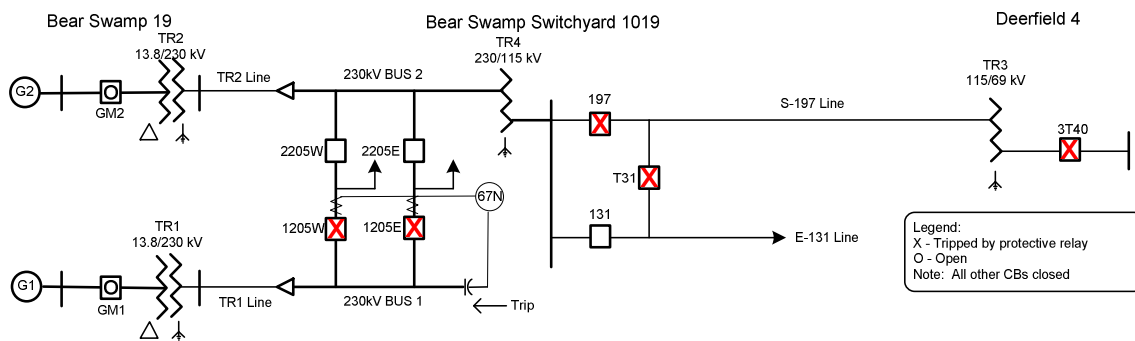
Figure 4. S-197 One-Line Diagram

On May 27, 2007 the System Control Center reported that at 23:33:32 a large oak tree fell on the S197 Line at Brittingham Hill Road near Tower 126 during a thunderstorm. At Bear Swamp 1019 the 197 and T31 circuit breakers (CBs) tripped, and at Deerfield 4 the 3T40 CB tripped (figure 4). At 23:33:33 the 1205W and 1205E CBs opened. At 23:33:37 the 197 CB closed auto and tripped immediately. All breakers were locked out. Targets reported for this disturbance are as follows:

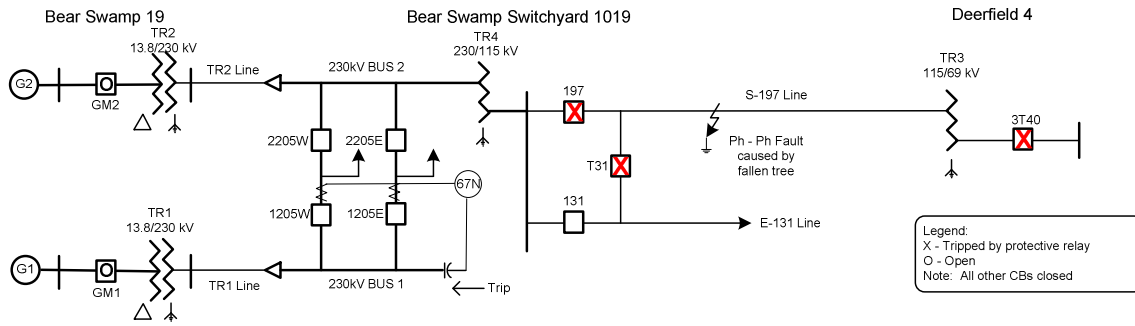
Figure 5. S-197 Line One-Line Diagram – Initial Fault

Analysis of the fault records determined the initial fault occurred at 23:33:29.610 when the tree fell on the S197 Line causing a B-C-phase fault. The 197 and T31 CBs at Bear Swamp and the 3T40 CB at Deerfield 4 tripped on DD Z1 S1 (figure 5). It was determined that the TR1 Line protection did not operate for the first S-197 fault (figure 6 and 7) or immediately after.

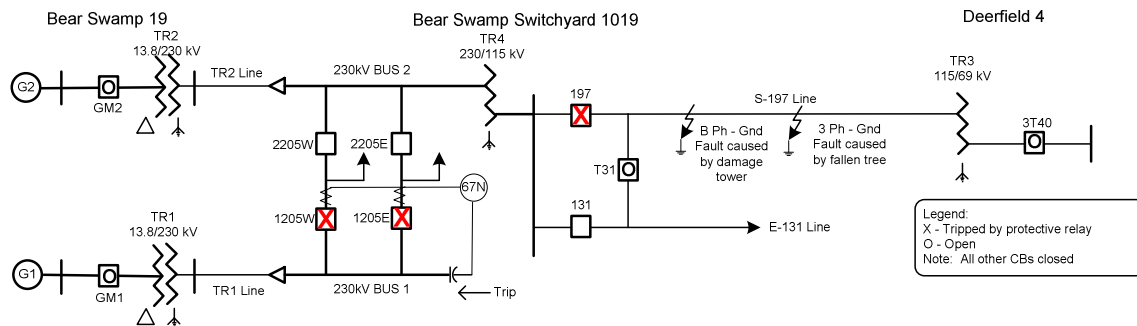
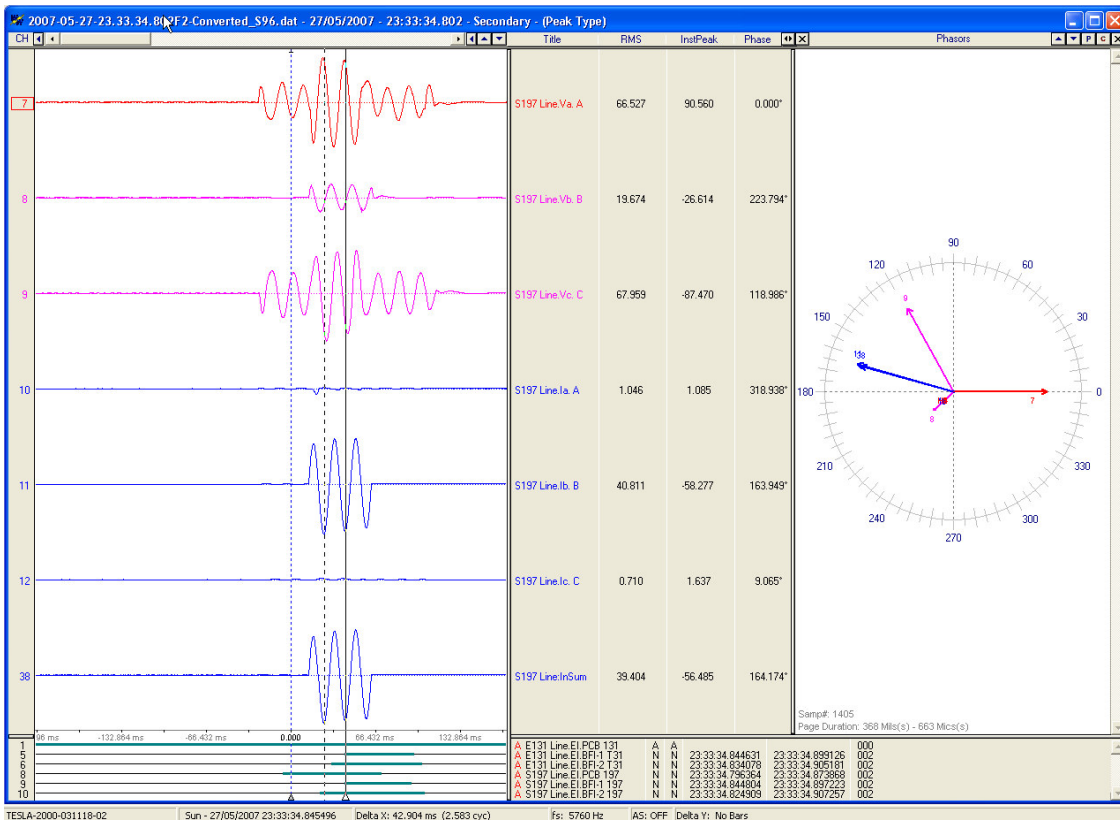
The fault record triggered at 23:33:34.802 shows the 197 CB auto closed, after five seconds, into a B-G fault, caused when a transmission tower was damaged as a result of the fallen tree, and tripped immediately (figure 8 & 9) on S197 IOC B-ph. At the same time the TR1 Line DG relay operated initiating transfer trip to the Bear Swamp Powerhouse, and tripped the 1205E and 1205W CBs (figure 10). The S-197 and TR1 Line CBs were at lockout after the second fault occurred. At this point it was clear the TR1 Line operation was not a separate incident but was the result of the auto-close attempt to re-energize the line. The investigation now focused on what caused the TR1 Line directional ground relay to operate. Further analysis of the fault record in figure 10 determined that the TR1 Line supplied zero-sequence fault current at the time the 197 CB auto-closed. The record shows that the TR1 Line A-, B-, and C-phase currents are additive and are summed in the TR1 Line neutral-current. The results obtained from the analysis now indicate that the TR1 Line directional ground relay operated properly for this fault condition.

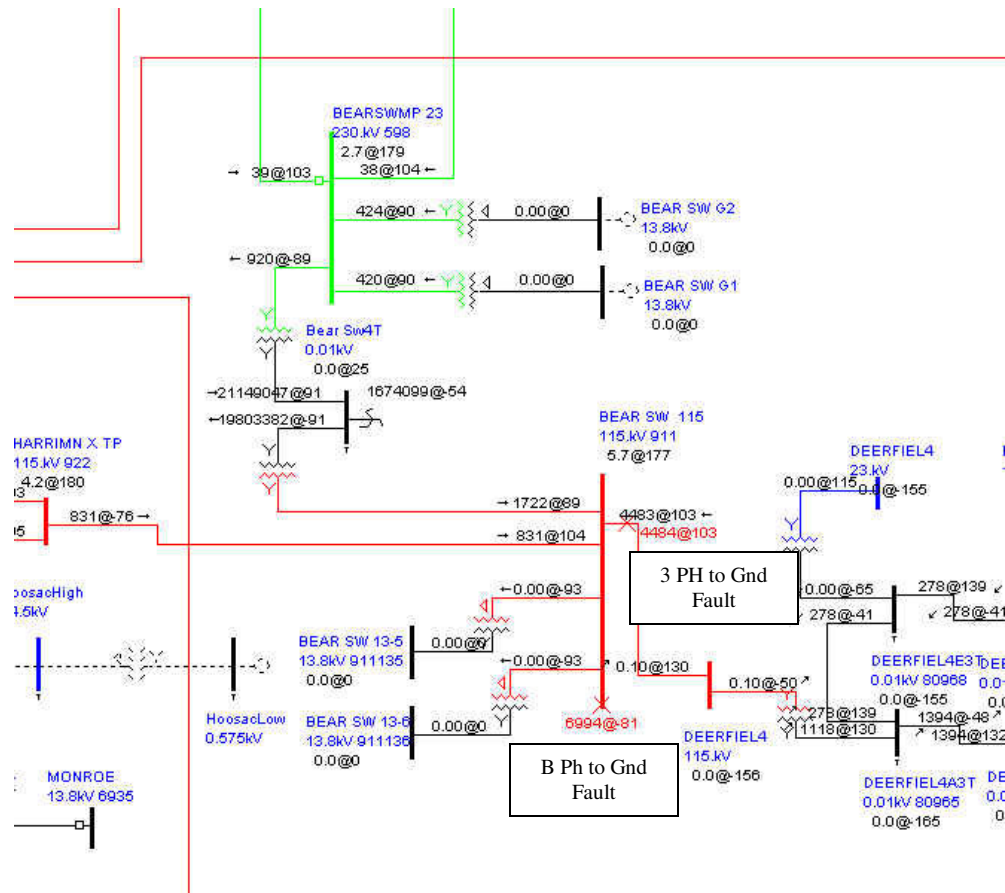
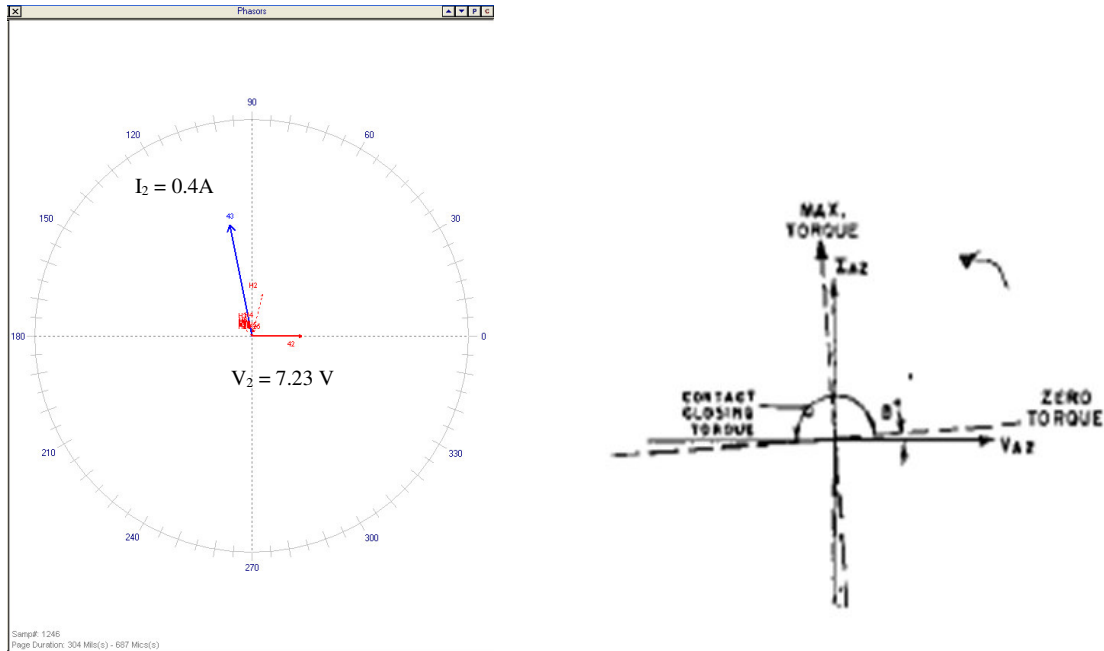
To confirm the TR1 directional ground relay operated properly for the fault, a short circuit simulation was performed. If the relay operated for the conditions in the fault simulation it would prove the operation was correct, while verifying that National Grid's system model was accurate. The simultaneous fault module would not allow placing two faults on the same line segment, therefore, it was decided that in order to create the simultaneous fault in the short circuit model first, a phase to ground fault was placed on the 115kV Bus at Bear Swamp because tower 126 where the B-phase to ground fault occurred was approximately one mile from the Bear Swamp Switchyard. Second, a three phase to ground fault was placed on the S-197 Line near Bear Swamp (figure 11). The simulation confirmed that the Directional Ground relay, which is a Westinghouse IRQ-9 with negative sequence polarizing, had sufficient polarizing volt-amperes in the forward direction and neutral current to operate. As a final check the TR1 line negative sequence quantities were calculated from the fault records to be 2.88VA, well above the 0.76 VA minimum pickup of the relays directional unit, and the phasors were compared to the IRQ directional unit characteristic. As can be seen in figure 12 the calculated negative-sequence components are similar and match the relay characteristic.
