Fault Experiences in Transmission Lines with Series Compensation

Presented to
Georgia Tech Fault and Disturbance Analysis Conference 2014
Georgia, Atlanta, USA

COES SINAC

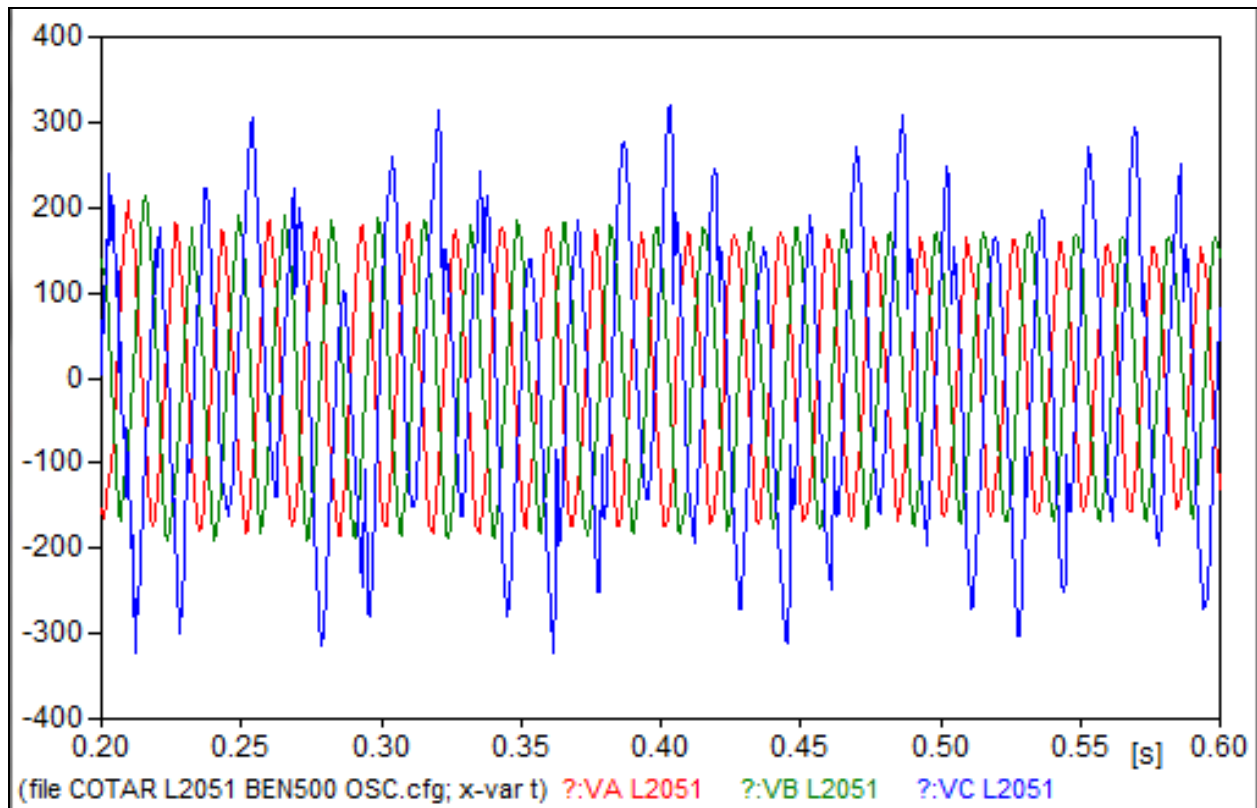
On 18.03.2007, there was a cross country fault in the lines L-2053 and L-2054 caused by lightning. In the line L-2053 there was a three phase fault tripping and opening in both ends. In the line L-2054 there was a single phase to ground fault in phase “C”, tripping and opening only the phase “C” of the line L-2054. During the dead time of the line L-2054, in the line L-2051 there was sub harmonic overvoltages, which were recorded in the Cotaruse substation. This overvoltage produced the operation of the overvoltage protection in the line L-2051 tripping and disconnecting it.

Figure 3 : Sub harmonic Overvoltage recorded on 18.03.2007 in the line L-2051 in Cotaruse Substation

The issue in this case is to explain the sub harmonic overvoltage. After the opening of the breakers (figures 4 A and 4 B), the series capacitor remains with charge and with a maximum voltage, that happened because the electric arc in the breakers extinguishes when the current crosses by zero. The energy in the series capacitor oscillates in the R-L-C circuit which is still connected from Mantaro Substation, and in this configuration a sub harmonic oscillation about (14 to 20 Hz) began (figure 3).

5.1 Lines with series compensation and shunt reactors are susceptible to sub harmonic over voltages. For that this phenomena must be studied in order to mitigate them.

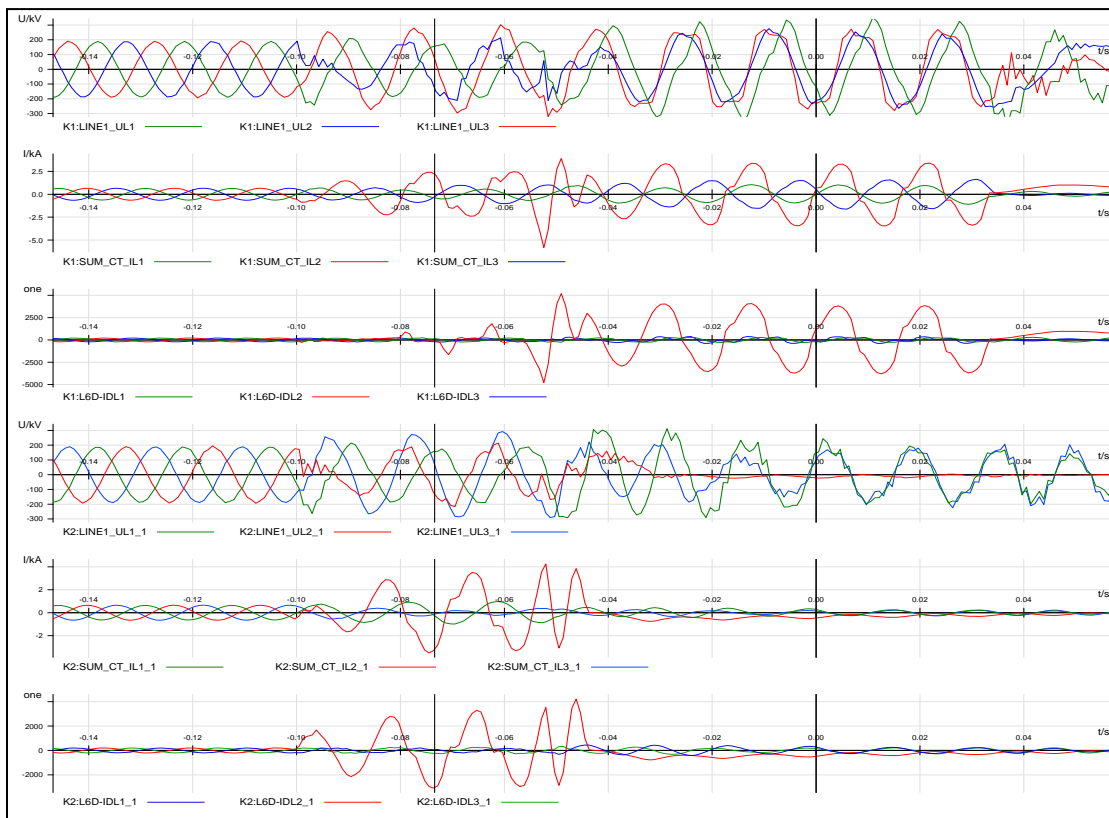
On 15.02.2012 at 15:11:27.250 hours, a single-phase to ground fault occurred in phase "S" of the line L-2052 and about 60 ms after a single-phase to ground fault occurred in the phase "S" in the parallel line L-2051 (figure 5). According the fault locators, the faults were at 24.4 km from the Cotaruse substation. The Power flow in the link Mantaro – Socabaya before the fault was about 329 MW measured in the Socabaya substation.

Figure 5. Fault Record of the lines L-2051 y L-2052 in Cotaruse Substation from the faults on 15.02.2012

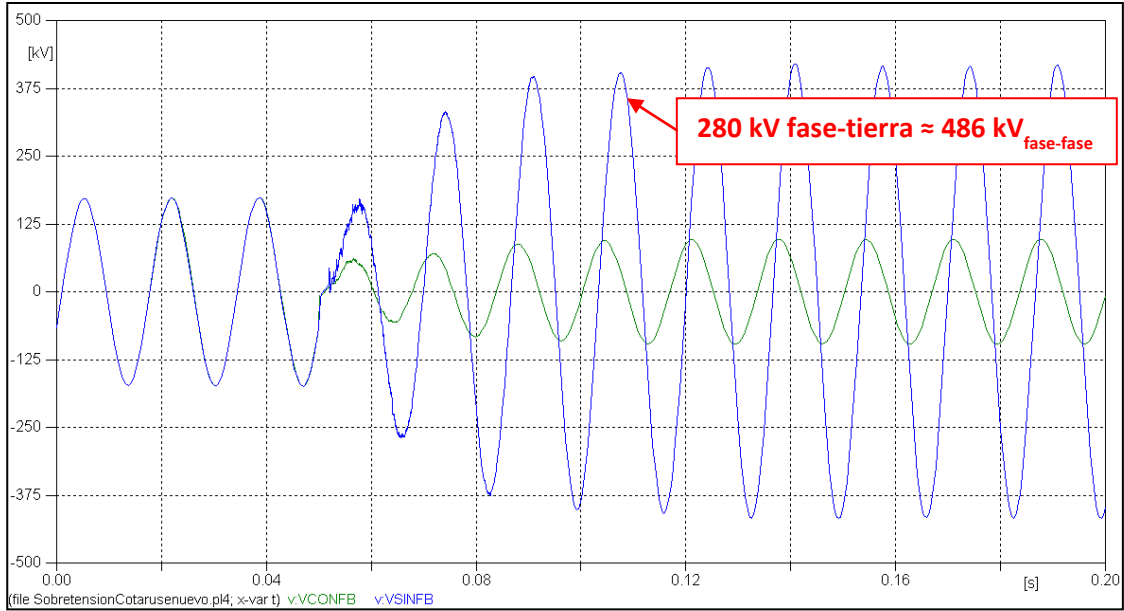
During the fault analysis, a simulation with ATP was made in order to determinate the origin of the faults. In the simulation (figures 7 and 8) during a fault in the line L-2052 in the same phase of the parallel line L-2051 an over voltage appear, this overvoltage is about 335 $KV_{Phase-Ground}$ (2.63 p.u), which could break the insulation of the line. This overvoltage can make to operate the MOV that are installed in the transmission line, and when the MOV are conducting a differential current can appear in the differential protection relays. The value of the differential current depends of the MOV conducting during this temporary overvoltage as is shown in the figure 9.

Figure 7: Overvoltage in the line L-2051 due to a single phase to ground fault in the line L-2052 with $R_f = 35 \Omega$, located at 24,4 km from the Cotaruse Substation ($v:VCONFB$, voltage in the phase “S” fault location in line L-2052; $v:VSINFB$, voltage in the phase “S” in the fault location of L-2051)

5.2 In parallel lines with series compensation and shunt reactors, the overvoltage produced during a fault in one line, must be studied. The studies must be used to verify the insulation.

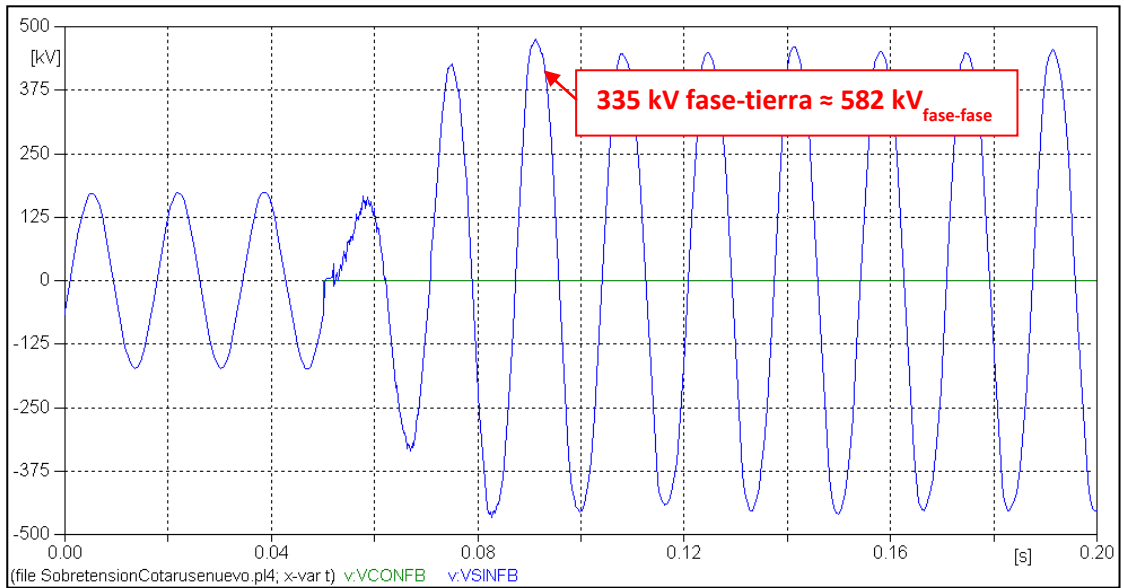
Figure 8: Overvoltage in the line L-2051 due to a single phase to ground fault in the line L-2052 with $R_f = 0 \Omega$, located at 24,4 km from the Cotaruse Substation ($v:VCONFB$, voltage in the phase “S” fault location in line L-2052; $v:VSINFB$, voltage in the phase “S” in the fault location of L-2051)

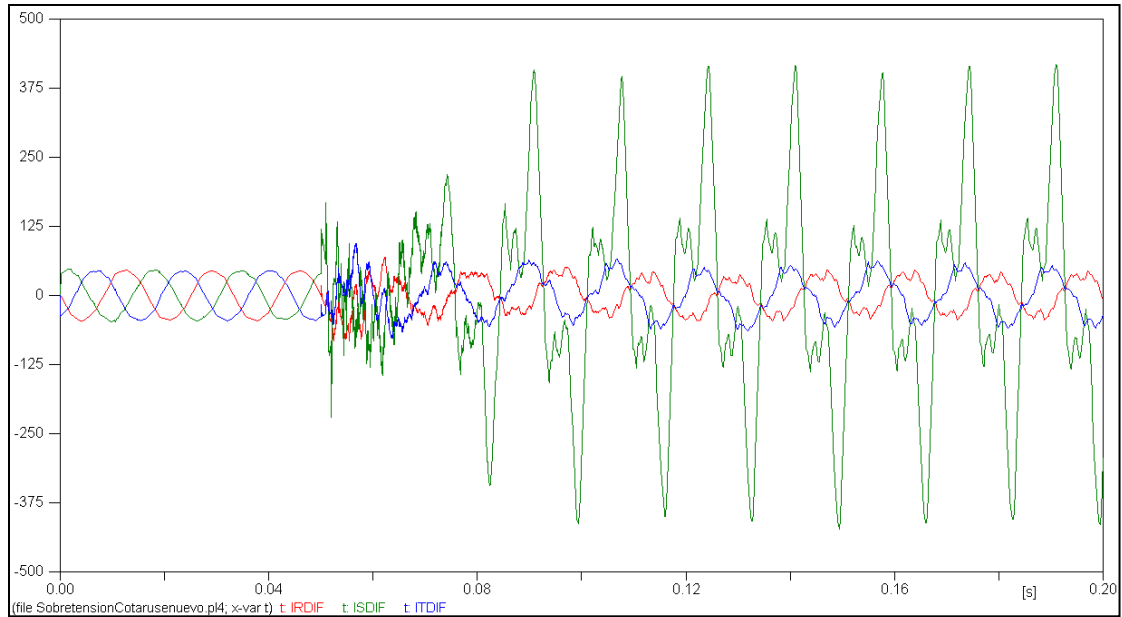
Figure 9 : Differential current due to the MOV conduction due to a single phase to ground fault in the line L-2052 with $R_f = 0 \Omega$, located at 24,4 km from the Cotaruse Substation.

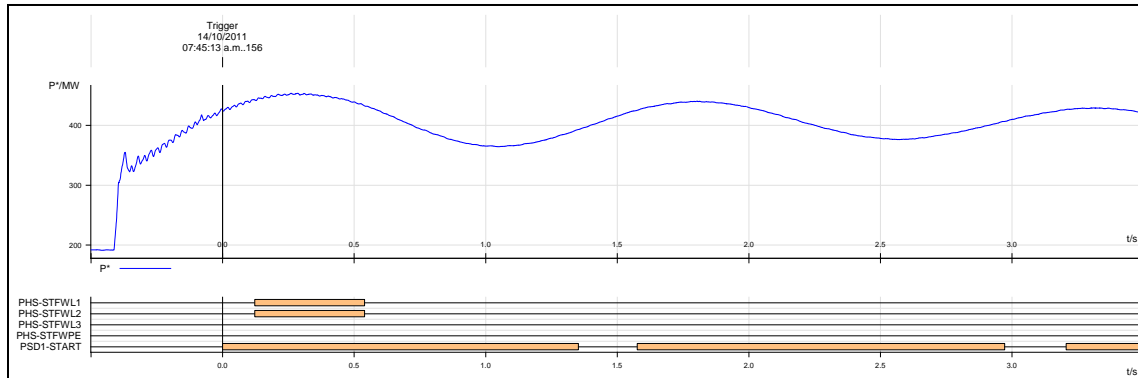
On 14.10.2011 at 07:45:13 hours, the line L-2054 was disconnected manually for maintenance with 192 MW of load from Cotaruse to Socabaya. As a result of the disconnection, the system began to oscillate, and the power swing was detected by the distance relays RED670 of the parallel line L-2053 (Figure 10).

Figure 10: Active power record in the line L-2053 in Cotaruse substation on 14.10.2011.

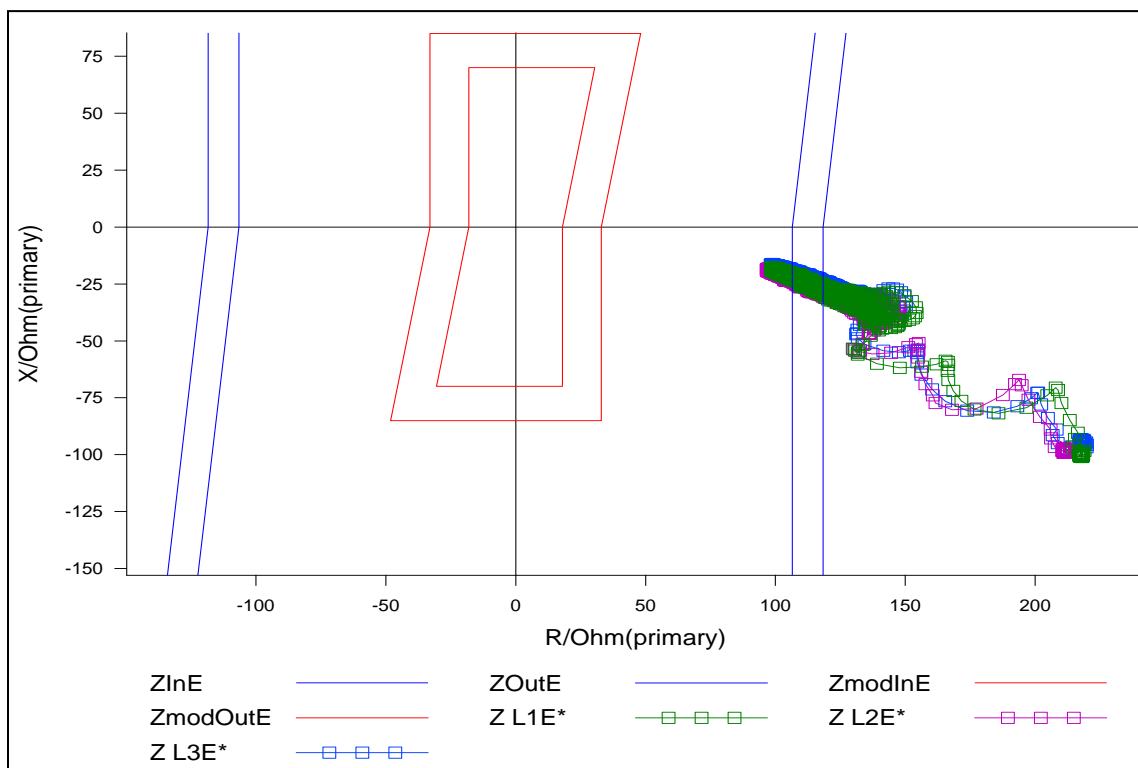
In the figure 11 the impedance recorded during the power swing is shown.

Figure 11 : Impedance during a power swing recorded in the distance relay of the line L-2053 Cotaruse Substation

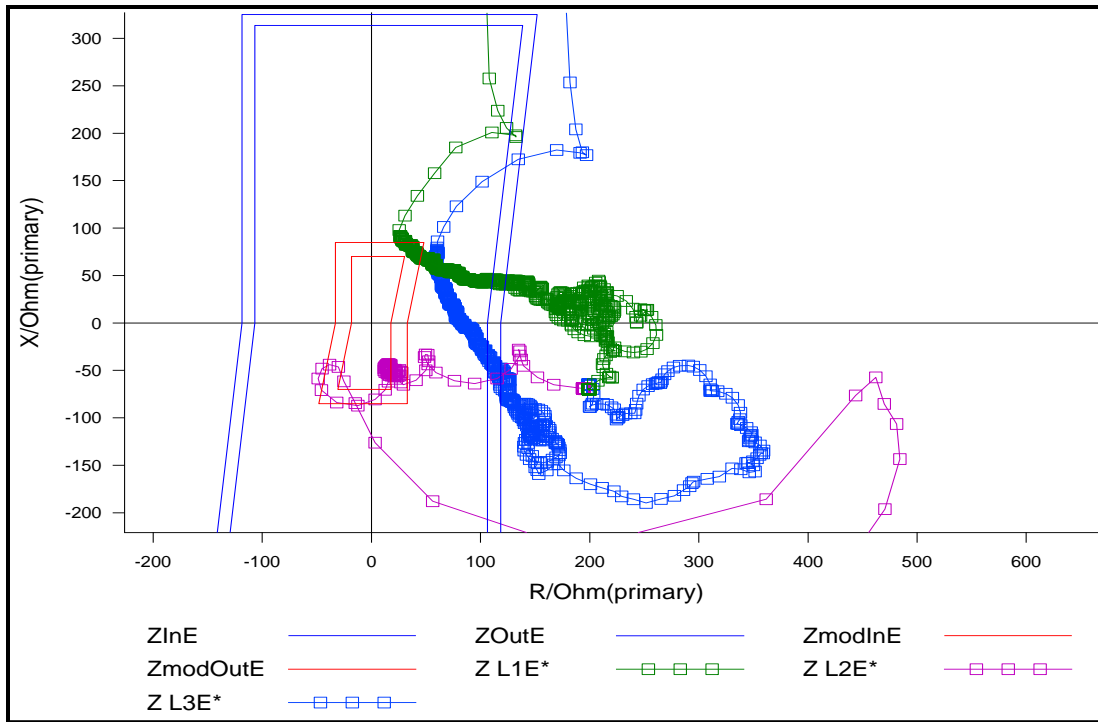
During the faults occurred on 28.12.2011, 19.01.2012 and 08.02.2012, the relays RED670 did not activated the Power Swing blocking function (68) during the dead time of the reclosing in one line of the link between Mantaro – Socabaya (figure 12). The power swing blocking was not active because the internal logic of the relay was blocked by the distance start (PHS-STPE).

Figure 12 : Impedance during a power swing recorded in the distance relay of the line L-2053 Cotaruse Substation on 08.02.2012

5.3 The parallel lines with high load flow, must count with power swing blocking schemes, that not only work on the traditional scheme which is based in blinders.

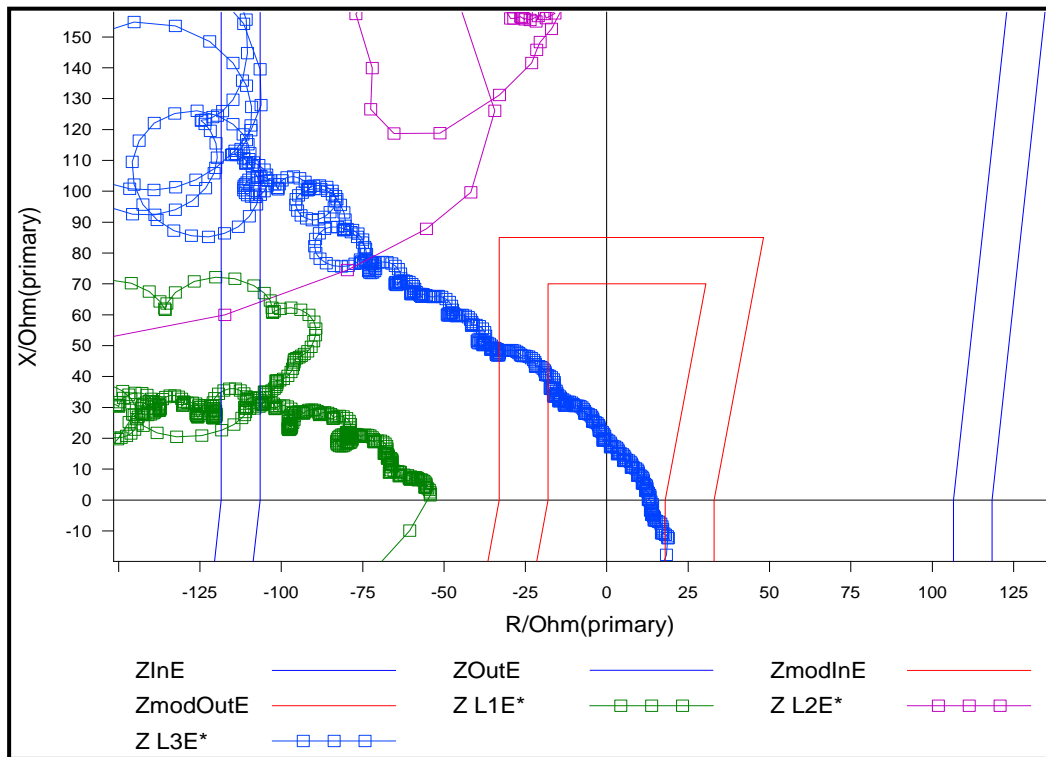
With those events, we found that for some events the power swing function was detected correctly, while for other events function power swing was not detected, causing and incorrect tripping of the distance protection (Figure 13)

Figure 12 : Impedance during a power swing recorded in the distance relay of the line L-2053 Socabaya Substation on 08.02.2012
