Investigation and Analysis into the Mis-Operation due to Carrier Holes

John J. Meinardi - Florida Power & Light Co.
Miriam P. Sanders, PE - AMETEK Power Instruments

A bus fault event occurred that resulted in mis-operation of two transmission lines. This paper presents a summary of the event utilizing fault records to determine what happened as well as the use of a portable digital fault recorder to verify the proposed solution to prevent this from occurring again. We will first present the investigation, and then the testing and solution that followed. Carrier Holes have been a topic of discussion for eons and tend to be a mystery. Some typical causes will be presented, with suggestions for identification, prevention, and mitigation.

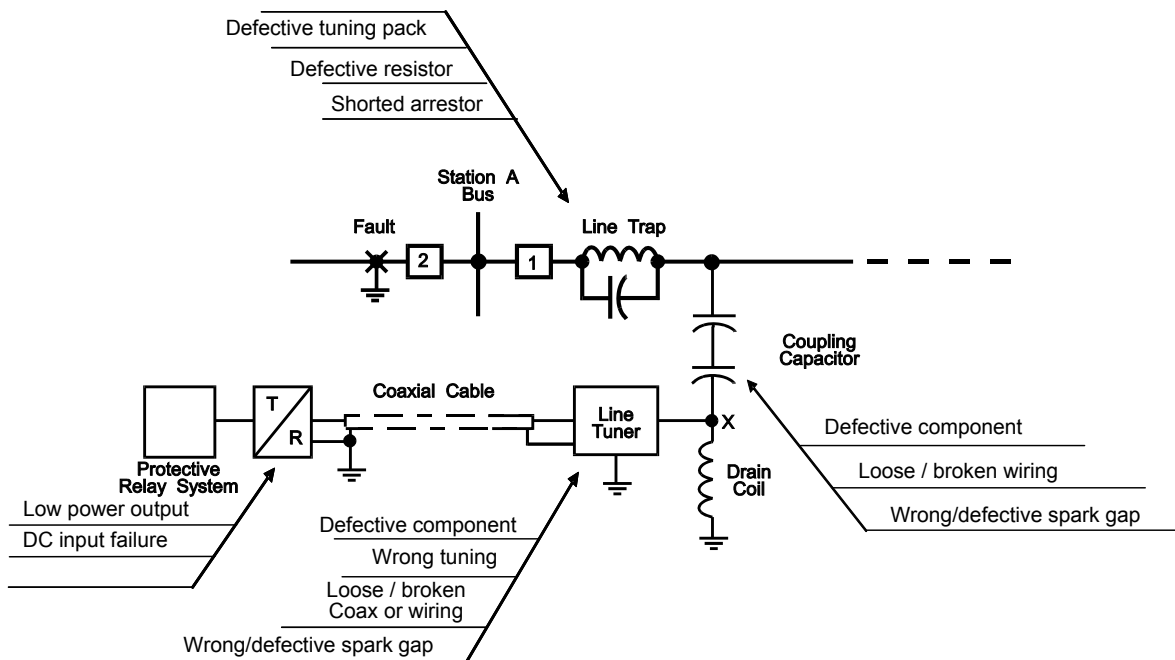
Figure 4 - Root Cause Analysis

Nothing really pointed to why we lost signal after the fault started. We used a fault tree analysis to aid us in the search for our root cause, see Figure 4 **Error! Reference source not found.** A Cause Effect Analysis was also done for Loss of Guard and "Carrier Hole", these both pointed us in the same direction. Gaps came up in several places as a possible reason for the loss of channel. From the investigation done on site within a few days of the fault, we reviewed the tuning unit's gap measurements and found them within specification. The one area left untouched at this time was the ccvts. In order to investigate, this would require a line outage – meaning coordination of crews and time to organize it.

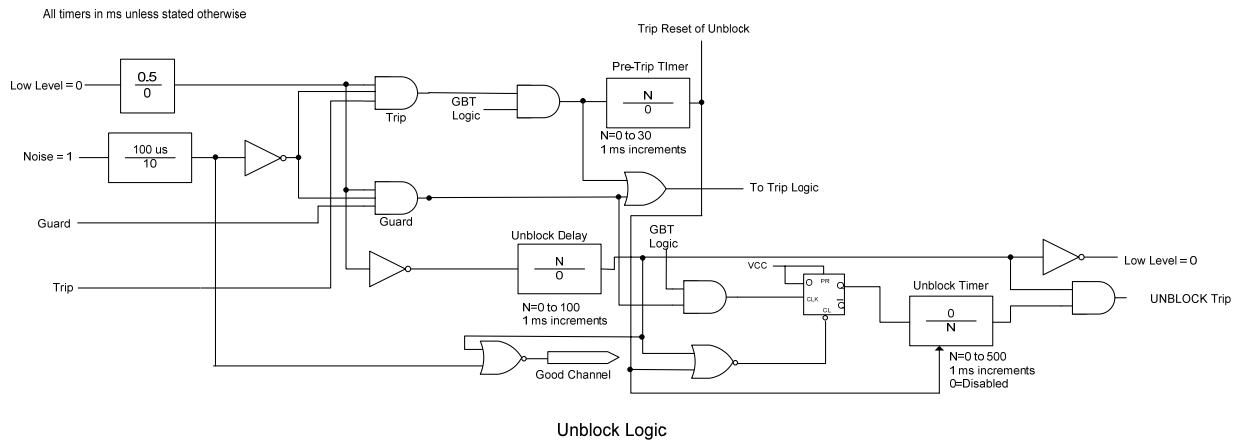
Figure 5 Unblock Logic

vendor's assistance, we found that there was a 10 ms dropout delay on the noise circuit to prevent extraneous alarms. See Figure 5.

The delay was reduced in the receiver circuit by the vendor to 2 ms, and we were provided with proto-type receivers to run through our tests again. This time, we accomplished what we had wanted. We are able to put a short time delay on the unblock timer of less than 10 ms. This will give us the ability to ride through short carrier holes on the Directional Comparison Unblock systems, while still maintaining the overall reliability of the relay system. Putting a longer delay on the unblock output was not acceptable to us, as we need to be aware of longer carrier holes that would indicate a significant issue with gaps or other component flashovers.

After all the testing and analysis by both the vendor and us, a way to work through this was reached. A change was made to add an optional time on the receiver module to reduce its dropout time from about 10 milliseconds to 2 milliseconds. This will allow us to still use the setting we think is correct to allow for a loss of channel and still provide a trip for a fault in a time frame which we feel is acceptable.

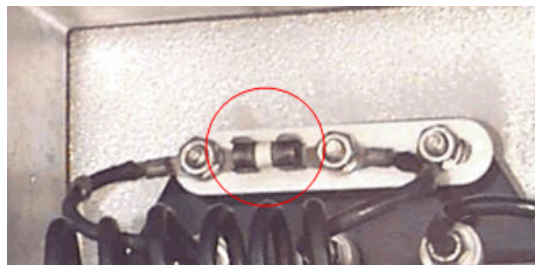
Figure 6 - Non Adjustable Gaps

Once an outage was allowed, the ccvt's were found to have a fixed non-adjustable gap. There were signs that they had flashed-over and some were dark looking, like they had been firing, and been hot, see **Error! Reference source not found.** Figure 7 - Evidence of flash-over and heat damage**Error! Reference source not found.** We proceeded to replace these gaps with new adjustable units from the vendor which had previously not been available.

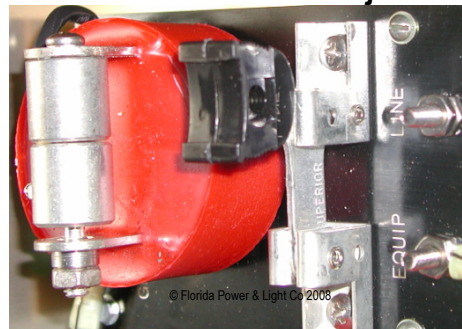
Figure 9-Adjustable Gap Assembly

At this point we wondered if the tuning units had fired even though they didn't seem to outwardly show it. There gaps were set as specified for coordination with the ccvt's. A closer look revealed after disassembling them that they had indeed fired but it was not visible unless they were inspected with a mirror or removed. They had fired but not to any great extent, the gap was in very good condition. See Figure 9

Note: This was the type which showed no flash marks until disassembled

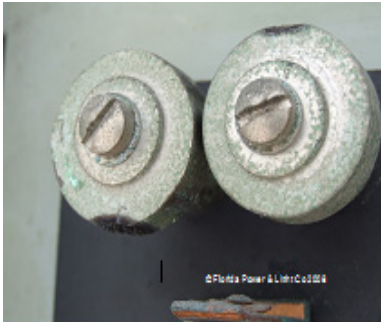
Figure 11 - Obvious Flashover Marks

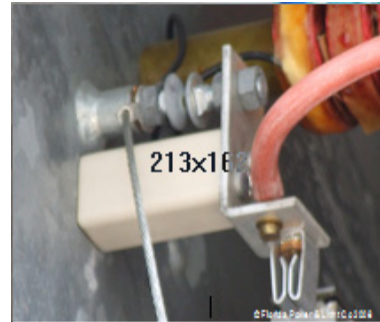
Figure 12 - More Flashover Mark

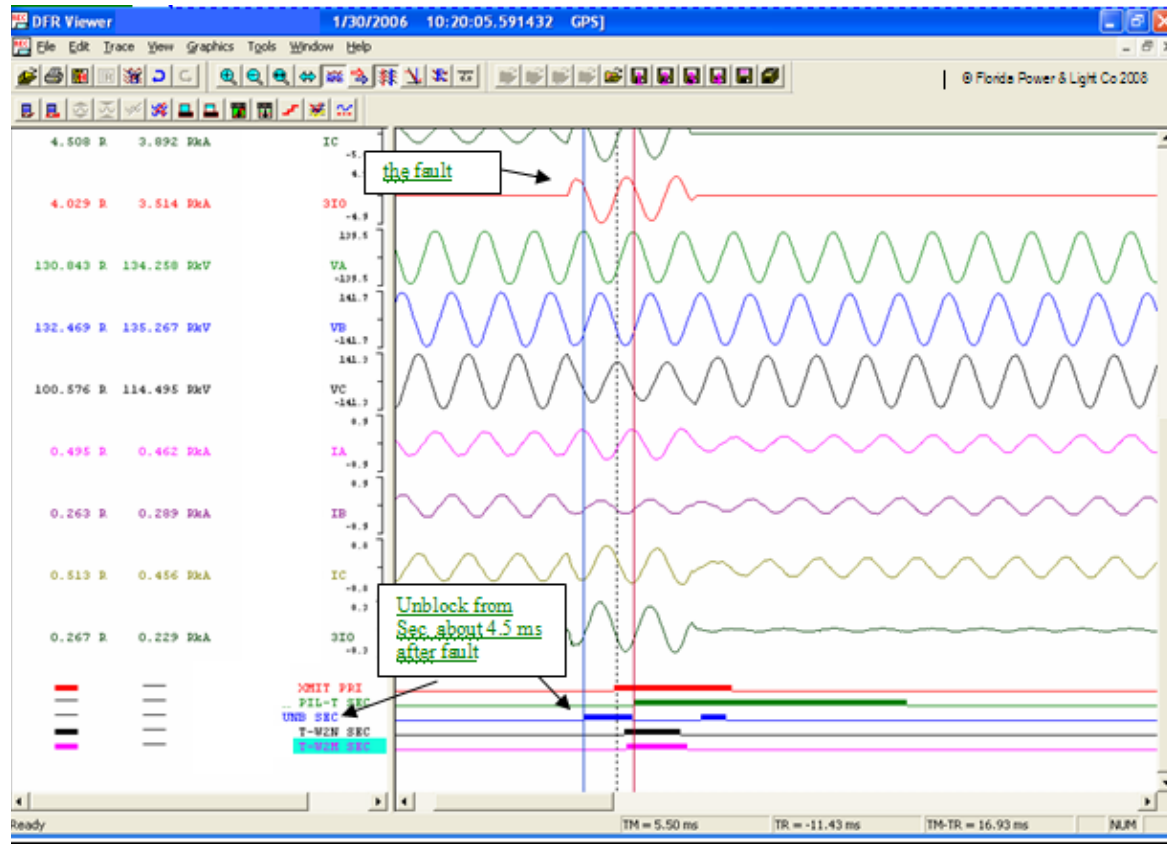
Figure 13 - Event record

channel, transmission protection and analysis and others. After review, a plan of attack was reached for testing and further investigation to be done by the field. From the DFR information, Figure 13 and Figure 14, at hand, an Unblock trip occurred on both lines. . An unblock trip is when a fault causes a loss of channel on the Power Line Carrier, the carrier logic will output a trip to give permission to the line relay to trip. This is to allow tripping on an internal line fault which causes the loss of channel. From a reliability point of view, this provides a very dependable system.

We reviewed all the available information we had on the operation, - targets, records from various DFR's, SOE, and SER. We determined that an unblock trip occurred, from the Loss of Channel, at 4.5ms (~1/4 cycle) into the fault, thus allowing the Station A and C terminals to trip for the C phase to ground fault at Station B.

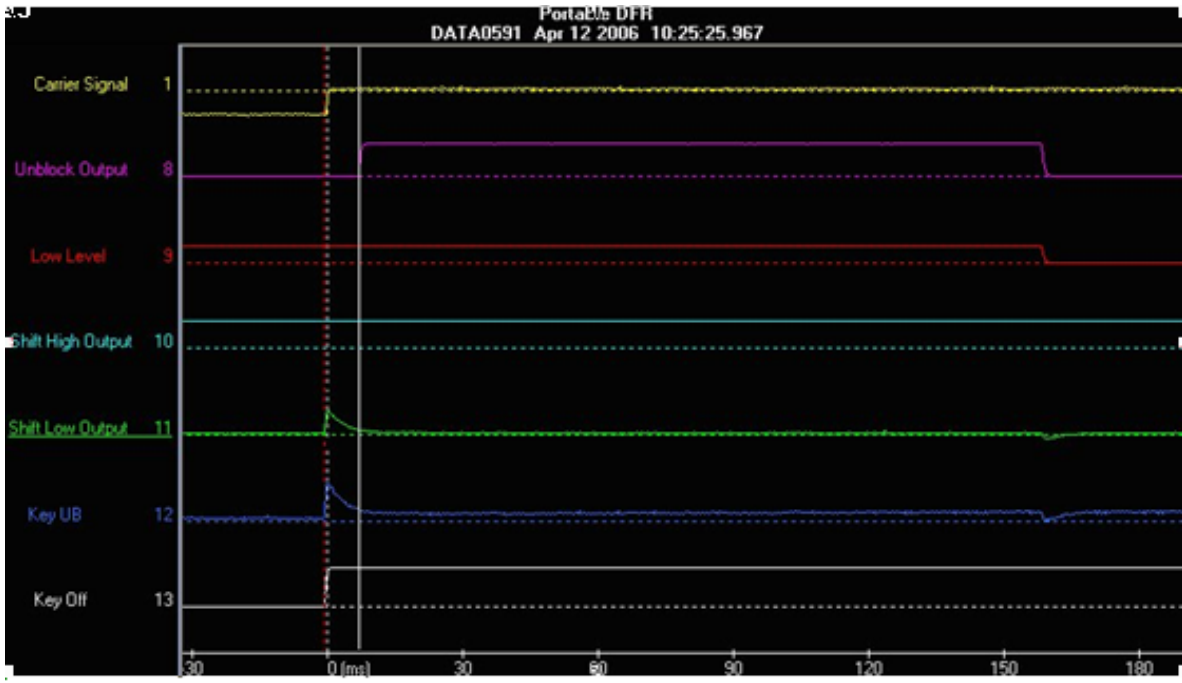
Figure 15– Test DFR Shot before any changes to the logic timers with a loss of channel

This is a DFR shot from a portable DFR we used for the investigation and analysis of this problem. Channel 1 shows the Loss Of Channel (LOC) and channel 8 shows the unblock from the local receiver 8 mS after the LOC which lasted 150 mS. Other items were monitored for analysis if needed.

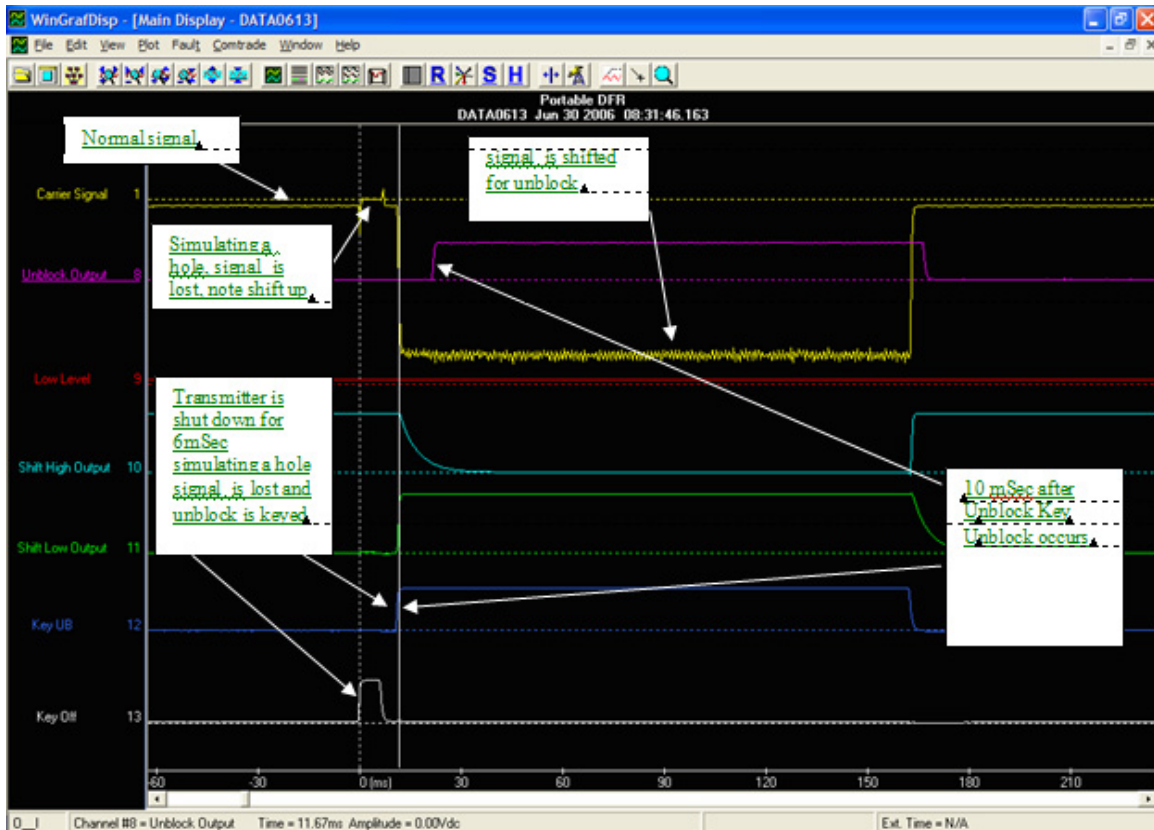
Figure 16 - Test DFR shot with a simulated 6 mS hole from our test setup

So a simple setup with a spare carrier set through an attenuator to replicate the line attenuation, was put together to see how it would react to our simulated carrier holes. The carrier holes we simulated to be on the order of 2 to 6 ms, see Figure 16 We used a portable DFR to monitor all aspects of our test. We monitored the pulse from our remote carrier and compared it with the local unit to see how this new logic operated. We were very surprised to find out that the time we chose as the delay we wanted to use on our system was not really working, we were still getting immediate unblock trip outputs. We started seeing a difference when we increased the setting to over twice what we wanted. We found an interesting thing that happened to the local receiver - it would mask any return of signal until after almost 10 milliseconds. We tried many values for our delay setting but until we were above 10 milliseconds we saw really no change and it would still send a trip output. This was unacceptable, the vendor was contacted. With the
