A Most Unusual Event Analysis

1. Introduction:

On Saturday night 2/25/2017 at 20:51:15 a transformer differential relay associated with the Sheffield wind farm 115KV/34.5KV GSU transformer misoperated resulting in the tripping of the 115KV interconnection and wind farm collector 34.5KV circuit breakers. A severe lightning storm was in progress at the time with a trip/reclose of a nearby 115KV transmission line occurring 8 seconds prior. The transformer and wind farm were returned to service after an Operations Analysis had determined that the transformer differential relay had misoperated.

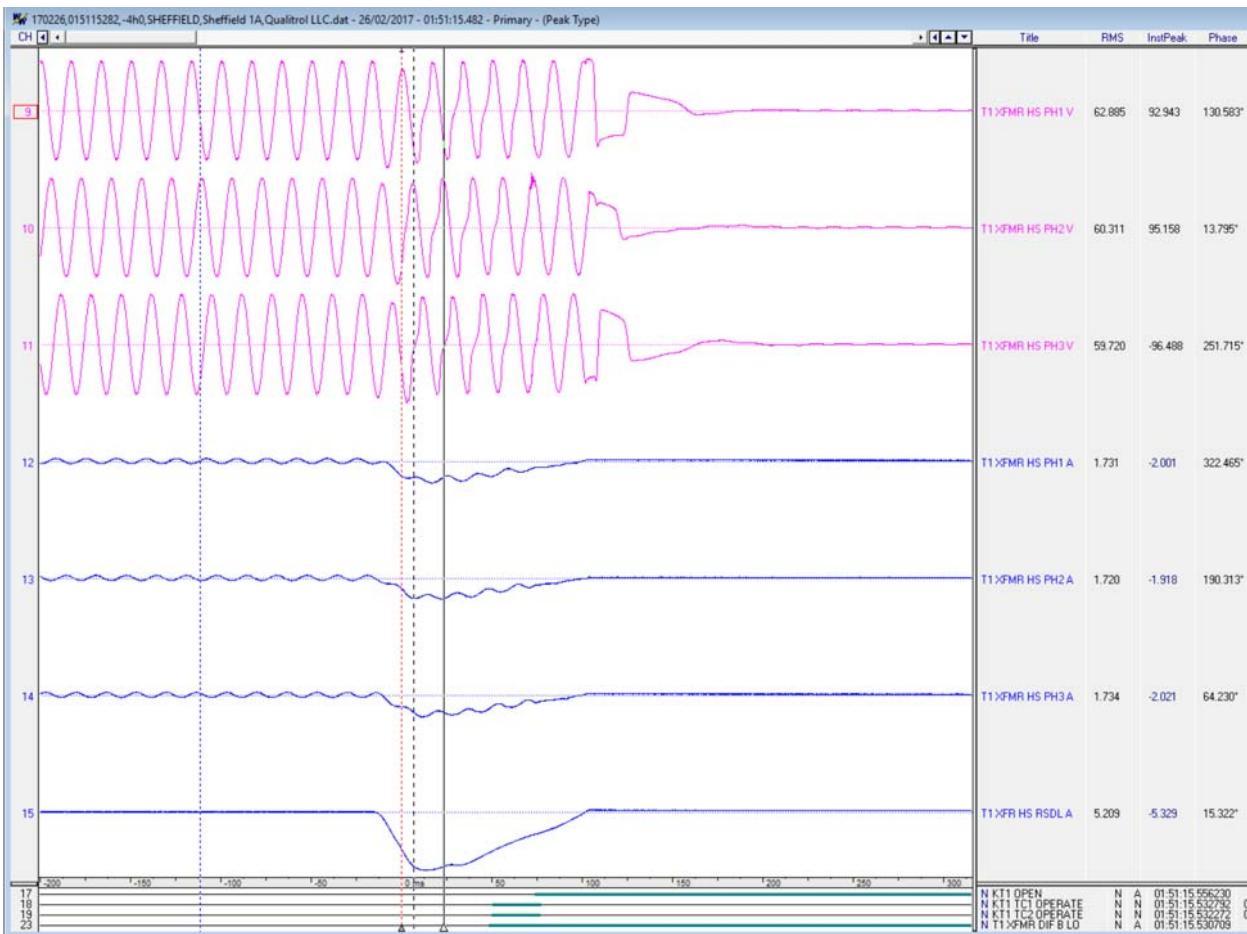
Sheffield T1 DC Current Pulse

The DFR recording of the DC current pulse at Sheffield T1 is shown below. The duration of the DC current pulse was approximately 120 milliseconds with a linear decay starting ~50 ms after the pulse started. The DFR record below provides the Sheffield T1 115KV currents and voltages. The RMS quantities shown are KV and KA. The time/date noted is UTC time (EST = -5hr). The DC ground currents peaked at approximately $3I_0 = 5200A$ DC, $I_{Phase} = 1730A$ DC.

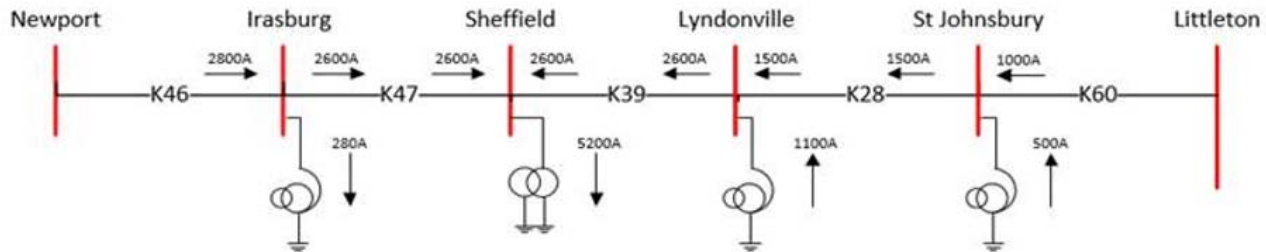
Northern Vermont DC Current Path

The flow of the DC current pulse on a portion of the 115KV system is shown below. The DC current obeyed KCL's entering & leaving all of the substations and the current flow appeared in the transformer tertiary. DFR records for all of the above transformers are included in section 4 of this report.

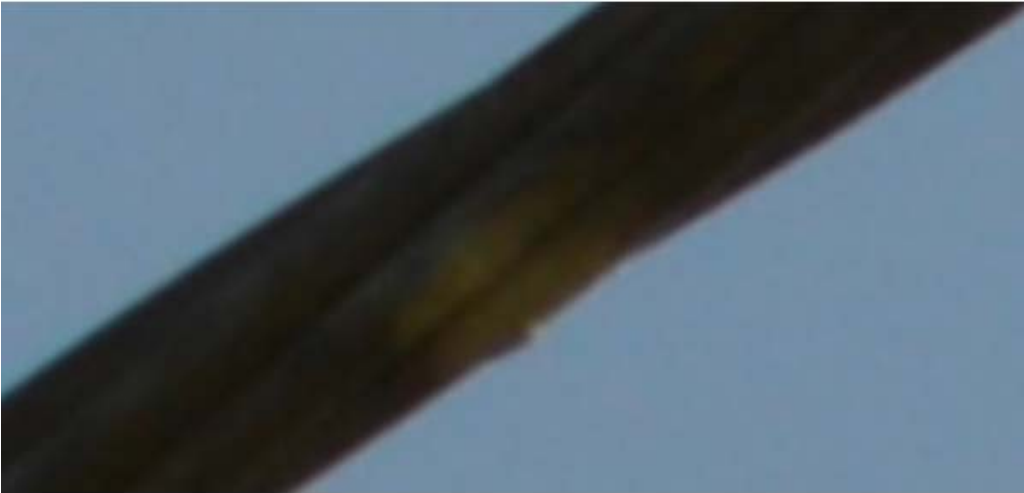
K60 Shield Wire Arc Mark

Detailed ground level photographs were taken of the shield wire and DC Pole conductors at all four K60 line shield wire crossings with particular attention to the crossing that appeared to be the closest and which exhibited audible corona. An examination of the photographs identified a shield wire anomaly at that location.

Two sections of the static wire that included arc marks 1 & 3 were sent to a materials lab for analysis with no information provided on the origin of the samples. The materials lab concluded that the shield wire marks that were present were due to a localized thinning of the zinc galvanized layer and that no structural damage to the steel occurred which would be typical for exposure to an electrical arc. There were no significant differences in the composition of the material at the damaged spots from an undamaged remote spot on the wire. The cause of the corrosion could not be determined but there was no evidence of a manufacturing defect in the wire or evidence of a typical arc.

The origin of the shield wire samples and the suspected arcing of the shield wire to -450KV conductor were discussed with the metallurgist. The metallurgist concluded that the observed features of the shield wire localized corrosion could be produced by an arc of a short duration with the galvanized steel wire acting as the anode.

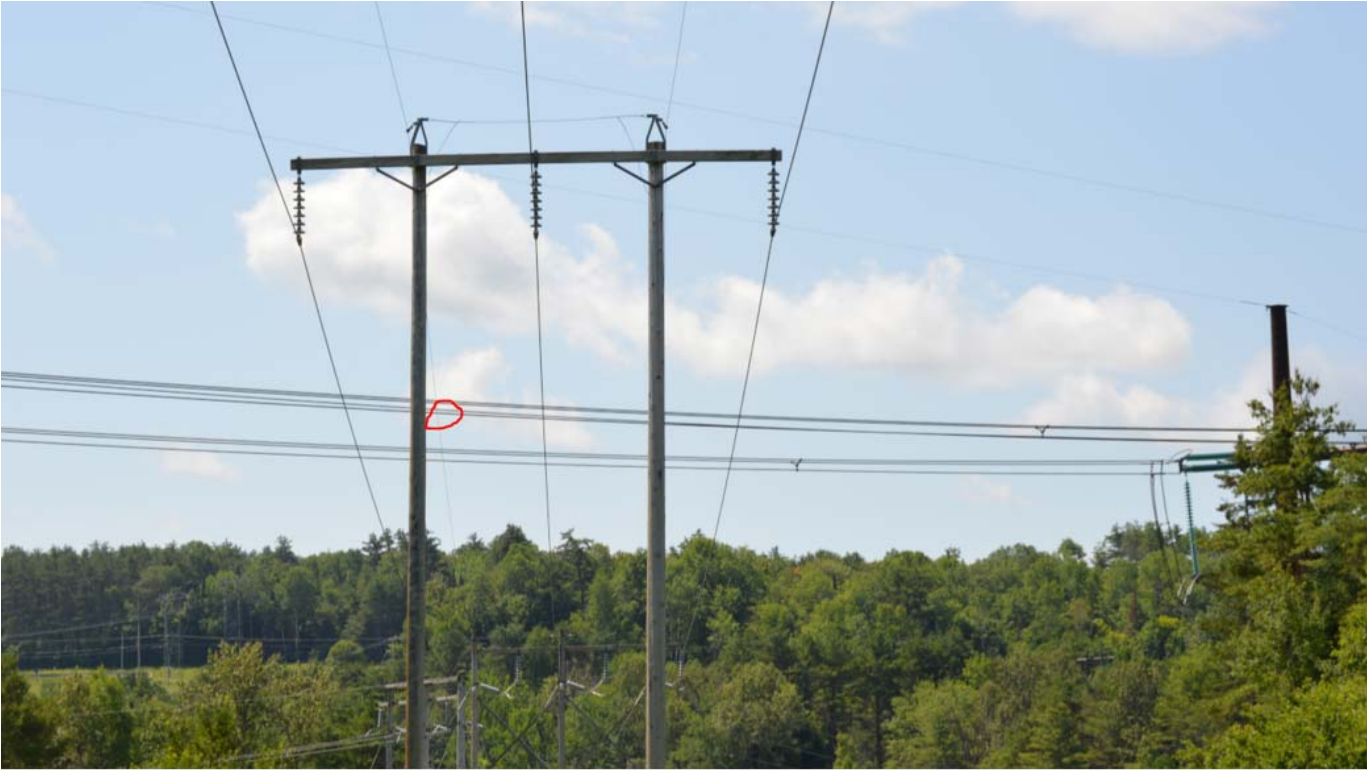
K60 – HVDC Line Crossing Fault Location

An investigation into the cause of the DC current flow determined that the Phase II HVDC -450KV pole faulted to the K60 shield wire at the line crossing in Waterford VT and that the fault self-extinguished.

The HVDC line operated normally during this event and no that abnormal conditions or alarms were recorded. A review of line clearances at the fault location indicates that the DC line conductor/ K60 Shield wire clearances were marginal during certain weather and loading conditions. The K60 shield wires at the HVDC/K60 line crossing were removed which eliminates the possibility of this event happening again.

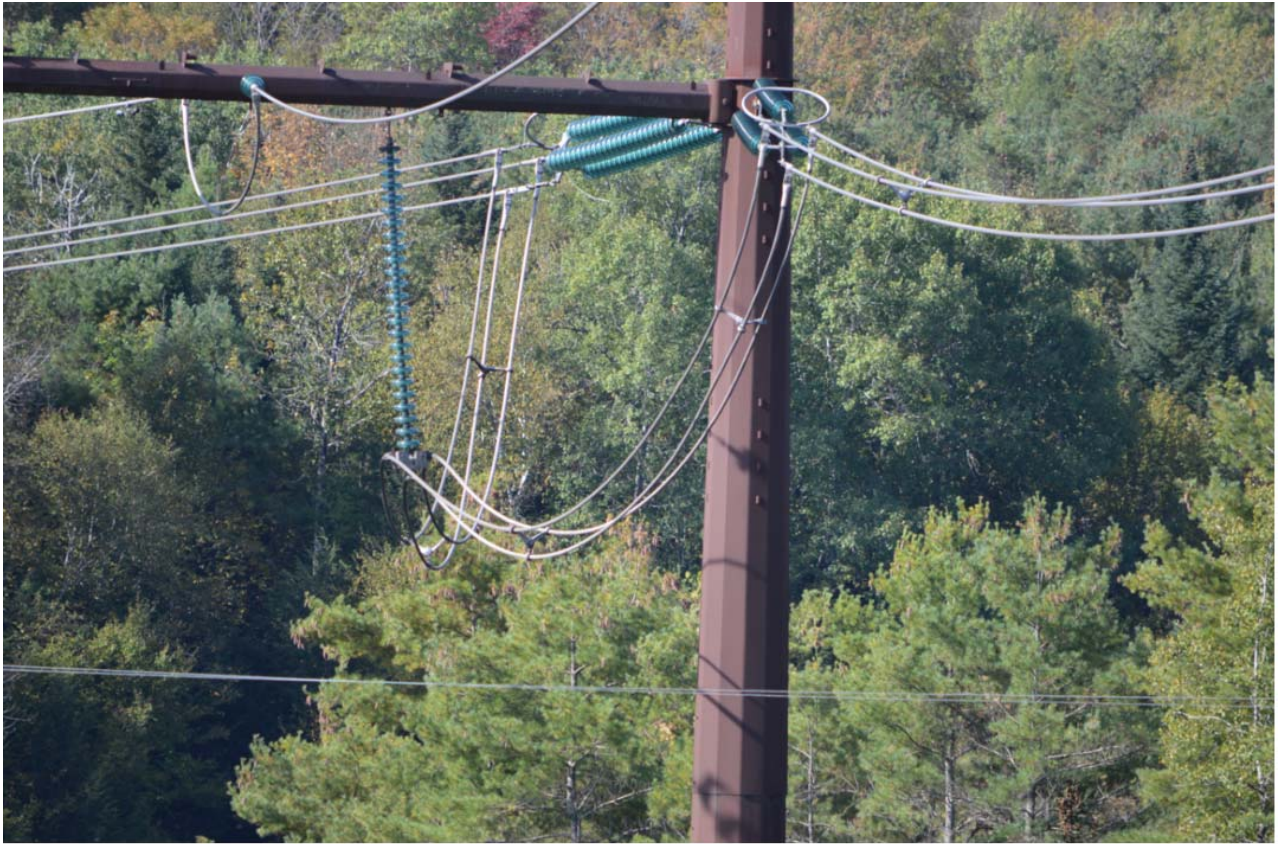
K60 Shield Wire Clearances

A review of DC line and the K60 line conductors and shield wires indicated that although the clearances meet NESC code under certain line operating conditions and weather cases, less than desirable clearance buffers exist and could have been as low as 10.4 feet at the crossing with the shield wire anomaly. Velco decided to remove the K60 shield wires at this crossing location in view of the minimal clearance that was there. This span would remain adequately protected from lightning via the DC shielding conductors. The shield wires were permanently removed and hand inspected. Shield wire surface anomalies were found at six locations, all in proximity to the highlighted HVDC negative pole crossing. The surface anomalies were all aligned on one side of the shield wire and were all roughly the same size.

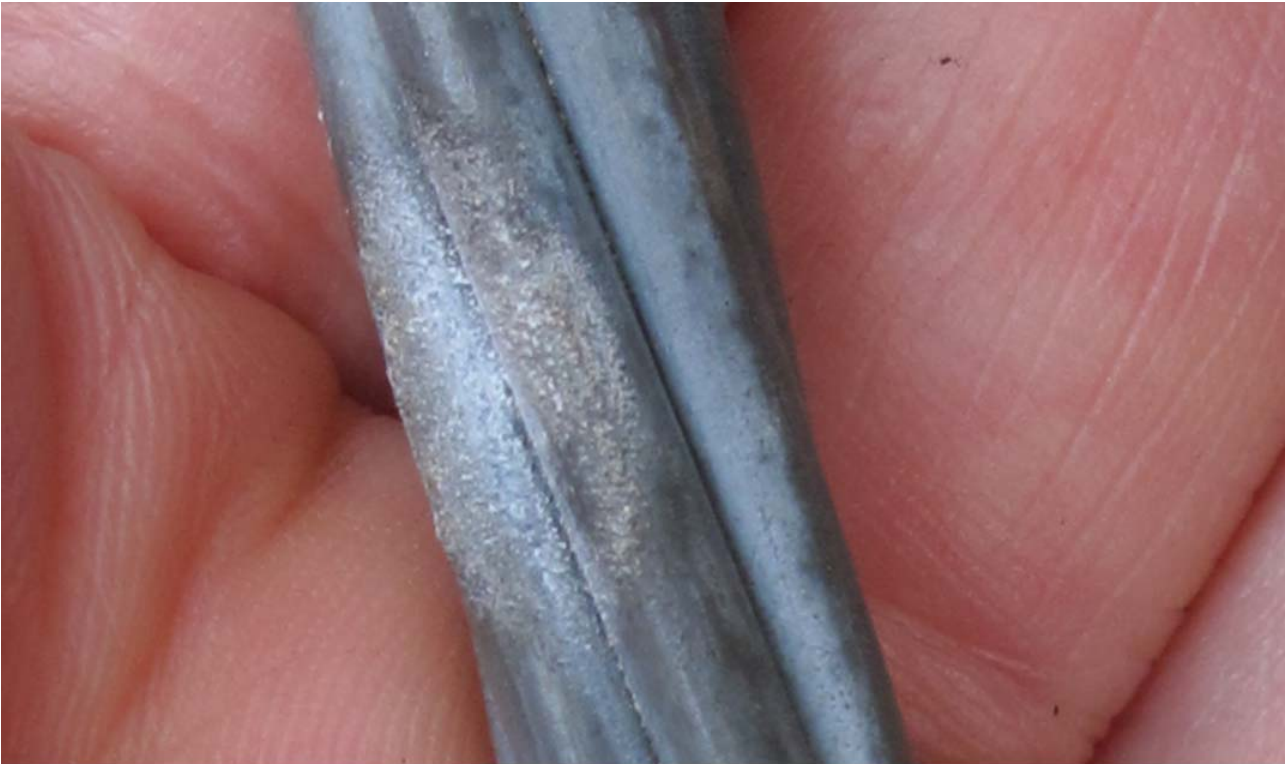
K60 Shield Wire Arc Mark #5

K60 line static wire w/ marks B. Pauletto 8/2/18

Measurement of marks along section of wire. All measurement referenced to end₁. Values are approximate given unworkability of wire.

1	2	3	4	5	6	end ₂
in	9 in	75 in	124 in	174 in	187 in	214 in	278 in

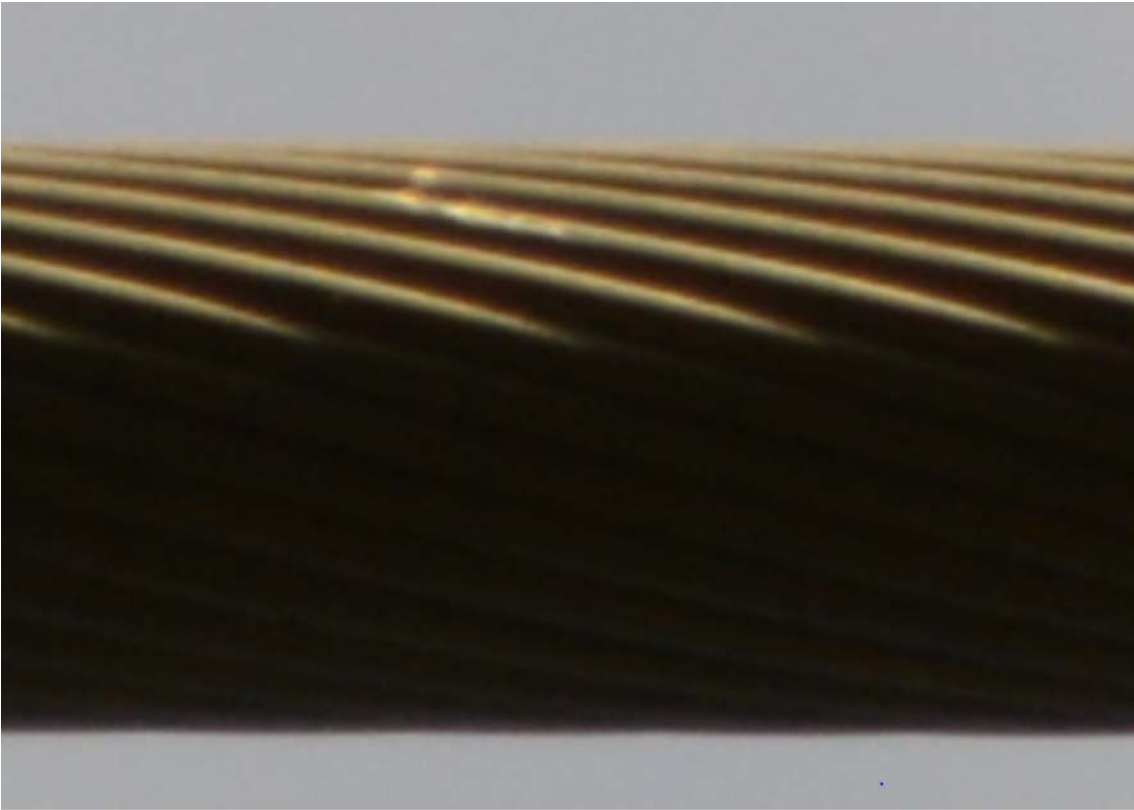
Arc Mark HVDC Pole Conductor Photo 0355

A picture of the suspected “cathode Spot” on the HVDC pole conductor is shown below.

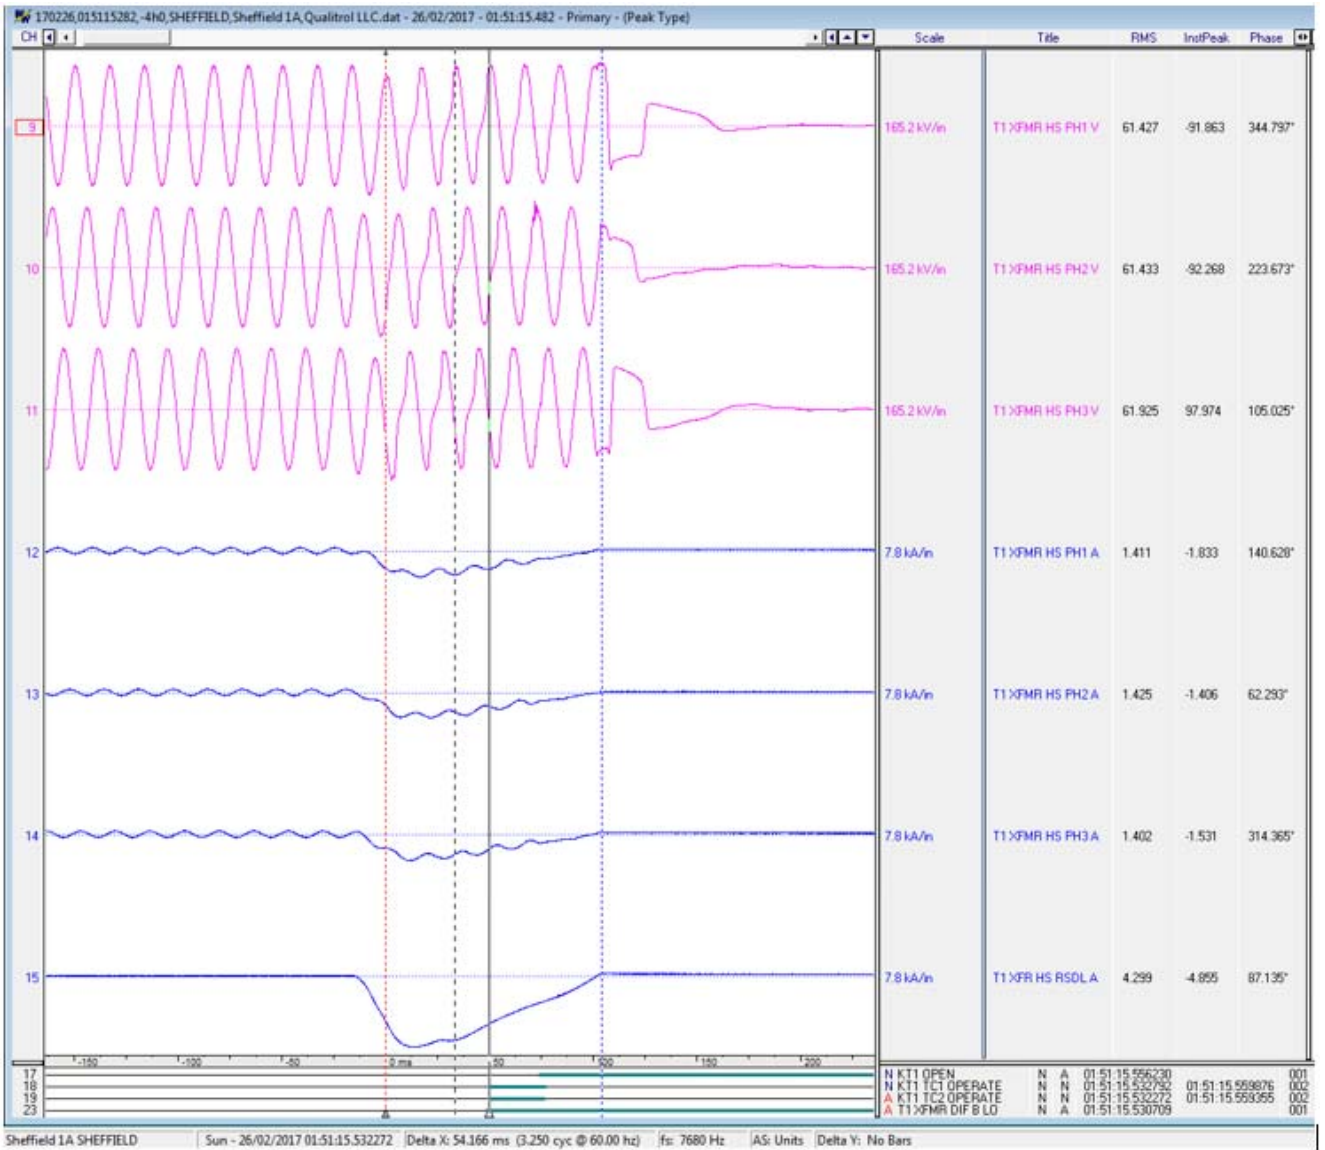
Sheffield DFR Record

The below DFR record provides the Sheffield T1 115KV currents and voltages. The RMS quantities shown are KV and KA. The time/date noted is UTC time (EST = -5hr). The DC ground currents peaked at approximately $3I_0 = 5200A$ DC, $I_{\text{phase}} = 1730A$ DC. The currents at the time of trip coil operation were $3I_0 = 4300A$, $I_{\text{phase}} = 1430A$ DC. The DC current extinguished 3.25 cycles after the KT1 and K47 trip coil operation.

The Sheffield 115KV bus voltages sagged to 0.92 pu and exhibited extreme distortion during the event.

Rated AC current for the 30MVA T1 transformer is 151A at 115KV. 1730A DC per phase flowed through the grounded 115KV windings of this transformer.

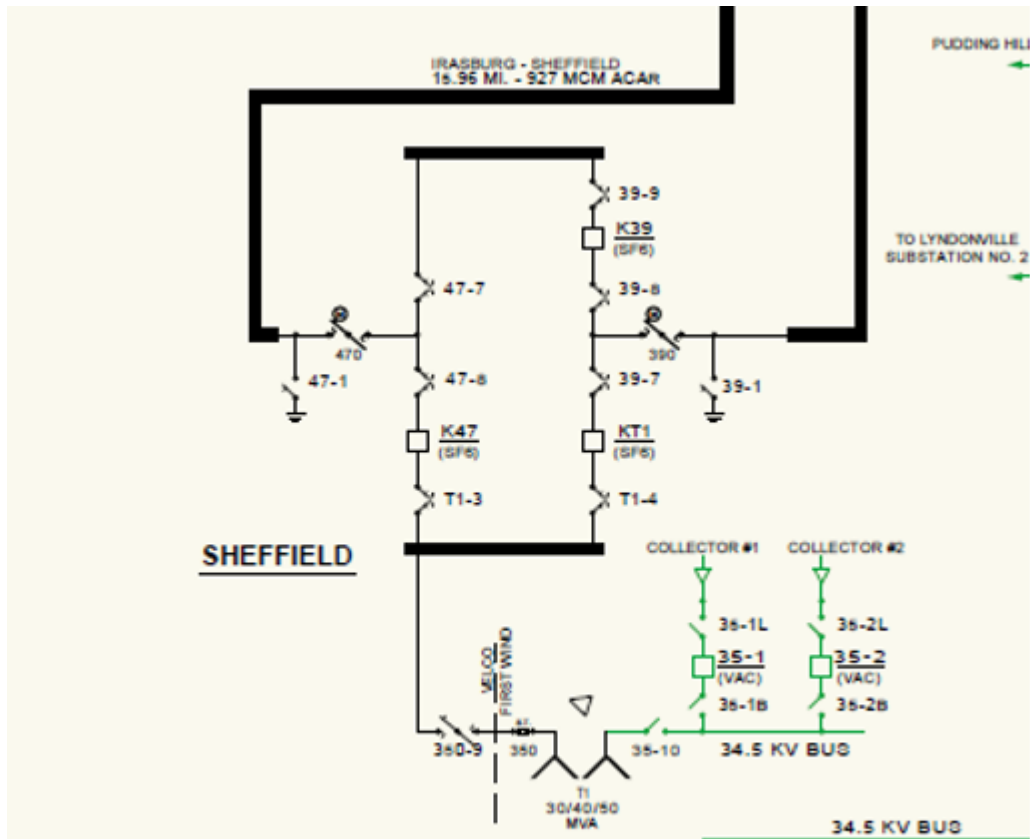
Sheffield One Line

The Sheffield 115KV substation is a ring bus arrangement. The Sheffield One line is below.

The Sheffield K47 and KT1 115KV circuit breakers tripped during the event and had sustained DC current flow while the contacts were open. The breakers were inspected and no unusual contact wear was noted.

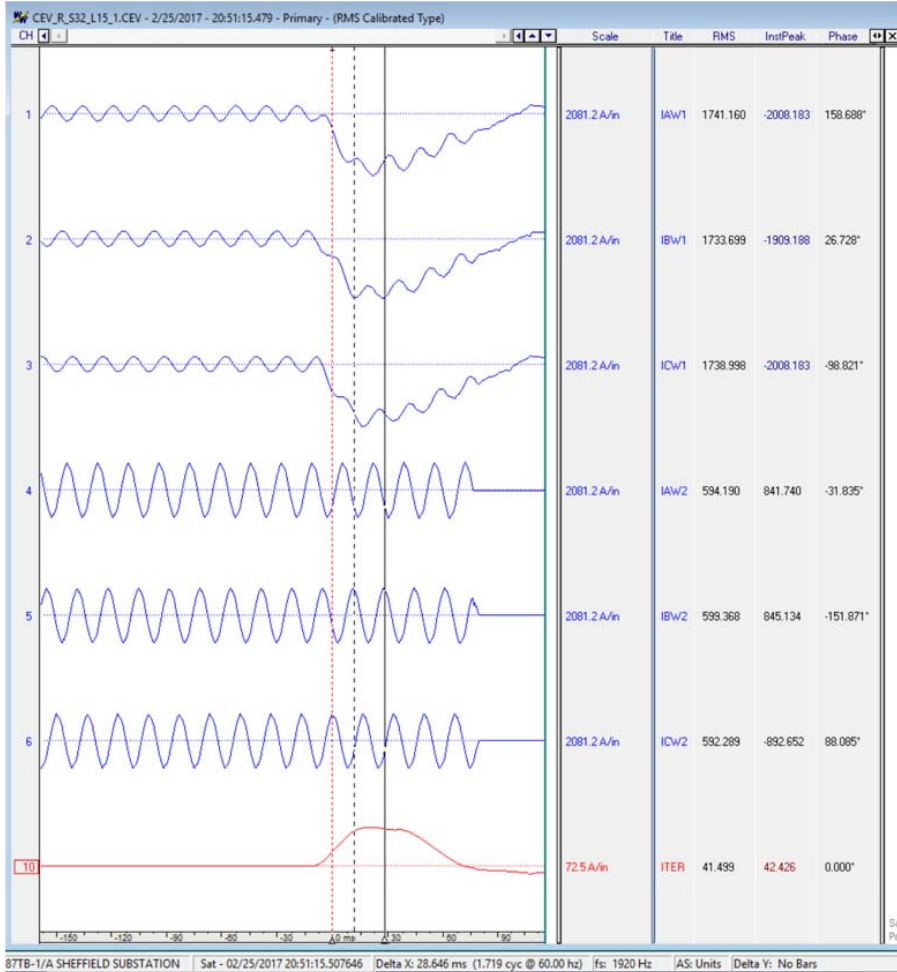
Sheffield T1 SEL387 Event Report

The 87T1S transformer differential relay differential relay operated incorrectly for the DC current flow. The relay phase compensation jumpers "IN1 J1" and "IN2 J2" are set to "DELTA1" which should have removed the zero-sequence quantities from the phase currents. The DC ground current was a pure zero-sequence quantity. This relay is not designed for operation with DC current flow. The security of this relay could be improved for this very unusual current flow condition by connecting the CT's in delta to externally filter the zero-sequence current. This is not recommended since the relay has been secure for all other external fault conditions.

The 87T1P numerical differential protection correctly restrained for the DC current flow. The winding 1 currents are the summed 115KV currents from K47 & KT1. The winding 2 currents are 34.5KV currents from wind farm 34.5KV collector breakers 35-1 & 35-2. The transformer differential winding compensation setting W1CTC setting = 12. This setting filters the zero-sequence component from the winding 1 phase currents. The DC ground current was a pure zero-sequence quantity and the relay correctly restrained when these currents were filtered from the differential calculation.

Relay event report data is shown below. The ITER current value is the 13.8KV transformer tertiary displayed in secondary amps, 41.5A secondary, 6640A primary. The transformer was operating at the 117.88KV tap. The transformer magnetizing current was approximately 1740A – $6640 * (13.8 / (117.88 / \sqrt{3})) = 394A$ per phase.

The Sheffield 87T1S transformer differential relay operated incorrectly due to the high DC current flow that it experienced and not due to any other design or setting issue. The relay could be de-sensitized to the zero sequence DC current flow by connecting the CT's in delta and changing the settings. This is not required/recommended.
