# **Analysis of a Transformer Differential Relay Over-trip on an External Fault at National Grid**

By: Yujie Irene Lu & Song Ji, National Grid

On April 1<sup>st</sup>, 2010, National Grid experienced a fault on 23kV bus at WH substation. As a consequence of this fault, one of the substation 115/23 kV step-down transformers connected to the un-faulted bus experienced an over-trip by the transformer differential relay. The protection system shall work properly to identify and isolate faults quickly and minimize the impact on interrupting service to customers. Correct and rapid fault clearance and power outage minimization are of concern to utilities and regional Independent System Operator. Base on a disturbance investigation, this paper presents an analysis of the event utilizing fault records, from digital fault recorders and relays, and short circuit simulation to determine what happened and why the 115/23kV transformer differential relay responded to the close-in external 23kV bus fault. The fault records captured by disturbance monitoring equipment and relays and the short circuit simulation provided valuable data which gave an insight into the nature of this disturbance. The

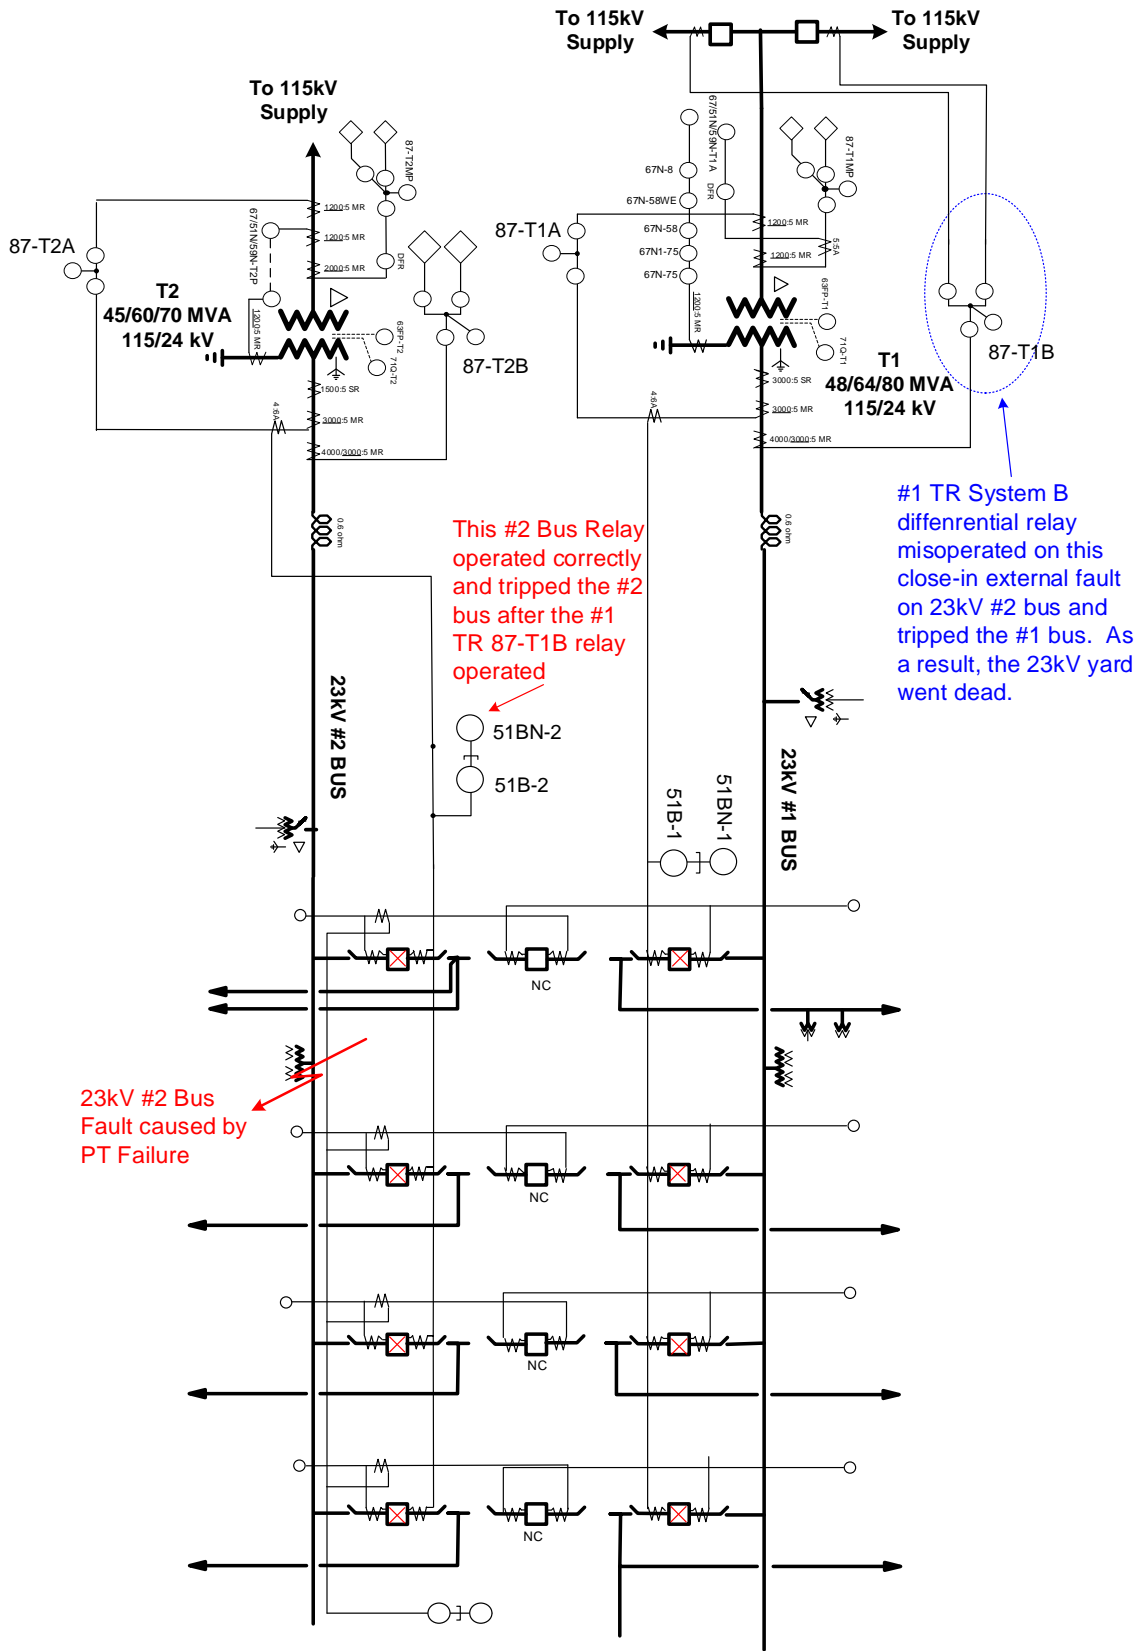
Figure 1 The Simplified System & Relay One-Line Diagram at WH Substation

Each transformer is protected by two transformer differential relays, relay A and relay B with different relay maker, wrapping around 115kV circuit breaker's bushing CTs and 23kV transformer outer bushing CTs. Each 23kV bus is protected by differentially connected bus overcurrent relays, wrapping around 23kV transformer inner CTs and all 23kV bus breaker's bushing CTs. The simplified system relay one-line diagram is shown in Figure 1.

On April 1<sup>st</sup>, 2010 at 6:00 AM, a fault occurred on the 23kV #2 bus at WH substation due to the bus potential device (PT) failure. Because of this bus PT fault, one of the 115/23kV #1 transformer differential relays, relay B (87-T1B), on the un-faulted bus side responded to this external bus fault before the #2 bus differential relay (87-B2) operated, which tripped all 23kV #1 bus (un-faulted bus) breakers incorrectly. The #2 bus differential relay operated with a short time delay and tripped all 23kV #2 bus breakers correctly to isolate the #2 bus fault. Up to this point, the entire 23kV yard went dead.

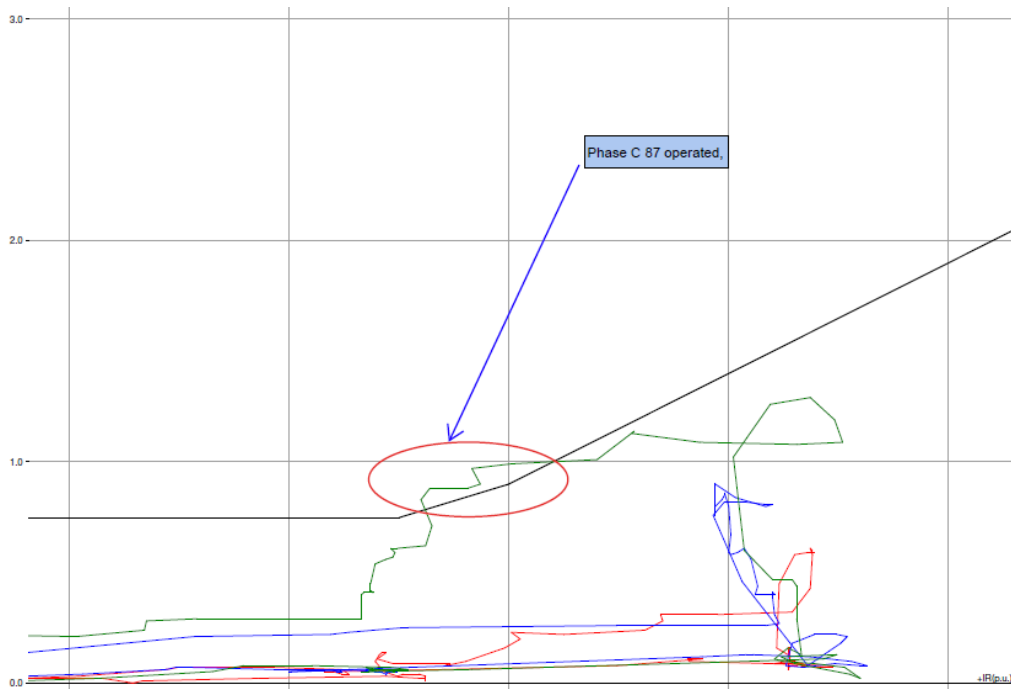
Figure 2 The C Phase of the 87-T1B Relay Fault Record – Differential Trajectory (IO-IR plane)

1. As seen in Figure 2, the C Phase of the 87-T1B relay's operating current exceeded the restraint current a little bit. That explained why it operated.

5. It seems that the 87-T1B relay saw some DC offset at the start of fault. Based on the fault records, the relay saw about 8 cycles of DC offset for this bus fault before the bus relay operated.

*Note: This is a trajectory of differential fault going back through slope 2. This is a condition of CT saturation. This is a C Phase operation.*

5. Due to DC offset and CT saturation, the differential trajectory (IO-IR plane) entering tripping zone during the fault recovery. Refer to Figure 2.
6. In-sufficient margin in the Slope 2 region during this external fault with saturation due to DC offset.

1. Short term solution - to change the transformer differential relay slope setting characteristics to ride through this type of through fault. Temporary setting change request for all relays at National Grid system were issued from the in-house investigation team to testing group in two weeks. The testing team then made the setting changes in another week.

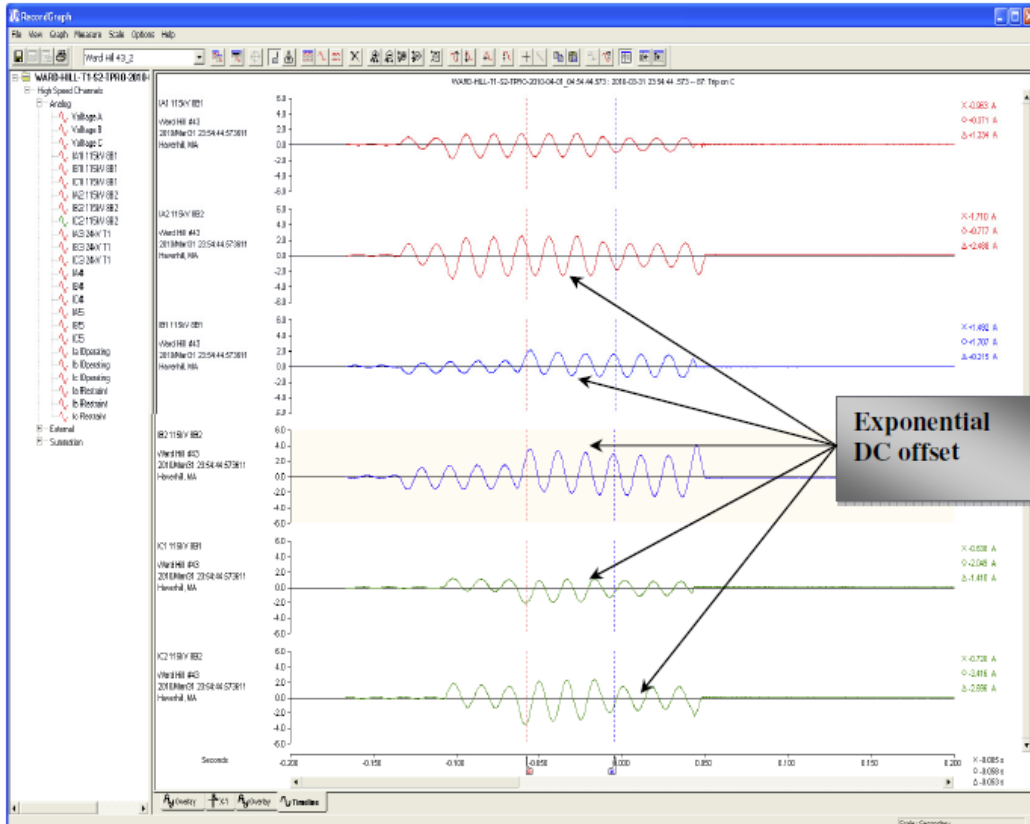
Figure 3 The Misoperated 87-T1B Relay Fault Record – Exponential DC Offset on All Input Currents

1. Exponential DC offset on all the input currents on both 115kV and 23kV side as seen in Figure 3. It appears that secondary current with DC offset was transformed by the main CTs and contributed to the misoperation. These offset current waveforms seem to be more pronounced for faults on nearby buses.

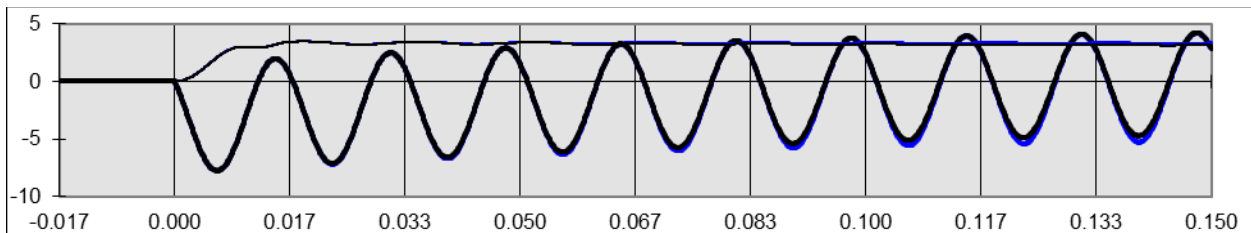
Figure 4 The Offset Simulation for 115kV Side Current by IEEE Version of CT Saturation Calculator

3. A simulation of the CT performance as observed was done using a CT saturation program. The parameters of the main CTs used were adjusted to match the response seen during the misoperation. The results can be seen in Figure 4 for the 115kV side currents experienced. The error for the 115kV side current of DC offset was quite marginal.

As per vendor's internal CT saturation simulation (Figure 4, 5 & 6) and analysis, it was determined that this relay internal auxiliary CT saturation and large amount of through DC offset current resulted in this inappropriate operation, i.e. the improper operation was due to the internal auxiliary CT saturation and DC offset effect.

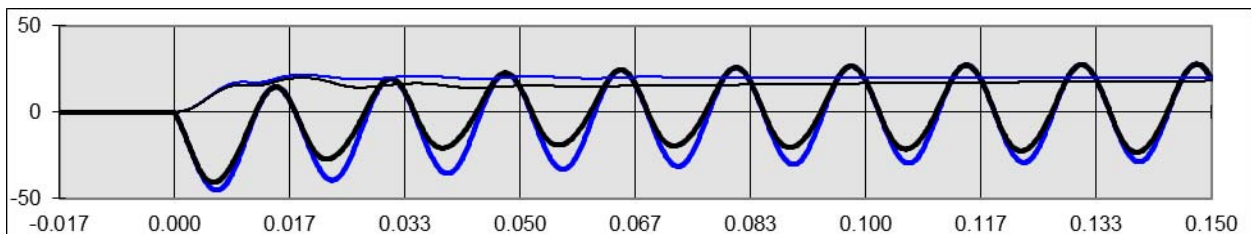
Figure 5 The Offset Simulation for 23kV Side Current @ 12kA by IEEE Version of CT Saturation Calculator

4. The offset simulation was then run for the 23kV side where fault current was approaching 12kA in magnitude, the result is illustrated in Figure 5. As shown in Figure 6, while the fault level was reduced to 5kA, the CT response for this fault level is much closer to the ideal.
