# Event Investigation of 69 kV Double-Circuit Faults

Ahsan Mirza, Christopher Bolton, Girolamo Rosselli, and Sergio Flores, *San Diego Gas & Electric*  
Amanvir Sudan, *Schweitzer Engineering Laboratories, Inc.*

**Abstract**—Two rare yet similar faults occurred within hours on SDG&E’s 69 kV parallel circuits. Because the faults involved two parallel lines, they caused unconventional fault waveforms seen by multiple relays. This, in turn, challenged the directional elements and overcurrent coordination, producing unexpected relay operations.

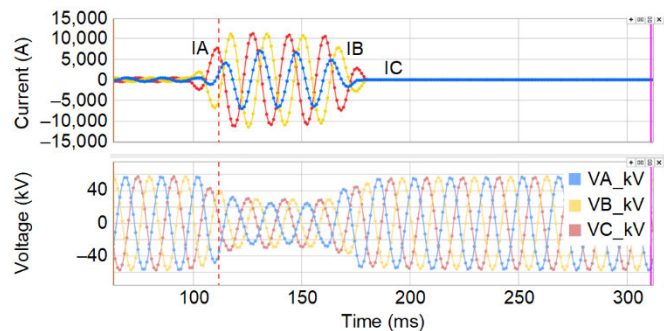
Fig. 2. T7P Relay Current and Voltage Oscillography

It is immediately clear that this oscillography reflects fault conditions, as all three phase voltages are depressed and currents are as high as 10 kA peak value. Something that also catches the eye is the unbalance in currents, even though there is high current in all three phases (reflecting that all three phases are faulted). There is slight unbalance in the voltages as well. All three phases are involved in the fault, but a conventional fault involving all three phases is a three-phase fault, which is mostly balanced in nature (ignoring the effects of line untransposition). That is not the case here, so a natural question arises: What kind of three-phase fault would create such significant current unbalance? There is little doubt that we are dealing with an unorthodox fault type.

It is interesting to see that at the intersection of the IA and IB waveforms lies the peak of the IC waveform. This waveform oddity manifests itself in the form of a clue from the current phasor diagram of Fig. 3. In the top pane, we see that the IC phasor is acting as an angular bisector of the IA and IB phasors. An additional hint as to the fault type and location is disguised in the ambiguity presented by unequal current magnitudes, where IA and IB are equal yet larger than IC. We compare this

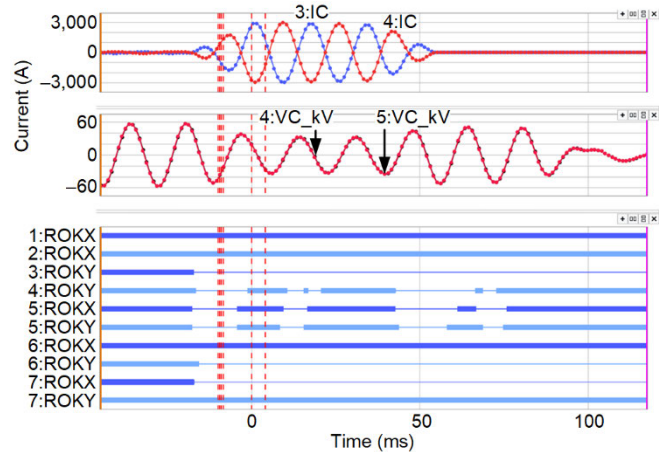
Fig. 16. Combined Event Report of All Seven 87L Relays Showing ROK Bits

To get to the root of the issue, we decide to plot ROK bits of all seven relays together. The bottom portion of Fig. 16 shows the pertinent ROK bits of all seven 87L relays (T1P, T2P, and so on) combined.

Based on this behavior, we look for the commonality in the data and observe that channels connecting the T4P and T5P relays are the ones affected. The T4P and T5P relays belong to the same substation and therefore must be using the same communications equipment or technology—perhaps the root cause behind the 87L element disruption at multiple relays. The 87L elements of T1P and T2P were intact perhaps because they used a communications channel independent of communication equipment and media at the B45 substation.

- The 87L scheme for both Lines L567 and L34 disabled right after the double-circuit faults started. We took advantage of the already combined and time-aligned event reports to lay out the 87L communications channel health indicator bits (ROKX and ROKY) for all the relays. Systematically examining the ROK bits suggested issues with the communications equipment at the N45 substation housing the T4 and T5 relays. It was later found that these 87L schemes indeed used leased copper telecom lines at the N45 substation, which would be affected during nearby system ground faults. There is a project underway to upgrade 87L communication technology for these 69 kV lines.

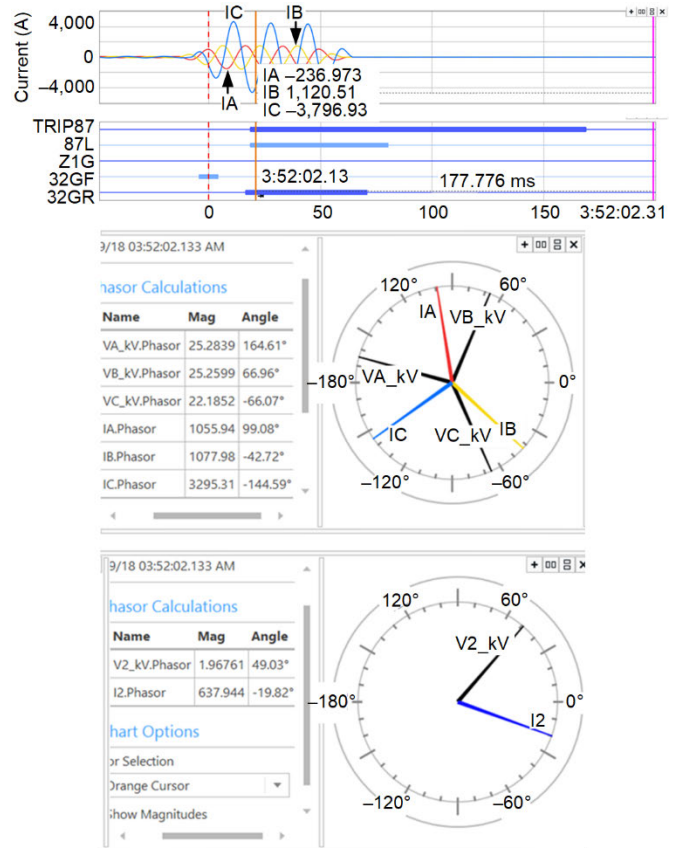
Fig. 19. T2P Event Report Showing Mho Ground Zone 1 (Z1G) Element Remaining Deasserted

We observed that the mho elements of relays at T5 and T6 remained secured, as expected. Mho elements of relays at T1, T3, and T4 operated as expected. What was not expected was the mho element dormancy for the T2 relays. There was an internal fault on Line L12 protected by T2P and T2S, so their mho elements should have operated. Fig. 19 shows Z1G in T2P remaining deasserted throughout the event duration. Why?

The answer lies in the negative-sequence voltage ( $V_2$ ) and current ( $I_2$ ) values seen by the relay for the double-circuit fault. In Fig. 19, which shows  $V_2$  and  $I_2$  phasors as seen by T2P,  $V_2$  leads  $I_2$  with an angle less than 90 degrees. This is, in fact, the  $V_2$  and  $I_2$  relationship expected for a reverse single-line-to-ground (SLG) fault! This rare double-circuit fault has been successful yet again in challenging the relay directional element, this time by hiding the forward directionality of the fault.
