**FAULT ANALYSIS AS A BASIC INPUT FOR MAINTENANCE MANAGEMENT
TO IMPROVE THE OVERALL RELIABILITY OF THE BELGIAN
TRANSMISSION GRID**

Patrick De Cuyper
Elia Asset NV
Belgium

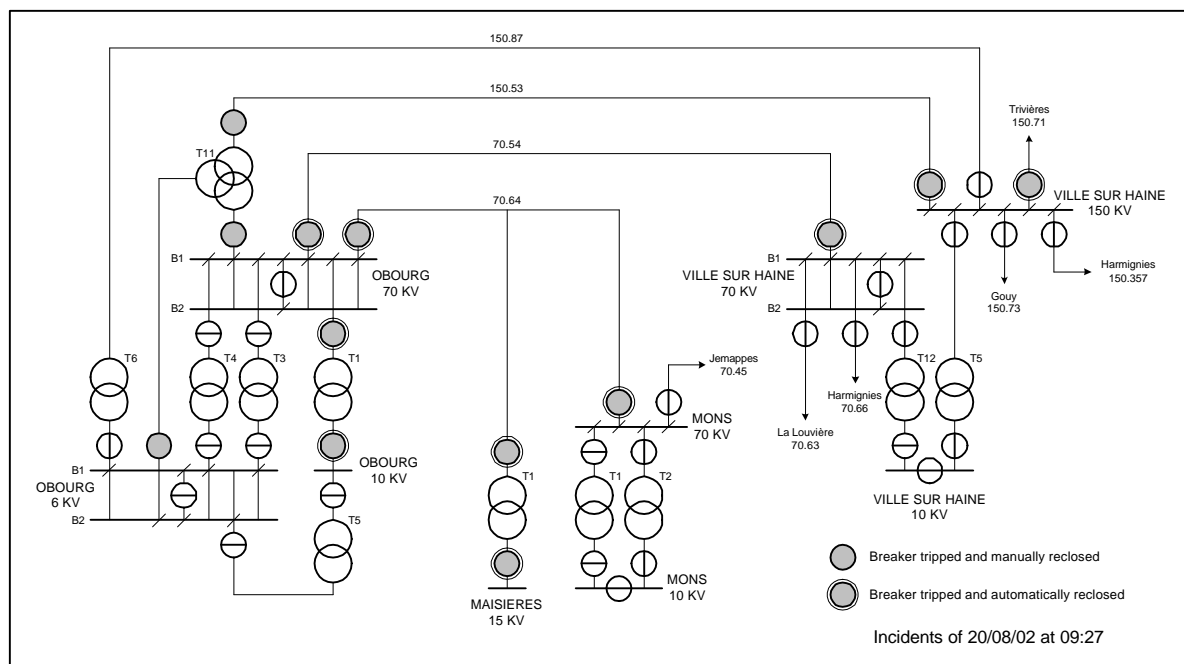
Figure 2: Situation of a part of the Southern network on 20/08/02 at 09:27 AM

From the above figure it can already be seen that all lines, which tripped automatically reclosed. The only action conducted at the Control Centre was the reclosing of transformer T11 150/70/6 kV at the Obourg substation. The tripping and the automatic reclosure of transformer Obourg T1 70/10 kV has to be considered as normal, as the 70 kV substation of Obourg passes at zero voltage and transformer T1 is subsequently tripped by clearing. Once the voltage is present again, transformer T1 automatically recloses. The same situation happens for transformer T1 70/15 kV at Maisières site, due to the tripping of the line 70.64, and, once the voltage is present again on the line 70.64, transformer T1 at Maisières substation automatically recloses. At first sight the only unexplained trip for the Control Centre was the tripping of the circuit breaker of the line Trivières 150.71 at the Ville sur Haine substation. All other trips were linked to a lightning strike that has hit the lines 150.53, 70.54 and 70.64 nearby the Obourg substation. This assumption proved to be right for the Control Centre by an automatic fault location conducted on the line 150.53, which indicated a fault 4-N at 0,95 km from Obourg. So for the Control Centre this part of the Southern network was fully operational after they manually reclosed transformer T11 150/70/6 kV at 09:39 AM. The only comment they made to the Fault Analysis department was, besides mentioning the manual reclosure of transformer T11 at 150 kV side, a request for

investigation on the unwanted tripping of the circuit breaker of the line Trivières 150.71 at the Ville sur Haine substation, since they assumed a protection problem.

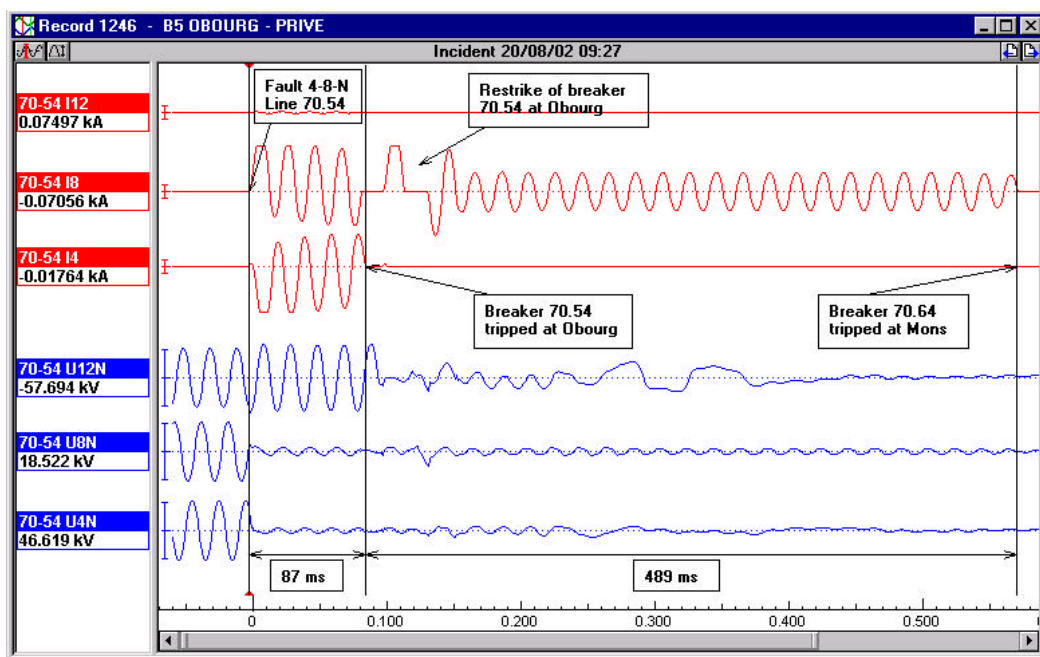
Figure 3: Registration of currents and voltages of line 70.54 at Obourg substation

Looking to the recording from the DFR installed at the Obourg substation for the line 70.54 Obourg – Ville sur Haine the occurrence of a fault 4-8-N is noticed. This fault is cleared at the Obourg station after 87 ms by the three phase tripping of the installed air-insulated circuit breaker, type DCF 80 of EIB. But 15 ms after the opening of pole 8 of this breaker a first restrike on this pole is noticed. The breaker manages to cut the fault current by his further mechanical opening but the isolation is insufficient resulting in a second restrike 33 ms after the first one. As the breaker is at this moment mechanically totally open, he does no longer achieve to cut the fault current. At the end the fault on the line 70.54 is cleared by the back-up opening of the breaker, second zone tripping, on the line 70.64 at the Mons substation.

From the recording of figure 3 can also be seen that there was no fault on the line 70.64. The line tripped in back-up at the Mons substation, due to the non clearance of the fault on the line 70.54. As already stated above, once transformer Obourg T11 150/70/6 kV has tripped, the 70 kV substation of Obourg passes at zero voltage and as for transformer T1 70/10 kV also the breaker Mons 70.64 trips subsequently by clearing.

Once these phenomena were noticed the Fault Analysis department contacted the Control Centre requesting to put breaker 70.54 at the Obourg substation out of service in a safe way. The breaker wouldn't probably even cut any load current or charging current of the line anymore. So it was necessary to isolate the breaker totally. This could be achieved by switching over the line 70.54 on busbar B2 at the Obourg substation. Now the load current could be cut off by the breaker 70.54 at the Ville sur Haine substation and the charging current of the line with the bus coupler at the Obourg substation. All this was done at the beginning of the afternoon on August the 21th. Immediately field crew started their investigations on the suspected circuit breaker. During the disassembly of the pole 8 of the breaker some damage could be clearly noticed, at the mobile and fixed contacts of the breaker.

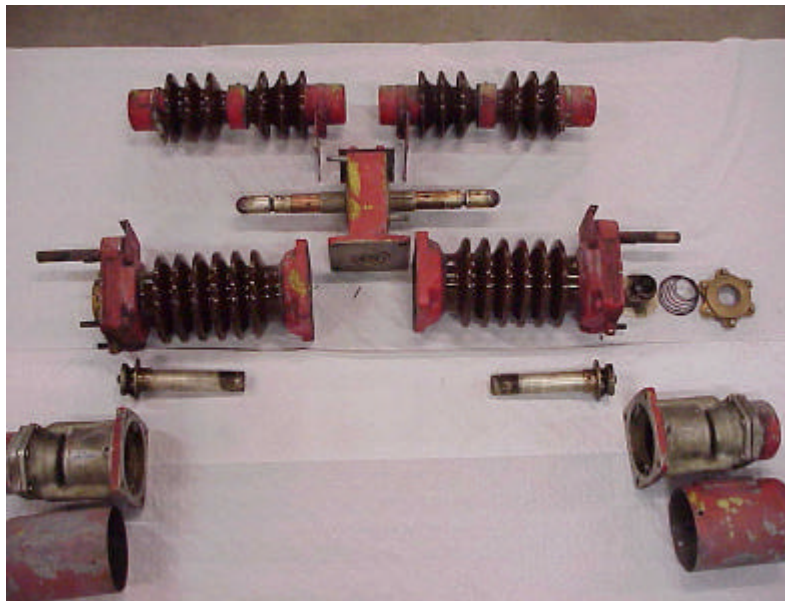
Photo 1: The disassembled pole 8

This damage is showed with the next three photographs of the damaged pole. The first photograph gives an overview of the disassembled pole 8. On the picture can be seen that the mobile and the fixed contacts of both chambers are seriously damaged.

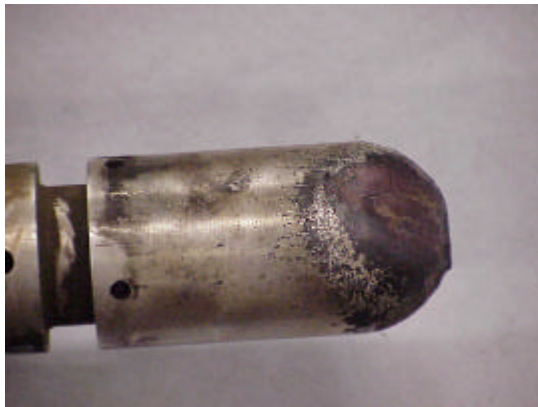
Photo 2: The fixed contact

The next two pictures are showing the burning in due to the internal arcing on the mobile and fixed contact.

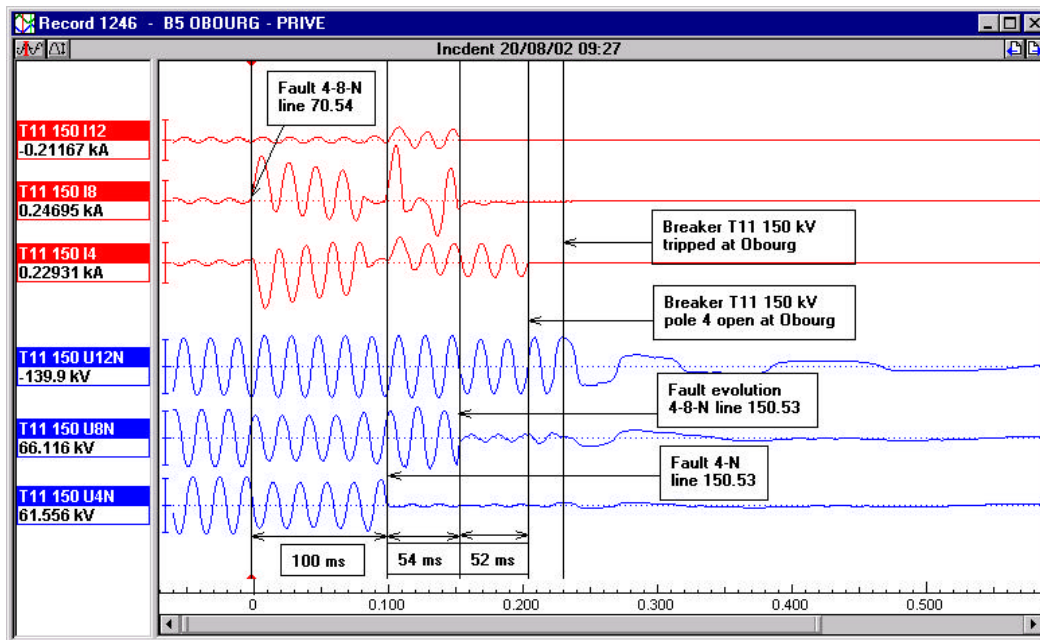
Figure 4: Registration of currents and voltages of line 150.53 at Obourg substation

But what happened with the line 150.53 and why did the breaker of the line Trivières 150.71 at the Ville sur Haine substation trip. For the line 150.53 it was also the fault recording from the DFR installed at the Obourg substation that gave a correct view on what happened. From figure 4, also part of the same record as for the fault on the line 70.54 can be seen that the line 150.53 is only hit 100 ms after the inception of the fault on the line 70.54. This moment

coincides with the internal restriking of breaker 70.54 at Obourg substation, but has to be classified as by chance.

From the recording can furthermore be seen that 54 ms after the fault 4-N on the line 150.53 the fault is evolving to a 4-8-N fault. This fault evolution has had a small impact on the further cause of the incident. As about 106 ms after the beginning of the fault the 150 kV breaker of transformer T11 performs a single pole opening of phase 4, which is normal, since on 150 kV and above single phase tripping is applied for single-phase faults on lines. But due to the evolving nature of the fault, the differential line protection has converted the single pole order into a three pole order and some 26 ms later the 150 kV breaker of transformer T11 trips the remaining other poles, and blocks the autorecloser. This explains also why the Control Centre had to perform a manual reclosure on this breaker.

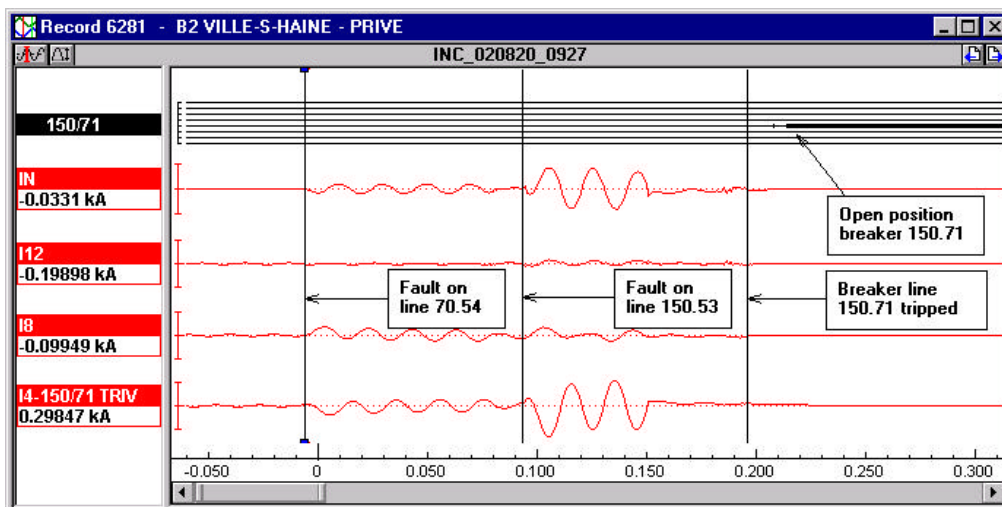
Figure 5: Registration of currents and digitals of line 150.71 at Ville sur Haine substation

From the record, shown in figure 5, can be seen that the breaker tripped about 202 ms after the beginning of the fault on the line 70.54, or 102 ms after the beginning of the fault on the line 150.71. This ascertainment was used to suppose that the tripping of the breaker was ordered during the fault on line 150.53. Furthermore the tripping contact of the distance relay did not show up on the logical channels for the line 150.71, the only logical channel attracted was the open breaker position. So it was assumed that the tripping was ordered by the differential line protection, as the tripping contact is not registered. But some questions remained open: “Why did the differential protection only trip at one side, why not immediately after the beginning of the fault on the line 70.54. Also the older electromechanical differential relay installed, type RN27b of Siemens, had proven reliability statistics, and the last preventive maintenance on the relay panel was carried out some two weeks ago” All of this made that the origin of the problem was probably to be found on the differential relay, installed on the line 150.71 at Trivières substation. All this proved to be right as field technicians found an open circuit on all three phases on one winding of the current transformer.

Investigations carried out on the three current transformers showed that all of the three current transformers didn't suffer a lot of the open circuit, beside of a premature ageing. The non-destruction of the current transformers was averted by the presence of four windings, thus limiting the voltage raise on the open winding, and a rather low load current on the line. But as a precaution all of the three current transformers were replaced.

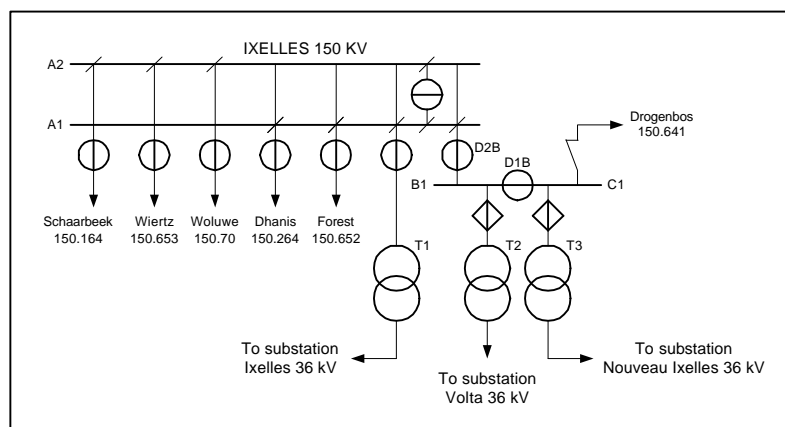
Figure 6: Single line diagram of Ixelles 150 kV substation

Due to a problem with the 150 kV oil-filled cable Drogenbos – Ixelles 150.641, some switching operation had to be performed at the Ixelles 150 kV substation. To put the cable 150.641 out of service also transformer T3 150/36 kV at Ixelles substation has to be switched off as shown on the single line diagram presented by figure 6.

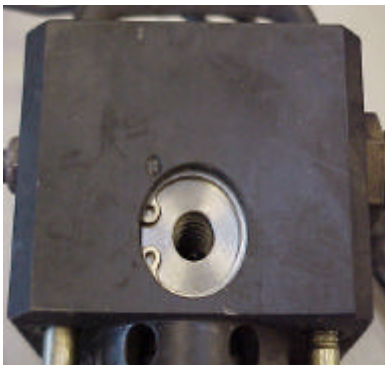
Photo 4: The electrovalve

Investigations showed that the fault was due to a high overvoltage caused by a synchronising delay on one pole of the breaker D1B, type MHM 170 of Magrini. This synchronising delay was found coming from an internal problem in the command box EPM 255 of one phase, being an improperly fitted circlip in one of the electrovalves used for closing all three poles of the breaker. Also a deformation of the circlip was noticed, which caused the circlip to leave its location. This has as a result that the valve is more relaxed and thus the speed of switching in of that pole is slower than the two other poles. The next two photographs are showing the electrovalve and the deformation of the circlip.

As a result of this investigation Elia has decided to replace all circlips of the electrovalves on all command boxes EPM 255 during the next maintenance of the breaker equipped with the specified command box. It is important to mention that by using DFR registrations, which are normally not verified, no reporting of an incident by the Control Centre, a certain amount of outages to schedule have been avoided in this case.

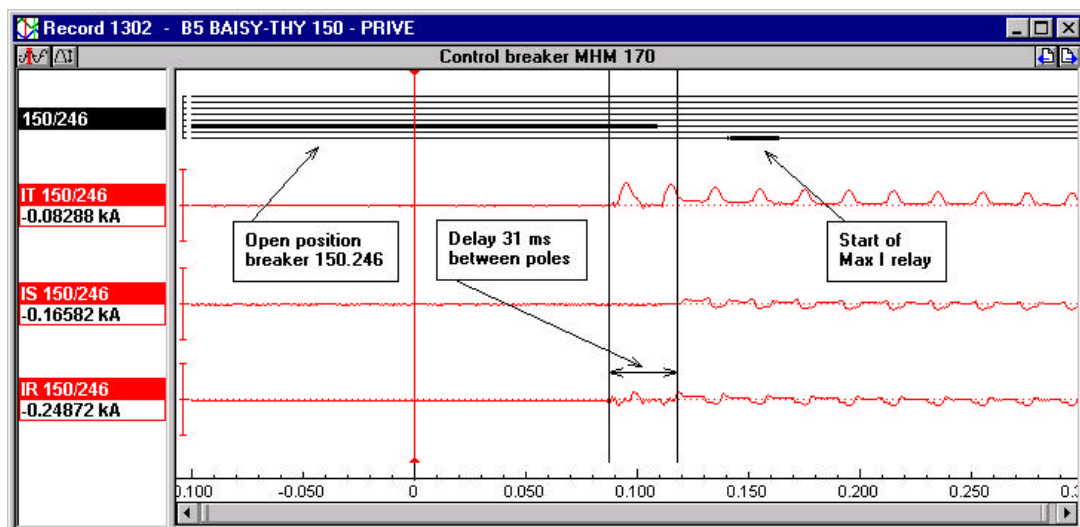
Figure 7: Registration of currents and digitals of line 150.246 at Baisy-Thy substation

Figure 7 shows the switching in of the line 150.246 at Baisy-Thy substation. At the line end a transformer 150/36 kV, without a breaker at 150 kV side, is connected. In the recording of the inrush current of the transformer a delay can clearly be seen between phases R and S, and S and T respectively. This delay was also due to the earlier mentioned problem with the circlip in the electrovalve of the command box EPM 255 for breaker MHM 170 of Magrini. In some other cases almost the same registration could be found, not necessary with a delay as high as showed in figure 7.
