# **Fault Analysis Using Protective Relay Digital Fault Records From the Big Rivers Electric Corporation 161 kV System**

**Elmo Price**

**Bob Warren**

**Fault and Disturbance Analysis Conference**

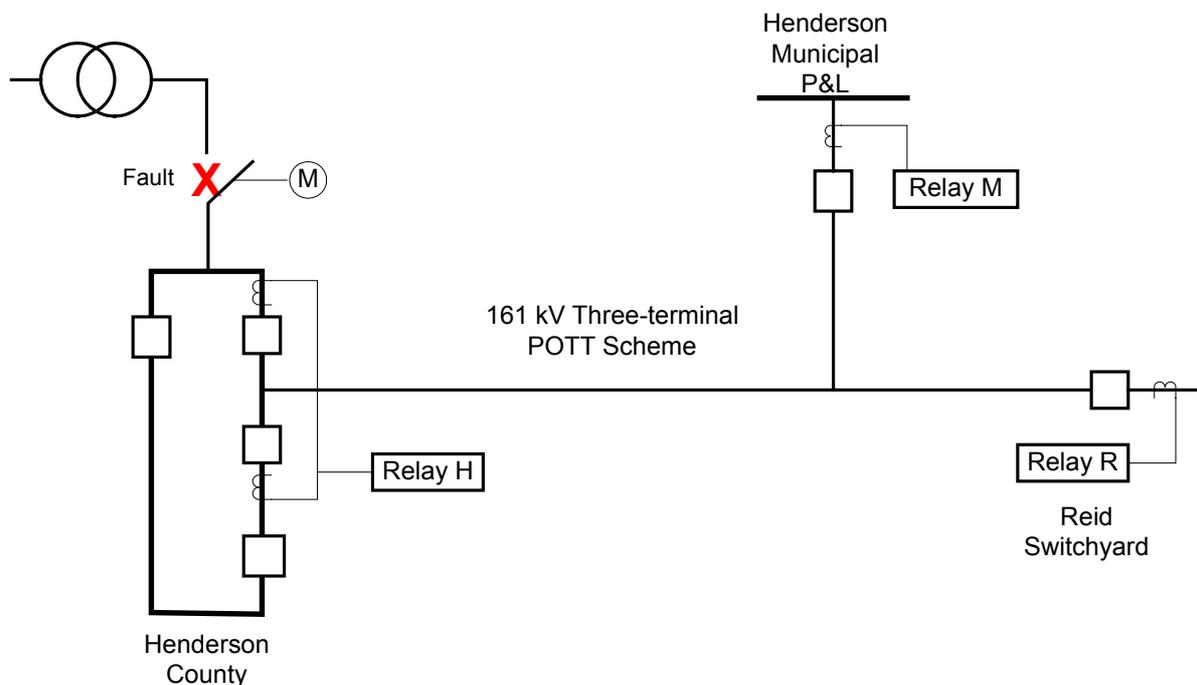
Figure 1. Henderson-Reid-HMP&L Three-terminal Line

Figure 1 shows the basic line and bus configuration needed for analysis. The Henderson-Reid-HMP&L 161 kV line is protected by a three terminal POTT scheme utilizing a microprocessor system relay at each terminal and pilot communications over microwave. The motor operated disconnect on the transformer high voltage at Henderson accidentally closed into a three phase ground chain. The relays at all terminals tripped.

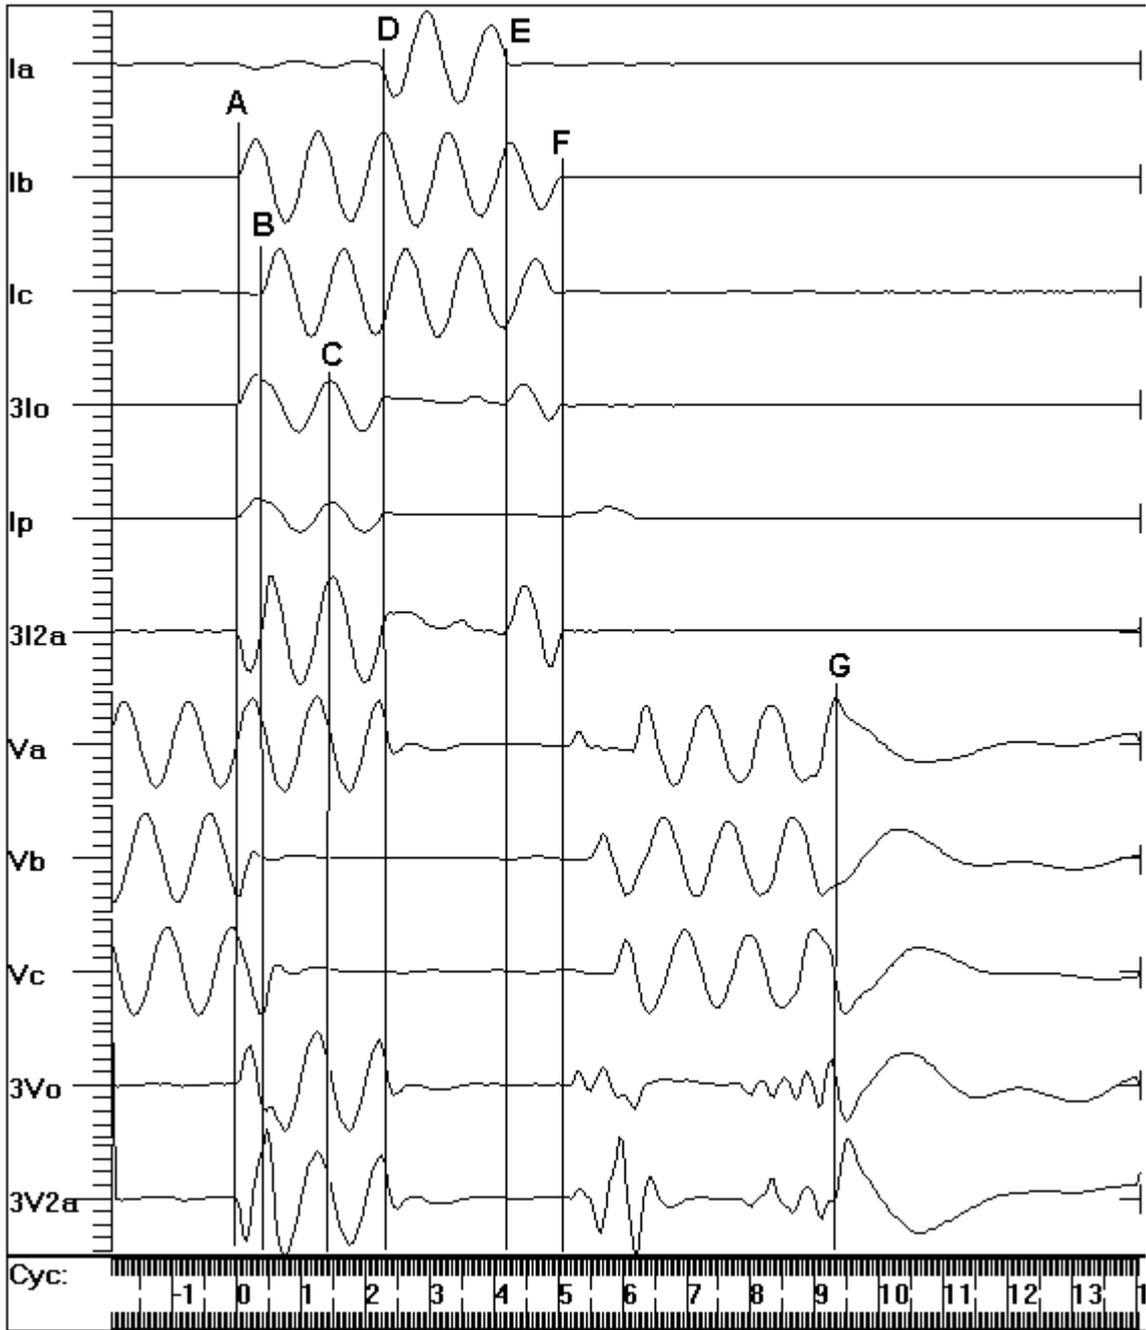
Figure 2. Relay H Reverse Fault Analog Data

Figure 2 shows the oscillographic analog data recorded by Relay H at Henderson for the reverse fault. There are 7 points or regions of interest. These are:

- A. Fault inception starts with the fault on phase B-to-ground.
- B. The fault evolves to phase C creating a two-phase-to-ground fault.
- C. It is observed that  $3I_0$  (zero sequence current measured  $-3I_0=I_A+I_B+I_C$ ) and  $I_p$  (transformer polarizing current input) are in phase. For a reverse these quantities should be out of phase. A large negative sequence current,  $3I_{2a}$ , is also observed.
- D. The fault evolves to phase A creating a three-phase fault. The negative sequence ( $3I_{2a}$ ) and zero sequence ( $3I_0$ ) currents diminish.
- E. Phase A clears (goes to zero). The negative ( $3I_{2a}$ ) and zero ( $3I_0$ ) sequence currents return
- F. Phases B and C clear.
- G. The voltage source is removed from the relay.

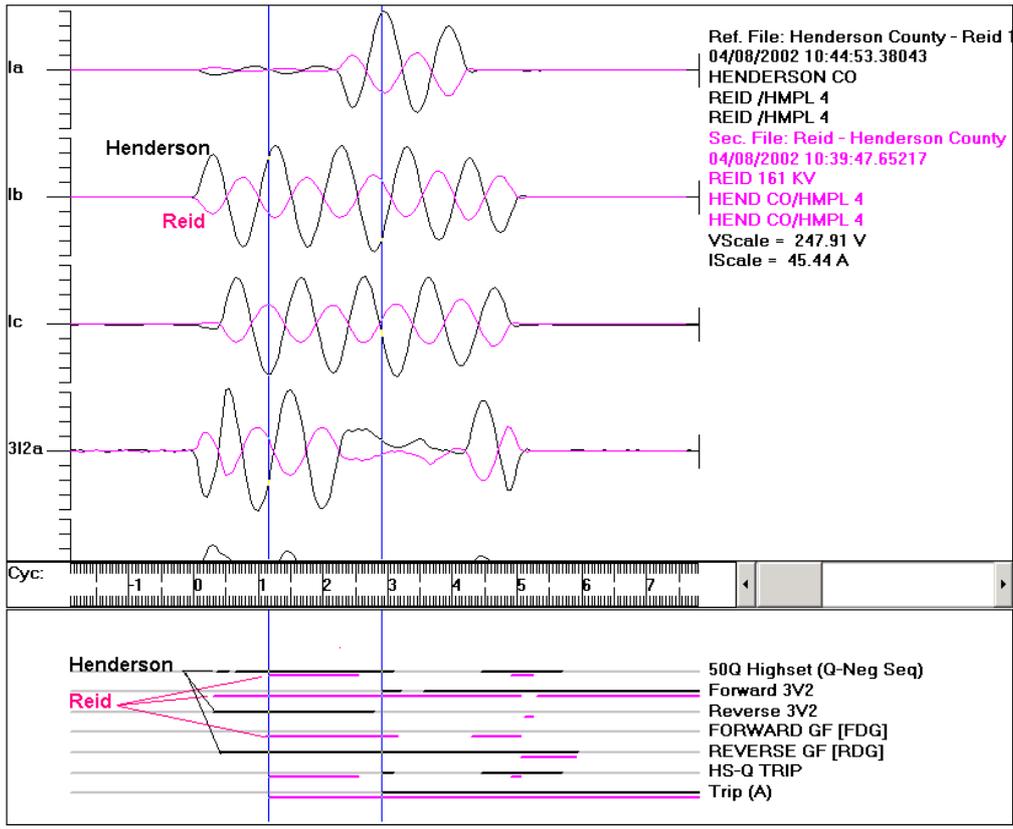
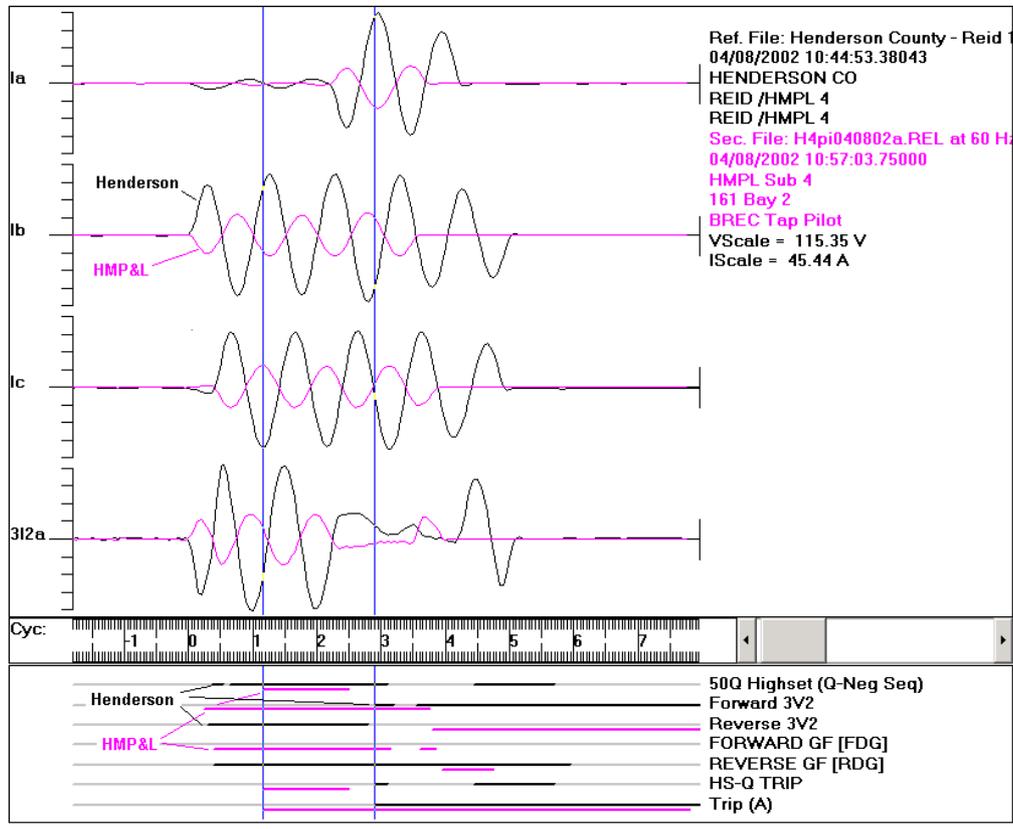
Figures 3 and 4 show the current analog and digital logic signals that explains the trips at Henderson [County], HMP&L (Henderson Municipal P&L) and Reid [Switchyard]. Tables 1,2 and 3 show the phase and sequence quantities computed from the relay sampled data for one cycle of the fault between 0.65 and 1.6 cycles. Reading the digital signals of Figure 3 we observe that both relays tripped for the HS-Q function (50Q Highset AND Forward 3V2). This is the direct tripping high set negative sequence overcurrent unit (50Q Highset) that should be set to trip for a forward phase-to-phase faults on the line, and be set above the maximum negative sequence current produced by a single phase-to-ground fault. The trip setting at Henderson and Reid was 9.0 A and 10 A, respectively, and both units were forward directionally supervised by the negative sequence directional units Forward 3V2.

At Henderson, Relay H's 50Q Highset picked up almost immediately after the fault inception. The negative sequence current (3I2) level was 33.55 A for the two-phase-to-ground fault, well above the 9 A. setting. The Reverse 3V2 directional unit also correctly picked up for the reverse fault. At about fault cycle 2.3 (point D of Figure 1) the fault evolves to three phase and the negative sequence current 50Q Highset begins to dropout and does at cycle 3.1. However, before the 50Q Highset unit drops out, the Forward 3V2 negative sequence unit picks up at cycle 2.9 due to the unbalanced fault transient of the evolving two to three-phase fault. Thus, the trip of Relay H occurred. The negative sequence directional unit operation is discussed in detail in a later section.

It is the nature of an instantaneous overcurrent unit to pickup faster and dropout slower as the fault current level increases above the pickup level. In this case the fault current was about 3 times the pickup at Henderson and the unit operated (the upper digital signal on the 50Q Highset line) in 0.35 cycles and dropped out [after a three-phase fault] in 0.8 cycles. At Reid the fault current level was about 1.3 times the setting and the unit operated (the lower digital signal on the 50Q Highset line) in 1.15 cycles and dropped out [after a three-phase fault] in 0.25 cycles.

At Reid the Forward 3V2 negative sequence directional unit (lower signal) remained operated through the fault. Tripping at Reid occurred because of an apparent low 50Q Highset setting. Similar operations occurred at the HMP&L terminal. This gives us two issues to investigate: an incorrect negative sequence directional unit operation at Henderson and larger negative sequence fault currents at HMP&L and Reid than was expected based on fault study analysis.

The highset negative sequence overcurrent unit is provided to complement the zone-one phase-to-phase unit for faults within 80%- 90% of the line length. The setting was determined from a fault study and was selected to reach a forward phase-to-phase fault at 90% of the protected line. This was determined to be 9.0 amps secondary. A setting of 10 A for the Reid and HMP&L terminals was also determined. Table 2, however, shows that the negative sequence fault current through Relay R for a fault at 100% (the location of the remote bus) was 13.0 A, well above the 10 A setting. This would be expected to be even higher at 90% of the line length. The setting of 10.0 A at HMP&L is also observed to be too low based on the data of Table 3. The corrective recommendation is to increase the 50 Q Highset setting at all terminals to a value that would assure tripping only for a fault on the line. A setting in the order of 15 to 16 A would be more reliable.

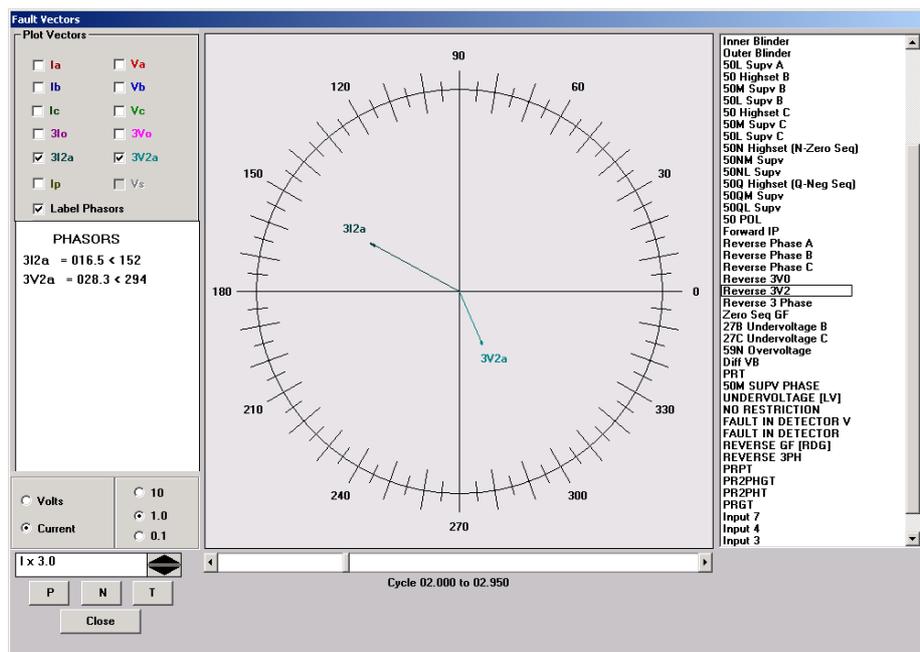
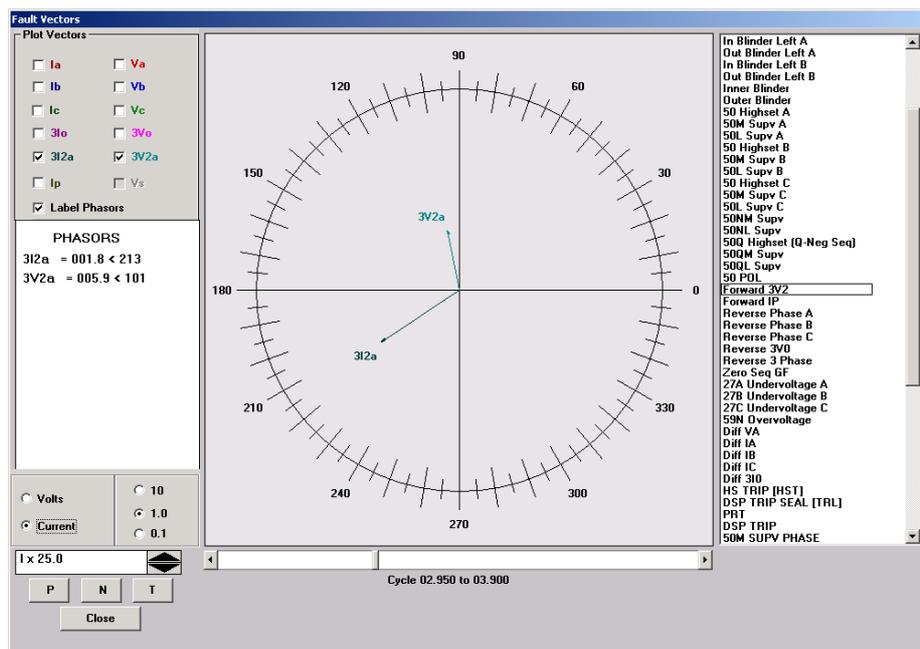
Figures 5a and 5b demonstrate the operation of the forward and reverse negative sequence directional units. The forward or reverse operation is basically defined by the phase relationship of the measured negative sequence current (3I2) and voltage (3V2). 3I2 leading 3V2 is forward and 3I2 lagging 3V2 is reverse. Figure 5a shows the Reverse 3V2 directional unit is correctly operated for the reverse fault in the second fault cycle. 3I2 is lagging 3V2. Figure 5b shows that the Forward 3V2 negative sequence unit operated in the third fault cycle as a result of the fault evolving to three-phase. 3I2 is now leading 3V2. Note that the Reverse 3V0 zero sequence unit [shown in the operated logic list on the right side of the figure] operated correctly for both fault cycles. This shows the instability of negative sequence polarization relative to zero sequence polarization for this particular event.

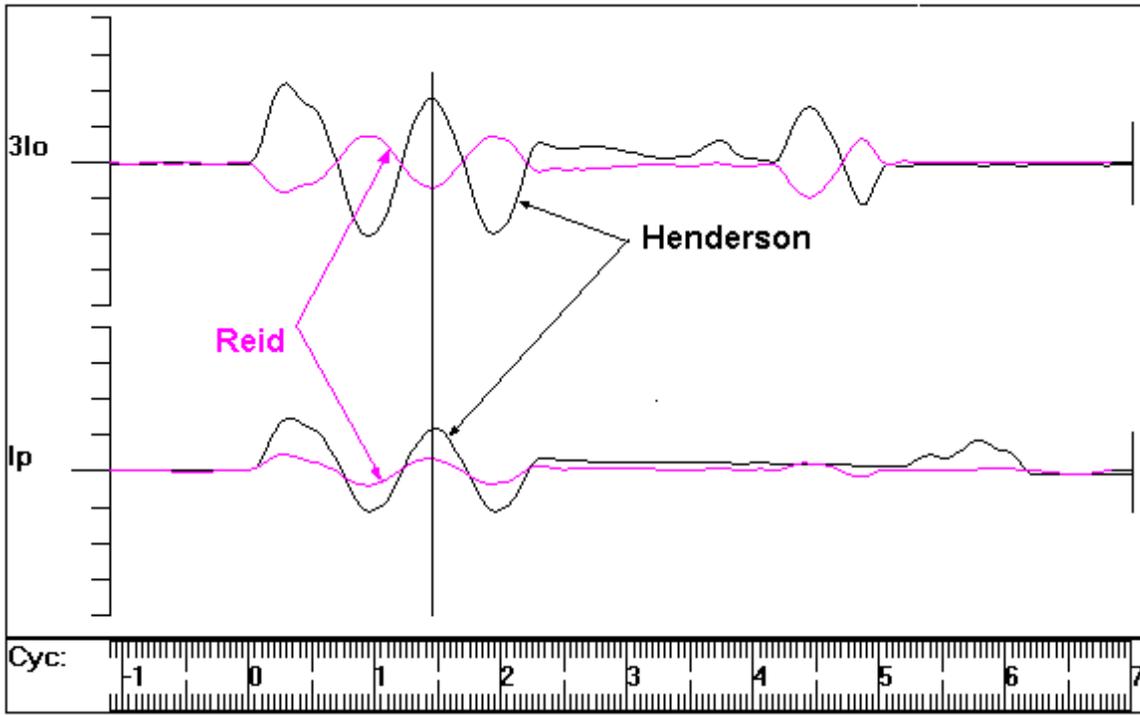
Figure 6. Phase Relationship of  $3I_0$  and  $I_p$

While analyzing the fault a seemingly incorrect phase relationship was noticed with the zero sequence current computed in the relay ( $3I_0$ ) and the external polarizing current ( $I_p$ ) measured from the transformer polarizing current transformer. Looking back at Figure 1, point C for Relay H at Henderson we can see that the quantities  $3I_0$  and  $I_p$  are in phase. This is incorrect for a reverse fault, as they should be  $180^\circ$  out of phase. Figure 6 shows the quantities at Henderson in phase more clearly. Also at Reid, the fault as seen by Relay R is forward and  $3I_0$  and  $I_p$  should be in phase. As observed, they are about  $180^\circ$  out of phase. This indicates a wiring problem at Reid as well.

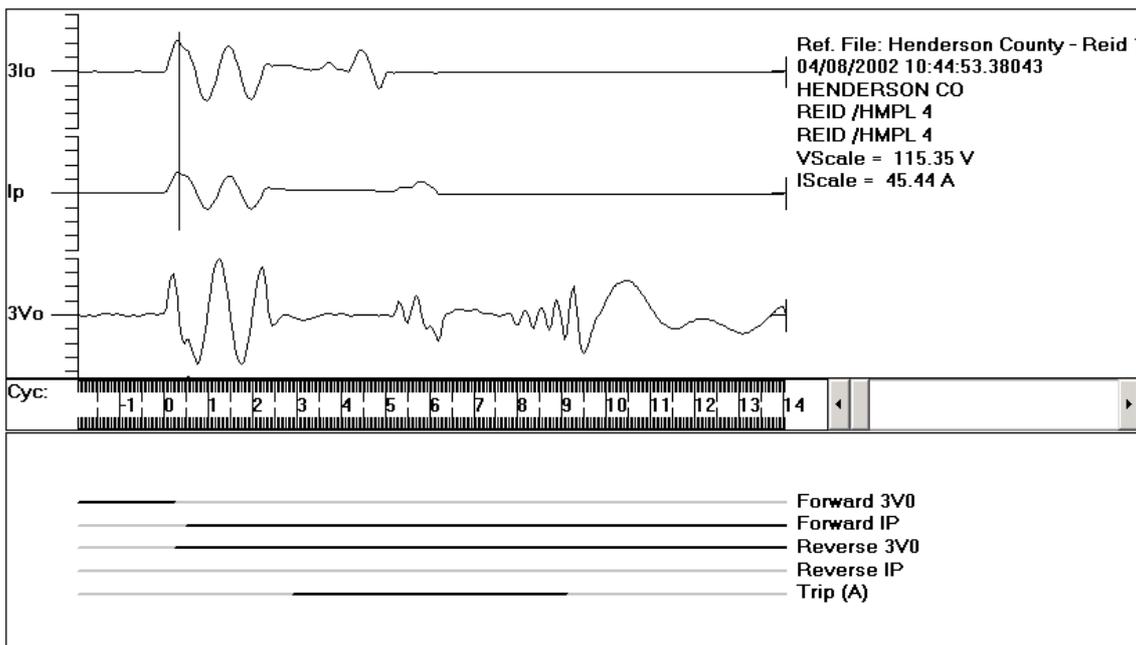
Figure 7. Directional Unit Operations

Figure 7 also confirms the incorrect polarizing current connection. The directional sensing method used by the relay is referred to as dual polarizing. The  $3I_0$  measured in the relay is polarized by an external polarizing ground current from a [grounding] transformer neutral or delta winding. If  $I_p$  is less than 0.5 it is presumed that the transformer is out-of-service and the  $3I_0$  measured in the relay will be polarized by the  $3V_0$  measured in the relay. The operation of Forward IP and Forward  $3V_0$  [and Reverse IP and Reverse  $3V_0$ ] should agree for forward line and reverse bus faults. In this case, however, Reverse  $3V_0$  and Forward IP are operated, indicating the connection problem. There is some operation of the Forward  $3V_0$  unit during pre-fault due to system unbalances. This, however, is of no consequence.

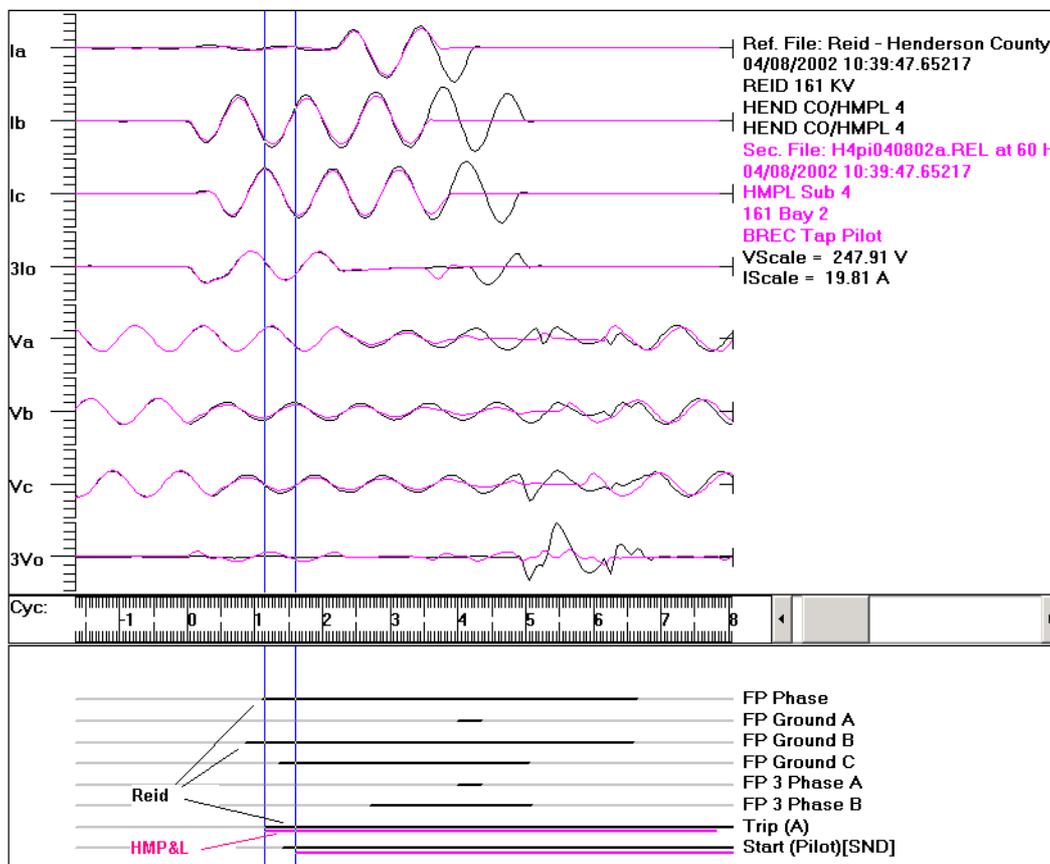
Figure 8. Forward Pilot Zone Mho Operation at Reid and HMP&L

For a fault at the Henderson bus it would be expected that both remote Reid and HMP&L relays' forward pilot phase zone would have operated. Figure 8 shows there was no Forward Pilot zone (mho unit) operation at HMP&L although it tripped for HS 50Q and 'trip' keyed (Start) the pilot channel.

Both relays are set for the same primary reach of 15.4 ohms, but differ in their secondary settings due to different CT ratios. The Reid unit's forward pilot phase setting is  $4.48 e^{j75}$  ohms (CT=2000/5) and the HMP&L unit's forward pilot phase setting is  $2.64 e^{j75}$  ohms (CT=1200/5). Tables 2 and 3 show the computed fault impedance,  $Z_{fBC}$ , from each relay. The fault impedance seen by the Reid relay is  $3.82 e^{j80}$  and within the 4.48 ohm reach setting. Therefore it operates. The setting is about 117% of the fault [or measured line] impedance and includes the effect of infeed from HMP&L. The fault impedance seen by HMP&L is  $2.88 e^{j80}$  and is beyond the set reach of 2.64 ohms. Therefore it does not operate. The setting is about 92% of the fault [or measured line] impedance and includes the effect of infeed from Reid. The cause of the underreach is due to the infeed from Reid and is shown by the following simple calculation. Figure 9 shows the secondary positive sequence line impedances for the three line segments and the measured phase B currents,  $I_b$ , from Tables 1, 2 and 3. Phase angles are close and are ignored for this simple calculation.

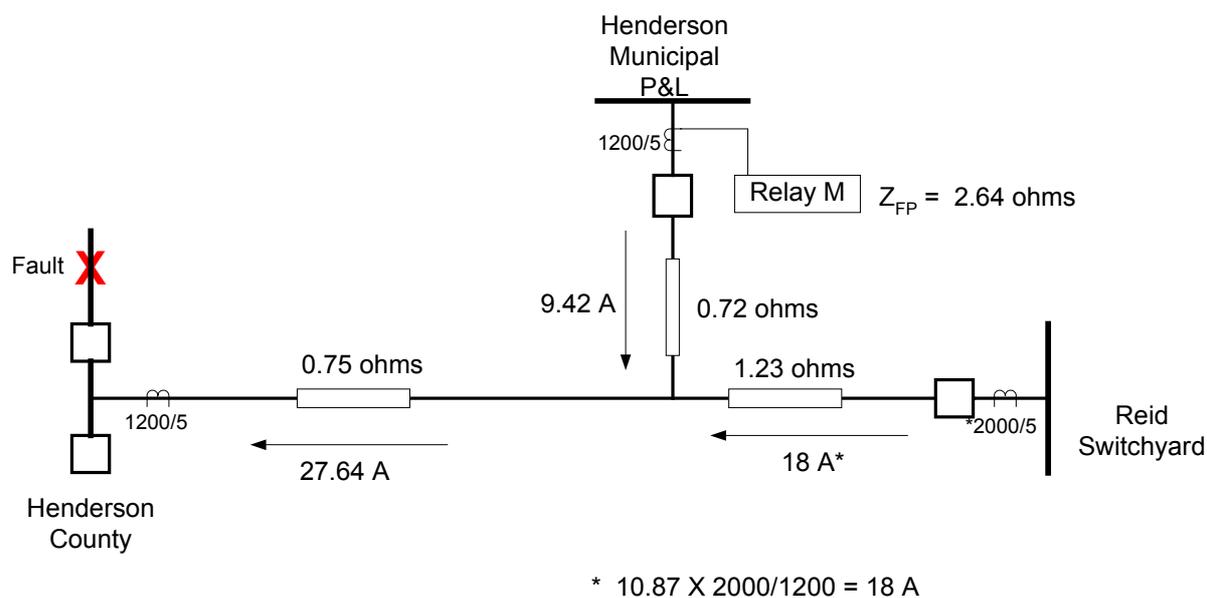
Figure 8. Calculating Relay M Underreach

The impedance between HMP&L and Henderson is 1.47 ohms and a setting at HMP&L of 2.64 ohms may appear adequate to assure overreaching of the Henderson bus. A strong infeed of 18 A. from Reid is observed and must be considered. To see the effect of the infeed, the phase B voltage drop is calculated from HMP&L to Henderson, the fault location:

This compares reasonably with the apparent impedance of 2.88 ohms computed by Relay M shown on Table 3 and is beyond the reach setting. Therefore, the setting at HMP&L should be increased to at least 120% of the measured line [fault] impedance ( $1.2 \times 2.88 = 3.46$  ohms). To assure overreaching of the forward pilot zones at all terminals, they can be set even higher as there are no coordination issues as with a zone-2 time delayed tripping in a step-distance scheme.

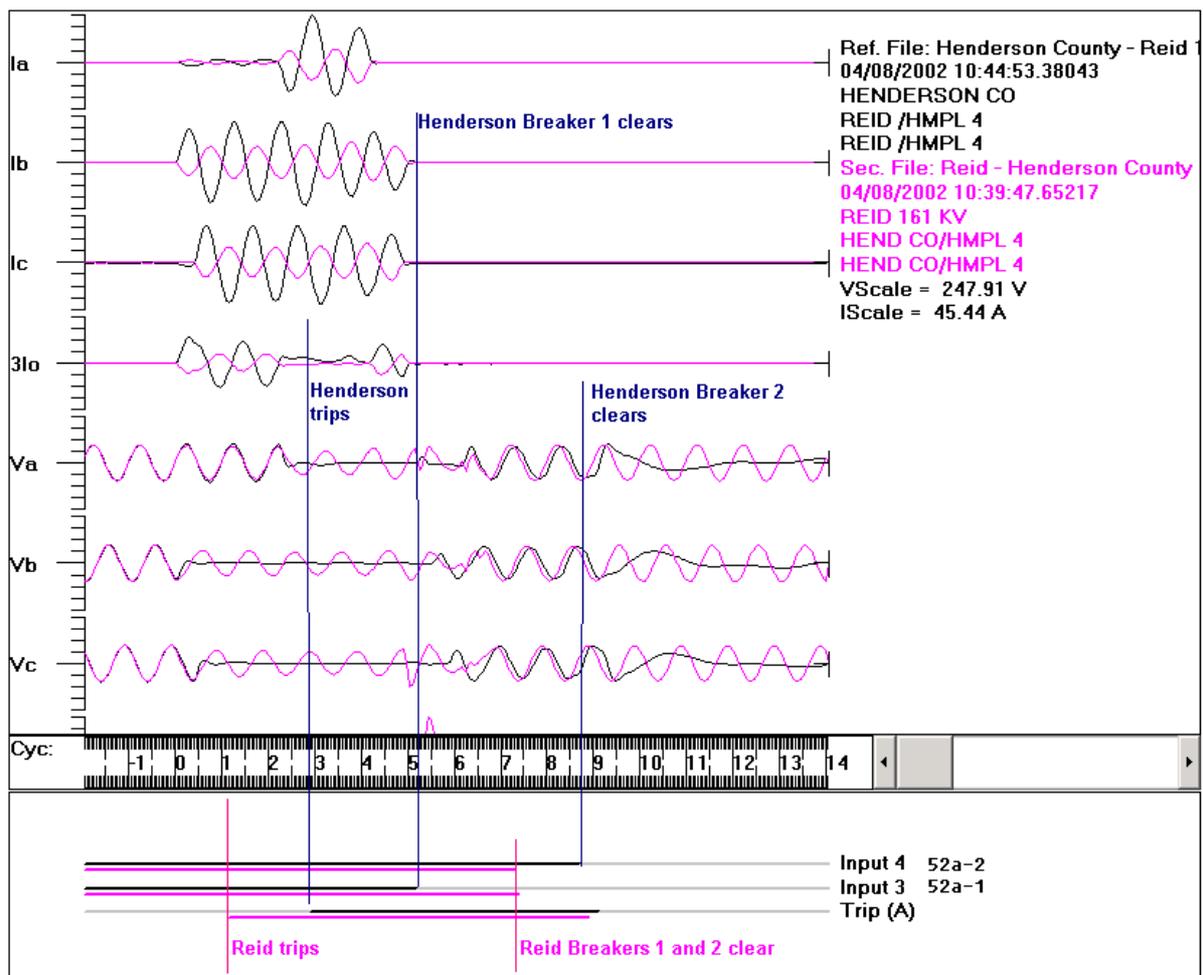
Figure 10. Breaker Clearing

Figure 10 shows the clearing of the associated Relay H breakers at Henderson. Breaker 1 clearing follows tripping by about 2.25 cycles as indicated by the dropout of the 52a-2 auxiliary contact input #3 and the simultaneous clearing of phase B and C currents. The second breaker opening of the ring bus as indicated by the dropout of the 52a-2 input #4, which follows tripping in about 6 cycles. The breakers at Reid, as shown in Figure 10, also take about 6 cycles to open. Although this may be of no consequence the discrepancy in the breakers' operating times should be investigated.

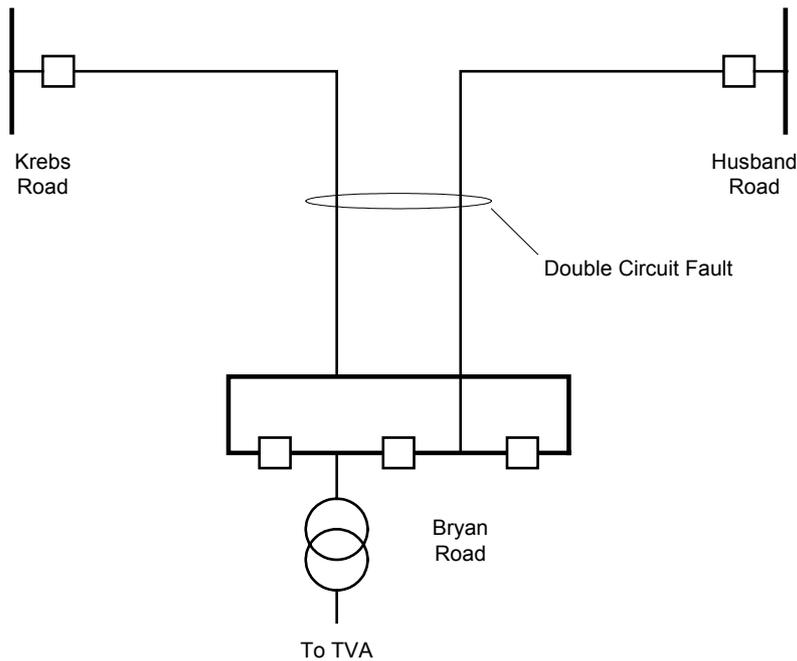
Figure 11. Bryan Substation and Krebs Road and Husband Road Lines

A double circuit [cross-country] fault occurred May 17, 2002 outside the Bryan Road substation on the Krebs Road and Husband Roads lines. The substation and protected line configuration are shown in Figure 11. Both relays protecting the two lines correctly tripped but gave different fault locations. The fault targets of each relay are shown in Figure 12. The fault appeared as a single phase B-to-ground fault at 0.1294 miles on the Krebs Road line and as a two-phase AC-to-ground fault at 0.2428 miles on the Husbands Road Line. Figure 13 shows the line tower structure and the conductor arrangement. Following is the event analysis that shows that the event is indeed a double circuit fault, determines the correct fault location, identifies operational issues, identifies dependable tripping units and allows us to better understand this particular double-circuit fault.

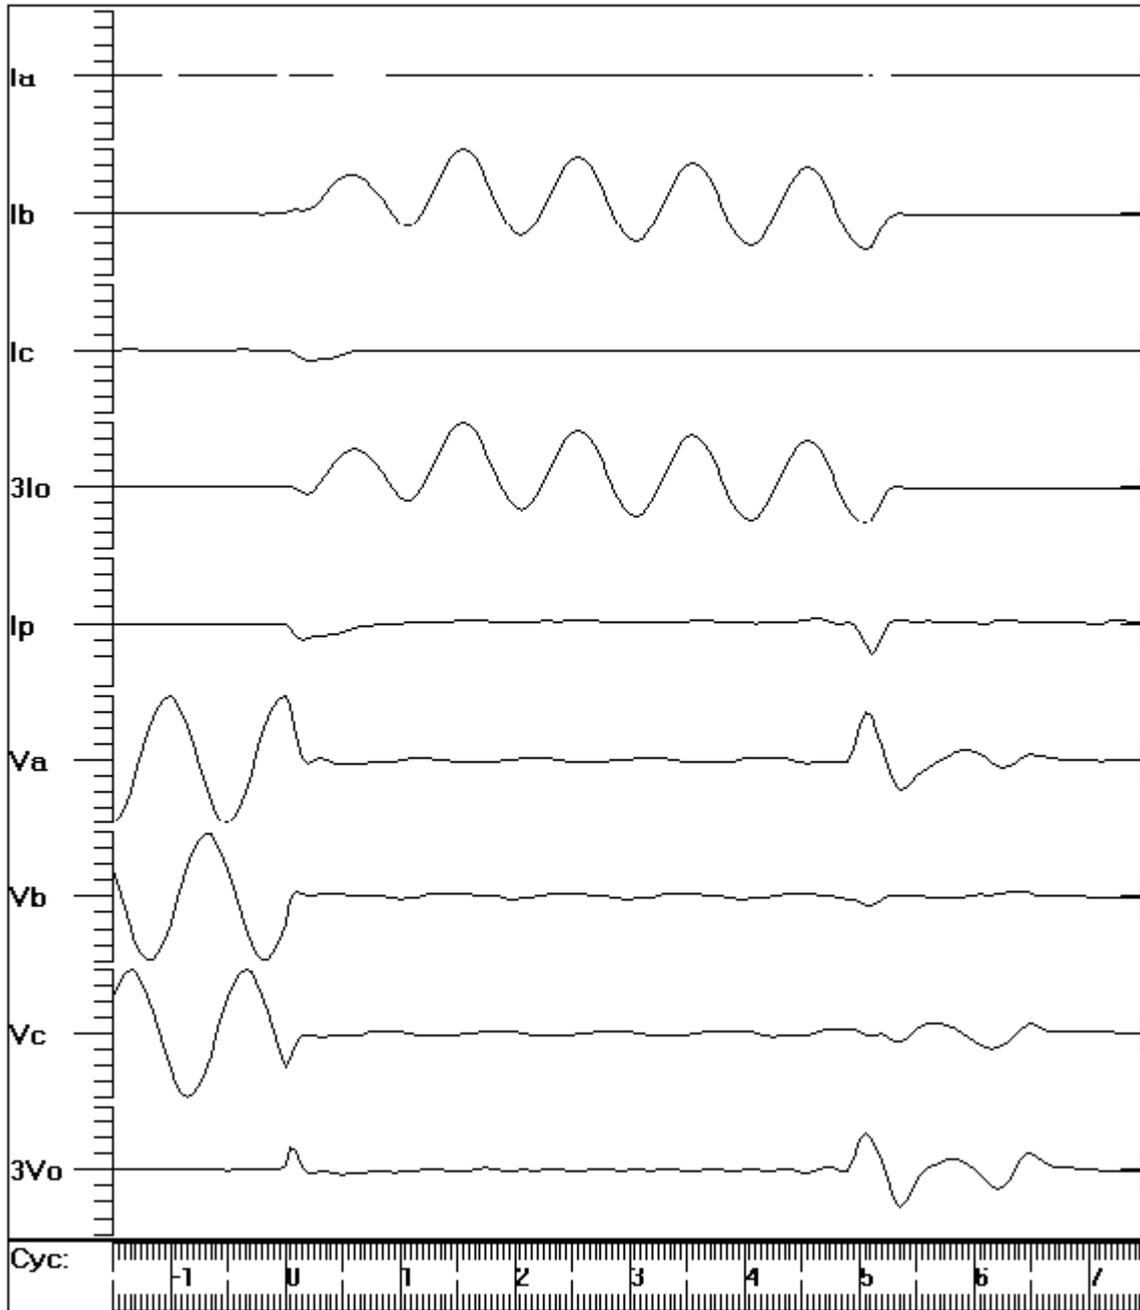
Figure 14. Bryan-Krebs Relay Fault Record

Figure 14 shows the Bryan-Krebs relay analog fault records. The first clue to a double circuit or simultaneous fault was when both lines tripped simultaneously. The second clue lies in the nature of this fault record. We observe a B phase fault current and no appreciable current on phases A and C. The zero sequence current measured by the relay appears equal to the phase B current, but the external polarizing current,  $I_p$ , measured at the transformer at Bryan Road substation is very nearly zero during the fault except for the period of the breaker opening transient. This implies that the fault is not a ground fault. Also, the voltage has collapsed on all three phases. Superimposing the fault records in Figure 15 gives us a better picture of the fault. The phase quantities for the third fault cycle are also shown in Table 4. Study of Figure 14 and Table 4 will lead to the conclusion that this is basically a three-phase fault involving phases A and C of one circuit and phase B of the other.

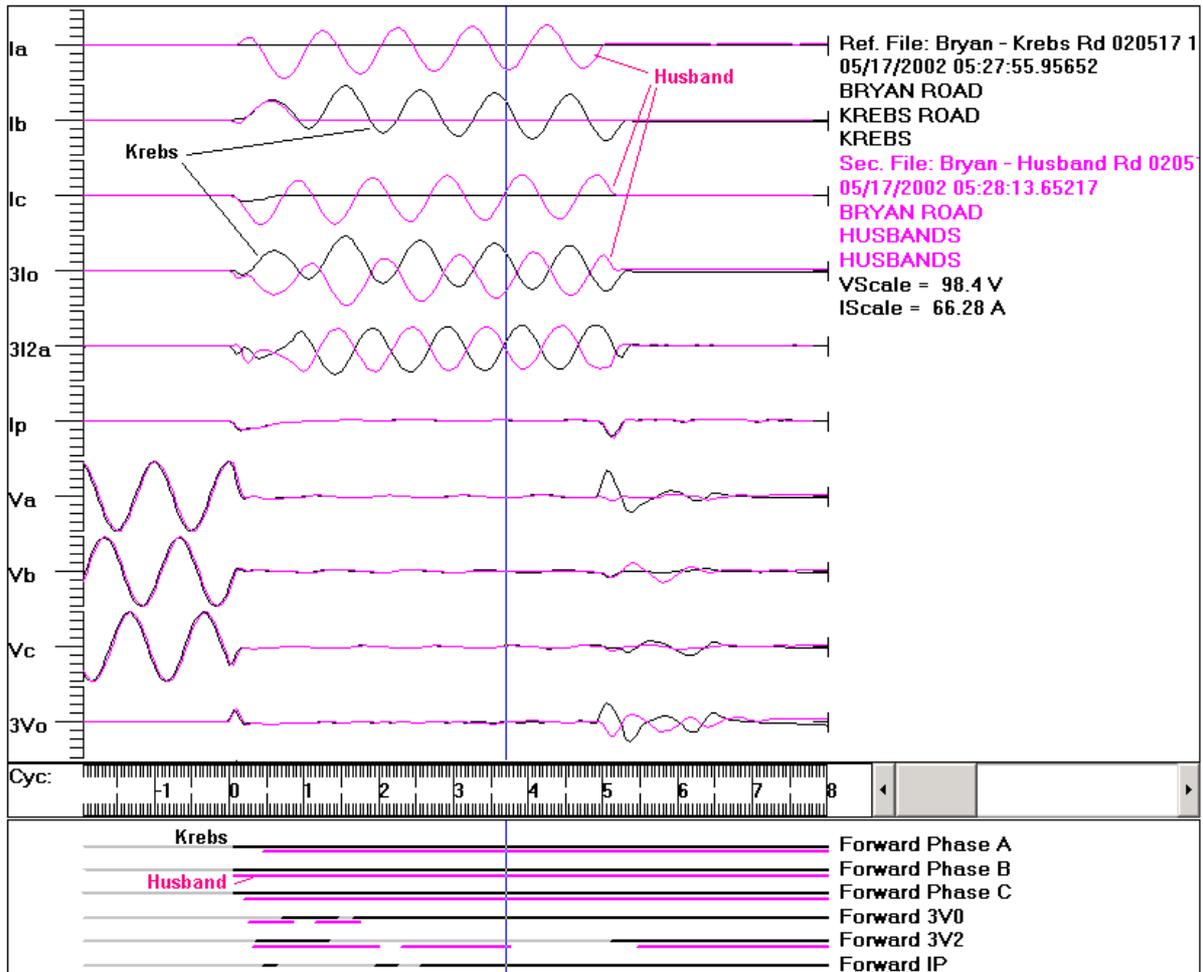
Figure 15. Bryan-Krebs and Bryan-Husband Relay Fault Records Showing Forward Directional unit Operations

The zone-1 and highset overcurrent-tripping units are supervised by the appropriate forward directional unit. Observing the directional unit operations of Figure 15 we see that the forward phase directional units, Forward Phase A, B and C, for both relays operated consistently through the fault. These are all correct and reliable operations. Each phase current is polarized with the cross phase-to-phase [memory] voltage (e.g.  $I_A$  polarized by  $V_{BC}$ ).

The ground polarized units, Forward 3V0, Forward 3V2 and IP, operated inconsistently. This is expected. In fact, all polarizing quantities,  $I_p$  (transformer delta winding current), 3V0 (zero sequence voltage of Figure 15) and 3V2 (negative sequence voltage) are very nearly zero and cannot be relied upon for correct polarizing.

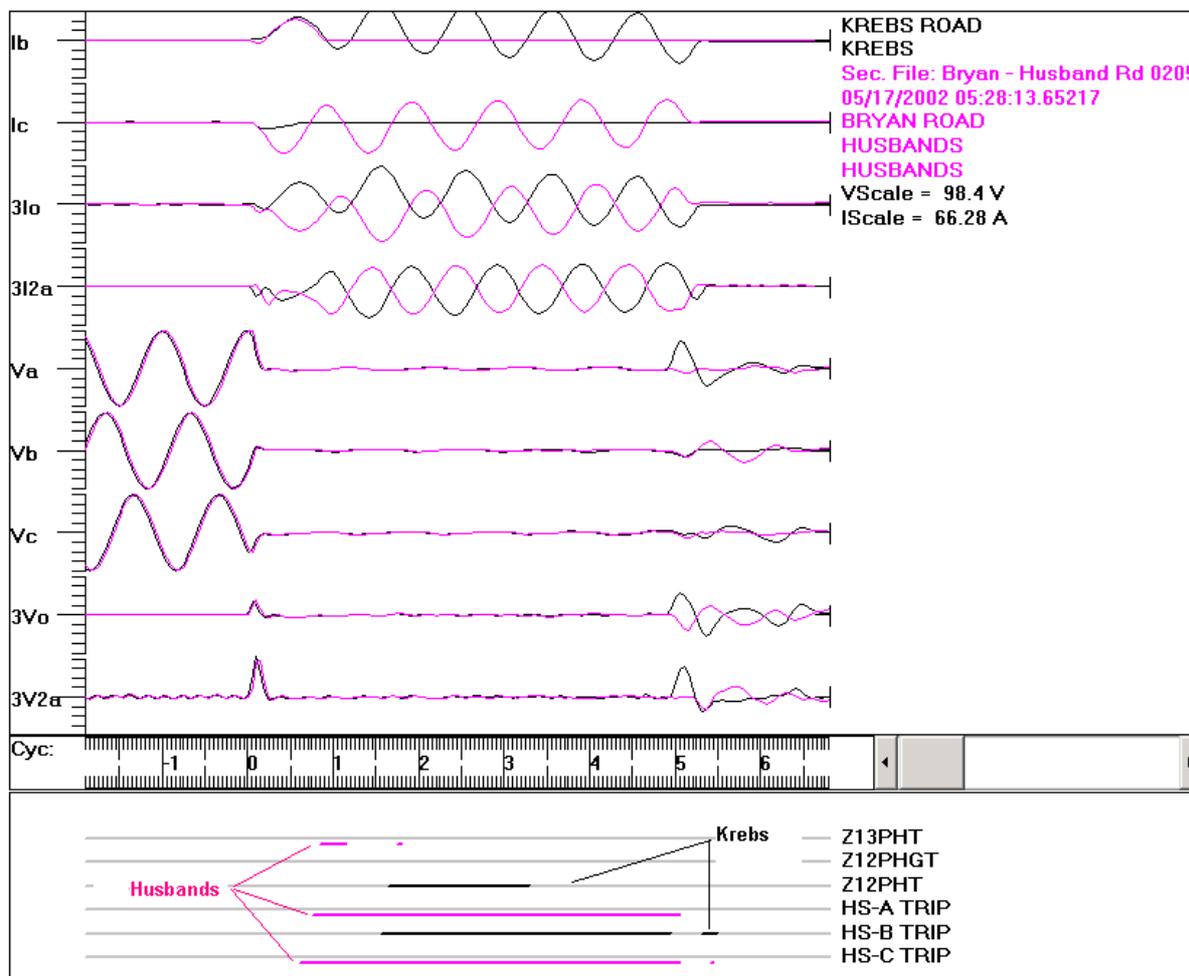
Figure 16. Bryan-Krebs and Bryan-Husband Relay Fault Records Showing Zone-1 Impedance and Highset Overcurrent Trips

Figure 16 shows the zone-1 phase impedance and highset overcurrent units that operated to provide a trip output. The Bryan-Krebs relay had a phase-to-phase impedance logic (Z12PHT) operation correctly providing an impedance trip while the Bryan-Husbands phase-to-phase logic did not operate. There was also a brief operation of the three-phase fault logic (Z1P3PHT), but the zero sequence current blocked it for most of the fault. The highset phase overcurrent units operated correctly on the respective faulted phases seen by both relays. This illustrates that although correct tripping may be initiated by the zone-1 phase impedance units, it is only assured with the application of the highset phase overcurrent units.
