# **Analysis of 115kV Local and Remote Substation Trips on 13kV Feeder Faults at National Grid**

By: Yujie Irene Lu and Song Ji, National Grid

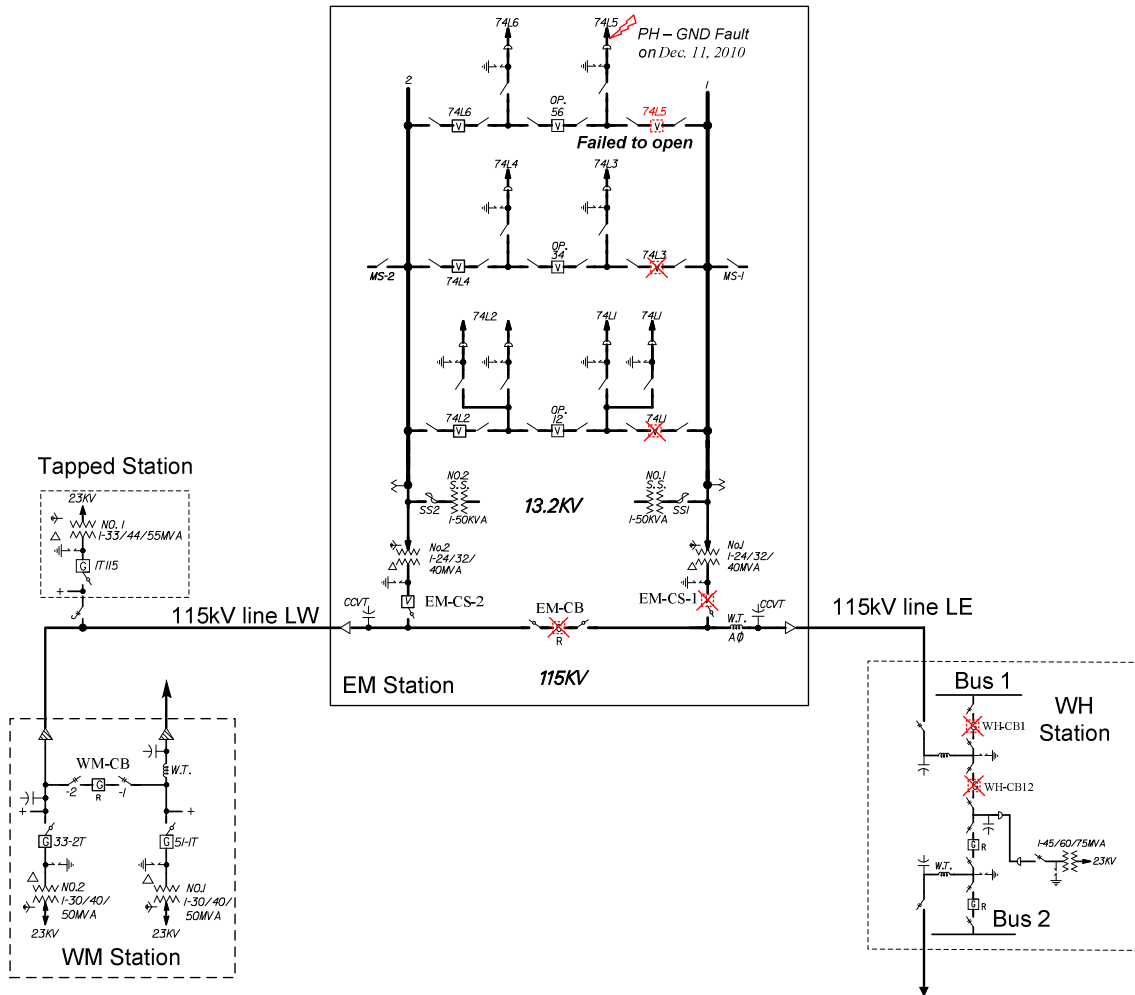
Figure 1. System One-Line Diagram with the L5 Feeder Fault

At 08:19:26, an A-Phase-to-Ground fault occurred on the 13.2kV L5 feeder at EM substation. The L5 feeder relay record shown that the feeder overcurrent relay responded to the fault correctly, but the feeder breaker L5 did not open after the relay trip command was sent to the breaker for more than 10 cycles. Due to the breaker failure, the transformer neutral ground function (51N-T1) of the transformer No.1, feeder backup protection, tripped the circuit switcher EM-CB-1 as expected, but over tripped the 115kV in-line breaker EM-CB and initiated a direct transfer tripping (DTT) signal to the remote end substation of WH connecting the line LE.

The system one-line diagrams are shown in Figure 1 and Figure 2. Relay targets reported at EM substation for the two events are as follows:

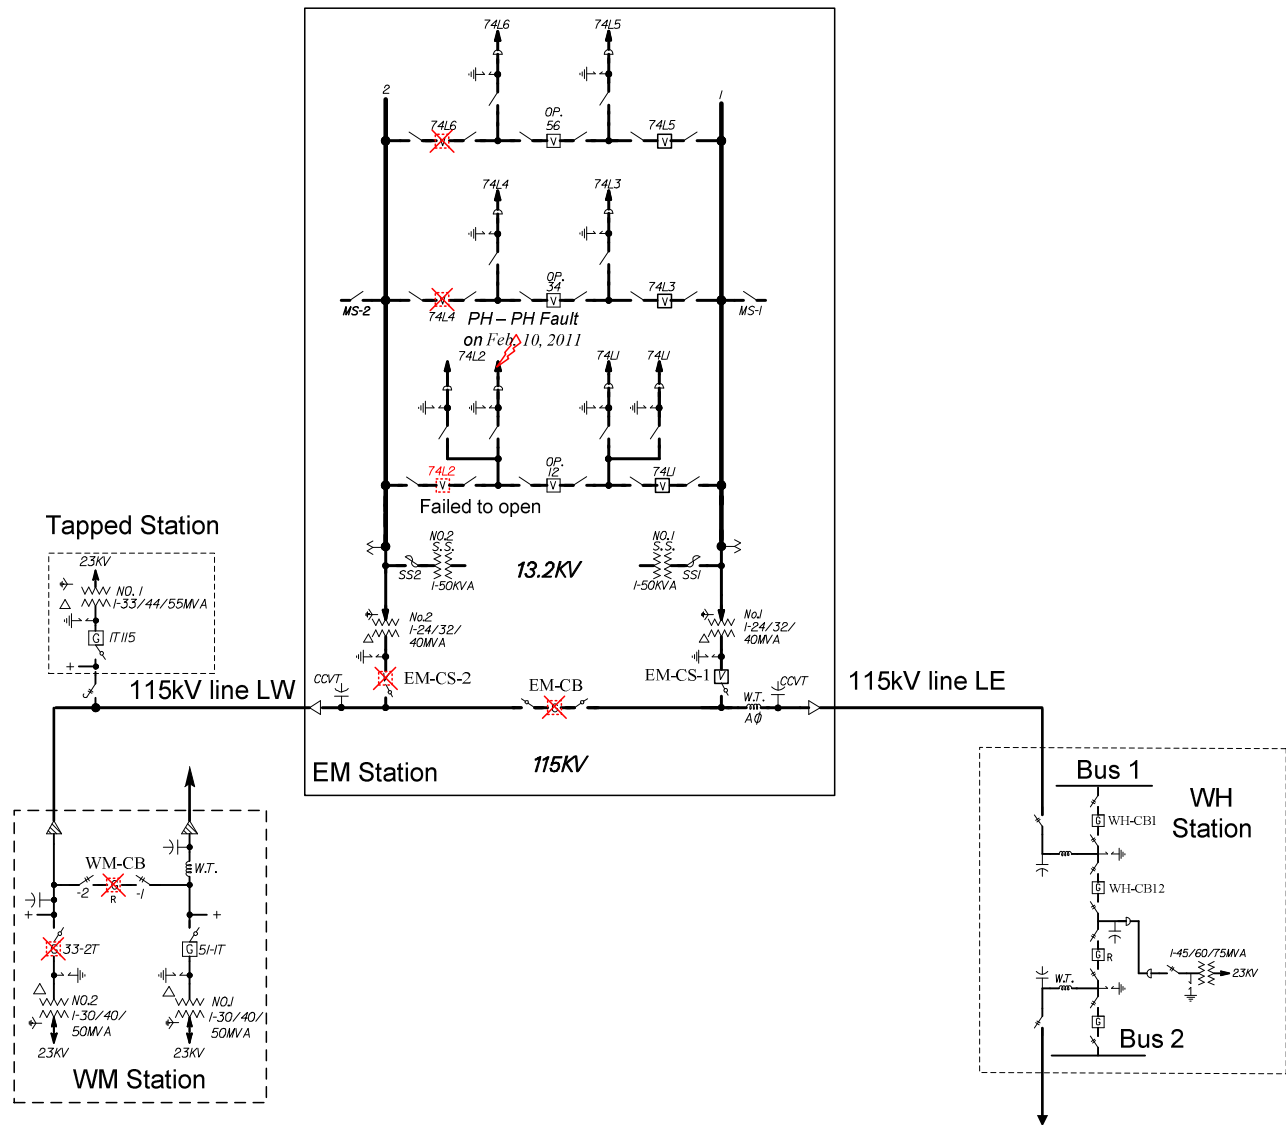
Figure 2. System One-Line Diagram with the L2 Feeder Fault

At 08:22:57, a close-in B-Phase-to-Ground fault occurred on the 13.2kV L2 feeder at EM substation. The L2 feeder relay record shown that the feeder overcurrent relay responded to the fault correctly, but the feeder breaker L2 did not open after the relay trip command was sent to the breaker for more than 10 cycles. Due to the breaker failure, the 115kV transformer phase overcurrent function (51-T2) of the transformer No.2, feeder backup protection, tripped the circuit switcher EM-CB-1 as expected, but over tripped the 115kV in-line breaker EM-CB and initiated a direct transfer tripping (DTT) signal to the remote end substation of WM connecting the line LW.

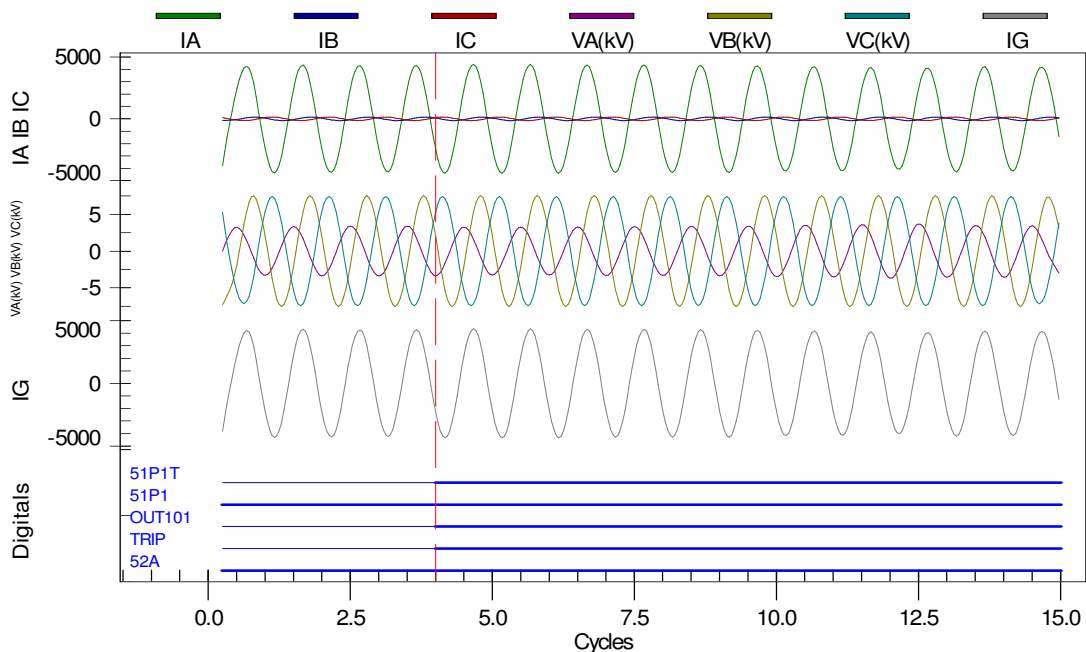
Figure 3. L5 Feeder Relay (SEL-351) Fault Records on 12/11/2010

1. An A-Phase-to-Ground fault occurred on the 13.2kV L5 feeder at EM substation on December 11, 2010. and the L5 feeder ground overcurrent relay (51N-L5) responded to the fault correctly, but the feeder breaker L5 did not open after the relay trip command was sent to the breaker for more than 10 cycles (Figure 3). As a result of the breaker failure, the transformer neutral ground function (51N-T1) of the transformer No.1, feeder backup protection, operated correctly (Figure 4) and initiated the following operations as:

**Why the L5 and L2 feeder breakers at EM substation did not trip?** Immediately after the L5 breaker failed to trip for the L5 feeder fault on December 11, 2010, it was noticed that several slow trips occurred with this type of circuit breakers at several substations in 2010. The manufacturer of the feeder breakers was contacted to investigate why the breaker did not trip. With technical support from the manufacturer, it was identified that the stuck of this type breaker was due to stuck bearing inside the breaker control. The department of Substation Services of National Grid then arranged to replace the failed bearing for this type of breakers across the National Grid system.

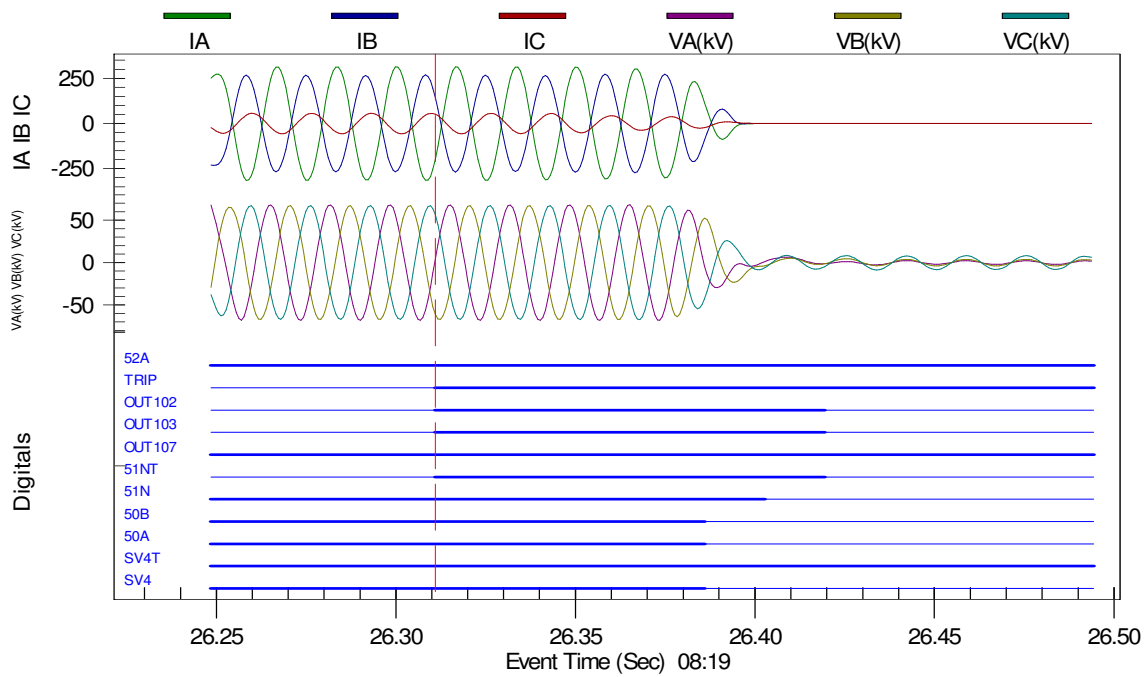
Figure 4. No.1 Transformer System 2 Relay (SEL-351) Fault Records on 12/11/2010

Based on the fault records captured by the No.1 transformer relay (SEL-351) for the event on 12/11/2010, the transformer neutral overcurrent (51N-T1) protection picked up and isolated correctly for this close-in feeder fault with the 13kV L5 circuit breaker failure. However, the 51N-T1 protection also tripped the 115kV in-line circuit breaker EM-CB and sent a Direct Transfer Trip (DTT) signal to WH and tripped out the 115kV breakers WH-CB-1 and WH-CB-1 at WH substation, which is as per how this SEL-351 relay has been set. By further review of the setting for this relay, it was noticed that not only the 51N-T1, but all backup functions of this transformer relay have been set to trip the 115kV breaker EM-CB at EM and initiate a DTT to trip the line LE at WH. Obviously, the relay setting is discrepant with what describes in the Relay Design and Operating Description. Given that it seems there are two improper settings for this SEL-351 relay, which are:

1. In the logic setting, the #1 transformer backup functions (51N-T1 and 51-T1) were incorrectly programmed to trip the in-line breaker EM-CB and send a DTT to WH.
2. In the pickup setting, the pickup level of a definite time current supervision element for the circuit switcher EM-CB-1 was set too low, which defeats the purpose of tripping the EM-CB and sending DTT in a short time-delay if and only if the circuit switcher fails to open. As a result, the EM-CB breaker was tripped and the DTT was sent (via OUT103) simultaneously as the circuit switcher EM-CB-1 tripped via the 51N-T1 function (via OUT102) since the current supervision had picked up prior to the fault. (via SV4T, see the SEL-351 relay fault records in Figure 4 in detail)

The trip logic for the No.1 and No.2 transformer relays (SEL-351) were re-programmed to initiate the DTT by primary protection only, which are listed as follows:

SV2 = 50P1 + 50G1  
SV4 = OUT101  
OUT101 = TRIP \* (SVT2 + 51GT)  
OUT102 = TRIP \* (51AT + 51BT + 51CT + 51NT)  
OUT103 = SV4T \* (50P3 + 50G3)

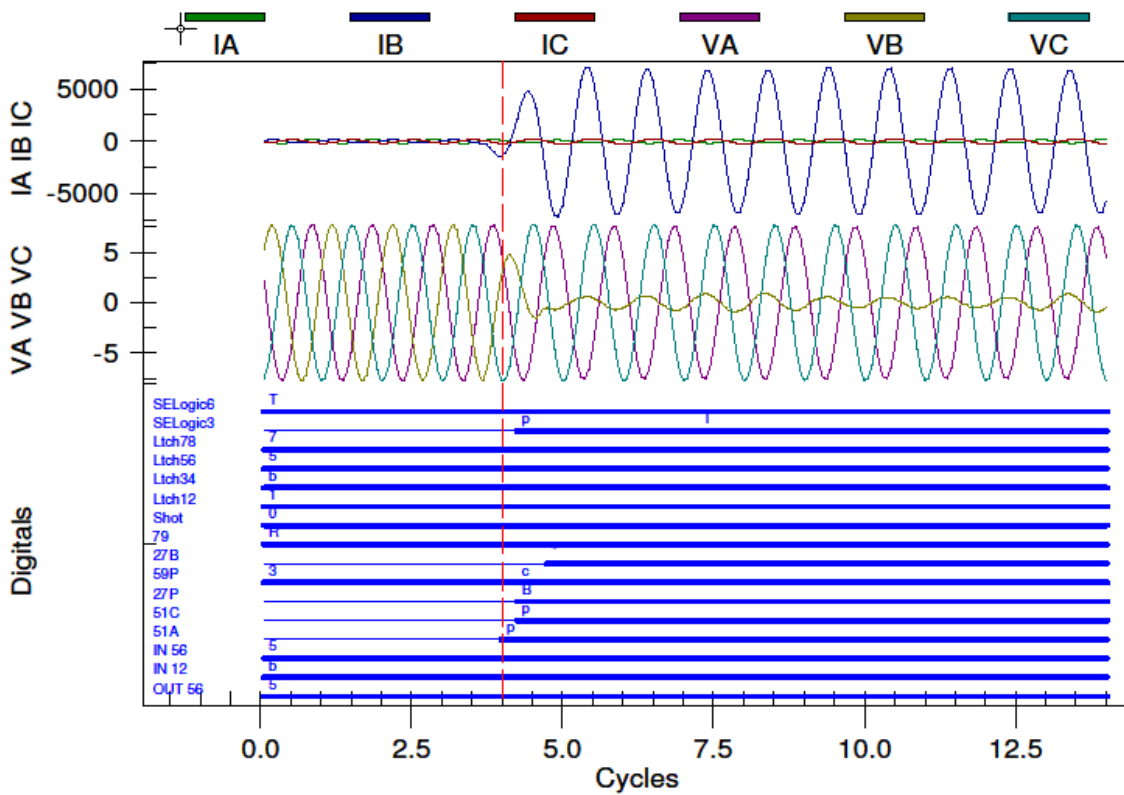
Figure 5. L2 Feeder Relay (SEL-351) Fault Records on 02/10/2011

2. A B-Phase-to-Ground fault occurred on the 13.2kV L2 feeder at EM substation on February 10, 2011, and the L2 feeder ground overcurrent relay (51N-L2) responded to the fault correctly, but the feeder breaker L2 did not open after the relay trip command was sent to the breaker for more than 10 cycles (Figure 5). As a result of the breaker failure, the transformer phase overcurrent function (51-T2) of the transformer No.2, feeder backup protection, operated correctly (Figure 6) and initiated the following operations as:

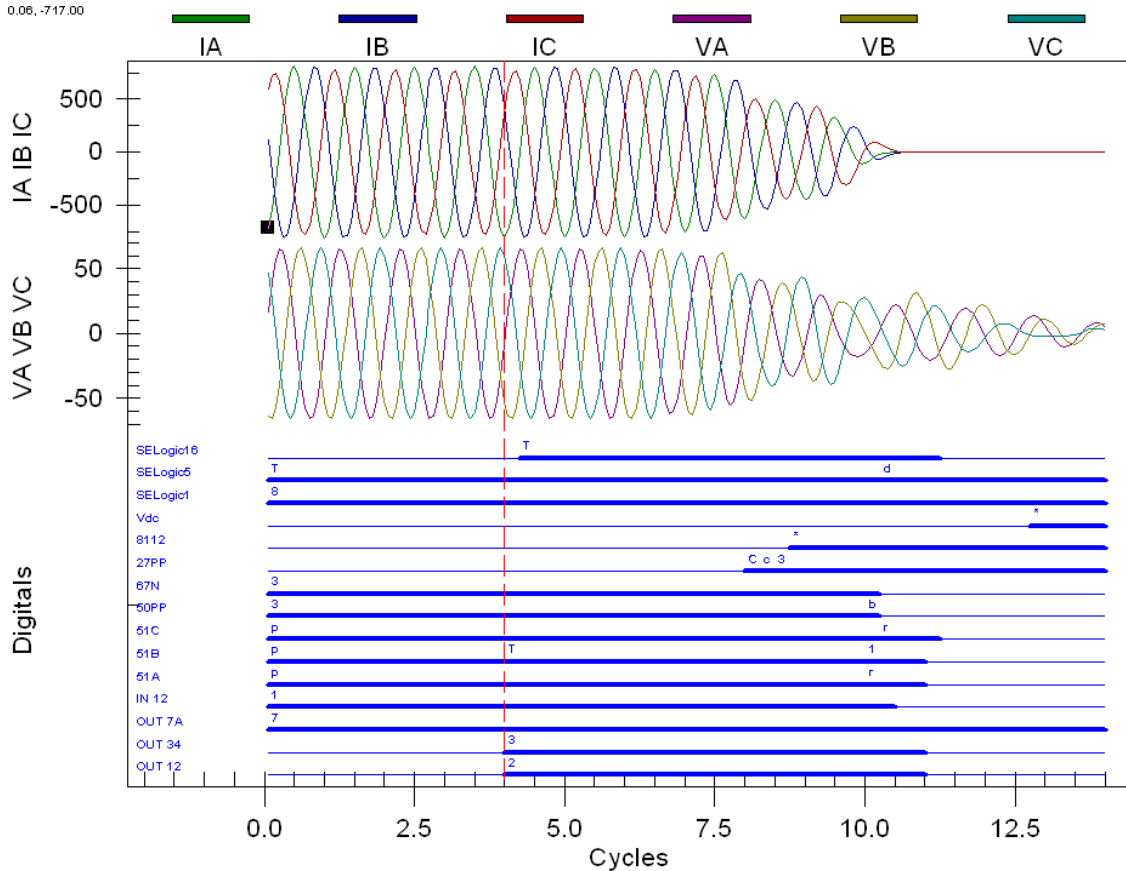
Figure 6. No.2 Transformer System 2 Relay (SEL-351) Fault Records on 02/10/2011

Similarly, for the L2 feeder fault on 02/10/2011, the No.2 transformer phase overcurrent (51-T2) protection picked up and isolated correctly for this close-in feeder fault with the 13kV L2 circuit breaker failure. However, the 51-T2 protection also tripped the 115kV circuit breaker EM-CB and sent a Direct Transfer Trip (DTT) signal to WM and tripped out the 115kV and 23kV breakers WM-CB and 2353 at WM, which is as per how this SEL-351 relay, is set. By review of the setting for this relay, it was noticed that not only the 51-T2, but all backup functions of this relay have been set to trip the breaker EM-CB at EM and initiate a DTT to trip the line LW at WM. Obviously, the relay setting is discrepant with what describes in the Relay Design and Operating Description. Similar to the No.1 transformer relay, there are two setting errors for the No.1 transformer SEL-351 relay as:

1. In the logic setting, the #2 transformer Sys 2 backup functions (51N-T2 and 51-T2) were incorrectly programmed to trip the breaker EM-CB and send a DTT to WM.
2. In the pickup setting, the pickup level of a definite time current supervision element for the circuit switcher EM-CB-2 was set too low, which defeats the purpose of tripping the EM-CB and sending DTT in a short time-delay if and only if the circuit switcher fails to open. As a result, the EM-CB breaker was tripped and the DTT was sent (via OUT103) simultaneously as the circuit switcher EM-CB tripped via the 51-T2 function (via OUT102) since the current supervision had picked up prior to the fault. (via SV4T, see the SEL-351 relay fault records in Figure 6 and Table 1 - East Methuen L2 Stuck Breaker Operation 02/10/2011)
