Analysis of unfaulted 115kV line over-trip by multiple grounds in VT secondary circuits at National Grid

By: Song Ji and Yujie Irene Lu, National Grid USA

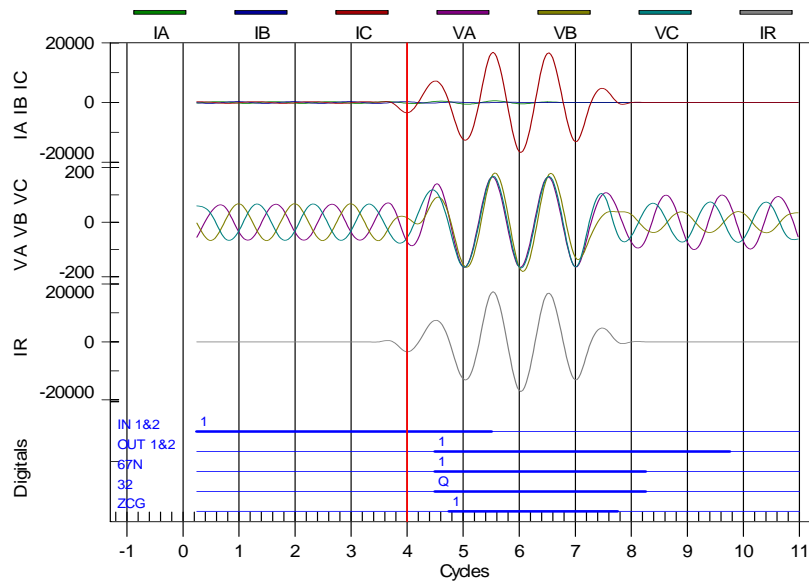
Figure 2: the system 2 relay record of Line L14 at station L on September 2nd of 2011

The record of line L114 system 2 relay at station L is shown Figure 2 below. It can be seen that a C-phase to ground fault occurred on the line and 15kA ground current was present. C-phase ground distance zone 1 element (Z1CG) and instantaneous directional ground overcurrent element (67G1) asserted right after C-phase to ground fault inception. The assertion of negative sequence direction element (32Q) did indicate the fault was forward direction. The line breaker R213 was then correctly tripped to isolate the fault.

It should be also noted that all 3-phase voltages recorded by the relay were elevated to high magnitude with small phase angle shift. Since the neutral of 115kV system in that region is effectively grounded, at least the magnitude of the faulted phase voltage should have been decreased during the fault rather than increased to an abnormal high value.

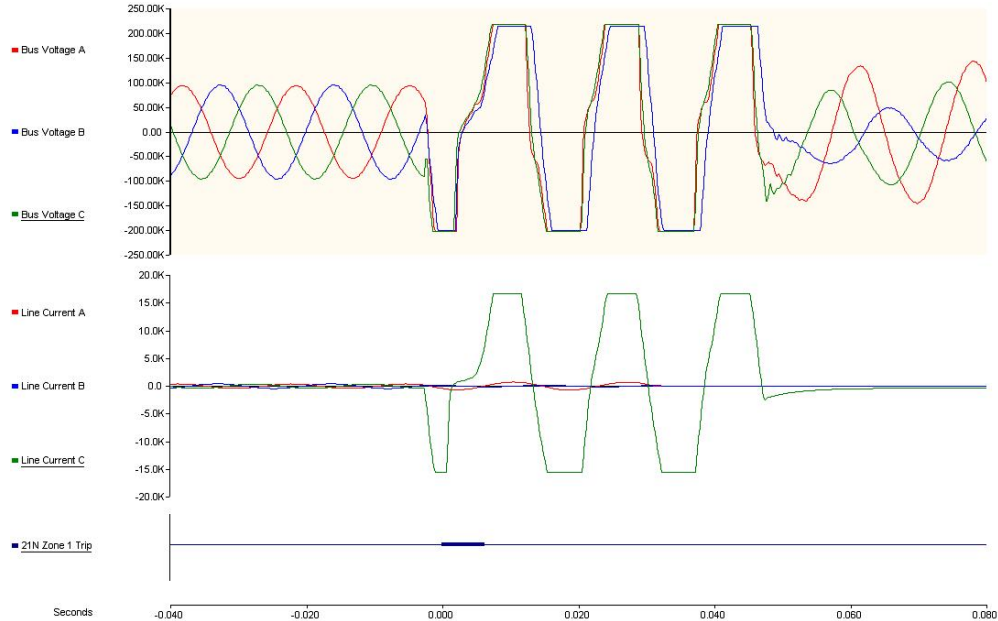
Figure 3: the system 1 relay record of Line L14 at station L on September 2nd of 2011

The system 1 relay record of line L14 at station L was reviewed as well and is shown in Figure 3. C-phase ground distance zone 1 element (Z1G) correctly asserted right after the fault inception. However, it can be seen that the faulted C-phase current measured by the relay was not sinusoidal and truncated from the peak while current waveform from system 2 relay didn't have that issue. This was caused by internal CT saturation inside the system 1 relay, which has been observed and known for some time.

The measured voltages by L14 system 1 relay were square waveforms with high magnitude during the fault. Apparently, the measurement circuit of system 2 relay can't handle the excessive overvoltage applied to the relay. It is necessary to check and compare the voltage measurement from other relays with the same type or manufacturer of system 2 relay at station L and see how the relay from different

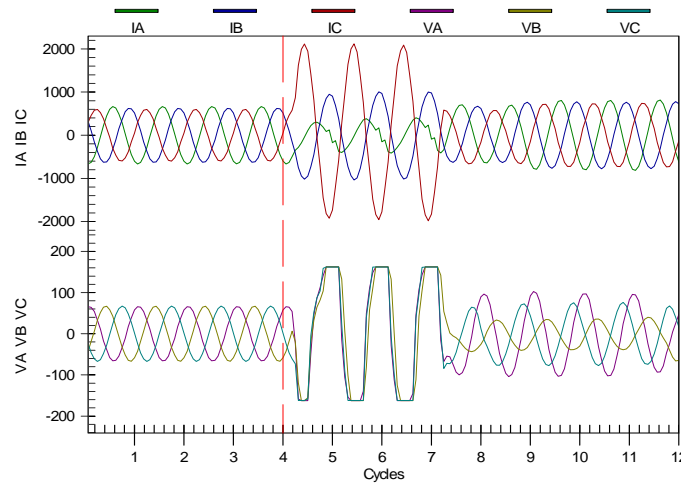
Figure 4: the system 2 relay record of Line L111 at station L on September 2nd of 2011

The relay saw the fault as reverse and didn't misoperate on the line L114 fault. However, the same odd voltage was present as seen by system 1 relay of line L114. System 2 relays for line L111 and L114 are of the same type and from same manufacturer. Since relays got voltage from same bus VT, why did two relays record have different voltage waveforms?

The instruction manual of system 2 relay of line L114 also indicates that the relay would not have any issue when up to 150V AC continuous line to neutral voltage is applied. However, the measurement errors would be present when excessive voltage is applied to the relay. Per Figure 4, it seems the margin of overvoltage capability of the relay from the manufacturer is +15%. The performance difference of L111 and L114 system 2 relays on overvoltage was mostly caused by individual difference.

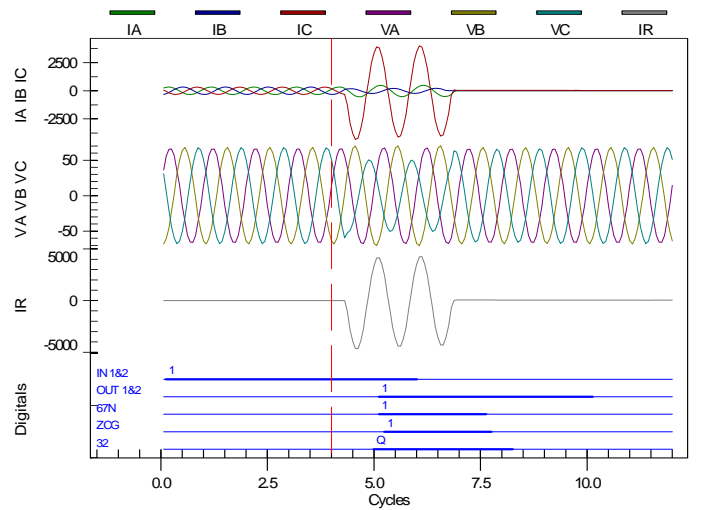
Figure 5: the system 2 relay record of Line L114 at station L on May 15th of 2011

The fault was 8.68 miles from station L per fault locator and the ground current from station L was 4.1kA as seen in Figure 5. The recorded voltages look quite reasonable and symmetrical. Comparing the relay records, it can be seen that the differences of two events on May 15th and September 2nd are the magnitude of ground fault current and the fault location. The abnormal voltages seen by relays only occurred during the close-in ground fault; therefore it is necessary to take a look on the grounding system of station L before performing further investigations.

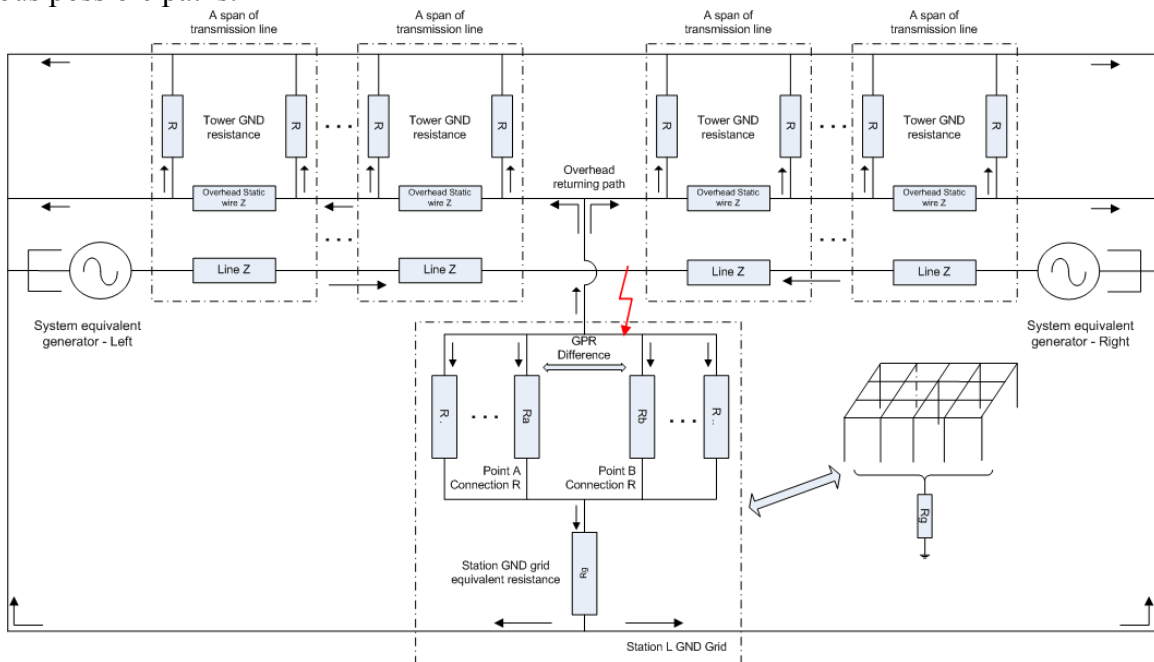
Figure 6: the ground fault current path through station L on September 2nd of 2011

From Figure 6, it can be seen that no ground source is available at station L and the total ground fault current is NOT equal to the ground grid current which uses earth as returning path to the source neutral. GPR in the substation is proportional to the magnitude of ground grid current and station grid equivalent resistance. The remaining portion of ground fault current uses overhead static wire to exit and doesn't result in GPR in the substation. The current is further diverted through several paralleled line tower footing resistance at individual line structure. It should also be noted that local grounding source at the station doesn't cause GPR for the local ground fault because that portion of fault current uses grounding grid as shortcut back to the local source neutral.

From station ground grid testing report, the resistance of station L ground grid is 0.5Ω . There are 12 transmission lines connected to the station L. The typical footing resistance of transmission tower in that area is 15Ω . Per curves to approximate split factor of Std. IEEE 80, the current split factor is approximately 30%, meaning 30% of the total fault current would go through station ground grid and 70% of fault current goes through overhead static wire.

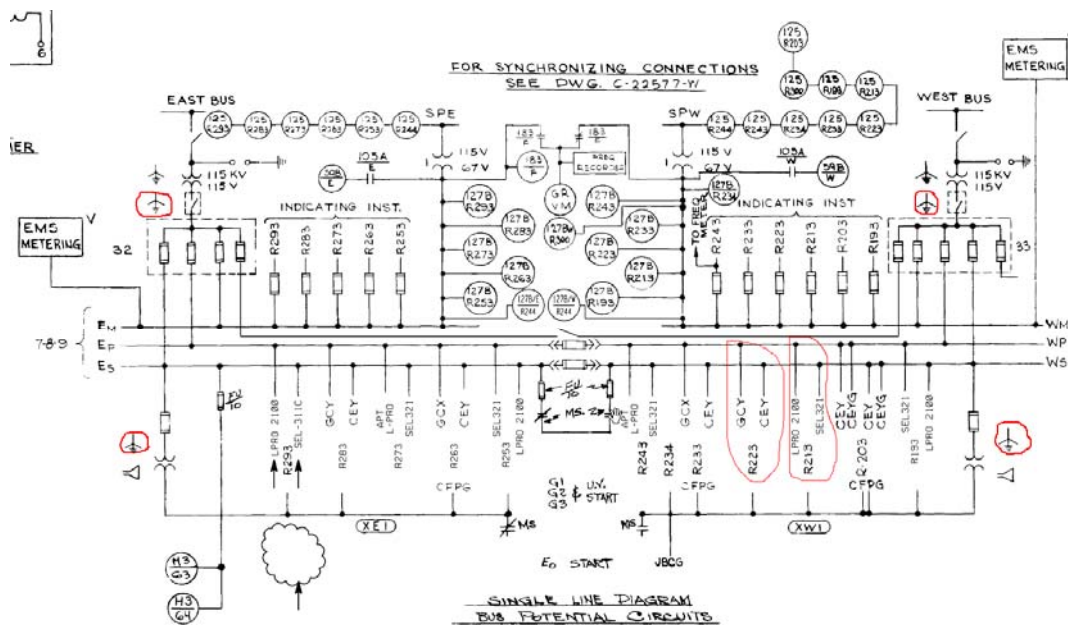
Figure 7: the bus PT connection diagram at station L

The VT secondary circuit drawings of station L were checked. Multiple ground points were found in the voltage circuits as seen in Figure 7, one is at local junction box of VT secondary neutral and another is located at voltage synchronization circuits in relay panels. Substation L was designed and built in 1940s, it was before the publication of AIEE Application Guide No 52 in the year 1952, which was the forerunner of IEEE Std. C57.13.3. In the ensuing station upgrades, no attention has been paid to the multiple grounds in the VT secondary circuits until this event occurred in the September of 2011.

The ground grid, even when designed with a very low resistance, can't be considered as an equal-voltage surface. Substantial GPR differences may exist particularly in a large substation yard. When a close-in SLG fault occurred, high magnitude of ground current was injected into station grounding grid, resulting in ground potential rise (GPR) difference between different station locations. The magnitude of GPR difference depends on the magnitude of injected ground current, locations and the design of station grounding grid. The abnormal high magnitude secondary voltage with erroneous phase angle during this SLG fault was actually caused by GPR difference between PT local neutral grounding point and other grounding points at relay panels.

Besides the grounding point at the relay panel, the additional grounding at local VT secondary neutral was identified and removed.

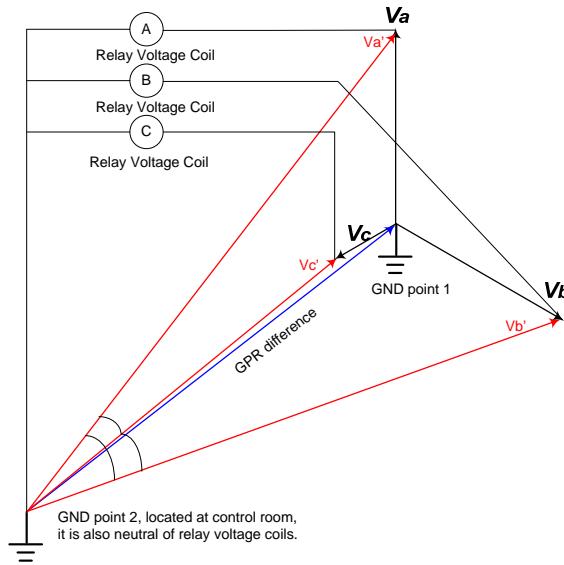
Figure 9: Multiple ground points on VT secondary circuit

The multiple ground points on VT secondary circuits introduce GPR difference between different locations into relay voltage measurements. This will be more pronounced when one ground point is at local VT junction box and other ground points at relay panels in the relay room. The voltage $V_{a'}$, $V_{b'}$ & $V_{c'}$ in Figure 9 are the resultant voltages of the VT secondary voltages superimposed with GPR difference during the fault. Those voltages are used by relays for distance calculations/measurements and can not reflect the actual faulted system parameters. This could also explain why all 3-phase voltages seen by relay were elevated and with erroneous phase angle shift during the fault.

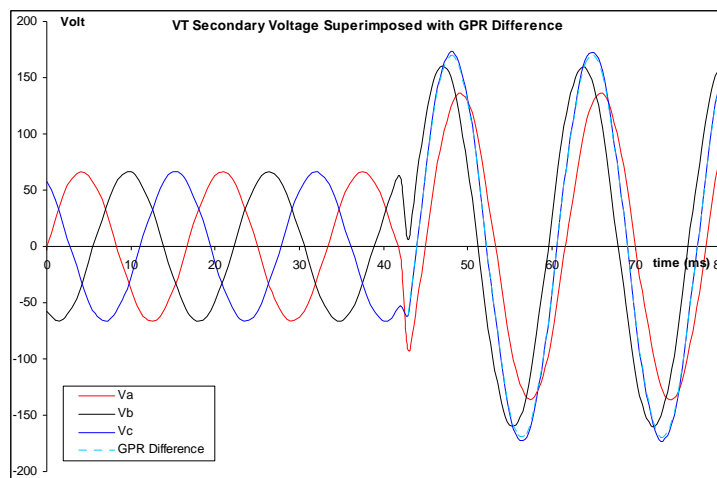
Figure 12: The calculated waveform of resultant voltage during line L114 fault at station L

The resultant voltage during the fault can be restored and manipulated in the time domain by using MS Excel. For the close-in single phase to ground fault at station L, the VT secondary voltage of the faulted and healthy phases are assumed to be 3V (4.5% of V_{LN}) and 64.5V (100% of V_{LN}) respectively as per previous discussion. Transients and DC offset are not considered for simplicity in the calculation. System 2 relay record of line L114 (in Figure 2) is used as reference, then the most proximity voltage waveform can be obtained by changing the phase angle of GPR difference (it is a simple error and trial method). The waveform is shown in the Figure 12 below, where the phase angle of GPR difference is 61.5° . It verifies the voltage vector diagram in Figure 9 and also confirms the ground grid current split factor method from IEEE Std. 80 is well acceptable.

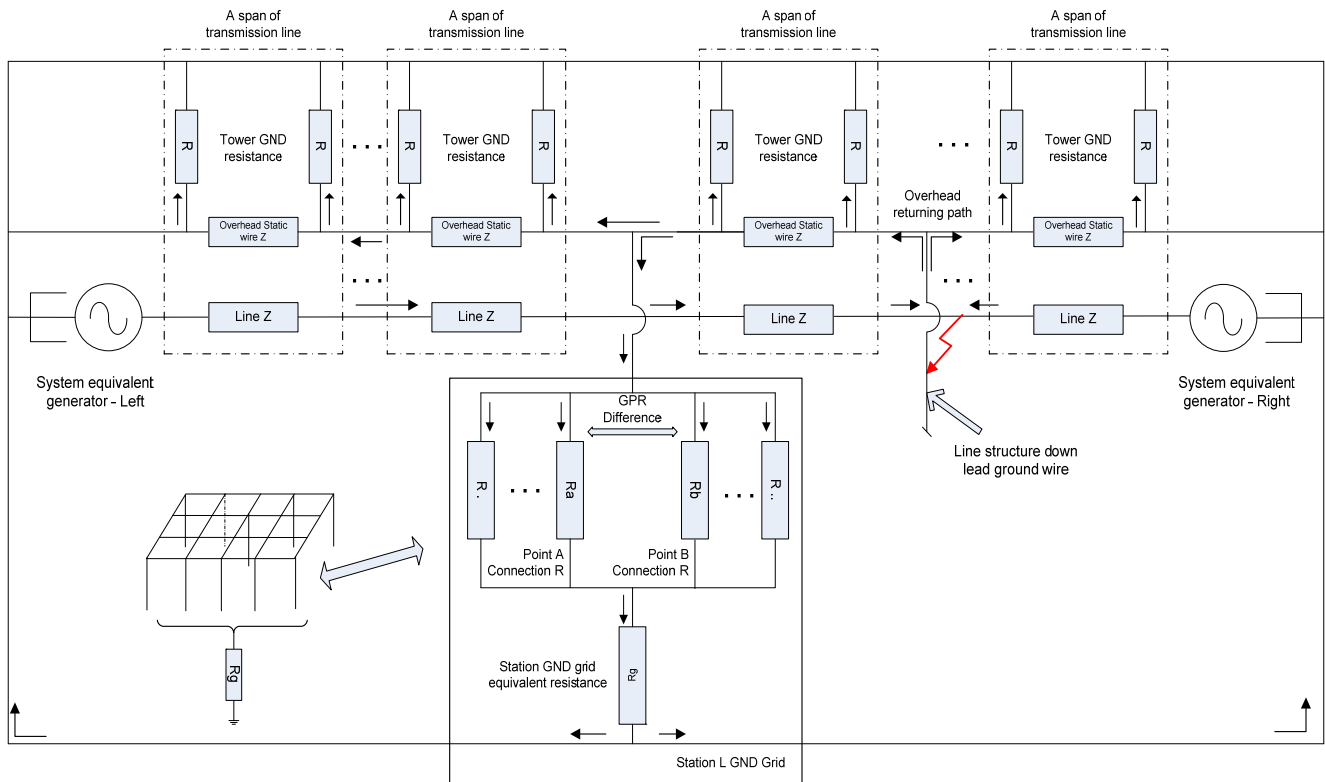
Figure 13: the ground fault current path through station L on May 15th of 2011

Why there was no secondary voltage issue on May 15th of 2011 even though the same type of ground fault occurred on line L114? According to relay records, the fault location was in the middle of line and fault current magnitude was relatively low. Since there is no ground source at station L, the ground fault current using station L ground grid as returning path to power source neutral was much smaller than the close-in ground fault near station L on September 2nd of 2011. The ground fault current path is shown Figure 13 below. Therefore GPR or GPR difference was not that pronounced and the relay voltage measurement at station L was ok.

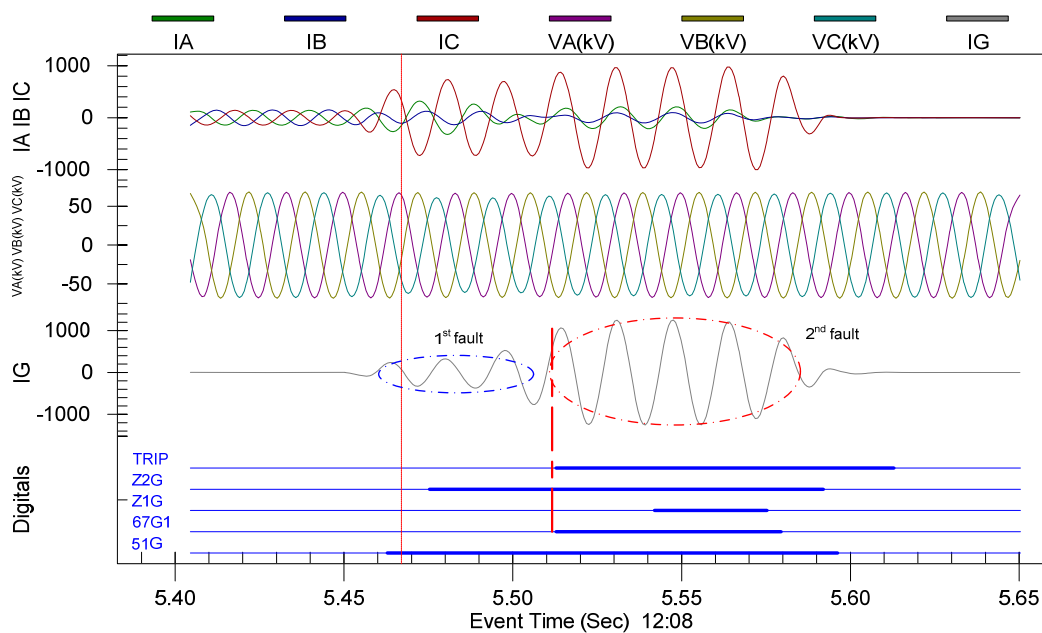
Figure 14: the system 1 relay record of Line L114 at station M on September 2nd of 2011

As per records of line L114 at station M shown in Figure 13, the relay was initially triggered by ground overcurrent element (51G) and zone 2 ground distance element (Z2G) asserted in 0.75-cycle. Due to the increment of fault current, the instantaneous ground overcurrent element (67N) asserted and issued the trip to line L114. It can be seen zone 1 ground distance element (Z1G) element asserted in approximately 1.5 cycles after the assertion of TRP relay word.

initial fault inception. The second fault location, which is 70% of the line from station M, was selected for the simultaneous fault simulation. The simulated results matched the relay records pretty well. From both relay records and fault simulation, it can be concluded that line L114 fault was of evolving nature with multiple points which occurred 2.5 cycles apart.
