**Investigating a 345 KV Line Misoperation  
From Problem Discovery to Problem Solved  
(and everything in between)**

**9th Annual Fault and Disturbance  
Analysis Conference**

**Atlanta, Georgia  
May 1-2, 2006**

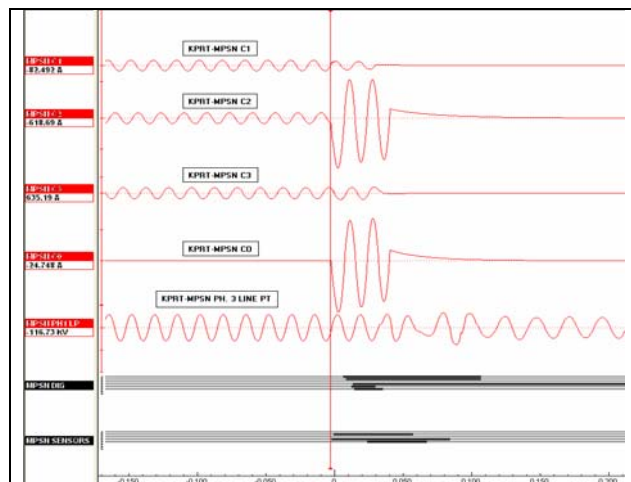
Figure 2A Kinport DFR record of Initial Fault

Figures 2A and 2B show DFR records for the phase 2-to-ground fault. Fault current at Midpoint was approximately 2100 amps. Fault current at Kinport was approximately 3800 amps.

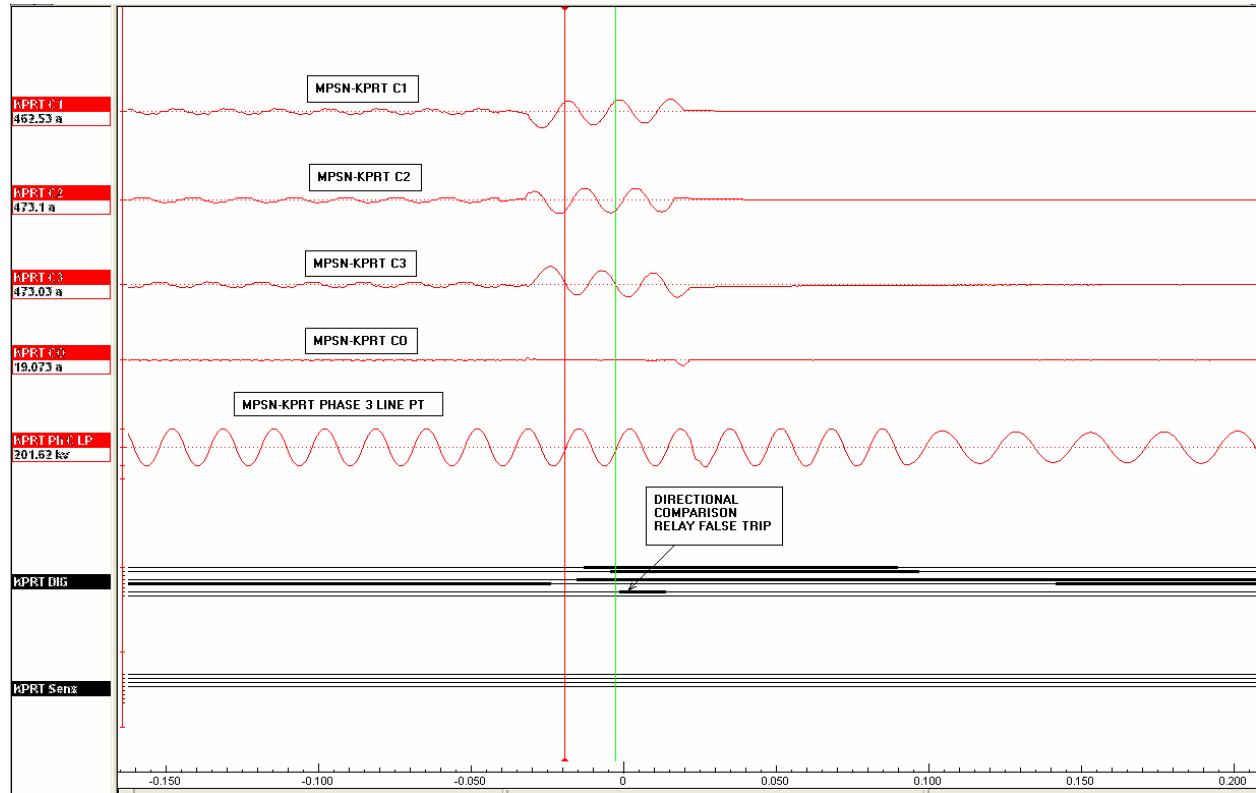
**Figure 3 Midpoint DFR Record of False Trip**

Figure 3 shows the DFR record at Midpoint for the false operation. Note that current was load current—approximately 475 amps. No DFR analog trigger sensors were activated—the DFR triggered due to the relay trip applied. Midpoint tripped via the directional comparison relay.

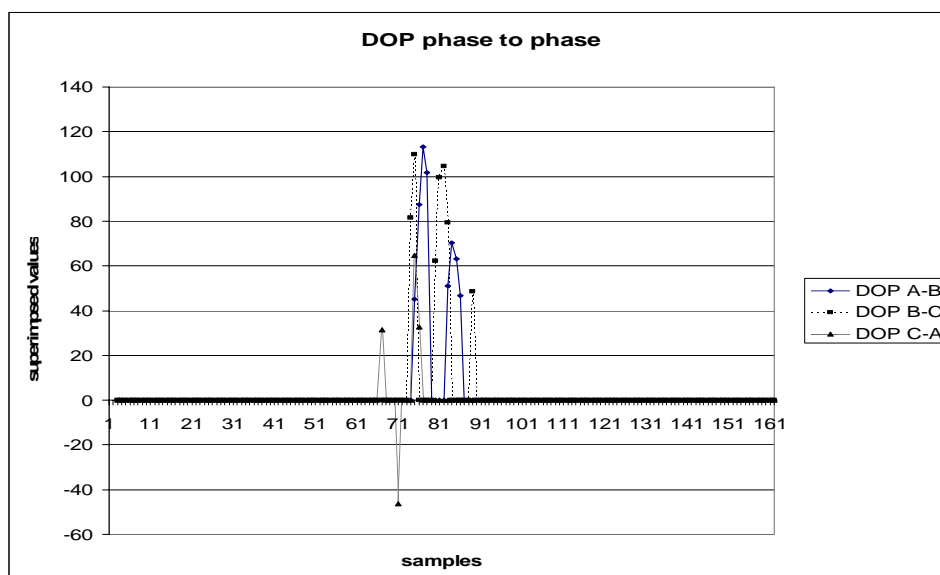
Figure 5 Directional Algorithm Analysis Chart

The directional comparison relay algorithm for determining direction is based on a quantity called the Directional Operating Signal ( $D_{op}$ ), which utilizes superimposed voltage and current quantities. Superimposed voltages and currents are derived as a delta value of the present voltage and current versus the value one cycle earlier. A counter increments three counts for calculations which result in a forward declaration, and decrements three counts for reverse calculation results. When the counter reaches nine, forward operation is declared. DFR and relay records of the misoperation event at Midpoint were used to evaluate whether the Midpoint relay should have declared a forward direction. A spreadsheet was developed to check the ( $D_{op}$ ) utilizing current and voltage values obtained from the primary #2 relay, which samples at 16 samples per second. The spreadsheet calculates the superimposed voltage and current values by comparing the fault value of current versus the value taken one cycle earlier (pre-fault), and the fault value of voltage versus the pre-fault voltage. For the voltage quantity, the relay algorithm (and thus the spreadsheet) accounts for fault angle by shifting the faulted voltage four samples in advance. This essentially puts the voltage and current in phase. As can be seen from Figure 5, forward direction was declared several times in succession during the time that Kinport closed and the Midpoint relay was seeing a transition from charging current to high flows into the Midpoint bus. In other words, the relay operated properly for the current and voltage values present during the Kinport re-close, based on the relay algorithm. Ideally, the relay should not have seen the quantities as a fault condition.

We reviewed relay settings and concluded that the settings were correct, and had been based upon sound EMTP (electro-magnetic transient program) studies. Decreasing relay sensitivity by increasing settings may result in failure to detect a remote end fault. The relay saw the condition as a fault during the transition from line charging to line loading conditions. This occurs during abnormally high load conditions and, since it is the nature of the relay at the settings applied, is not easily corrected.

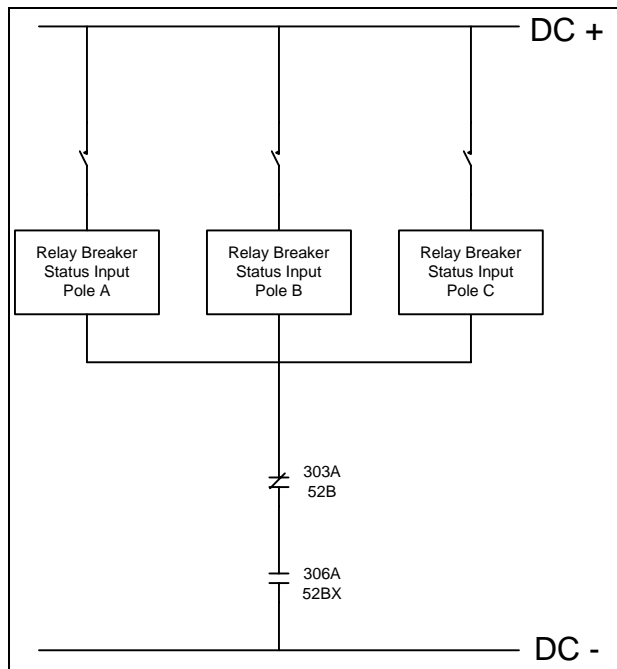
Figure 6 Kinport 52B Breaker Status Indication

Since there were no fault quantities present at the time of the misoperation, and the Kinport directional comparison relay did not trip, information at Kinport was scarce. The primary #2 relay did not trigger and the DFR did not trigger. According to the SER, the Kinport relay did send permission to Midpoint, even though it appears that it did not interpret the quantities as a fault and did not target or trigger. The relay does employ a breaker open echo feature, intended to facilitate high-speed protection in the event one end of a line is open and the other end is closed. If a fault occurs on the open-ended line, the directional comparison relay at the closed end sends permission to the relay at the open end. The relay at the open end sends permission back to the detecting relay, allowing a high-speed trip. Breaker status is required, and is wired to the digital input of the relay. The relay echo back logic prevents repeating the permissive signal back to the sending end if the receiving end breaker is closed. At Kinport, breaker status indication is done by utilizing two breaker 'B' contacts connected in series. Breaker closed status is declared when either 'B' contact opens. Examination of the contact arrangement revealed that the 52B contact from 306A was actually a normally open contact from an auxiliary 52BX relay. This arrangement would result in a delay caused by the time it takes the auxiliary contact to open. The relay would not receive timely breaker status indication. Figure 6 shows the 52B portion of the relay and breaker control circuit.

At this point we established the following theory: when the Kinport breaker 306A re-closed, the Kinport directional comparison relay echoed the permission back to Midpoint due to its 52B contact from 306A still showing closed (indicating the breaker was still open—even though it was actually closed).

The decision was made to replace the existing 52BX relay with a direct 'B' contact from breaker 306A. We were able to locate an unused 'B' contact for this purpose. We decided to wait to replace the contact until testing took place, to enable obtaining "As Found" and "As Left" test results.

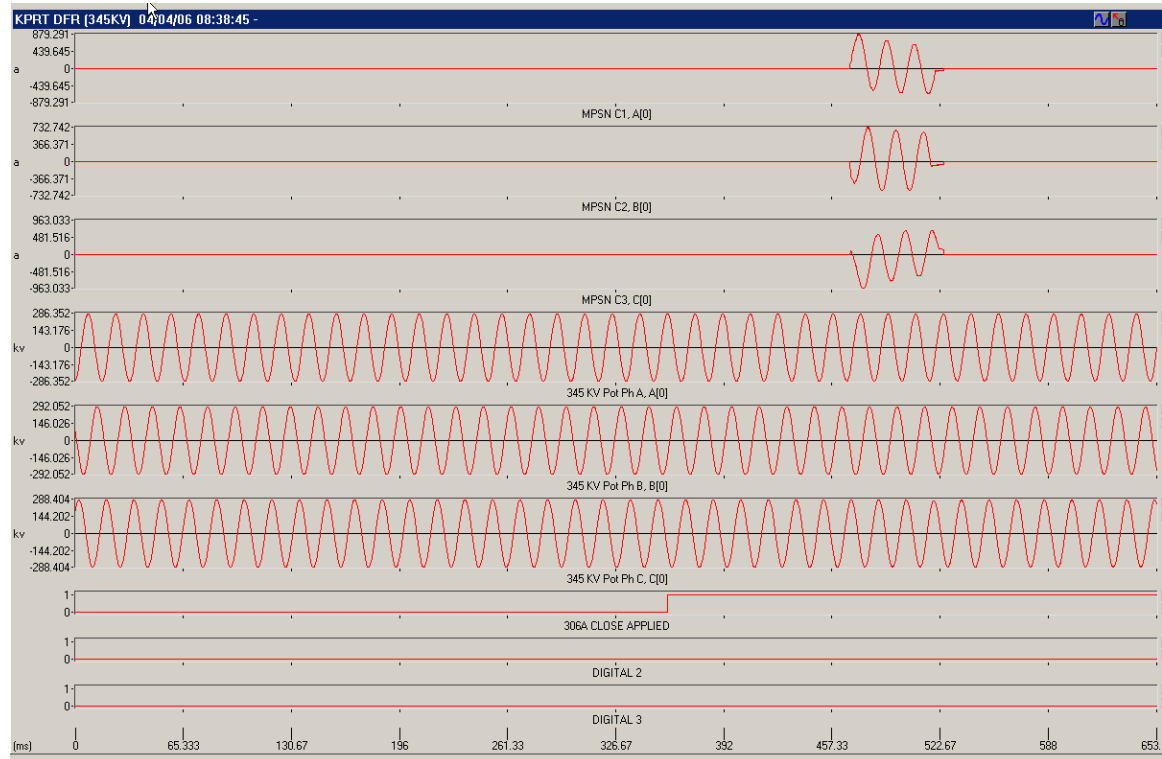
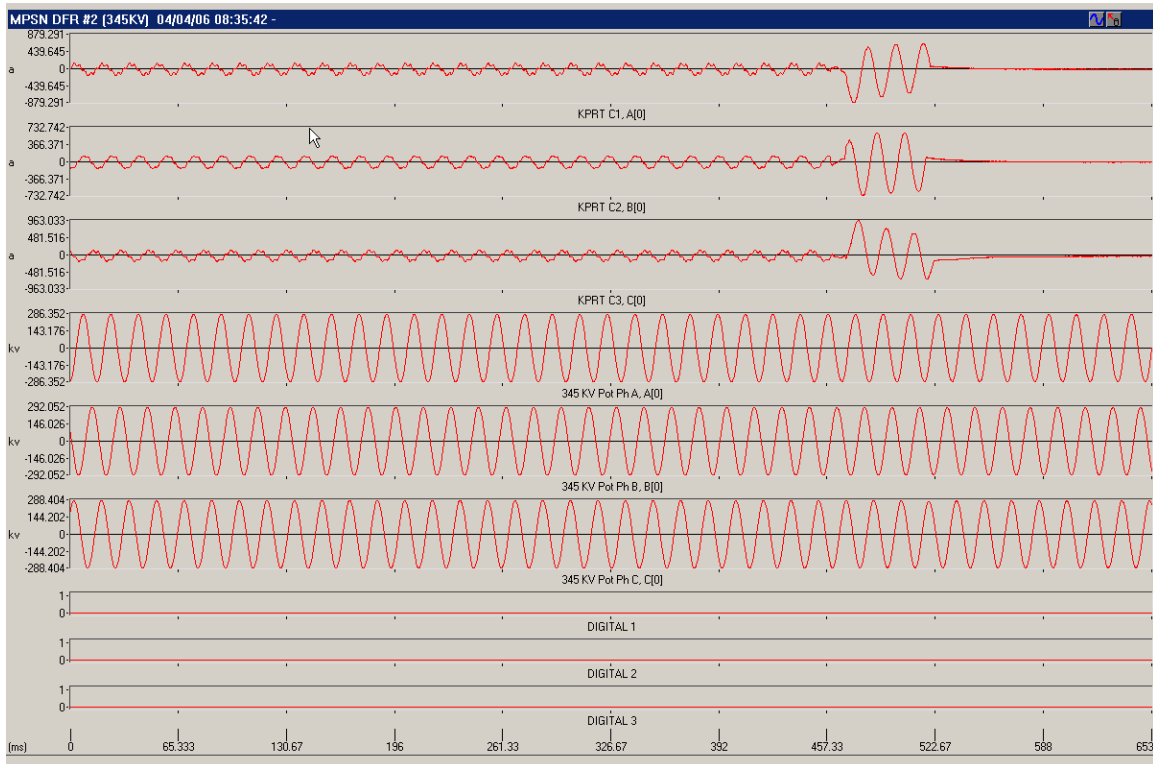
The first test was performed with the original 52BX contact still in place. We wanted to verify that we could duplicate the misoperation by reproducing all conditions that were present during the misoperation. Figures 9 and 10 show the test files from the test equipment software used for playback into the relays. These figures show the equivalent analog signals for the COMTRADE files that were recorded from the DFR at Midpoint for the Midpoint terminal or created from scratch for the Kinport terminal. The currents and voltages were injected into the relays at both ends simultaneously using end-to-end testing technology; then the results were analyzed.

The result of the As-Found end-to-end test was that Midpoint false tripped just as it had during the actual operation. The permission signal was sent from Midpoint and echoed back from Kinport to Midpoint resulting in a trip. We were able to successfully reproduce the misoperation. Timing tests on the 52BX contact showed the true nature of its delay. The 52BX contacts opened 36 ms after the breaker opened.

The 52BX auxiliary breaker contact was replaced with an actual high-speed 52B contact from the breaker 306A. The end-to-end test was repeated. The result: no false tripping at Midpoint. The Midpoint directional comparison relay sent permission to Kinport as before, but the Kinport 306A 52B contact opened much more quickly. By the time the permissive signal was received at Kinport, the 52B contact at Kinport was already open, indicating the breaker was closed. The directional comparison relay echo back logic prevented the permissive signal from being sent back to Midpoint. This test was repeated several times to ensure no misoperation would take place. The scheme operated properly with no misoperations. The direct 52B contact opened at the same time as the breaker main contacts (no delay).
