Incipient Fault Detection Through On-line Monitoring

Carl L. Benner and Dr. B. Don Russell
Department of Electrical and Computer Engineering
Texas A&M University

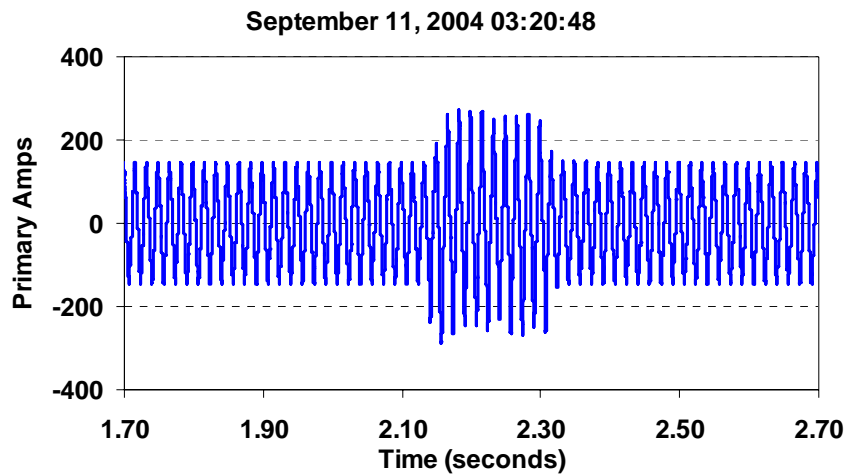
A DFA recorded several episodes similar to the current signal shown below in September 2004. DFA measurements are made from substation CTs and PTs, so the measured currents include normal load current plus any anomalous current that an event might generate. During the episode shown in the figure, the measured current increased by about 100 amperes peak (71 amps RMS equivalent) for eleven cycles. Detailed analysis of the waveform indicated that this was a temporary burst of arcing, not a motor starting or some other normal system event.

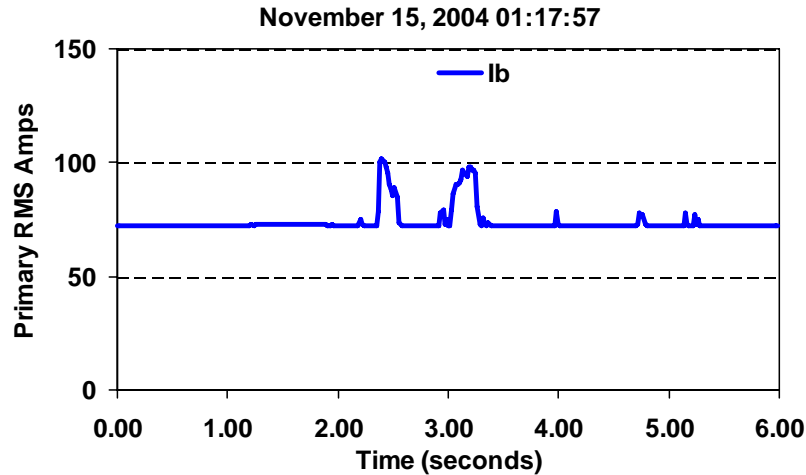
The crews did not know of the events that the DFA was recording at the substation. Under normal conditions master stations at Texas A&M and at each utility company retrieve data from these substation units one or more times per day. Internet service to this substation failed in early September, however, and was not restored until November. When Internet service finally was restored, the backlog of event waveforms was retrieved from the substation device to the Master Station and it was apparent that something was wrong.

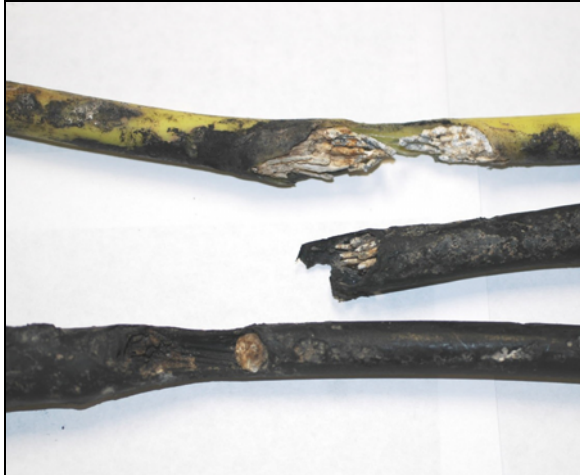
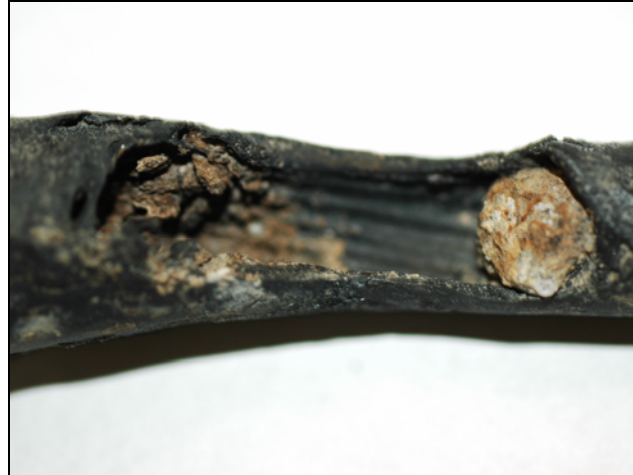
A section of the excavated cables appears in the photographs below. The left-hand photograph shows the two black "live" legs and the yellow neutral conductor. The right-hand photograph is a close-up view of the worst section of the bottommost conductor from the left-hand photograph. The insulation had deteriorated completely away in several obvious locations. What is most interesting in the right-hand photograph is that there were sections of cable up to an inch in length for which the entire conductor had corroded away, but these cables were still carrying load current, albeit with intermittent shorts and outages. The crew noted that there were multiple locations in the service cables that had damage similar to that shown in the photographs.

The customers whose transformer had been tripping called with another lights-out call early December 7, 2004. Having been alerted to the problem being reported by the DFA, the responding crew inquired as to whether the DFA had registered anything near the time this latest outage occurred. Upon learning that it had, they surmised that the problem likely was failing insulation on the direct-buried underground service cables to one or more of these customers' services. They strung temporary overhead services to these customers and then excavated the service cables when time allowed.

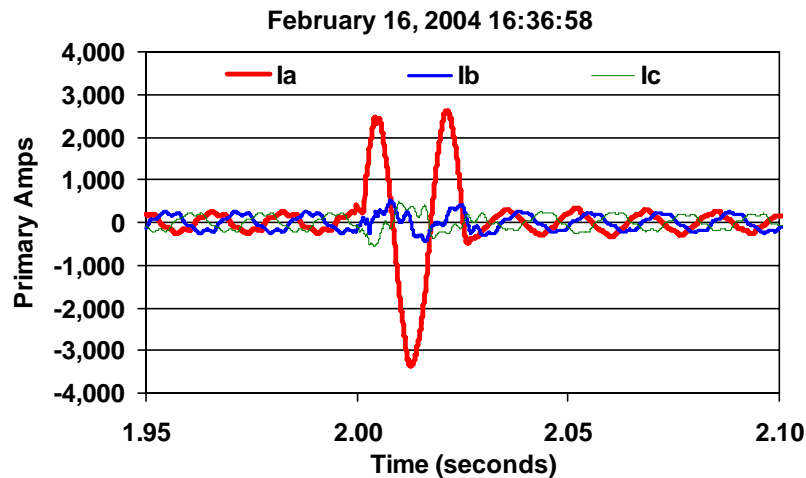
By mid February this capacitor bank had switched several thousand times. On February 16, the phase-A capacitor failed and caused a short circuit, as illustrated in the following waveform. It is believed likely that the capacitor's failure was precipitated by the excessive switching operations and the associated transient stresses.

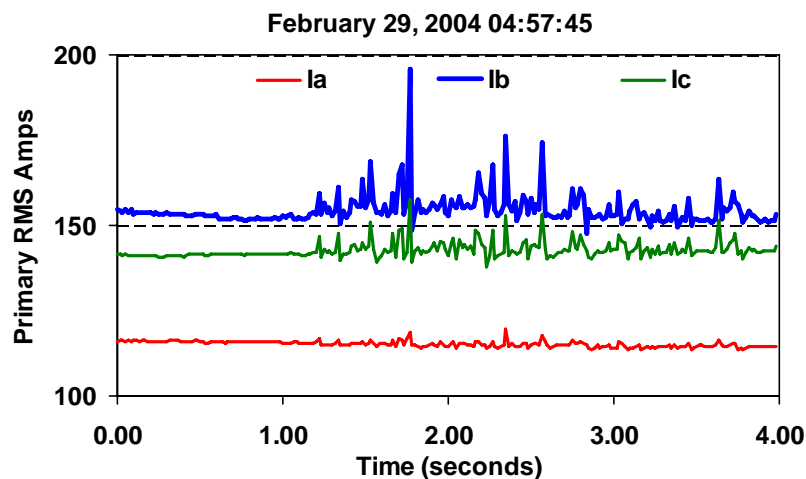
Following the failure of the phase-A capacitor, the controller continued to switch the bank's remaining two phases ON and OFF excessively. On February 29 the problem escalated further. After cycling ON and OFF repetitively in the early morning hours, the bank switched ON at 04:57:37. A few seconds later, the capacitor began to produce repetitive transients as the contacts in the oil switch for the phase-B capacitor began to arc internally. The thousands of switching operations over the past two months far exceeded the recommended maintenance cycle for this switch, and the switch's pitted contacts could no longer maintain proper electrical connection. The following RMS waveforms illustrate the erratic current caused by the intermittent connection in the capacitor switch's contacts.

Failure of oil-switch contacts is not a surprising phenomenon following several thousand operations. However, most engineers likely would assume that the contacts would destroy themselves completely within a relatively short time, perhaps a few seconds or minutes. In this case, however, the failing switch continued to conduct intermittently for four days before finally resulting in an open-circuit condition that effectively ended the problem. During this time the controller continued to cycle the bank ON and OFF repetitively. It was ON for a significant percentage of the time and continued to display erratic current when it was ON.

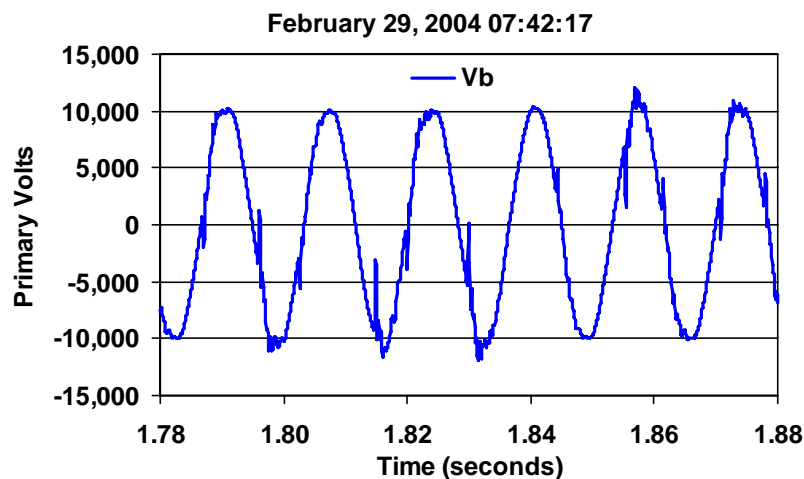
Each time a capacitor switches ON, it produces voltage transients that are seen along the feeder and at the bus. Because the transients appear at the bus, other feeders connected to that bus see the transient voltage as well. In the present case, the feeder with the failing capacitor switch shared a bus with one other feeder. The following figure shows the voltage distortion and transients present at the substation bus during one recorded interval. Because these signals were present at the bus, all loads and apparatus connected to both of this bus's feeders experienced their effects. The DFA recorded the significant transient currents that flowed in both of these feeders.

On the morning of March 1, about 28 hours after the switch began to fail, a capacitor on the other feeder connected to this bus short circuited and caused an overcurrent. The obvious conclusion is that the near-continuous coupled transients caused failure of this capacitor. In addition, over the four-day period of time during which the switch was failing, two other capacitors failed on the feeder with the faulty switch.
