Relay Mis-operation caused by Arcing CT and its Mitigation Discussions

Tao Xia, Robert M Orndoff - Dominion

Georgia Tech Fault and Disturbance Analysis Conference, May 6, 2013

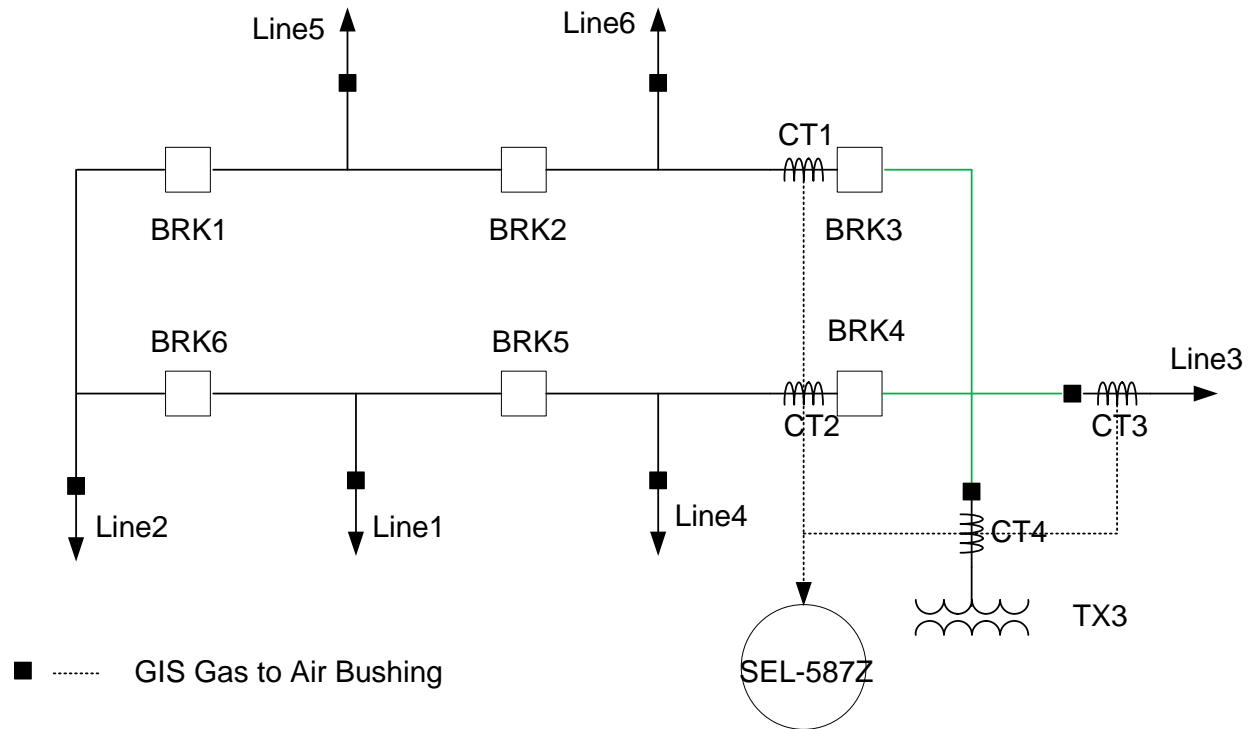
Figure 1

On June 12th, 2012, a bus differential relay (SEL-587-Z) in one of the transmission and distribution mixed GIS substations in Dominion Virginia Power (DVP) operated. It tripped two local GIS breakers (BKR3 and BKR4 in Figure 1) and transfer tripped two line breakers at the other end of the affected transmission line (Line3 in Figure 1), locking out the line and causing power outage for more than 50,000 customers. The bus differential relay under investigation is set up to protect the green section of the GIS system in DVP shown in Figure 1. This is a 230 kV GIS substation and there are 6 overhead transmission lines and a 230/34.5 distribution transformer connected to the GIS system via gas to air bushings. CT1 through CT4 are summed up to provide input to a high impedance bus differential relay SEL-587Z.

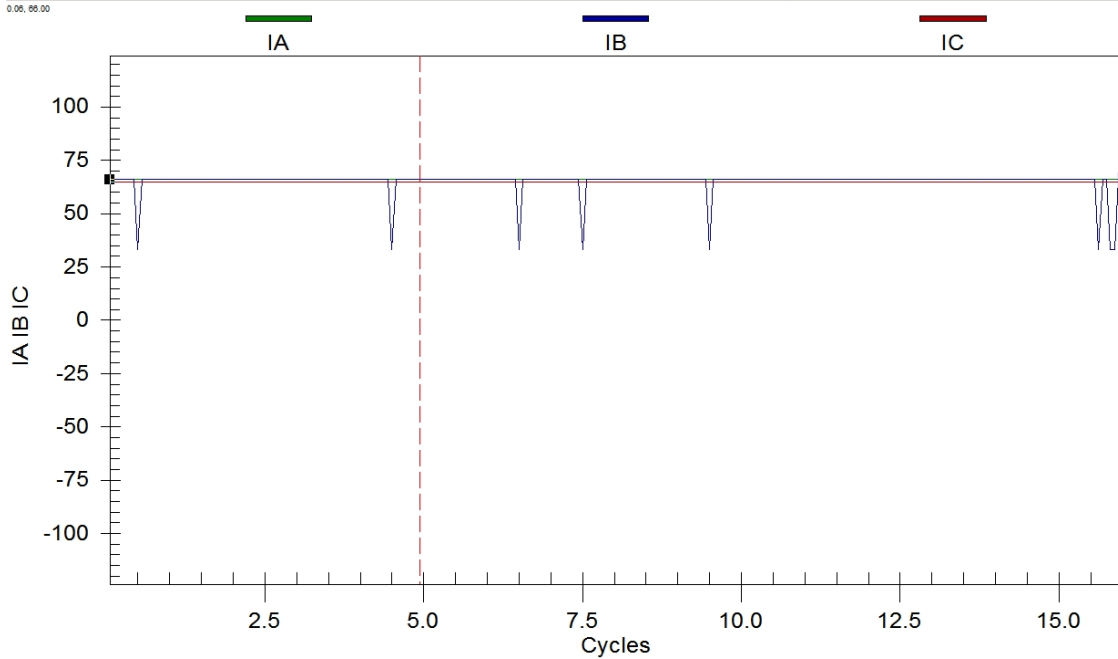
Figure 2

On site testing after the outage with the gas bus differential relay lockout blades pulled revealed that the B phase CT on Line 3 was producing a sporadic differential current as demonstrated in Figure 2.

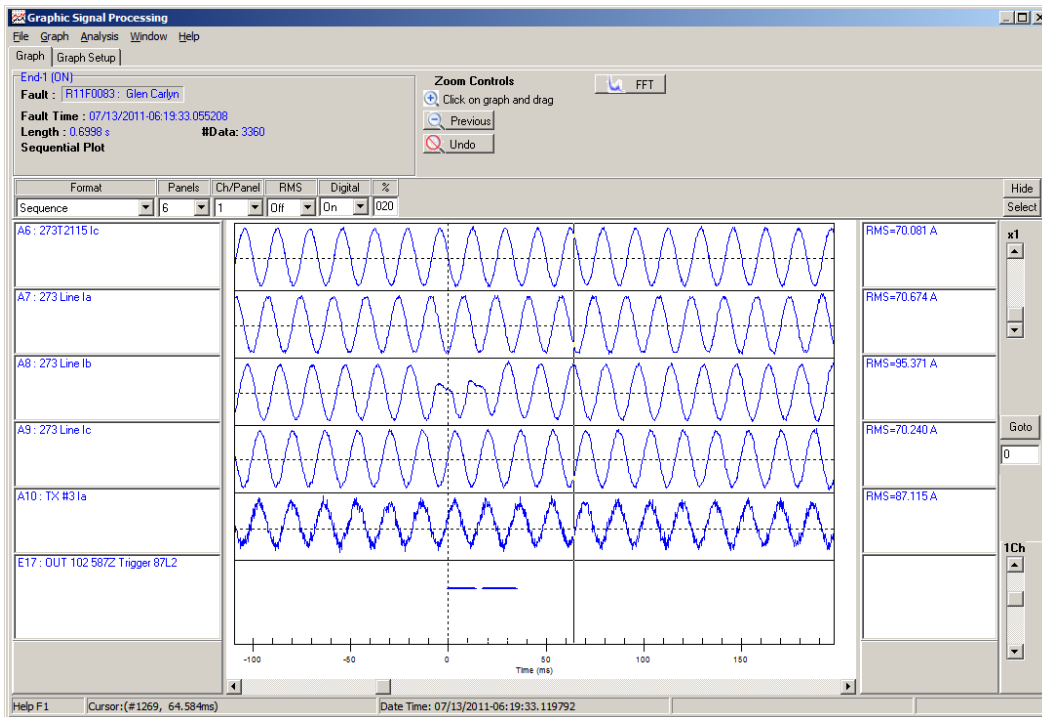
Figure 3

The waveforms that the portable DFR captured the next day after it was installed, which was nearly a month after the event, still showed the problem with the B phase CT, as seen in Figure 3. All evidence from the extensive monitoring and testing that were conducted pointed to a problem with the Line 3 B phase CT.

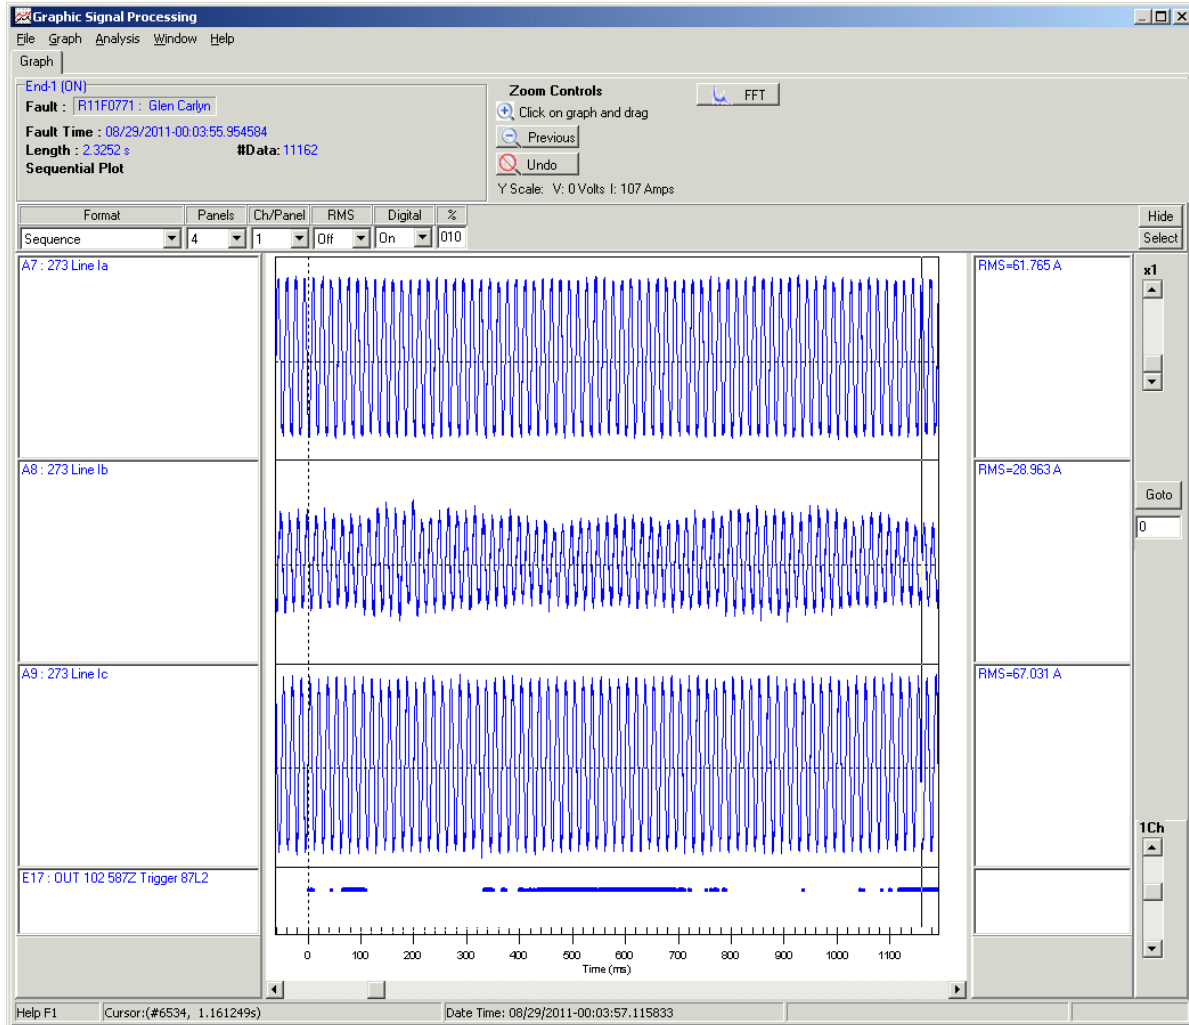
Almost 3 months after the mis-operation, the DFR was still triggering regularly, most often in the early morning hours. Figure 4 shows the traces of an event triggered by the bus differential trip signal. We didn't see any examples of the waveform being cut off like we saw at first; at this point it seemed that most of the records were just "wavering" currents produced by the line 3 B phase CT.

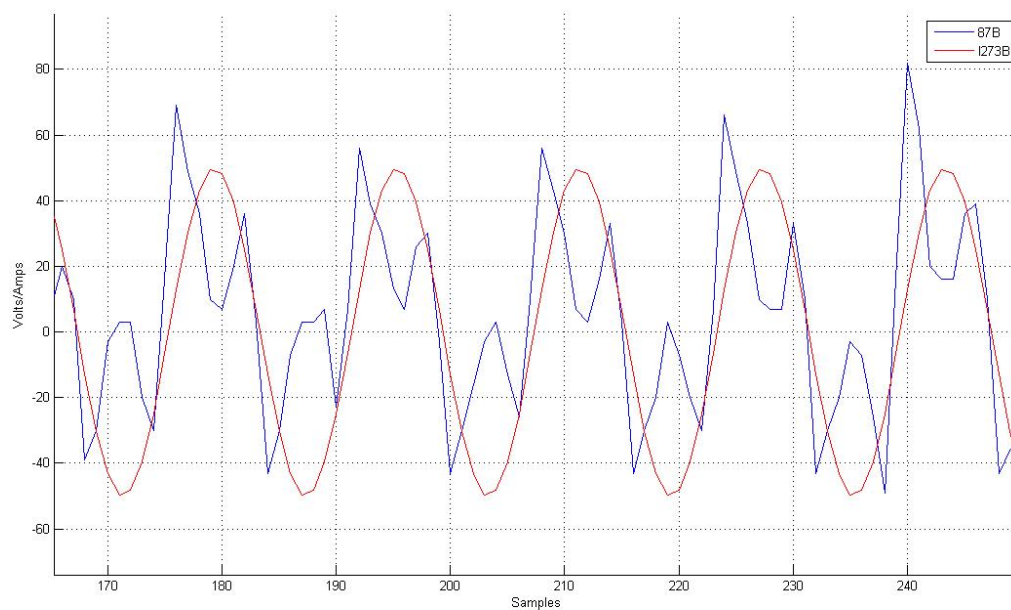
After overlaying the current trended back from the DFR file on top of the voltage recorded on B phase bus differential element of line 3, we find the saddle-shaped V-I characteristics in Figure 5 are exactly what we expect for arcing[1]. When the current goes to zero, the voltage decreases to zero. When the current goes up to a certain point, it starts arcing and the voltage starts to drop. When the current goes to maximum, the arcing intensifies and the resistance of the arc decreases. As a result, the voltage drops to minimum.

This is the end of the relay event data. The fundamental voltage is over 30 volts RMS with the peak reaching over 80 volts. We can also notice that the arc voltage starts to pick up. It is very likely the arc voltage rose to 91 amps and tripped the relay whose 87B set point was 88 volts.
