A Collection of Bedtime Stories for Protection Engineers - Volume 1

Ed Chen, Jianzhuang Huang, Pallavi Kuchikulla, Naresh Malla, Khawla Munawwer, Lizhong Situ & Daniel Taft,
Consolidated Edison Company of New York, Inc.

Abstract— This technical paper is a collection of recent events on Con Edison’s power system. Each event will have its own section for background, root cause analysis, fault calculation study and corrective action plan. These events demonstrate the uniqueness of the Con Edison power system, challenges, and lesson learns. Highlights of each are below:

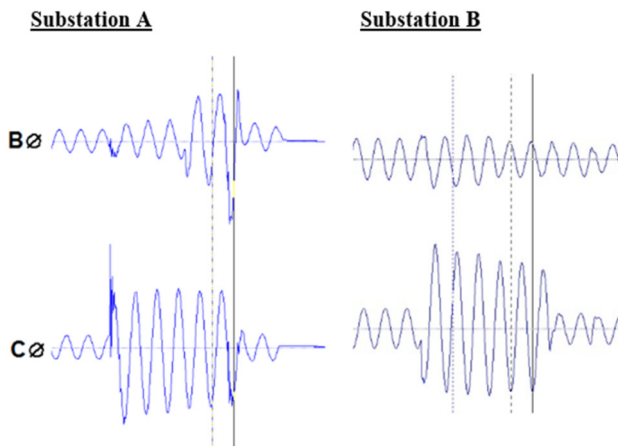
Figure 1b. Relay fault recording

The fault on Transformer 1 was on phase C. The System #2 relaying on Feeder 1 mis-operated on phase B. The oscillography downloaded from the Feeder 1 relays shows elevated current on phase B at its Substation A end, but not at Substation B end. Thus, it appears to the line differential scheme that there is a fault on Feeder 1. The current should not be elevated at either end on phase B. It should only be elevated on phase C at both ends, equal magnitude and opposite phase, as through current flowing to the external fault on Transformer 1.

The relay fault recording in the below Figure 1b shows Feeder 1 "C" phase current contribution from Substation A and Substation B. There is no "B" phase current contribution from Substation B. The "B" phase current in Substation A increases drastically 3 cycles after the fault. The current increase duration is approximately 2 cycles. The increase in "B" phase current subsides immediately after the fault is cleared.

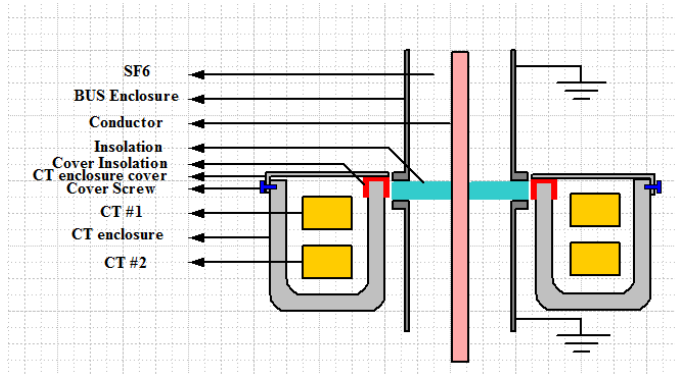
Figure 1d. Insulation between CT enclosure and top cover

Figure 1d below shows detail of the CT enclosure with the top metallic cover. To prevent the conductive loop around the CTs, the top cover is insulated from the CT enclosure casing by rubber insulation (red). Figure 1e shows this insulation around the inner circle of the CT enclosure. Figure 1f shows the CT enclosure.

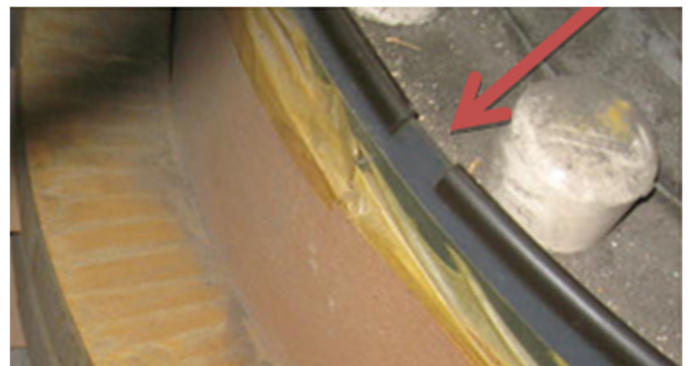
Figure 1g.

Both Breaker 1 & 2 are installed within the GIS enclosures of Substation A, so the preliminary conclusion is that the GIS breaker CT inter-core coupling problem that led to the over-trips of Feeder 1 during external fault, causing a secondary current mismatch to the differential relay system, resulting in a misoperation during an external fault. This "phantom B" phase current increase discussed above is directly related to the Inter-core Coupling effect.

Figure 1g shows a small section of the insulation around the inner circle of the CT enclosure that was missing. There is a small air gap between the top CT enclosure cover and the casing where the insulation is missing. During normal operation this small air gap does not impact the CTs. But during an external ground fault, the ground potential rises and bridges this gap. This momentary action will complete the conductive loop around the CTs and cause inter – core coupling

Since the time that the repairs were made to the breaker 1 CT housing, Feeder 1 properly restrained from over-tripping during four external faults on the 345kV system in the electrical vicinity of Substation A.

Conclusion: The CT cover insulation and the integrity of the insulation on bus enclosure of both the breakers is important and if deteriorated could cause inter-core coupling effect and could lead to relay misoperation and mislead event analysis which can delay system restoration. It is recommended to check this insulation during the breaker diagnostic tests and perform CT Inter-core coupling check to avoid mis-operations in the future. If possible, CT housing covers within GIS installation can be replaced with non-conductive material type, such as fiberglass, this can minimize the chance to encounter inter-core coupling issue.

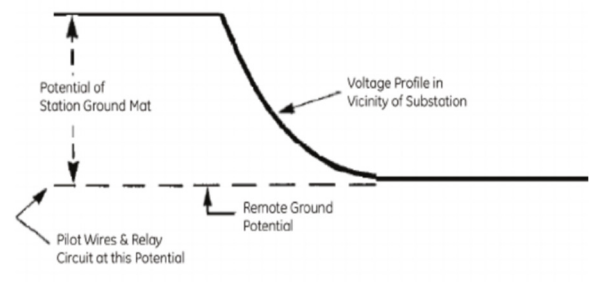
Figure 2f. Ground Mat Voltage Rise

This investigation determined that during the 2021 misoperation event, the momentary rise in ground mat voltage affected the pilot-wires and/or the relay case of the supervisory relay during the external fault, and caused a false trip (reference to “Ground-Mat Voltage Rise” problem in [4]).

2. The pilot wires relays for Feeder 2 and Feeder 3 were replaced with microprocessor-based relays with new modern communication channels in September 2022 and March 2022, respectively.

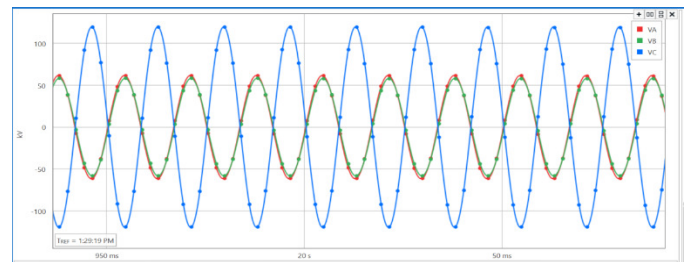
Figure 3c. Voltages Captured at Line C21 Prior to the Arcing

Prior to the event, V_{ab} at the disconnect switch of Line C21 was at about 0V while V_{bc} was at about 1.5 pu. Phase B was the middle phase and the other two were the outer phases. When the operator exercised the disconnect switch, Line C21 was inadvertently energized. The charging current with the potential difference of 1.5 pu caused arcing, between phase B and phase C, and caused a temporary short between the two phases. That forced V_b to be in phase to V_c with similar magnitude of 1 pu as shown in Figure 3d.

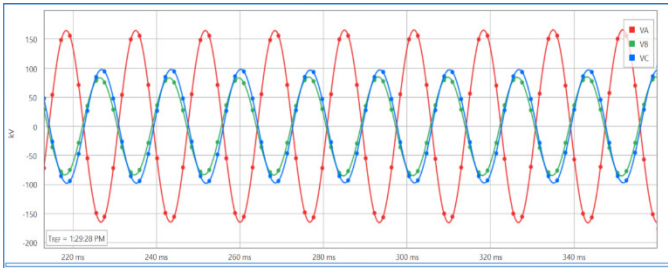
Figure 3e. Voltages Captured at Line C21 During Arcing

The new voltages were induced back to the tertiary windings of the auto transformer. Since V_a was equal to the negative of the sum of V_b plus V_c within the delta windings, V_a at that moment had the magnitude of 2 pu and 180 degrees out of phase. With induction back to primary and secondary windings

at Phase A, 2 pu voltage was presented at the surge arrester, causing it to fail with a Phase A to ground fault. Figure 3e shows the voltages at Line C21 captured by the relay oscillography during the arcing.

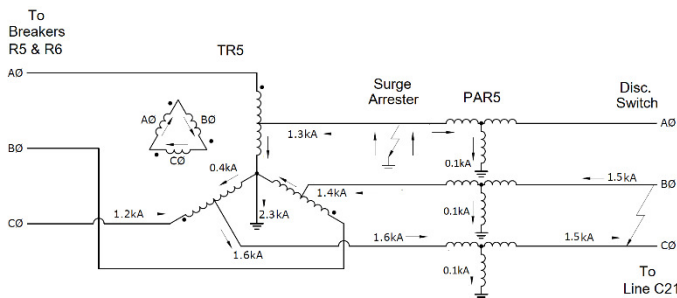
Figure 3f. Current Flow during Phase A Surge Arrester Failure

Relay oscillography also captured current waveforms around TR5 and PAR5 during surge arrester failure. Figure 3f illustrates the current flows in the section during the event.

Even though both the transformer and PAR differential relays tripped during the surge arrester failure, Breakers R5 and R6 were already opened. The fault could not be interrupted and continued to be fed through phase C of Breaker R6. A few cycles later, phase C of Breaker R6 failed. That resulted in a Phase C to ground fault at the source side of Breaker R6 that fell into the protection zone of the adjacent Transmission Line C1. Line C1 therefore was tripped open. The fault currents at Line C1 during the fault were shown in Figure 3g.

Line C21 did not trip at all. One corrective action plan was to lower the pickup of the fault detectors from 2.4kA to below 1.5kA.

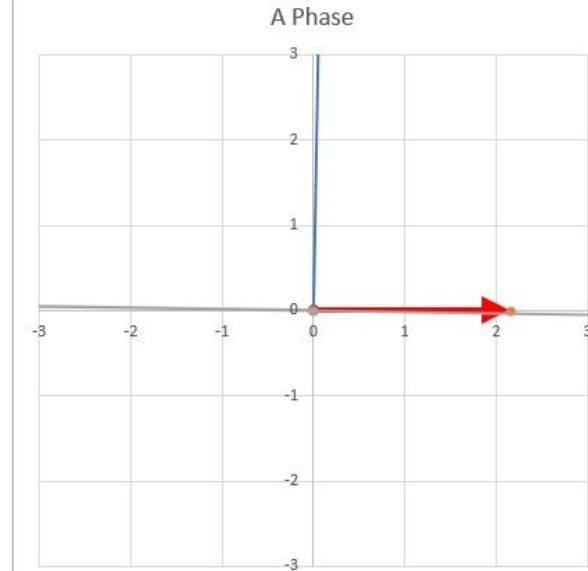
Figure 4c. Directional Element for phase A

on the edge for the relay to declare either forward or backward direction. The circulating current due to the CMVM issue stayed above the 67-element’s overcurrent element pickup and the angle of the current fell right at the edge for the System #1 relay to declare forward direction on phase A. Therefore, in this case, phase A of the System #1 relay declared forward and tripped. This is the correct operation but undesired under the CMVM issue conditions.

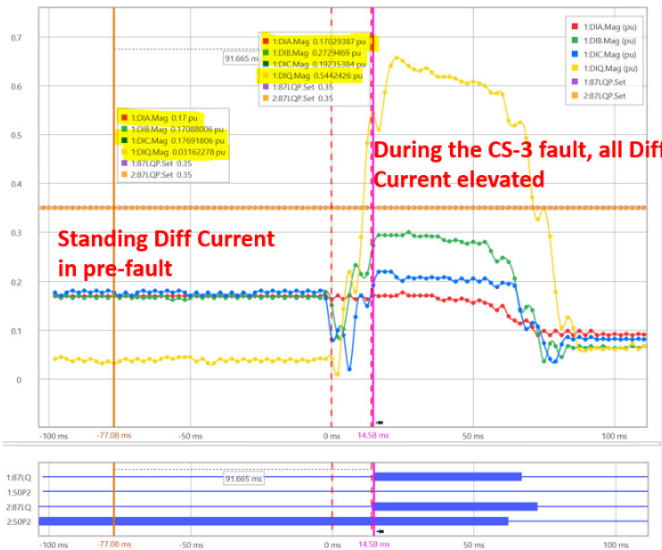
Figure 5c: Substation F Line # E1 Relay Event Record

Relay oscillography files indicated relays associated with 345kV Transmission Line E1 exhibited steady differential current prior to the event, indicating a pre-existing issue with the protection systems. During the Circuit Switch CS-3 fault at Substation H, all phases differential current elevated. The 87LQ element was as high as 0.67 PU during fault at Substation H Circuit Switch CS-3. The relay Pickup setting for the 87LQ was set at 0.35 PU.

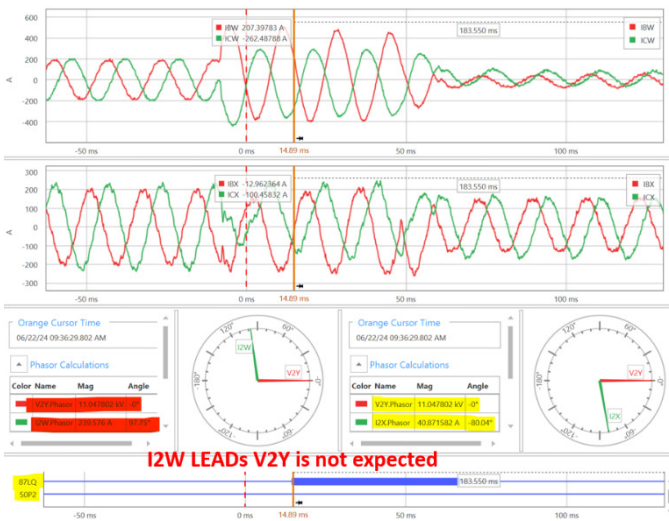
Figure 5f: V2 and I2 Relationship at Substation F Line # E1 from Relay Event Record

Since it was a thru-fault for Line #E1, for Substation F, we would expect to see both its breakers' currents to be 180 degree out of phase with respect to Substation D's currents, with the same magnitude. But per Substation F Line #E1's relay event file, we only can see one of the negative sequence current (I2X) lags its respective negative sequence voltage (V2Y), but realizing its other negative sequence current (I2W) LEADs its respective negative sequence voltage about 98 degree in Figure 5f. The absolute summation of the negative sequence currents of the local matched with its remote's. This is an evidence of the IW terminals three phase currents at Substation F Line #E1 relays had reversed polarity connection.

Further analysis indicated the current transformer Inputs from Substation F Breaker F1 to the Transmission Line #E1’s System 1 & 2’s protection relays were connected to the incorrect polarity, explaining the pre-existing differential currents and the differential relays mis-operations during an external fault.

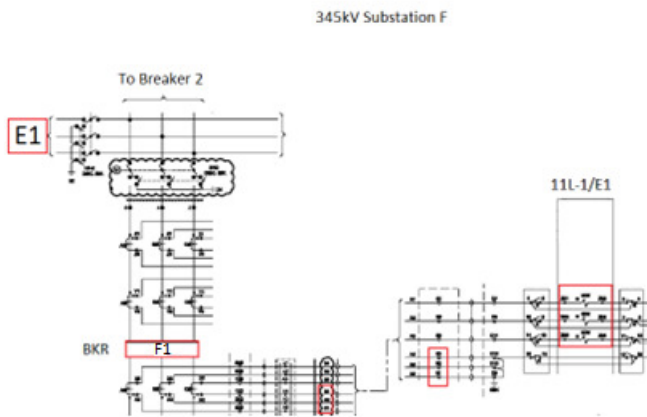
Figure 5g: 3 Line AC wiring diagram for 1st line Protection relay for Transmission Line E1

Substation F breaker F1 was recently upgraded and put back in service less than a month. Protection drawings issued for construction of the Substation F Breaker F1 replacement revealed the introduction of the polarity error into the system. The One line Relay schematic was issued, showing the correct polarity and connection. However, the 3-Line AC wiring diagram drawings indicated incorrect polarity connections as shown in Figure 5g. Breaker F1 CTs wiring to both system protection relays winding polarity side were wrong (using the non-polarity) side of the new breaker F1 CTs.

The error was on the 3-Line AC schematic drawing. The drawing was designed in compliance with the design procedure, and a follow-up design supervisor and checker was completed. Subsequently, in compliance with the Design standard, the 3-Line AC schematic was sent to the Relay Protection Engineer for approval, and the Relay Protection Engineer approved the preliminary 3-Line AC schematic. Before sending the drawings for formal approval in the drawing system, the design team noticed that they had carried a nomenclature from the old CT and decided to change it. Unfortunately, this nomenclature change caused an error in the CT polarity wiring. The Relay Protection Engineer did not have the opportunity for a final review/approval as the drawing was not transmitted in drawing system due to an issued with the title.

Never overlook an in-kind replacement, a simple disconnect and re-connect has to verify is the same as before. Although these digital relays were already commissioned, but these digital relays are excellent tools for us to use to find error, for example, performing load/differential currents reading using the relay’s front display or event trigger. Following company internal work process is a key to minimize chance of error. Engineering teams among themselves always communicate with each other’s for any changes from their respective team and perform proper peer checking to improve engineering design quality.
