Analysis and Troubleshooting of 500kV line operation with Unit feeder differential misoperation

Abstract—TVA experienced a tree-caused fault on one of the 500kV lines connected to a large generating plant. A feeder differential scheme on the high side of a generator step-up transformer (GSU) for an 1100MW generating unit misoperated 3 cycles after fault inception, followed by slow fault clearing at both 500kV line terminals (16 cycles and 18.5 cycles, respectively). This paper intends to provide analysis of the cause of slow clearing by the 500kV line protection, as well as the cause of the misoperation of the feeder differential. The reason for the slow clearing of the line fault was determined to be the insensitivity of the pilot ground protection for resistive faults. The reason for the misoperation of the feeder differential protection was much more difficult to determine. After some difficult and unsuccessful troubleshooting, a disconnected residual wire on one of the breaker CTs was found to be the cause. The reason why secondary injection testing was unsuccessful in pointing to the actual cause is discussed.

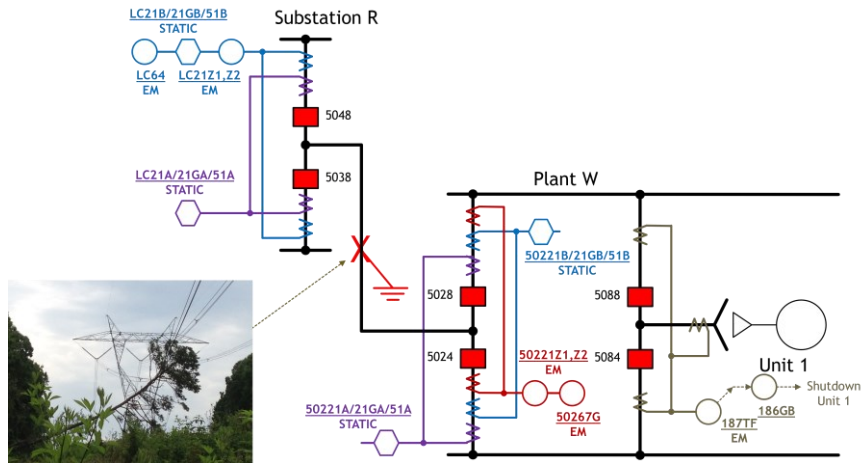
Figure 4. Phase-ground fault on the line from Plant W to Substation R

A phase-to-ground fault occurred on the line. The fault was subsequently determined to have been caused by a tree off the right-of-way that was cut by a landowner; the tree contacted the line as it fell (see Figure 4). Using single-ended data from DFR 1 and Plant W, the fault location was estimated to be roughly 55% of the line from Plant W to Substation R, with an approximate resistance of 19 ohms. Because of the fault location, we still expected the fault to clear instantaneously, even considering fault resistance and especially with dual pilot relaying.

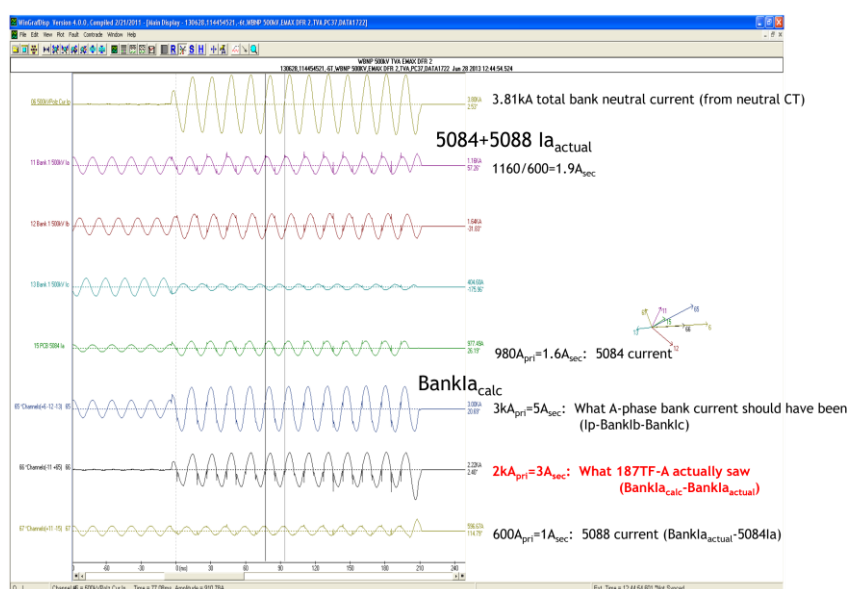
Figure 6. Initial fault DFR shot at Plant W, Unit 1 feeder quantities

The feeder differential should normally see zero current on load and for external faults since it is a summation differential, so Unit 1 should not have tripped for this event. But Unit 1 did trip in 13 cycles, with a feeder differential A-phase relay target (time, not instantaneous). The relay was set with a pickup of 900A primary (1.5A secondary) with a #2-time dial. (NOTE: The instantaneous attachment was set for 14000A primary (23A secondary), but information indicated that element did not operate.)

We used the DFR information (Figure 6) available at Plant W in an attempt to calculate the current seen by the A-phase feeder differential relay, with the following comments:

So, the relay saw 3.1A secondary. This is $3.1/1.5 = 200\%$ of pickup which for time dial 2 results in an operating time of about 10 cycles, which agrees with the clearing time of 13 cycles including lockout relay and breaker interrupting time.

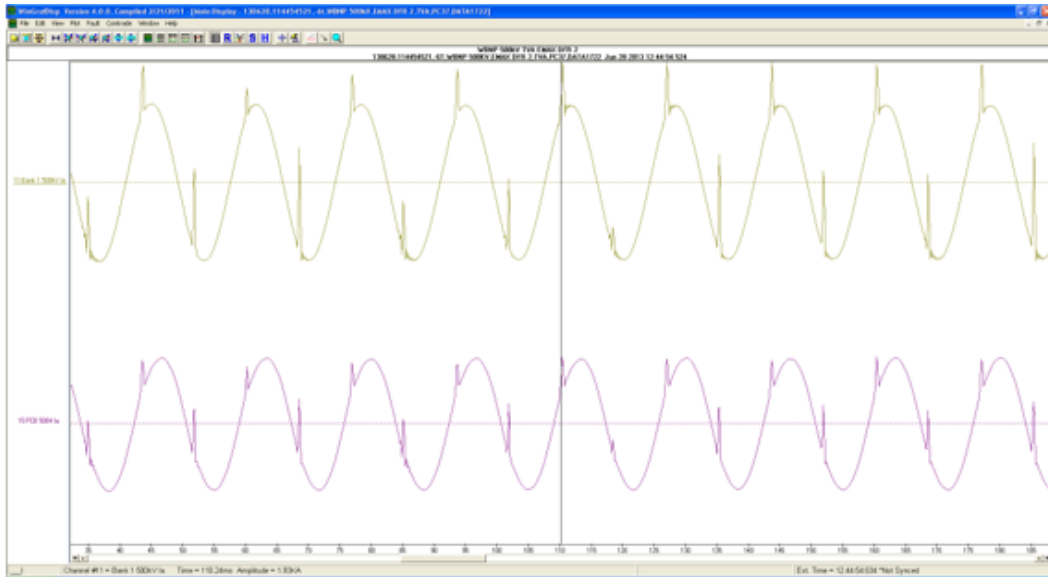
Figure 7. “Spikes” in 5084 CT circuit

There were a couple different incorrect theories that were set forth before the true cause was discovered, which were raised due to “spikes” seen in the waveforms of the currents in the DFR (see Figure 7).

The first was a loose connection at a test fixture in the 5084 CT circuit, which was raised because we suspected a possible open circuit somewhere in the CT circuit. However, the “success” of the secondary injection testing seemed to rule that out.

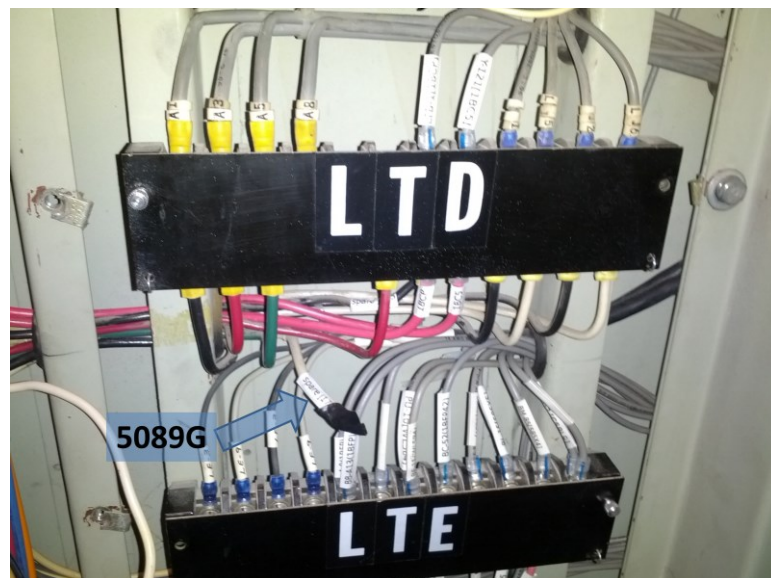
However, the third, which proved to be correct, was the discovery of a lifted residual wire in the 5088 CT circuit connected to the unit 1 feeder differential relays. This was found by visual inspection of the terminal blocks where the CT cables first terminated in the control building. See Figure 8.

Figure 8. Lifted residual wire in 5088 CT circuit to feeder differential circuit (first terminal block in control building).

The misoperation during this event was the trip of the GSU 1 500kV feeder differential, which was due to an open neutral (residual/return) wire in the CT circuit for one of the 500kV breakers.

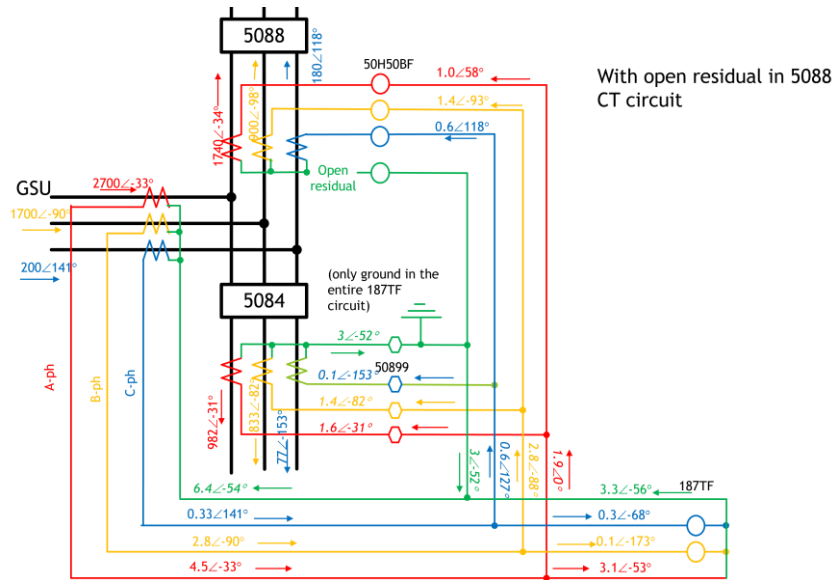
This lifted wire was figured in to the analysis of the secondary circuits, and which produced a current of just over 3A secondary to the A-phase differential relay. See Figure 9. This is about 200% of pickup which for time dial 2 results in an operating time of about 10 cycles, which agrees with the clearing time of 13 cycles including lockout relay and breaker interrupting time. Note the 5088 A-phase secondary current should have been $2.9\angle-34^\circ\text{A}$ ($1716/600$) but was only $1\angle58^\circ\text{A}$ (remaining $3.1\angle-52^\circ\text{A}$ forced thru CT magnetizing branch, due to the

open residual wire). Compare Figure 9 with Figure 10 which shows what the differential relays would have seen if the residual wire had not been lifted.

Figure 9. Unit 1 feeder differential relay currents during initial fault - with lifted 5088 residual wire

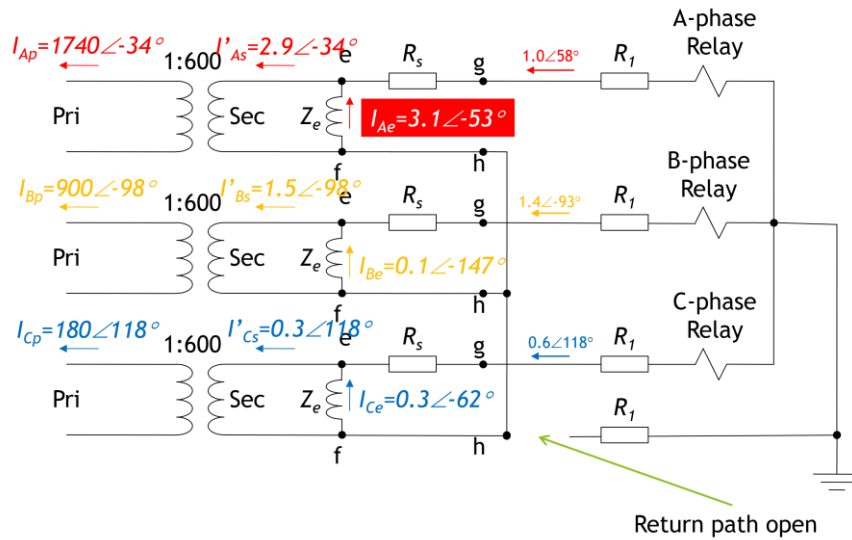
An attempt was made to analyze the CT circuit to see if there was any possibility of CT saturation due to the open residual circuit (see Figure 11). It can be seen from the currents shown that a potential path for the relay current was possibly through the magnetizing branch of the A-phase CT in 5088. So instead of 2.9A reaching the relay, only 1A from 5088 was sent to the relay, contributing to a false differential current and the subsequent misoperation.

Figure 11. Effect of open residual circuit (NOTE: Contribution of 5088 only to the differential relays shown)

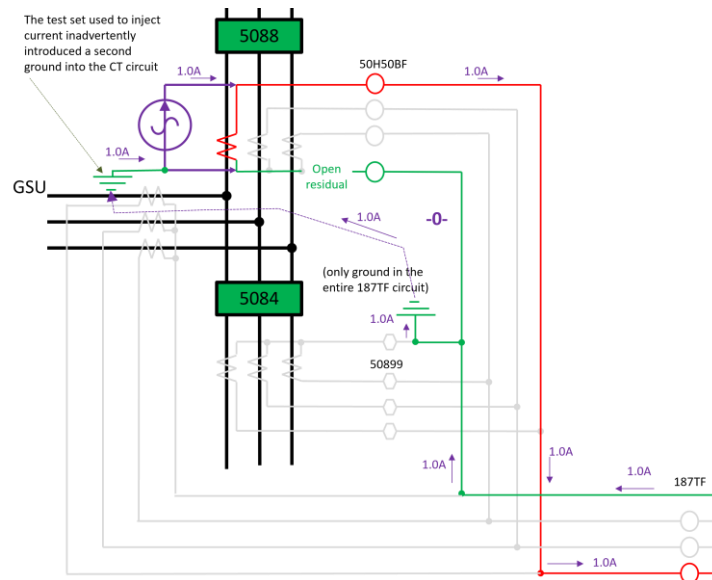
Figure 12. Secondary injection test that “passed”

The reason this was not caught during the secondary injection test is that the non-polarity terminal of the current test source is connected to chassis ground which is tied to the station ground mat through the three-prong power supply plug of the test set. See Figure 12. When current was injected in A-phase of the 5088 CT secondary circuit, the current passed from the yard through the cable to the control building, through the A-phase relay, returning through the single house ground to the station ground mat. So, the test set return ground was a false path.

When performing secondary injection testing, the presence of test set grounds must be accounted for in the circuit analysis.

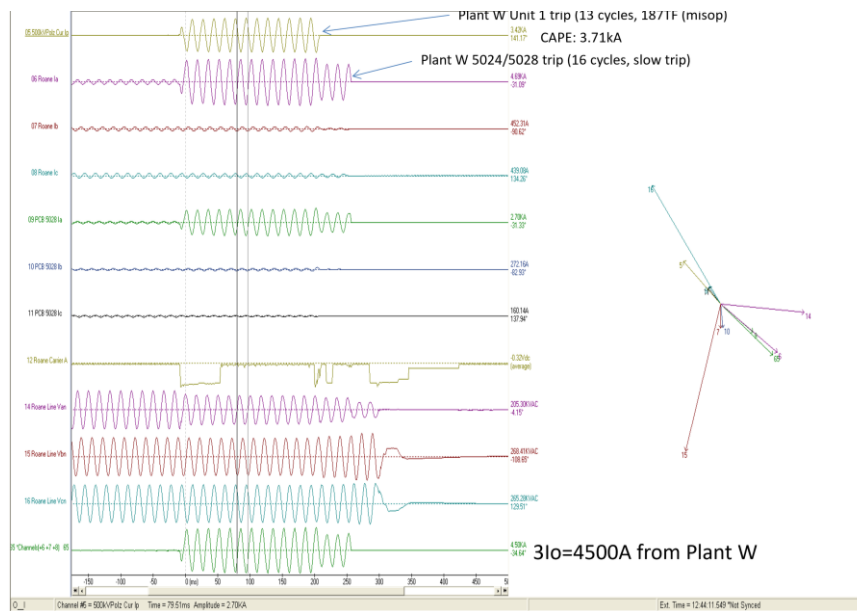
Figure 13. Initial fault DFR shot at Plant W, Substation R line quantities

The Plant W 5024/5028 terminal took 16 cycles to clear the initial fault and took 9 cycles to clear the subsequent fault. Both sets of static relays had targets (PH/G/T1/T2/T3/T4). Fault data was available from the station digital fault recorder, which revealed the faulted phase voltage sagged to about 71% of nominal, with faulted phase current of 4690A and residual current of 4500A. The fault angle was 26 degrees, indicative of the 19-ohm resistive fault.

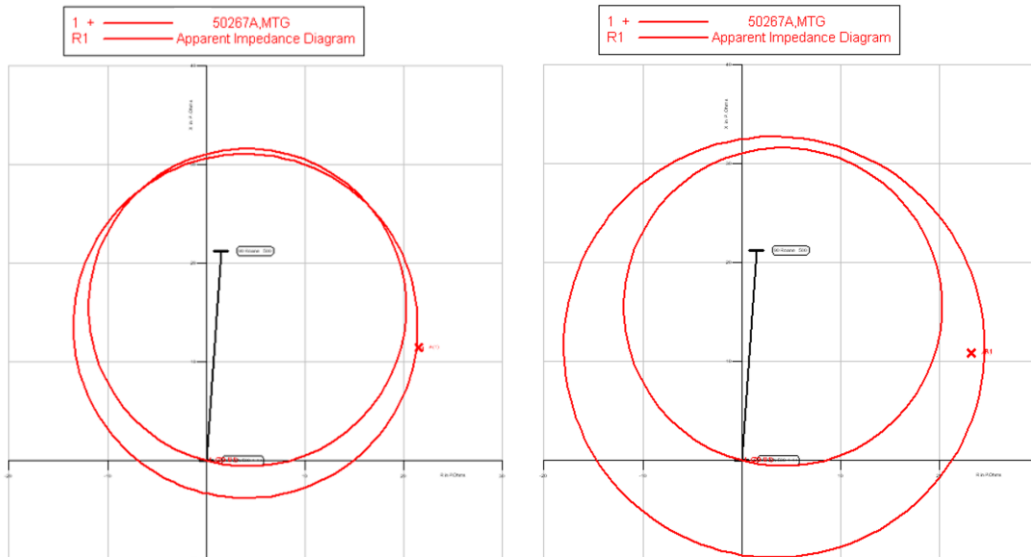
But it was expected the ground distance element should have. It should be noted that the G2 element is a residual ground fault detector only; it is NOT a sensitive ground directional overcurrent element. The only remaining tripping element is the MTG mho ground distance element. And it can be seen from Figure 14 that the resistive reach of the static mho characteristic is about 20 ohms primary.

The fault information was used in the short-circuit program and the apparent impedance seen by the ground distance was plotted (see Figure 14, left plot). Even with dynamic expansion of the mho element, the measured impedance is initially just outside the characteristic.

However, after the misoperation of the Unit 1 feeder and subsequent loss of fault current contribution from that source, the apparent impedance DID fall just inside the expanded mho characteristic (see Figure 14, right plot).

Thus, it was concluded that the limited resistive coverage of the MTG ground distance element was the reason for the slow trip.

Figure 14. R-X plot, SLYG ground distance element, Initial fault, Plant W terminal (each major division = 10 ohms primary) (left=Initial fault, right=after Unit 1 trip)

Present TVA practice continues to implement the overreaching ground distance mho elements in pilot schemes, with the addition of a low set carrier ground overcurrent trip element providing the 40 ohms of resistive coverage.

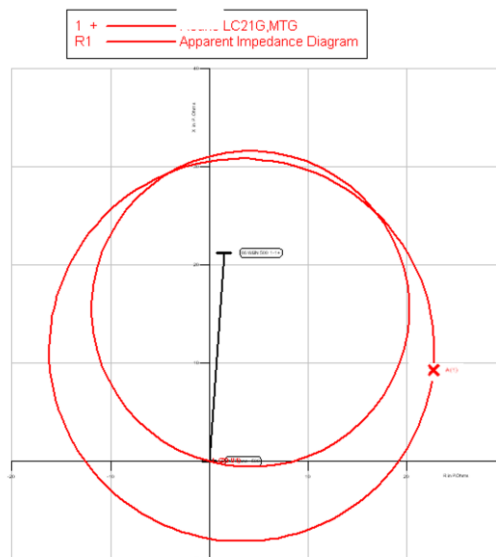
Figure 15. R-X plot, SLYG ground distance element, Initial fault, Substation R terminal

Given the single-ended fault information, the apparent impedance seen by the ground distance at this terminal was plotted. Once again, even with dynamic expansion of the mho element, the measured impedance is initially just on the edge of the characteristic (Figure 15).

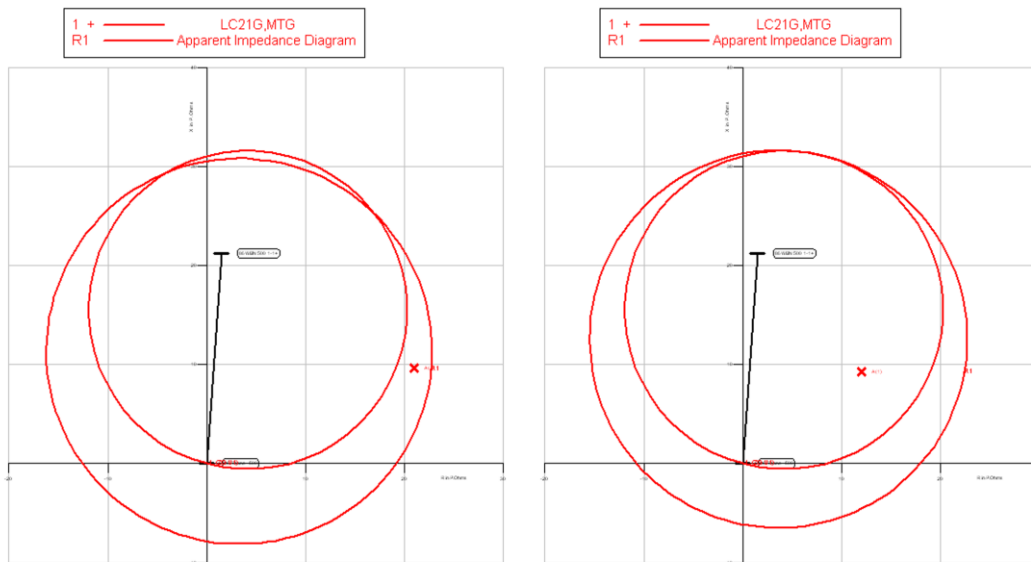
Even after Unit 1 tripped at Plant W, the apparent impedance was only slightly inside the expanded mho characteristic. But after the Plant W line terminal tripped, the apparent impedance was well within the characteristic. See Figure 16.

Figure 16. R-X plot, SLYG ground distance element, Initial fault, Substation R terminal (left=after Unit 1 trip, right=after Plant W terminal trip)

With no targets on the static relays at Substation R, and only the backup ground IOC target, we concluded that the SLYG ground distance element would have operated after Plant W terminal opened but the ground IOC element beat it. We had no record of the actual current contribution from this terminal, but the short circuit program estimated 5600A which was over the 4200A pickup.
