# Analysis of the misoperation of DCB scheme for transmission line protection

Song Ji, Yujie Irene Lu, Michael Gregg & Jim Murphy, National Grid USA

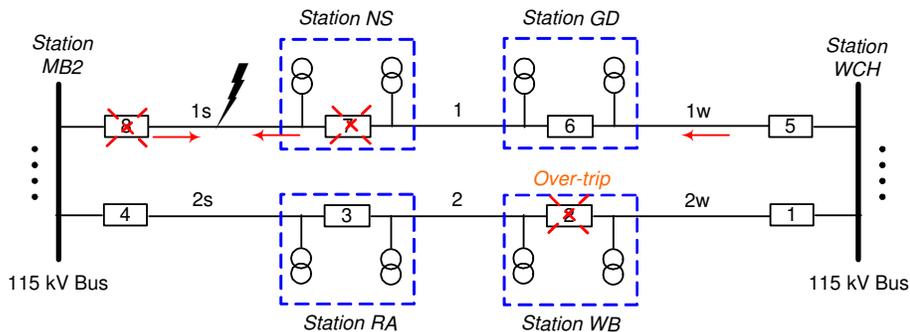
Figure 2: Fault on line 1s on May 29 of 2013 and breaker Status

On May 29 of 2013, a momentary ground fault, caused by lightning stroke, was on line 1s between stations MB2 and NS. The line 1s was tripped from both ends and then successfully reclosed. However, in the mean time, in-line breaker 2 at WB station (see Figure 2) was single ended tripped by line 2w DCB scheme.

- 2) The line 1s breaker 8 at MB2 tripped correctly prior to the line 1s in-line breaker 7 at NS station. Open of the breaker 8 resulted in the current reversal on line 2s, 2 and 2w. The current reversal occurred in 58ms after the original line 1s fault (see Figure 3 & 4).

- 4) In-line breaker 2 at station WB was tripped by the CDG element of the line 2w DCB scheme due to the early dropout of the received carrier blocking signal from the remote terminal WCH (see Figure 3 & 4).

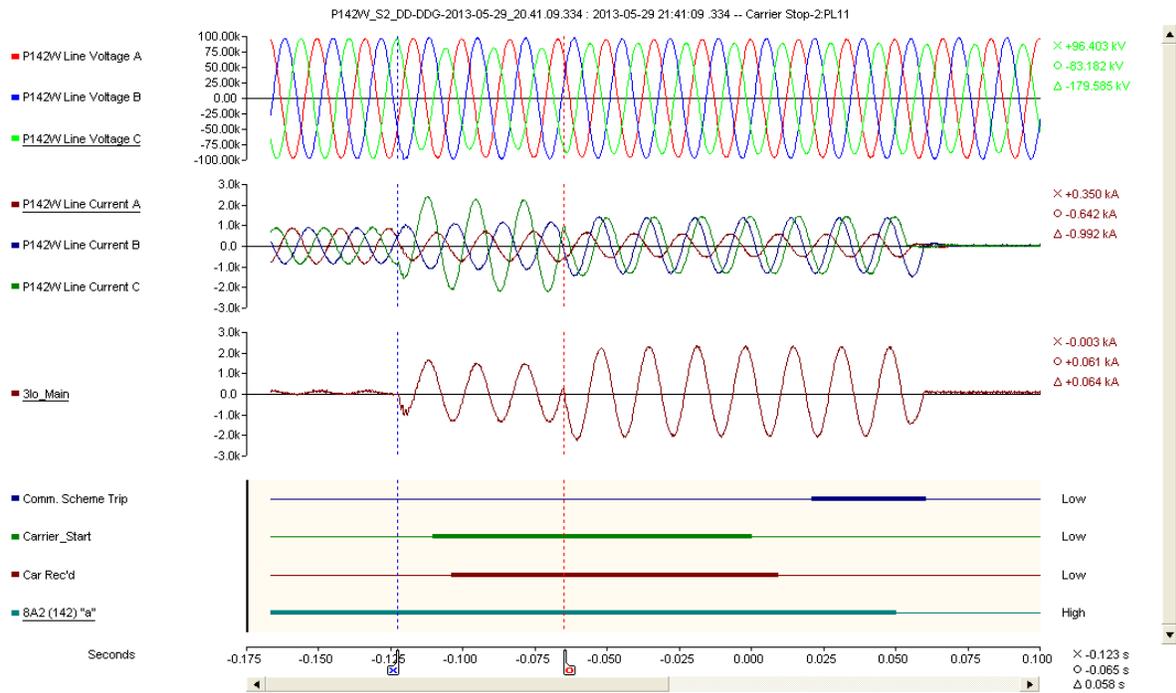
Figure 3: Line 2w relay record of DCB scheme at WB station

- 1) The original fault current flow direction on line 2s, 2, and 2w was from WCH to MB2, which can be confirmed by the assertion of “Carrier Start” in the digital trace of the line 2w relay records at WB (see Figure 3)

- 3) After the current reversal, the fault current flow direction on line 2s, 2, and 2w was then reversed from MB2 to WCH. The relay of line 2w at WB now sensed the fault as in forward direction and carrier directional ground OC trip element (CDG) of the DCB scheme would make a trip if the blocking signal from the remote terminal was not present.

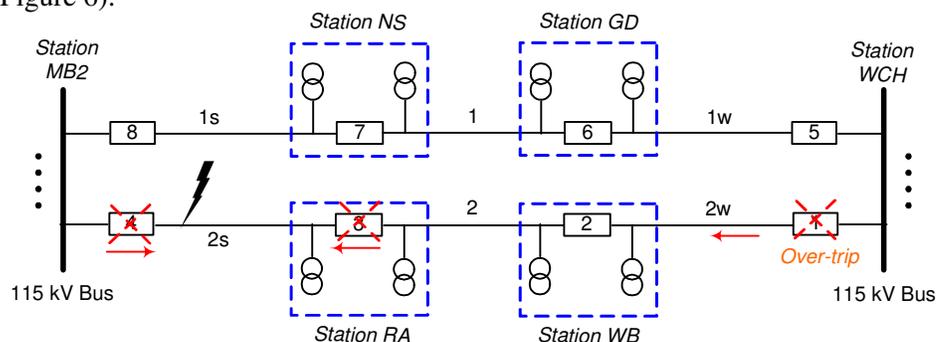
Figure 5: Fault on line 2s on July 3<sup>rd</sup> of 2014 and breaker trips

On July 3<sup>rd</sup> of 2014, a ground fault occurred on 2s line and the faulted line was correctly isolated from both line terminals MB2 & RA respectively. In the event of line 2s trip, line 2w breaker 1 at WCH station was unexpectedly over-tripped by DCB scheme of line 2w, resulting in the loss of the power supply at the tapped station WB. Since there were two in-line breaker stations between the faulted line 2s and the WCH station, the trip of line 2w line breaker at WCH was definitely undesired and should have been avoided. See Figure 5.

On July 3<sup>rd</sup> of 2014, a ground fault occurred on line 2s. The line 2w breaker 1 at WCH station was over-tripped by line 2w DCB scheme on the fault prior to the in-line breaker 3 trip at station RA (see Figure 5). As a result, the whole station WB lost the power supply. The line 2w relay record of DCB scheme from station WCH is shown in Figure 6.

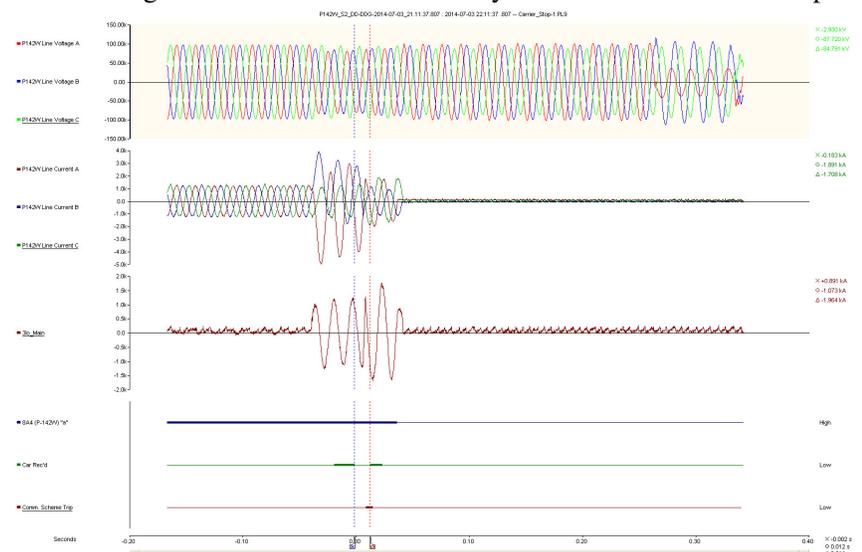
Figure 6: Line 2w relay record of DCB scheme at WCH station on July 3 2014

Prior to the in-line breaker 3 open, the carrier signal of the line 2w DCB scheme from WB had been continuously sent to the remote station WCH as the relay of line 2W at station WB sensed this reverse fault. However, line 2w breaker 1 at station WCH was inadvertently over-tripped by DCB scheme due to a carrier hole (see Figure 6).

Per relay record in Figure 6, the duration of 14ms carrier hole was present prior to the DCB scheme operation. The combination of the relay target of the line 2w carrier directional ground OC trip (CDG) and momentary missing of blocking carrier signal resulted in the line 2w trip from WCH terminal only for the line 2s fault.

In addition to the corrections in the communication system, the relay and logic settings were reviewed. By re-reviewing the past twenty years of DCB misoperations due to carrier hole at National Grid New England region, it seems the typical length of the hole is between 8 - 16 ms. Therefore, the setting of 16 ms, i.e. one cycle, for carrier hole extension timer should be able to satisfy most of operational scenarios. Given that the carrier hole extension timer setting on the line 2w was reset from half cycle to one cycle.

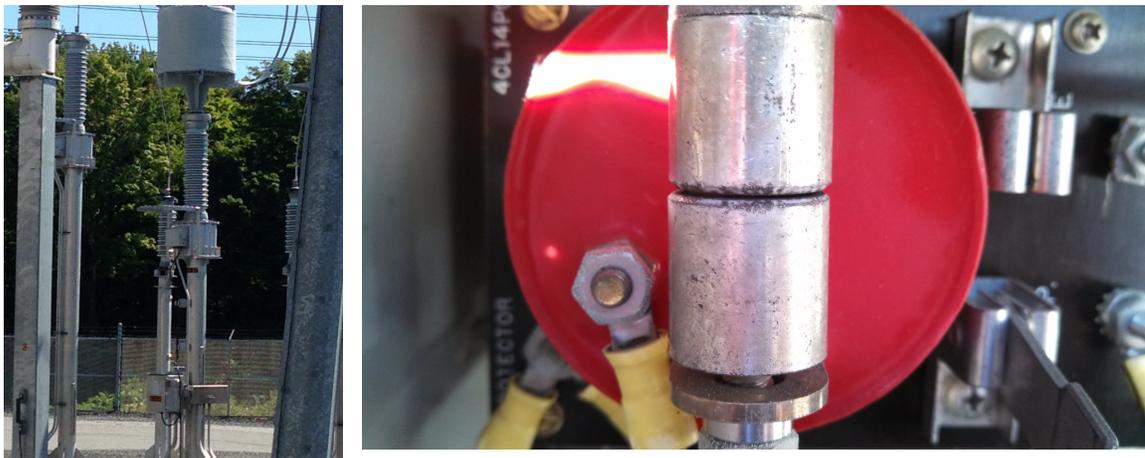
Figure 8: CCVT installation & the protective gap in CCVT with burning marks at WB

Figure 8 indicates the bad status of gap in the line 2w CCVT at WB. As seen in the figure, many burning marks were on the tip or edge of the gap and black color carbons were built-up, which reduced the effective distance of the gap and decreased the threshold of flash-over voltage.

Based on above mentioned findings, the combinations of reduced protective gap in CCVT and improper shield layer grounding of the communication cable were the root cause of the carrier hole. Thus, the protective gap in CCVT was cleaned and re-adjusted; the additional grounding on co-axial cable shield in the field at WB was removed.

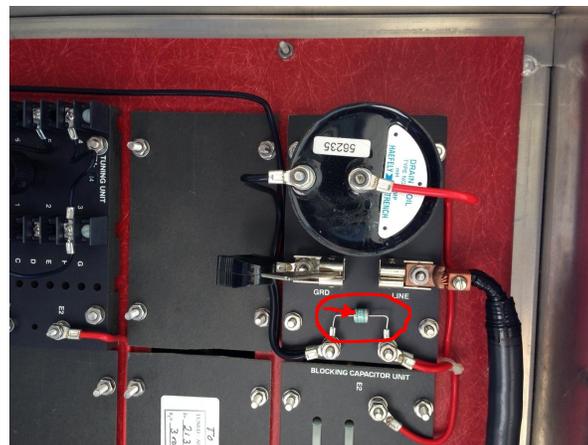
Figure 10, Line tuner and its protective gap

As mentioned before, the protective gaps are provided in CCVT and line tuner. The protective gap in line tuner is normally a sealed, non-translucent gas tube device which corresponds to the insulation level of the line tuner. (Refer to the contents in the red circle in Figure 10)

It is difficult to identify the working status of this tube gap and know whether it has previous discharges due to its non-translucent nature. A vendor in power line carrier industry recently released an innovative spark gap retrofit kit to replace the gas tube gap in the line tuner as shown Figure 11 below.
