Analysis of the Nuisance Tripping of a Dead Line Adjacent to a Faulted Line

By: Dean V. Sorensen (National Grid)

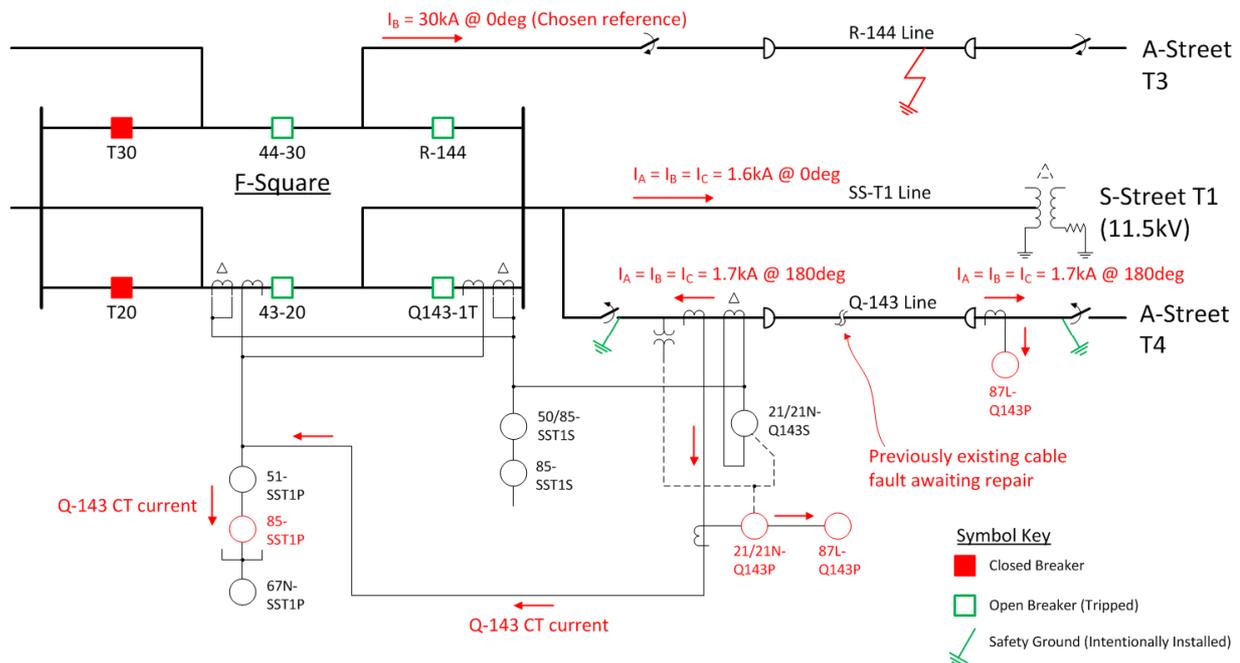
Figure 1: Area 1-Line Diagram Illustrating Operating and Fault Conditions

F-Square Sub is a 115kV station with a breaker-and-a-half bus configuration connecting a number of transmission lines. The R-144 and Q-143 lines are both 115kV 3-phase underground cables, each normally serving a 23kV subtransmission system through delta-grounded zigzag transformers at A-Street Sub. The SS-T1 line is an overhead line which serves 11.5kV distribution load at S-Street Sub through a wye-wye transformer. The Q-143 and SS-T1 lines share the same bay position at F-Square Sub. The 1-line diagram in *Figure 1* illustrates this arrangement.

Before the R-144 fault event, the Q-143 line was in a contingency arrangement (out of service and isolated by open disconnects at each end) because of a previous Q-143 cable fault. This contingency arrangement had been in place for roughly 2 years pending repair of the Q-143 cable. With the Q-143 cable isolated, the corresponding F-Square Sub breakers (43-20 and Q143-1T) were closed to provide normal service for the SS-T1 line. The 1-line diagram in *Figure 1* illustrates these contingency arrangement details as well.

The odd currents observed on the SS-T1 line are a consequence of poor Q-143 cable CT placement. The currents measured by Q-143 line CTs do not properly represent primary side currents. The false Q-143 line CT currents combine with 43-20 and Q143-1T breaker CT currents to form false SS-T1 line currents. *Figure 1* illustrates the flow of CT secondary currents. The prefault SS-T1 line current magnitudes in *Figure 3* are around 100A per phase whereas the current magnitudes during the fault are roughly equivalent to the measured Q-143 line current magnitudes (approximately 1200A per phase). It is clear that the measured SS-T1 line fault currents; which resulted in the misoperation of the SS-T1 pilot wire (85-SST1P) relay at F-Square Sub, were simply the product of bad instrumentation.

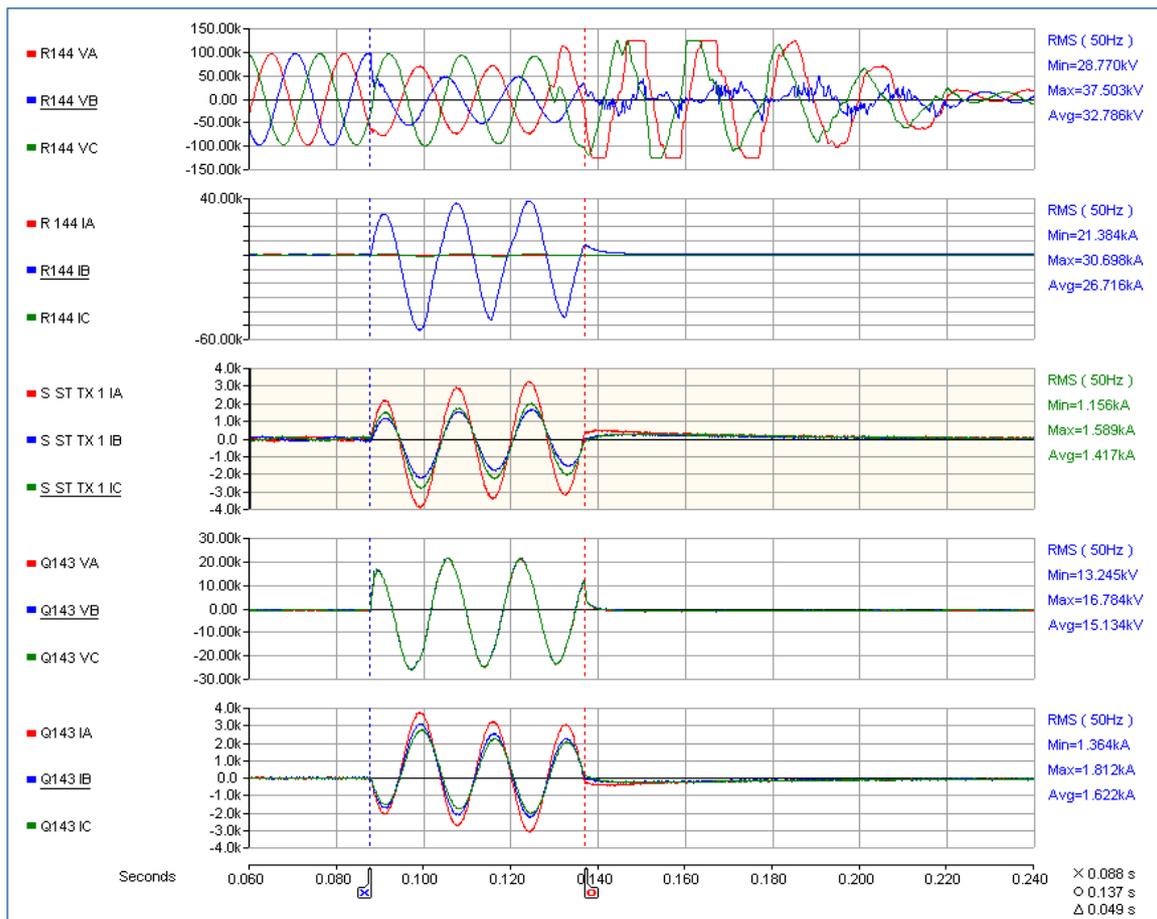
Figure 3: F-Square Sub DFR Waveform Data for the R-144, Q-143 and SS-T1 Lines

A review of the R-144 line voltages and currents in *Figure 3* (top 2 graphs) shows the cable fault to be a B-phase SLG fault (approximately 32.8kA) which was cleared in about 3 cycles. The A-phase voltage signal shows signs of clipping, which is consistent with the observed 59N relay target reported at A-Street.

The waveform data for the Q-143 line in Figure 3 is a stark contrast to that for the R-144 line. That there was any fault current at all on this line is unexpected. That the fault current is entirely zero sequence current (i.e. I_A , I_B and I_C are all predominantly of similar magnitude and are all in phase) is doubly odd. The sequence composition of the Q-143 line current clearly indicates that it did not originate from a balanced 3-phase source. Since the line consists entirely of an underground cable, the current also did not originate from any mutual coupling. Since the cable was isolated from the power system by open disconnects at both ends, how could current of any kind have flowed at all?

SS-T1 line currents in *Figure 3* (3rd graph) are entirely zero sequence current like Q-143 line currents (bottom graph). The direction of Q-143 line current is from F-Square Sub towards the S-Street Sub.

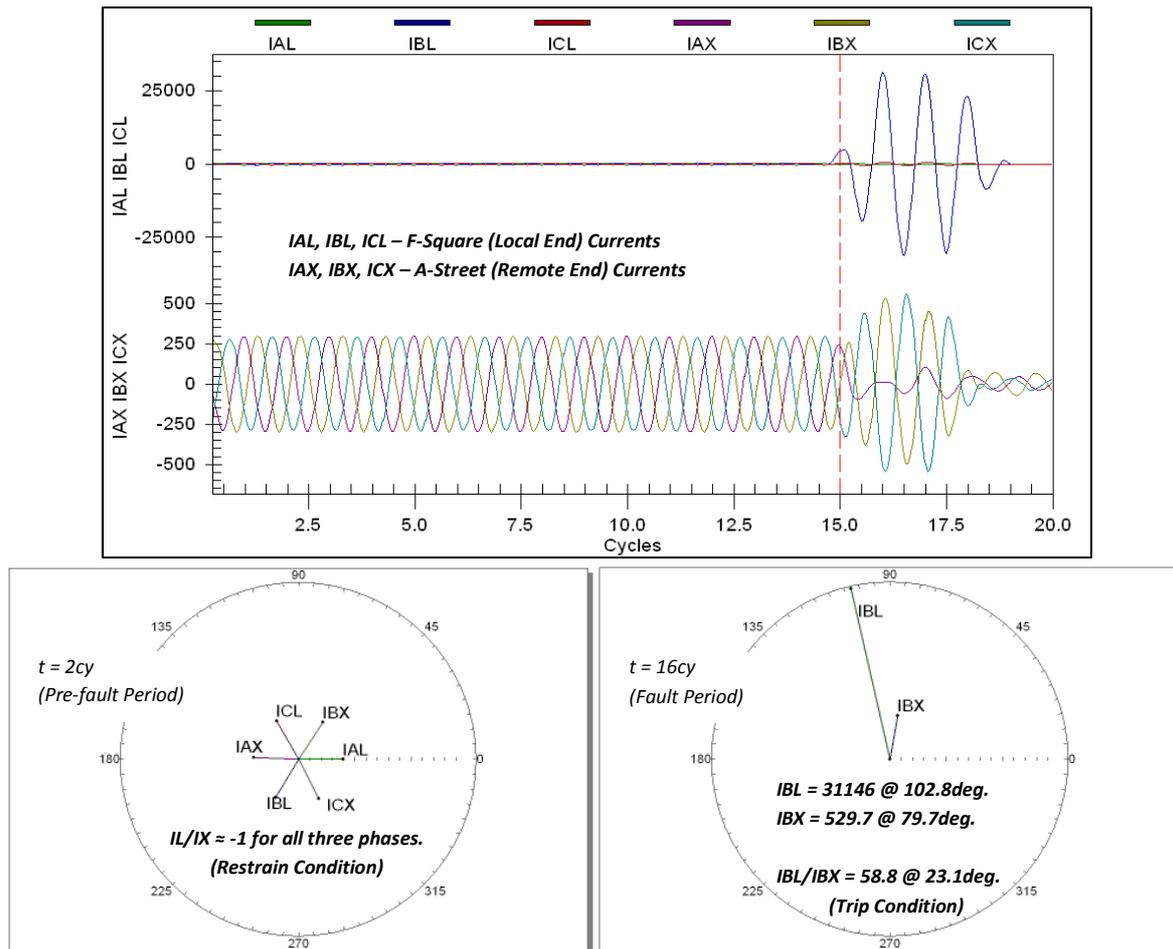
Figure 4: F-Square Sub R-144 Line Multifunction Differential Relay Fault Data

The fault current traces in *Figure 4* from the F-Square Sub R-144 line differential relay provide additional supporting details. The set of local end currents (I_{AL} , I_{BL} , I_{CL}) are a classic SLG fault signature. The remote end currents (I_{AX} , I_{BX} , I_{CX}) illustrate weak infeed from the 23kV subtransmission system appearing as a phase-to-phase fault because of the A-Street step-down transformer's delta-wye winding arrangement. Fault clearing from the A-Street side is also slower (beyond the record limit) because tripping is via 23kV breakers. Also shown in *Figure 4* are phasor comparisons of local and remote currents both before and during the fault, illustrating the differential relay's Alpha-plane performance during both timer periods. Although an Alpha-plane plot couldn't be generated from the relay data

using the vendor's software, the phasor comparisons show the pre-fault IL/IX ratios plot inside the restrain region whereas the fault IL/IX ratios plot well outside the restrain region.

Overall, this part of the event was unremarkably a correct operation.

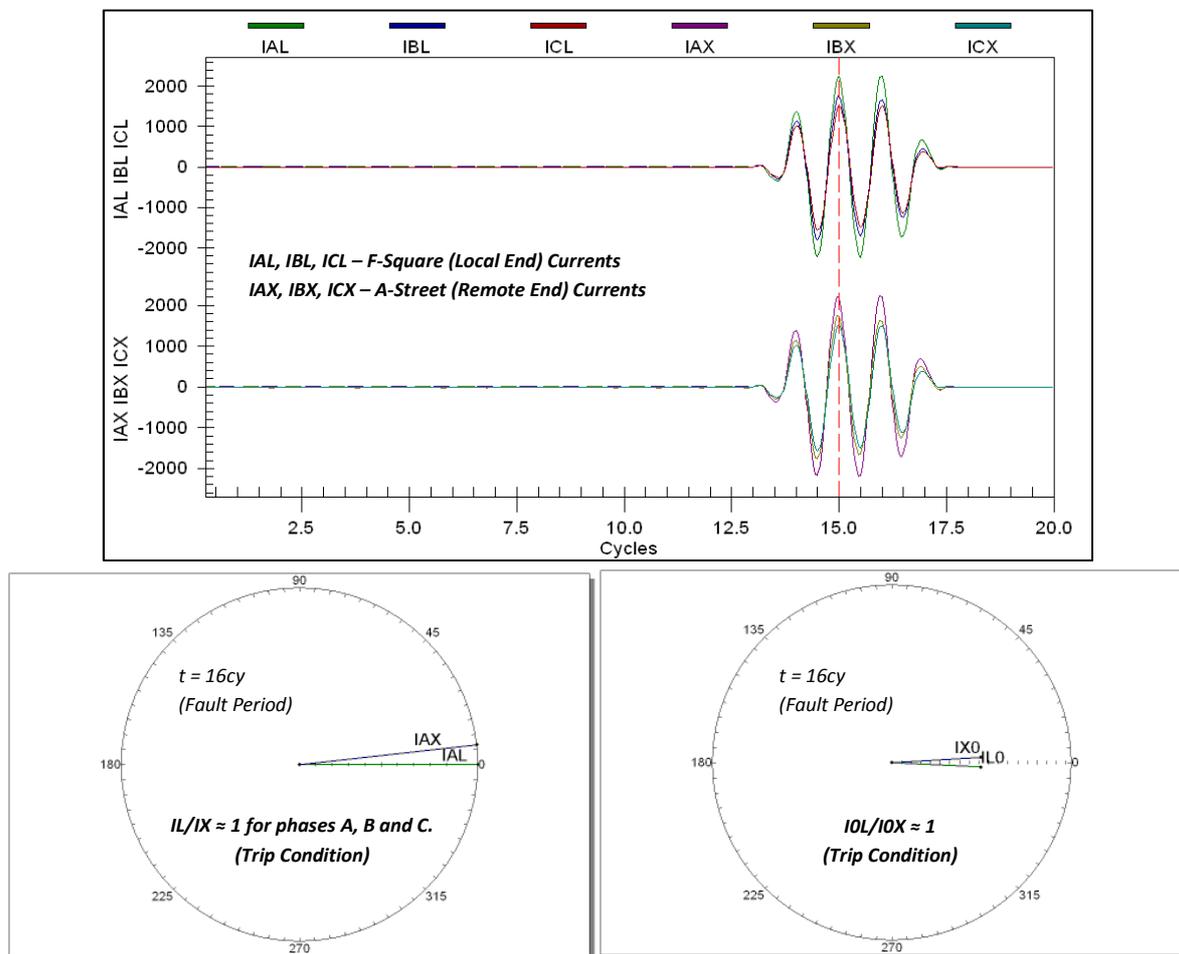
Figure 5: F-Square Sub Q-143 Line System 1 Multifunction Differential Relay Fault Data

Starting with the System 1 differential (87L) protections, the waveform record in *Figure 5* indicates that all zero sequence current exited the cable through CTs at both ends (i.e. I_L currents were in phase with I_X currents). The Alpha-plane response I_L/I_X evaluates to $I_L/I_X \geq 0$ for A, B and C phases as well as I_0 ,

which is a trip state and is consistent with the observed targets. Normally, local and remote line currents being in phase indicates current entering the cable at both ends because of an internal fault. However, a comparison of F-Square Sub Q-143 line and R-144 line B-phase currents (Refer to *Figure 3*) suggests that Q-143 line current is flowing from the cable towards F-Square Sub on that side and consequently from the cable towards A-Street Sub at the remote end. How is this possible? One possible explanation is that the damage point on the Q-143 cable provides a ground point between the safety grounds, which then splits the return current. Another possibility is the presence of an additional safety ground at one or both of the cable terminations. Unfortunately a positive determination could not be made for either conjecture. Even so, the observed line currents and 87L relay behavior is consistent with the addition of safety grounds.

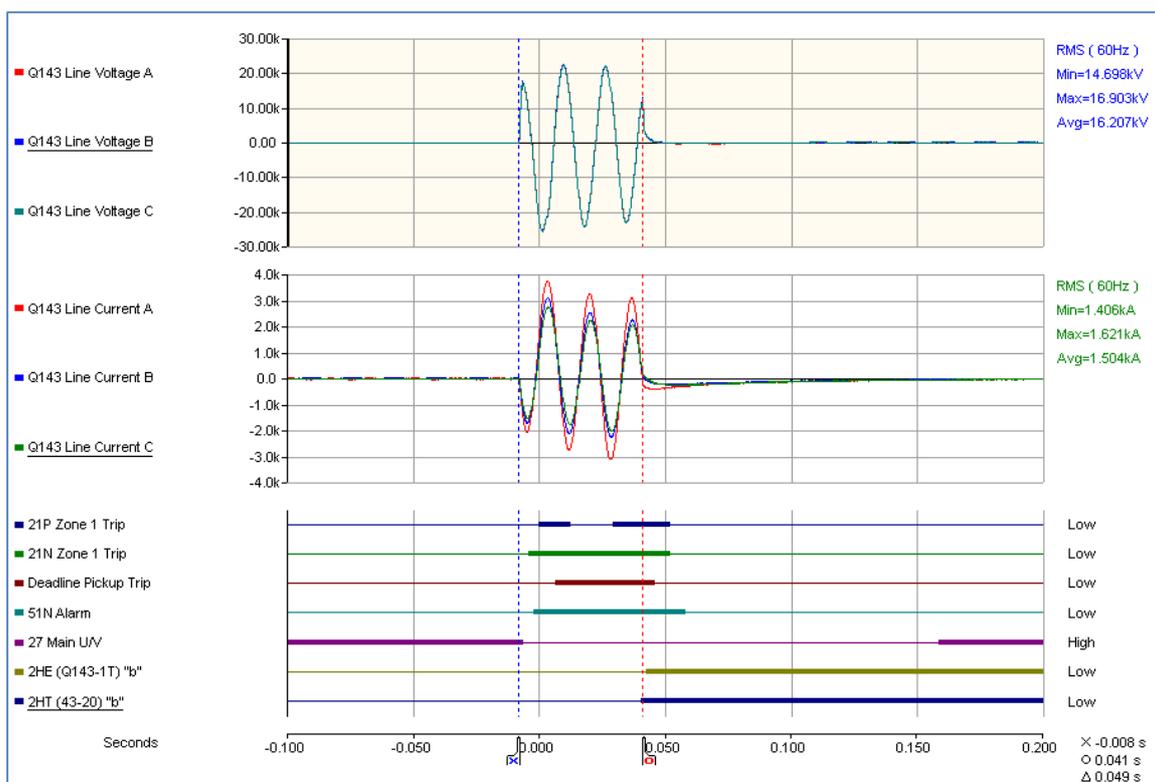
Figure 6: F-Square Sub Q-143 Line System 1 Multifunction Distance Relay Fault Data

The distance relay behavior is less straightforward. F-Square System 1 distance (21/21N-Q143P) protections operated whereas System 2 distance (21/21N-Q143S) protections did not. Nonoperation of the System 2 relay is explained by the observation that it is fed by delta configured CTs; which block the flow of zero sequence current to the relay. For the System 1 relay, *Figure 6* shows the apparent impedances as plotting behind the relay. This is consistent with the reported distance-to-fault being negative. It is also consistent with the current direction inferred from the 87L relay data. Note that the measured voltages are simply the voltage drops on each phase between the CTs and the safety ground behind them produced by the measured all-zero-sequence line current. Effectively, the apparent impedances represent the line impedances between the relay location and the safety ground behind it.

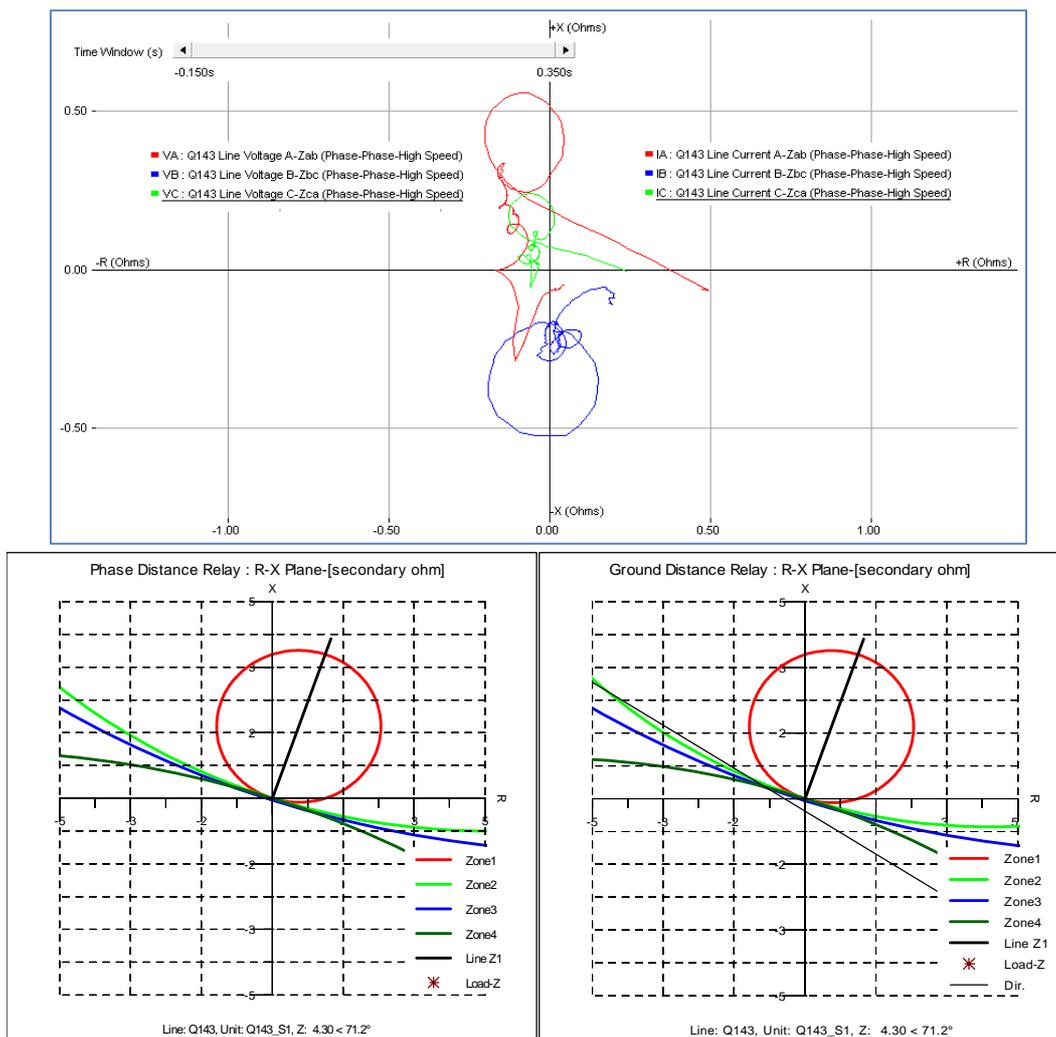
Figure 7: Comparison of F-Square Sub Q-143 Line Apparent Impedance Trajectories With Q-143 Line System 1 Relay Distance Element Setting Characteristics

A comparison of the impedance trajectories with the 21/21N-1 reach settings in *Figure 7* show that the apparent impedances for phases A and C plot well within the Zone 1 characteristic. Depending on the dynamic characteristic of the B-Phase B it is likely that the B-Phase impedance trajectory passed through the Zone 1 characteristic long enough for it to have asserted since a B-Phase target was also reported. This misoperation is simply a consequence of the CTs and VTs having been located inside the open disconnects. While the cable was isolated from the power system, the instrument transformers were still sending active voltages and currents to the relays. From this analysis, the observed 21/21N-Q143P relay behavior seems consistent with the addition of safety grounds.
