# Field Experience with CT Saturation Due To Forced Current Re-distribution

Hongbo Apollo Zhang and Ralph Peter Barone, BC Hydro

**Abstract** - This paper describes field experience with protection mis-operations caused by CT saturation subsequent to disturbance of CT secondary circuit connections. The increased excitation current associated with CT saturation allows the CT secondary currents to change in both magnitude and direction in order to accommodate the constraints of the circuit. By analyzing two system disturbance events described in this paper, the authors are able to use simple circuit analysis to explain why and how these changes occurred and to predict the new equilibrium state.

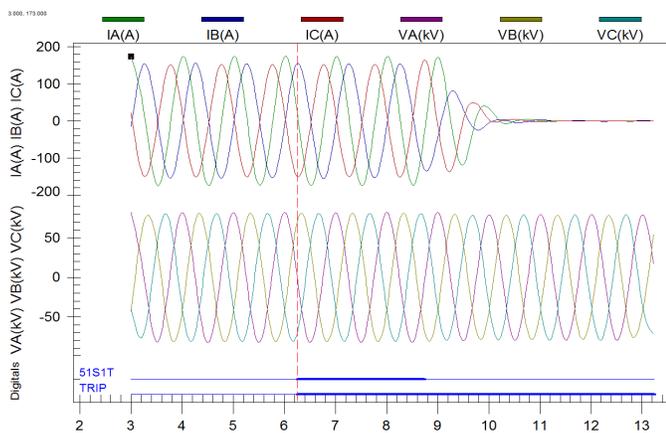
Fig. 3 1L243 Event Record

The target was found to be B-G fault on the primary relay (21L), however no event record was triggered on the standby relay (21LS). A review of the primary relay event record shows that line voltages were healthy; but currents in B and C phase were atypical, almost 180 degrees out of phase. Figure 3 is the event record showing the line voltage and current waveforms. The primary protection relay detected an intermittent residual over-current (3I0), and triggered a series of event records until it finally timed out and issued a non-reclosable trip.

Further review of the COMTRADE event record (which shows both CT inputs separately) revealed the source of disturbed current reading was from the 1CB17 CT, while 1CB18 CT currents remained small but balanced. 1CB17 was taken out of service for inspection. Later, it was reported that one loose connection was found in the 1CB17-CT1 neutral connection.

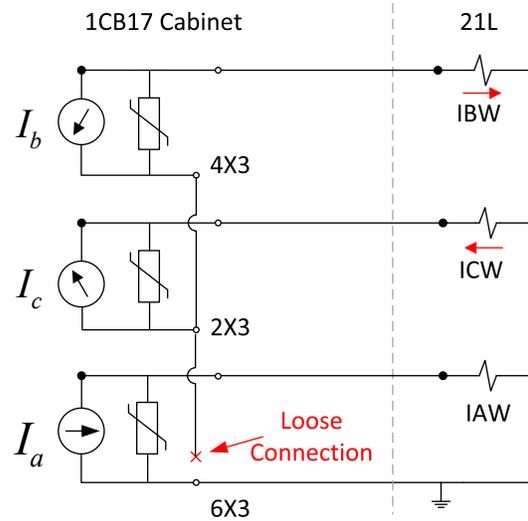
Fig. 4 Simplified 1CB17 CT Connection Diagram

Figure 4 is a simplified wiring diagram for the 1CB17-CT1 connection. The CT was Wye-connected. Referring to Figure 4 below, the loose connection was found at 6X3 which is the neutral connection between C phase and A phase CTs. This disconnection effectively separated the Wye-connected three phase CT circuit into two separate circuits. The A phase CT was connected normally to the relay and neutral, however, B and C phase CTs were in series without a connection to the neutral. Basic circuit analysis shows that the only solution is for  $I_b$  and  $I_c$  at the relay to be of equal magnitude and opposite direction.

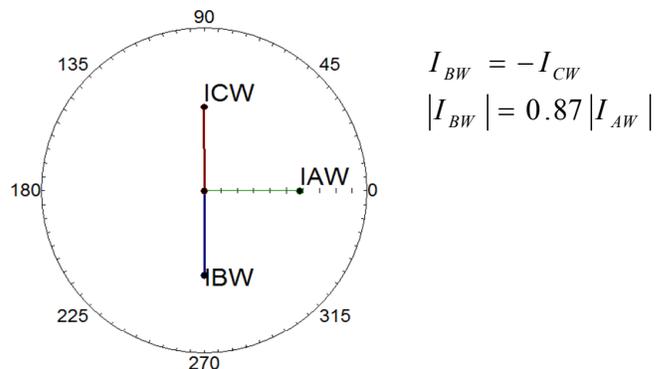
Fig. 5 Phasor Diagram of 1CB17 CT Currents after Re-distribution

The root cause of the protection mis-operation was simple. However, it is interesting to a protection engineer that currents on B and C phase not only shifted in angle to become opposite in direction, but also reduced in magnitude to approximately 87% of their original value, as shown in Figure 5. How did it reach the new steady state?

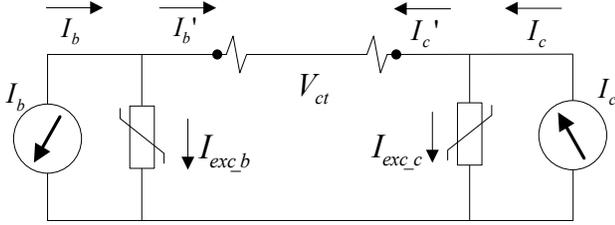
Fig. 6 Event #1 CT Secondary Circuit

The answer comes from applying basic circuit analysis theory. If we redraw the circuit as in Figure 6, we can determine by inspection that  $I_b' = -I_c'$ .

If we make the further assumption that the wire and relay burden between the two excitation circuits is small with respect to the impedance of the magnetizing branches<sup>1</sup>, then we can make a further simplification of the equivalent circuit and state that the terminal voltage  $V_{ct}$  for both CTs is identical, meaning that if the CTs have identical excitation characteristics, the excitation current in both CTs must be identical, i.e.  $I_{exc\_b} = I_{exc\_c}$ . Further algebraic simplification results in the solution below.

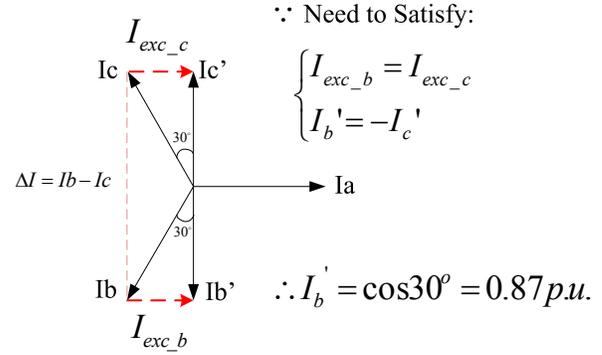
Fig. 7 Excitation current aligns current phasors

As shown in Figure 7, the excitation current required to reach the new balance state causes a 30 degree shift each way and forms a right-angled triangle. The red arrow indicates the excitation current. A simple calculation proves that the new steady state current is equal to  $\cos(30^\circ)$  or 87% of the original magnitude. This mathematically confirms the phasor

It is noted that because the primary system is well balanced, the current angle shift for both CTs is identical at 30 degrees. If the pre-disturbance condition currents were not perfectly matched, the angle change would be different, as will be seen in the next event.

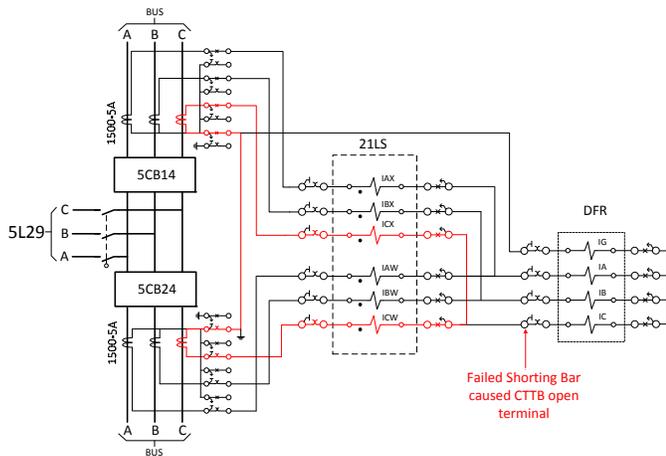
Fig. 8 Simplified Three Line CT Connection Diagram

A simplified three phase wiring diagram is shown in Figure 8 to illustrate the bushing CT connections to the line protection relay (21LS). It is worth noting that the CTs are connected individually through the relay first before being combined at a Digital Fault recorder (DFR) to record the total line current. For each device, there is a standard CT Test Block (CTTB) to provide shorting and isolating functionality.

It was later reported that a failed shorting bar was found at the DFR CTTB, as shown in Figure 8 above. When the field crew was performing routine maintenance on the DFR, the shorting bar opened rather than shorting to neutral. Hence, the two originally parallel connected CTs formed a series circuit. The currents flowing through ICX and ICW in 21LS relay became equal magnitude and opposite direction, as shown in Figure 9. This explains why the total C phase line current seen by the relay was nearly zero in the event record.

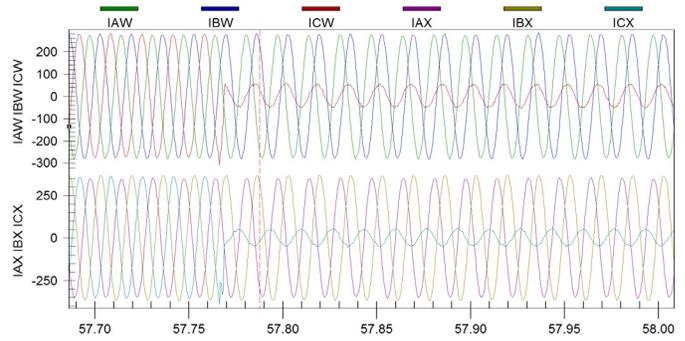
Fig. 9 Event Record Showing Equal and Opposite C Phase Currents

Further investigation analyzed the C phase current from both circuit breakers – 5CB14 and 5CB24. As shown in Figure 9, both breaker CT C phase currents had a step change in magnitude, and the phase angles shifted to become opposite to each other. This effectively resulted in net zero total current and led to the protection mis-operation.

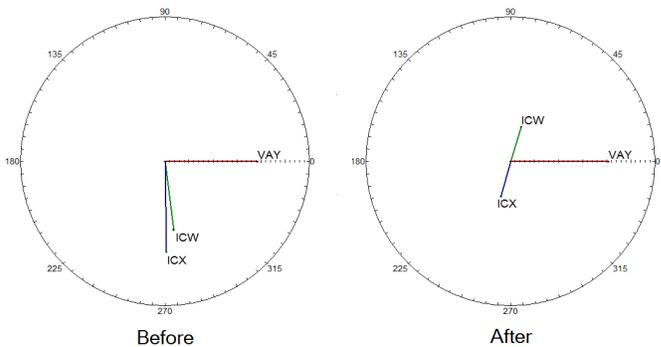
Fig. 10 Current Phasors Before and After the Disturbance (not to scale)

Q1: Similar to Event I above, the originally paralleled CT circuits became series connected. But the behavior of the relay currents was quite different. In Event I, the magnitude of currents reduced to 87% after the disturbance, but in this event, the post-disturbance currents were much smaller, only 16% or less of the original magnitude. In addition, both currents show unequal phase shifts. As can be seen in Figure 10, ICW’s angle shifted more than ICX’s. Given that these two CTs are of same type, why would they behave differently?

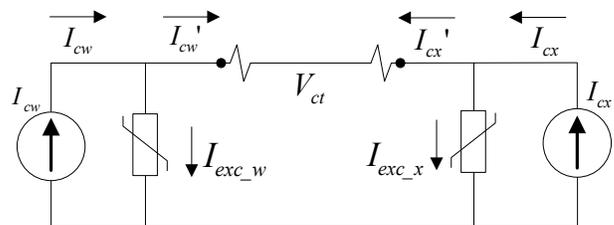
Fig. 11 Event #II CT Secondary Circuit

The equivalent schematic for this event is essentially identical to that of event #I, with only changes to source CT current directions and labels.

Again, this reduces to the same system of algebraic equations we derived for Event I, with the same solution.

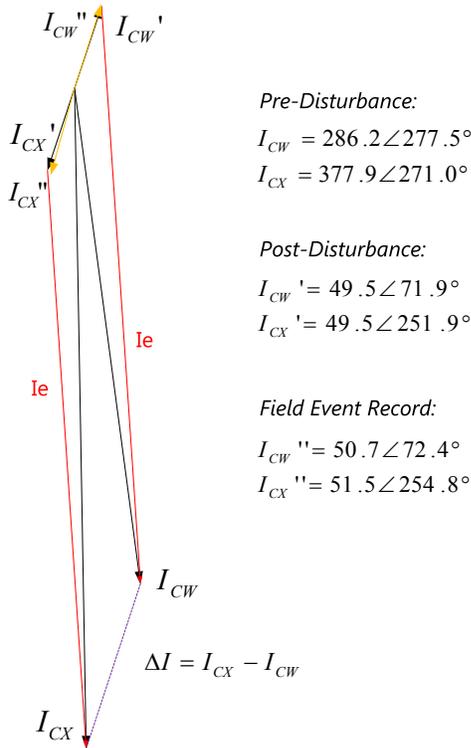
Fig. 12 Theoretical Values vs. Event Record Data

The algebraic solution is plotted in Figure 12, together with the field record values. It clearly shows that the calculated results match the field record. It is noted that the field record is in unfiltered format. The discrepancy may vary at different sampling points, but in general the field record values are within +/- 10% of the calculated value.

It is also interesting to note that the excitation current associated with the 5CB24 CT ( $I_{cw}$ ) exceeds the pre-

disturbance current from the CT in Figure 12. Referring to equation (1), since each CT shares half of the **total** excitation current, it is entirely possible that the excitation current in the CT exceeds the pre-disturbance current.

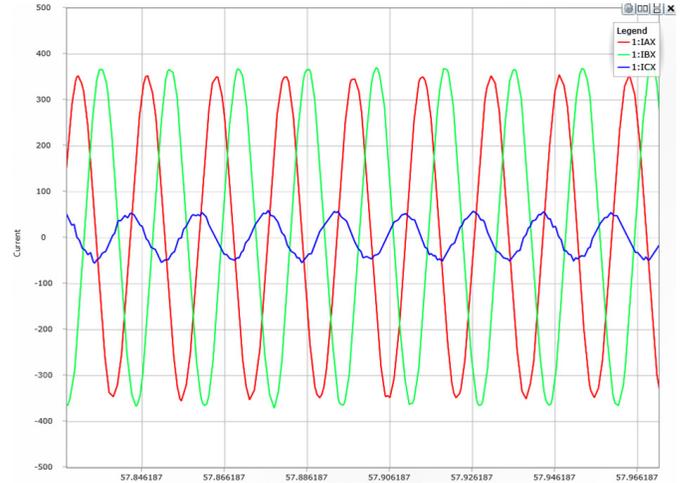
Fig. 13 Atypical Sinusoidal CT Saturation Current Waveform

Q2: The post-disturbance C phase current waveforms are relatively clean and remain sinusoidal, as shown in figure 9 and 13. How did the CTs maintain sinusoidal outputs when they were heavily saturated?

Question 2 in the beginning of this section can be addressed by Equation (1), (2), and (3). Since the relay output current ( $I_{cw}'$  or  $I_{cx}'$ ) is proportional to the difference in the unsaturated CT currents ( $I_{cw}$  and  $I_{cx}$ ), the relay output current will remain sinusoidal even though the CTs are saturating. In addition, the CT excitation current must also remain sinusoidal to satisfy the equations. This will remain true as long as the two CTs have identical excitation characteristics and the voltage drop corresponding to wire and relay burden is minimal with respect to the excitation voltage of the CTs. Figure 13 is a high resolution (2000 samples/sec) event record and the relay current associated with the saturated CTs shows no visible signs of what we typically consider CT saturation.
