GREGG 230 KV SUBSTATION SHUNT CAPACITOR BANK FAILURE AND CASCADING AREA DISTURBANCES

Leo B. Hisugan, Aaron M. Feathers, Fortino Arroyo Rivera
Pacific Gas & Electric Company

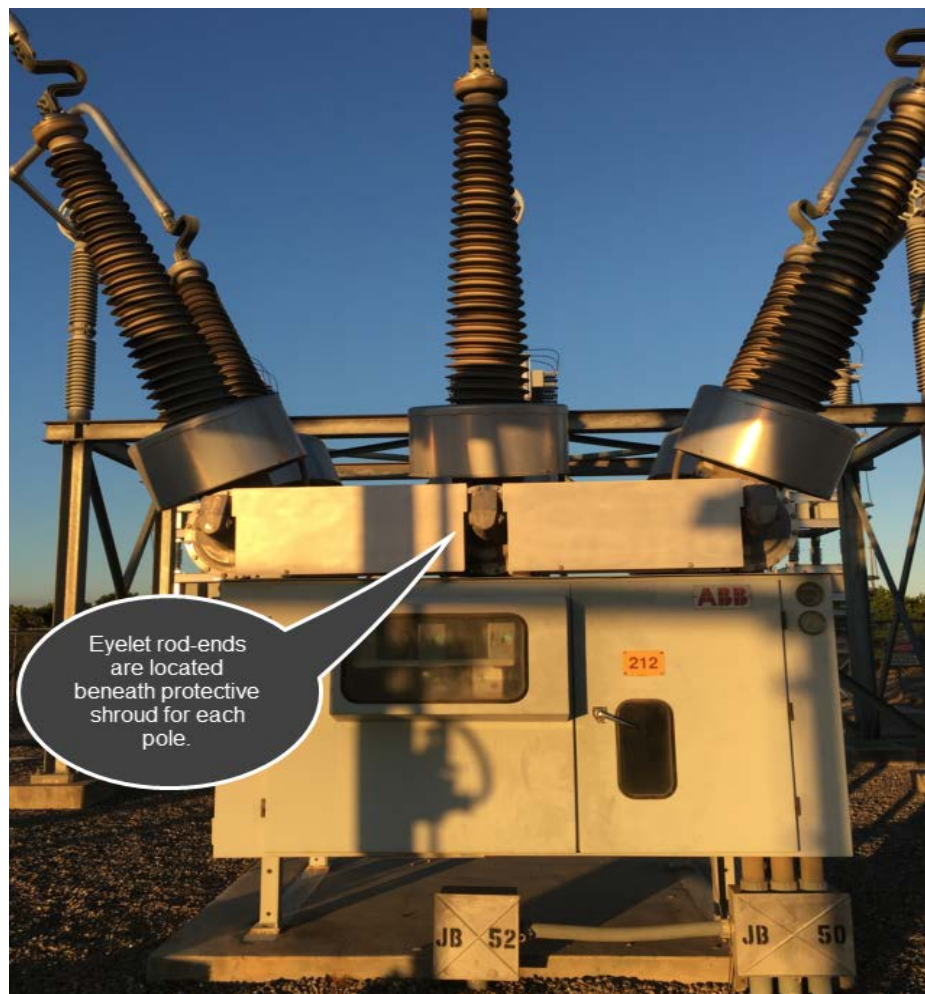
Figure 5 CB 212

- a) The operating rod was out of adjustment as evidence of mechanical stress indicated on the rod-end eyelet bolt.
- b) The threads on the front side of the rod-end eyelet bolt were compressed together while the rear side threads were spread apart indicating that the mechanical failure of the rod-end eyelet occurred during the last close operation that took place on Monday 06/13/16 at 02:54 hrs.
- c) The rod-end eyelet bolt appeared to have been fractured on the rear side for some time to allow a small portion of the metal to grind smooth and flat, and the

remainder of the eyelet bolt material finally snapped due to fatigue.

- d) The left pole showed evidence of over-travel as a small mark on the rod was evident on the top side of the operating pullrod surface where it had been making contact with the bellcrank assembly.
- e) Removal of the upper retaining pin revealed excessive wear at the interphase shaft slots and it is believed that the wear could explain the minor over-travel.

The mechanical failure point was obstructed by a protective shroud above the breaker mechanism cabinet furthermore concealing the issue.

- Replaced Gregg CB 212 with new synchronous control unit, zero voltage crossing closing circuit breaker.
- Checked all other breakers for similar problems.
- Replaced Phase “C” Capacitor Bank units and associated metering and relaying components.
- Corrected breaker failure relay settings on Gregg CB 212.
- Checked and verified all other breaker fail relay settings matched the setting of record.
- Replace Gregg CB 212 and CB 222 breaker failure relays with new microprocessor relays per PG&E strategy and to modernize and incorporate additional security features.

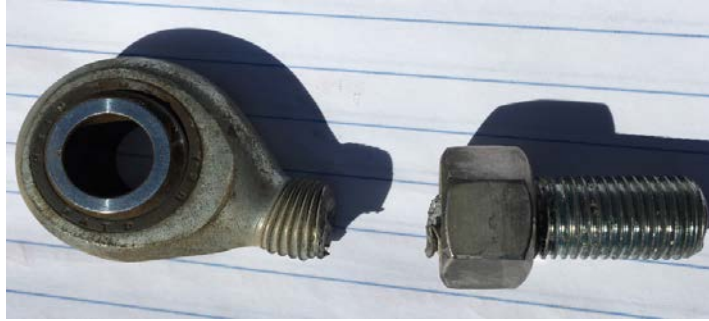
Figure 6 CB 212 rod-end eyelet bolt

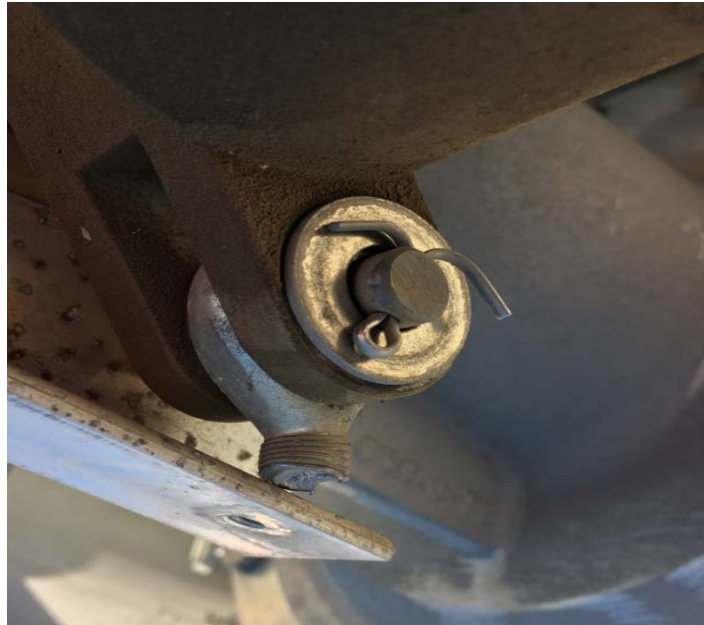
Figure 7 CB 212 rod-end eye bolt with retaining ring

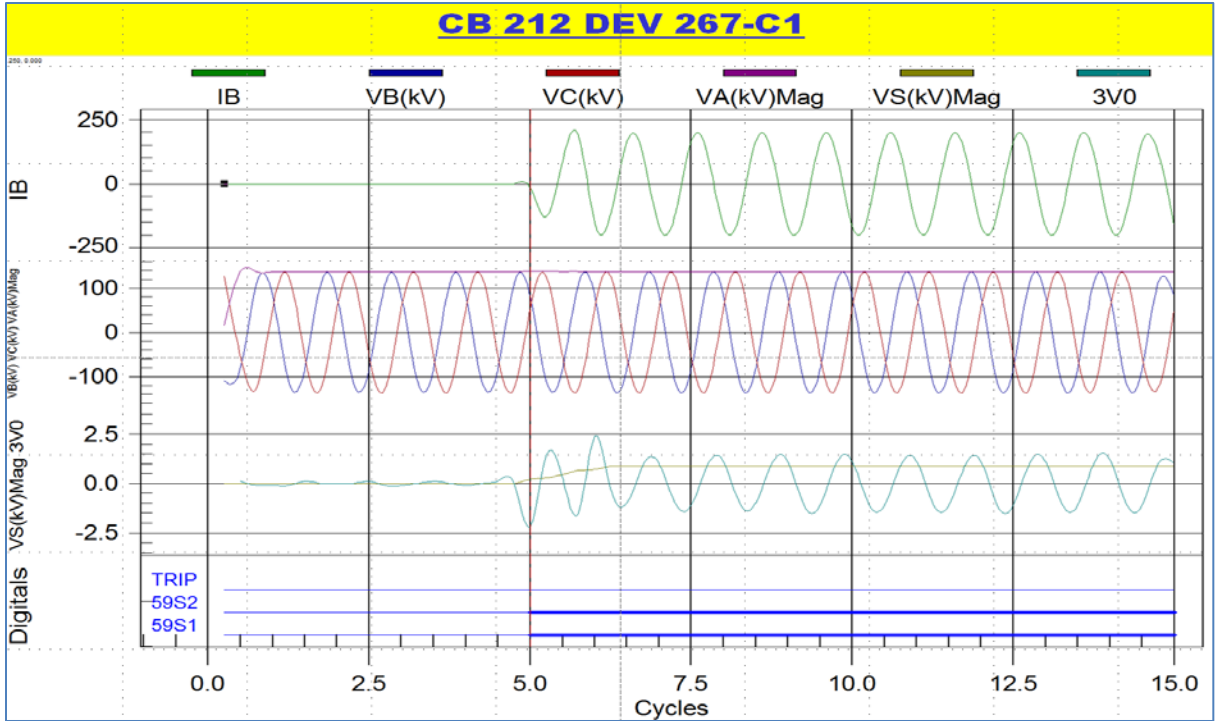
Figure 8 CB 212, Device 267-C1 Oscillography

Based on the events retrieved from microprocessor relays, prolonged voltage impressed on the neutral caps was seen exceeding 1100 volts rms, or 1556 volts peak voltage, and 2400 volts 3V0, Zero Sequence Voltage, for more than 65 seconds. This 1100 volts rms is 133% above the rated terminal voltage, 825 volts rms, of the Neutral Capacitors. This explain why the single line to ground fault took so long to develop (**65 seconds**) as it gradually broke down the LV Capacitor insulation until it catastrophically failed. **LV Capacitor voltage surge** was due to **single phase arcing of the disconnect switch 211 to the capacitor bank Phase C.**

The voltage transients surge (3V0, VS), as seen in the following graph in **Figure 8** could be attributed to voltage instability during inrush, high frequency harmonic current, or unsynchronized closing of breaker pole on zero degree crossing. One or more of these conditions may have transpired by the nature in which the capacitor bank was inserted into the system using a partially closed Switch 211 on Phase “C” only. Harmonic Analysis showed presence of 2nd, 3rd, 4th, 5th, 6th and 7th harmonic currents ranging from 5.35 – 10.16 amps on top of fundamental current, 128.3 Amps.

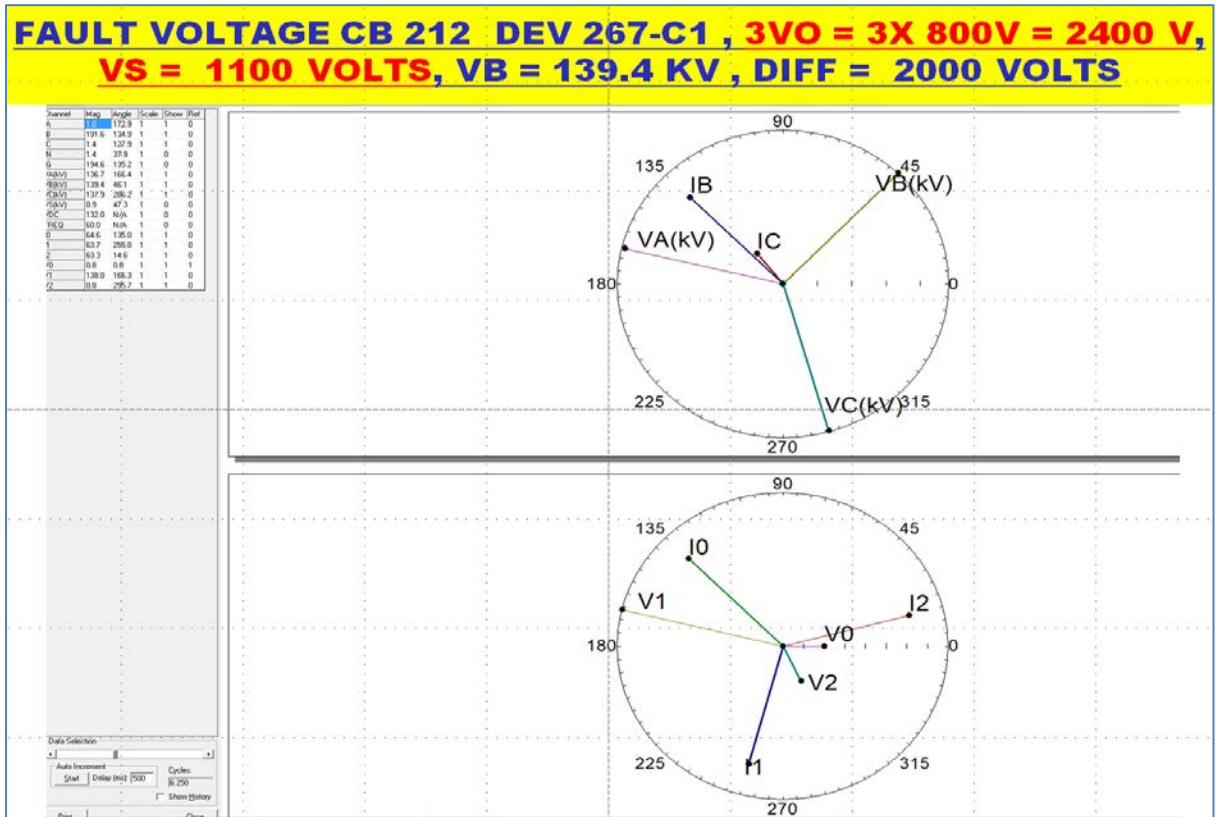
Figure 9 CB 212, Device 267-C1 Phasor Diagram

The partial energization of DSW 211 to the Capacitor Bank 1 on Phase C only, caused an unusual Phase Voltage Imbalance that produced a shift of Neutral (N) star point to Ground (G) point. The Phase C Voltage to Neutral, VCN, shifts to Phase C Voltage to Ground, VCG, when phase imbalance occurred without Phase "A" and Phase "B" of the Capacitor Bank energized.

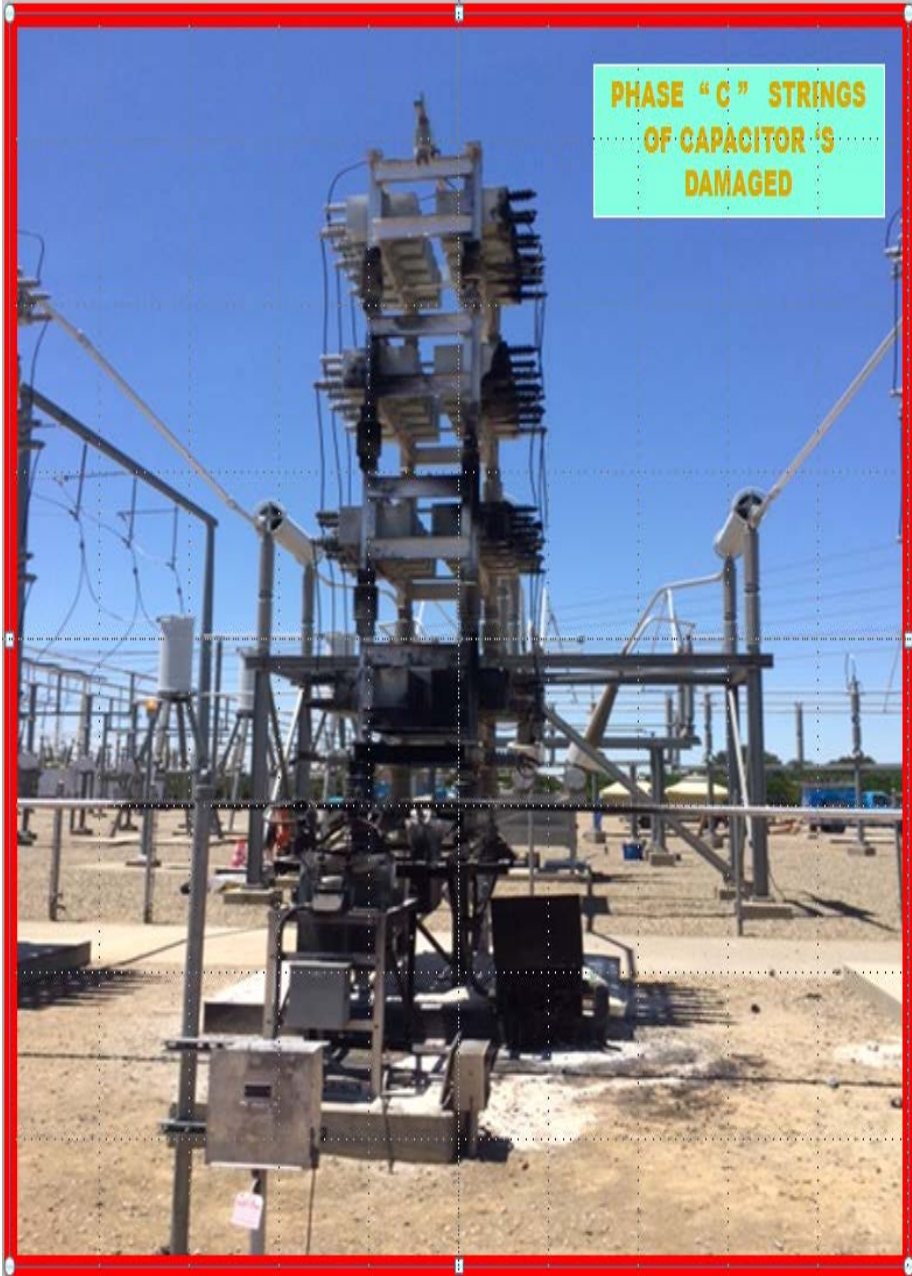
PG&E Applied Technology Services (ATS) noted also the same cause of catastrophic failure on the low voltage neutral capacitors. It was prolonged exposure (65 seconds) to an over-voltage event which resulted in internal insulation breakdown and rupture of the capacitor tank due to the high pressure gas produced by internal arcing.

Figure 10 Capacitor Bank 1 with Phase "C" String Damage

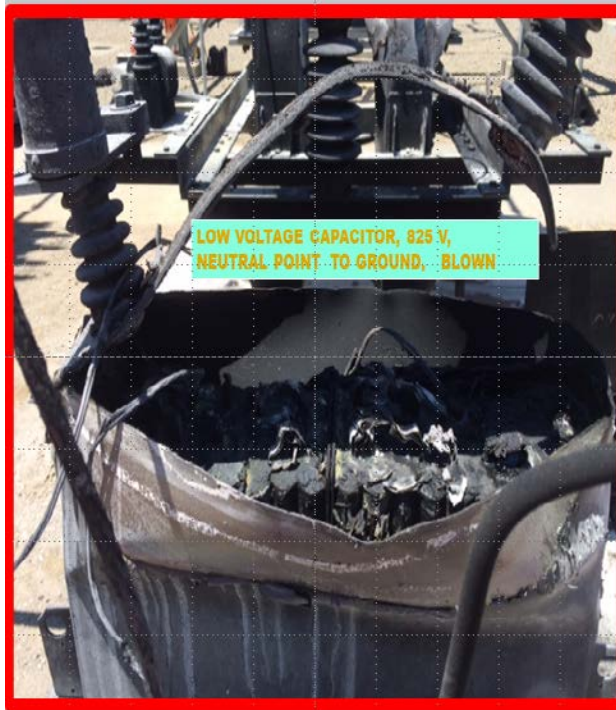
Figure 11 Low Voltage Neutral Capacitor Blown

1. Disconnect Switch (DSW) 211 partial energization of only Phase “C” of Capacitor Bank 1 caused an unusual phase imbalance that produced a shift of Neutral (N) star point to Ground (G) point. The arcing of DSW 211 during switching provided high inrush currents and developed an excessive neutral overvoltage condition from Ground (G) up, exceeding voltage rating of the LV Neutral Capacitor. Prolonged continuous full load current of 200 amps impressed to Neutral (N) Point to Ground, coupled with excessive neutral overvoltage consequently caused breakdown of internal insulation and rupture of the capacitor tank due to the high pressure gas produced by internal arcing.

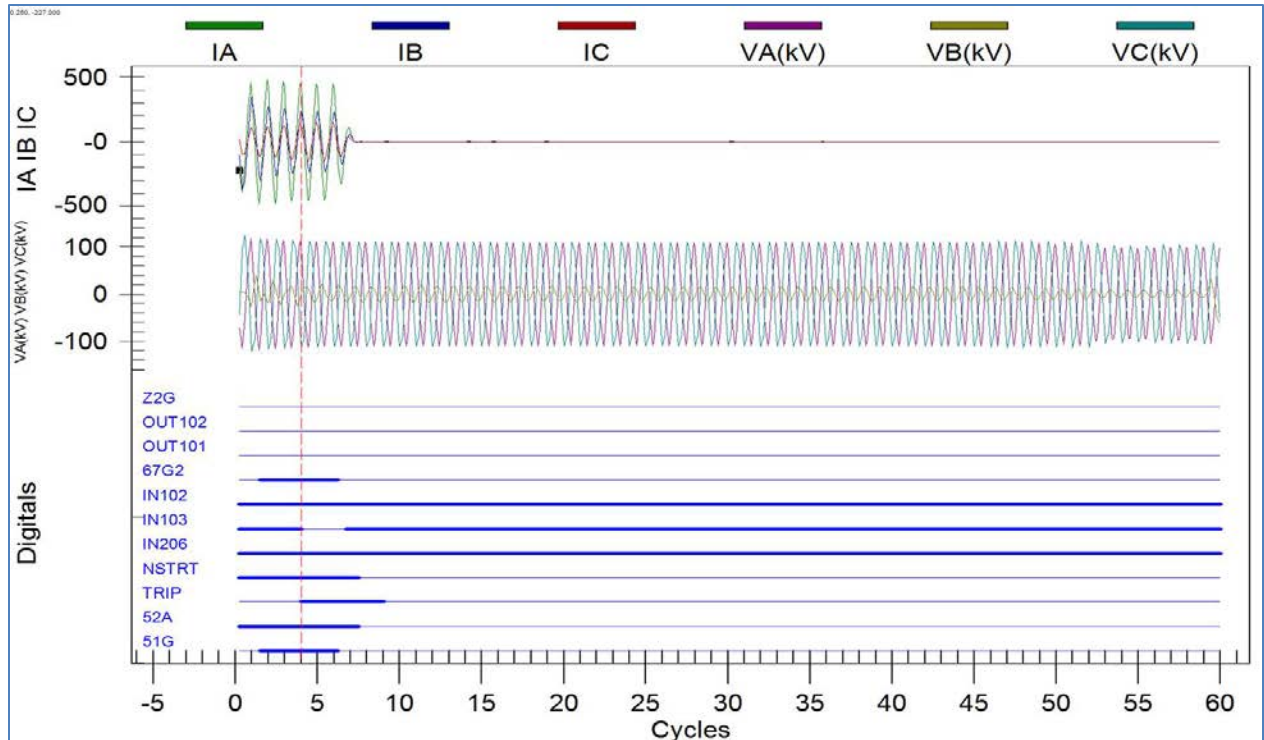
Figure 12 Herndon CB 242 Relay Oscillography

The Herndon CB 242 terminal of the Ashlan – Herndon 230 kV line over tripped when there was a momentary loss of blocking signal received from Ashlan Substation. This overtrip resulted in the loss of Ashlan and Fig Garden distribution substations. The high speed reclosing (HSR) did not initiate at Herndon CB 242 due to a missed directional ground element (67G2) at High Speed Reclose Initiate logic output contact.

A Carrier Hole (blocking signal lost) in Herndon 242 pilot line relay caused the over trip as shown in the relay event oscillography in [Figure 12](#) below. Herndon 242 did not High Speed Reclose although it was Cut In per Grid Control Center (GCC). Based on the event oscillography, OUT101, High Speed Reclose (HSR) Initiate did not have 67G2 relay element but it tripped by 67G2 when Carrier Hole in IN103 lasted for 2 cycles.

The Ashlan Directional Comparison Blocking Carrier scheme did not operate as designed during this event due to a failed Power Amplifier Transmitter, 285AC-1, and a failed Carrier Ground Relay, 267NC-1.

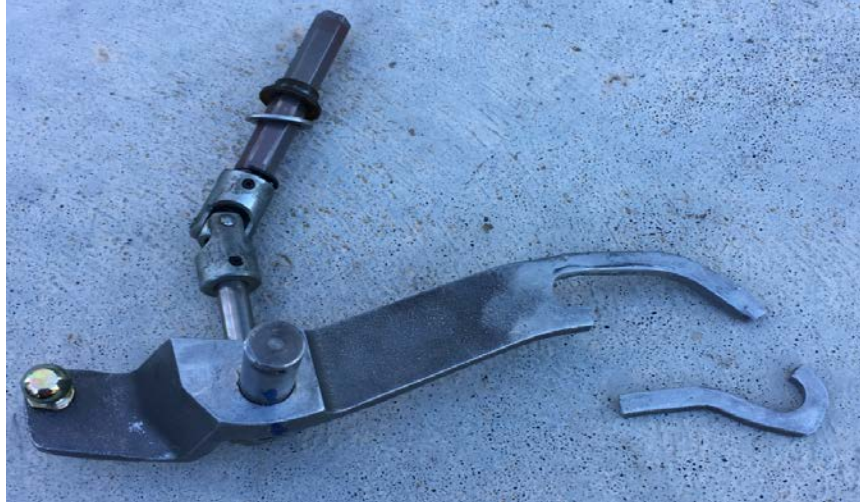
Grid Control Center (GCC) operator noticed that CB 572 continued to indicate closed after the event via SCADA screen. CB 572 was really open but did not indicate at the time of event. Substation maintenance crew cleared CB 572 to troubleshoot and found this breaker also had a broken linkage (called lever for this breaker) as well as a burned trip and close coil. The coil failures were a result of the broken lever, shown in [Figure 13](#).

PG&E ATS analysis determined that the failures of the linkage lever metal were attributed to interconnected voids formed in the metal due to solidification shrinkage during original manufacturing process. This is coupled with high operational stresses arising from the sliding motion over the shoulder bolt when the breaker was operated frequently. The ATS report compared well with circuit breaker manufacturer recognition of the same problem occurring on similar breakers belonging to other utilities.

Figure 13 CB 572 Broken Linkage Lever

3. Gregg CB 572 failure of the operating linkage lever was concluded by PG&E ATS to the pre-existing solidification shrinkage defect in the equipment and high operational stresses over the shoulder bolt during frequent operation.
