FDA Conference April 30 to May 1, 2018

# Gregg 230 kV SS Shunt Capacitor Bank Failure and Cascading Area Disturbances

Leo B. Hisugan, P.E., Supervising Protection Engineer, PG&E  
Aaron M. Feathers, P.E., Principal Protection Engineer, PG&E

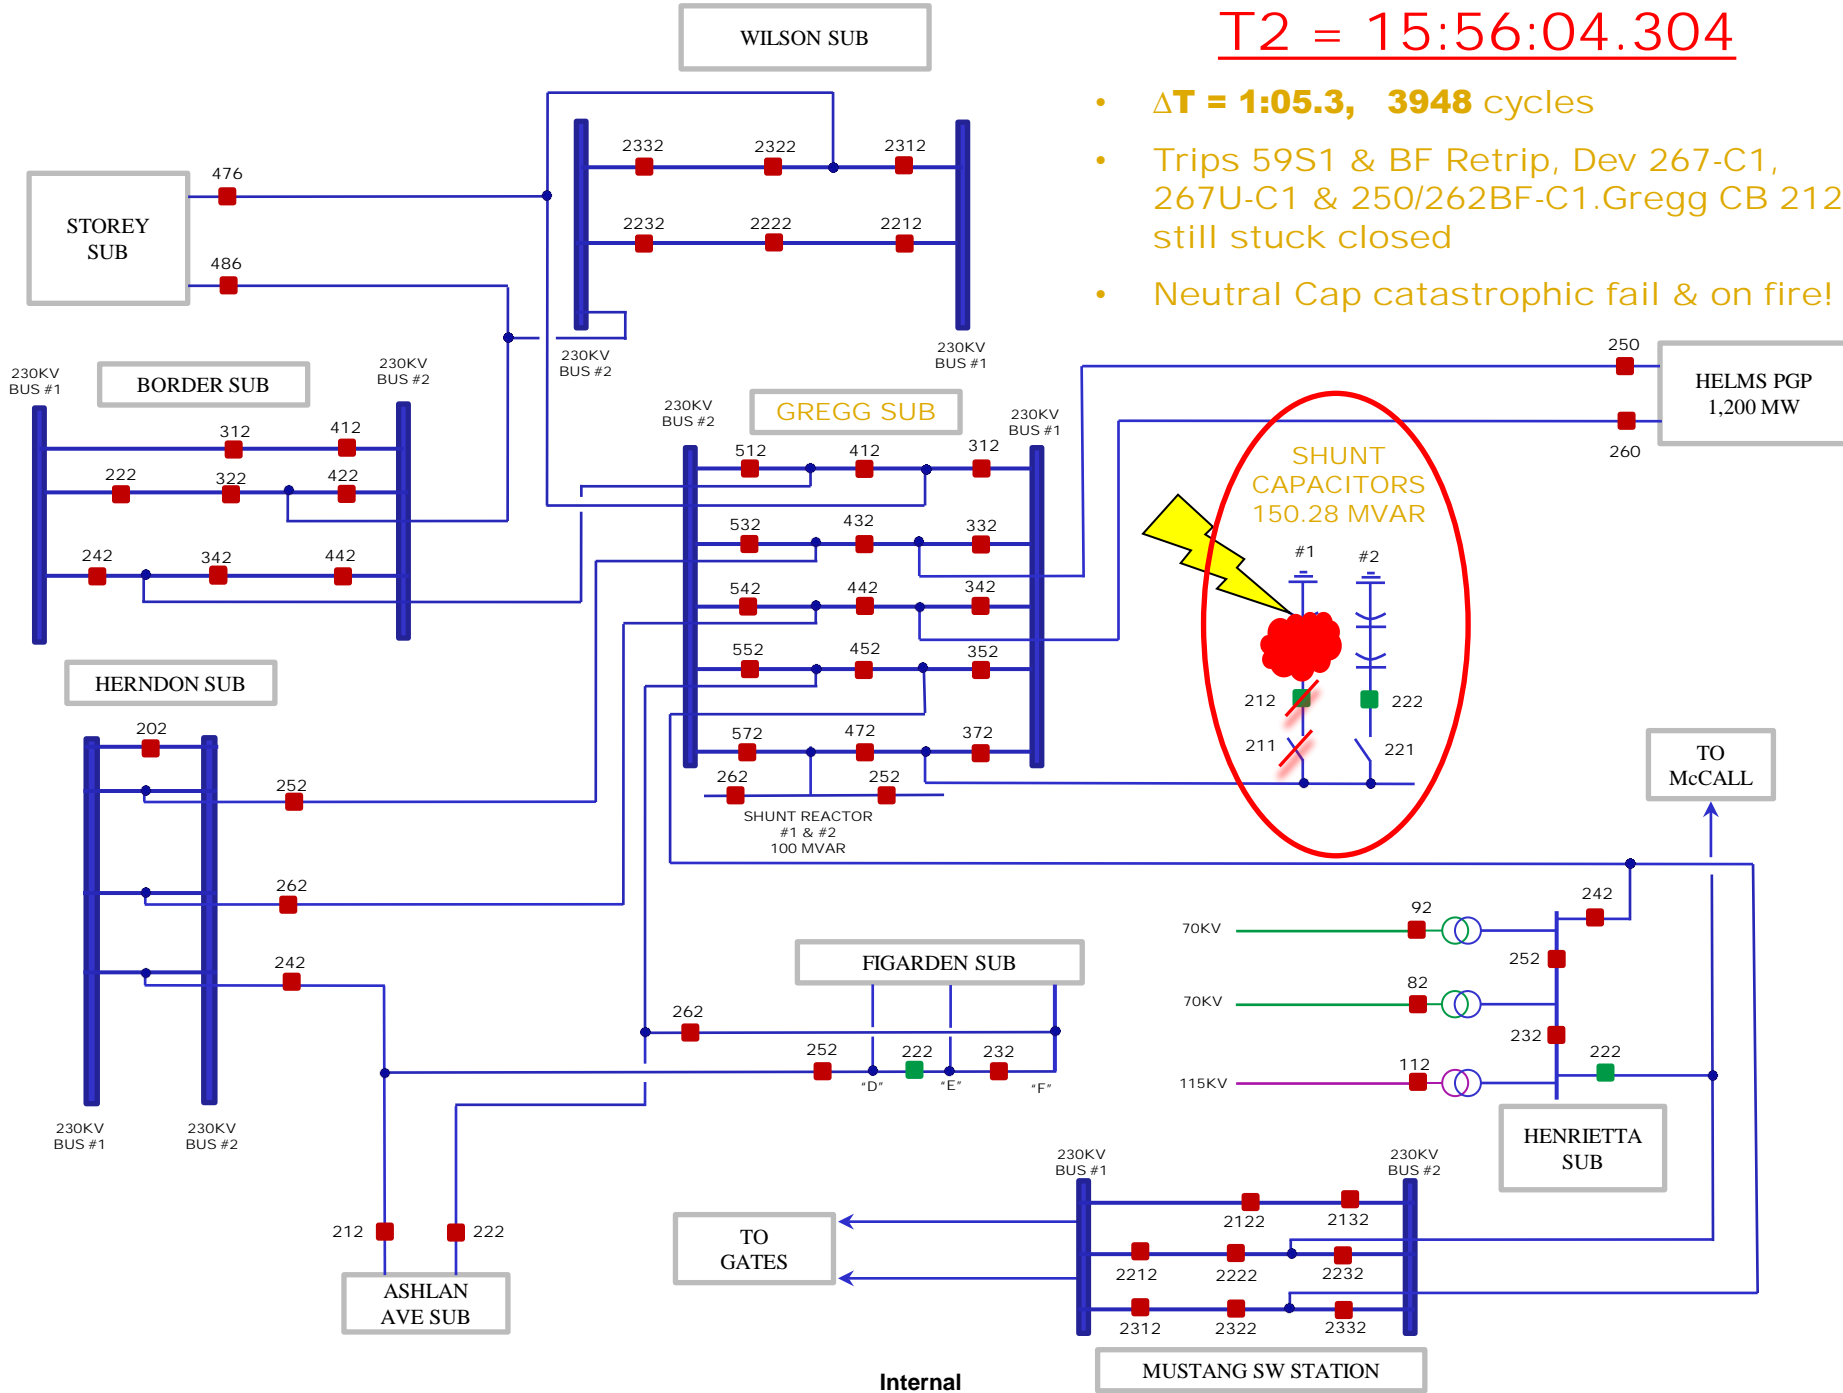
T2 = 15:56:04.304

- $\Delta T = 1:05.3$ , 3948 cycles
- Trips 59S1 & BF Retrip, Dev 267-C1, 267U-C1 & 250/262BF-C1. Gregg CB 212 still stuck closed
- Neutral Cap catastrophic fail & on fire!

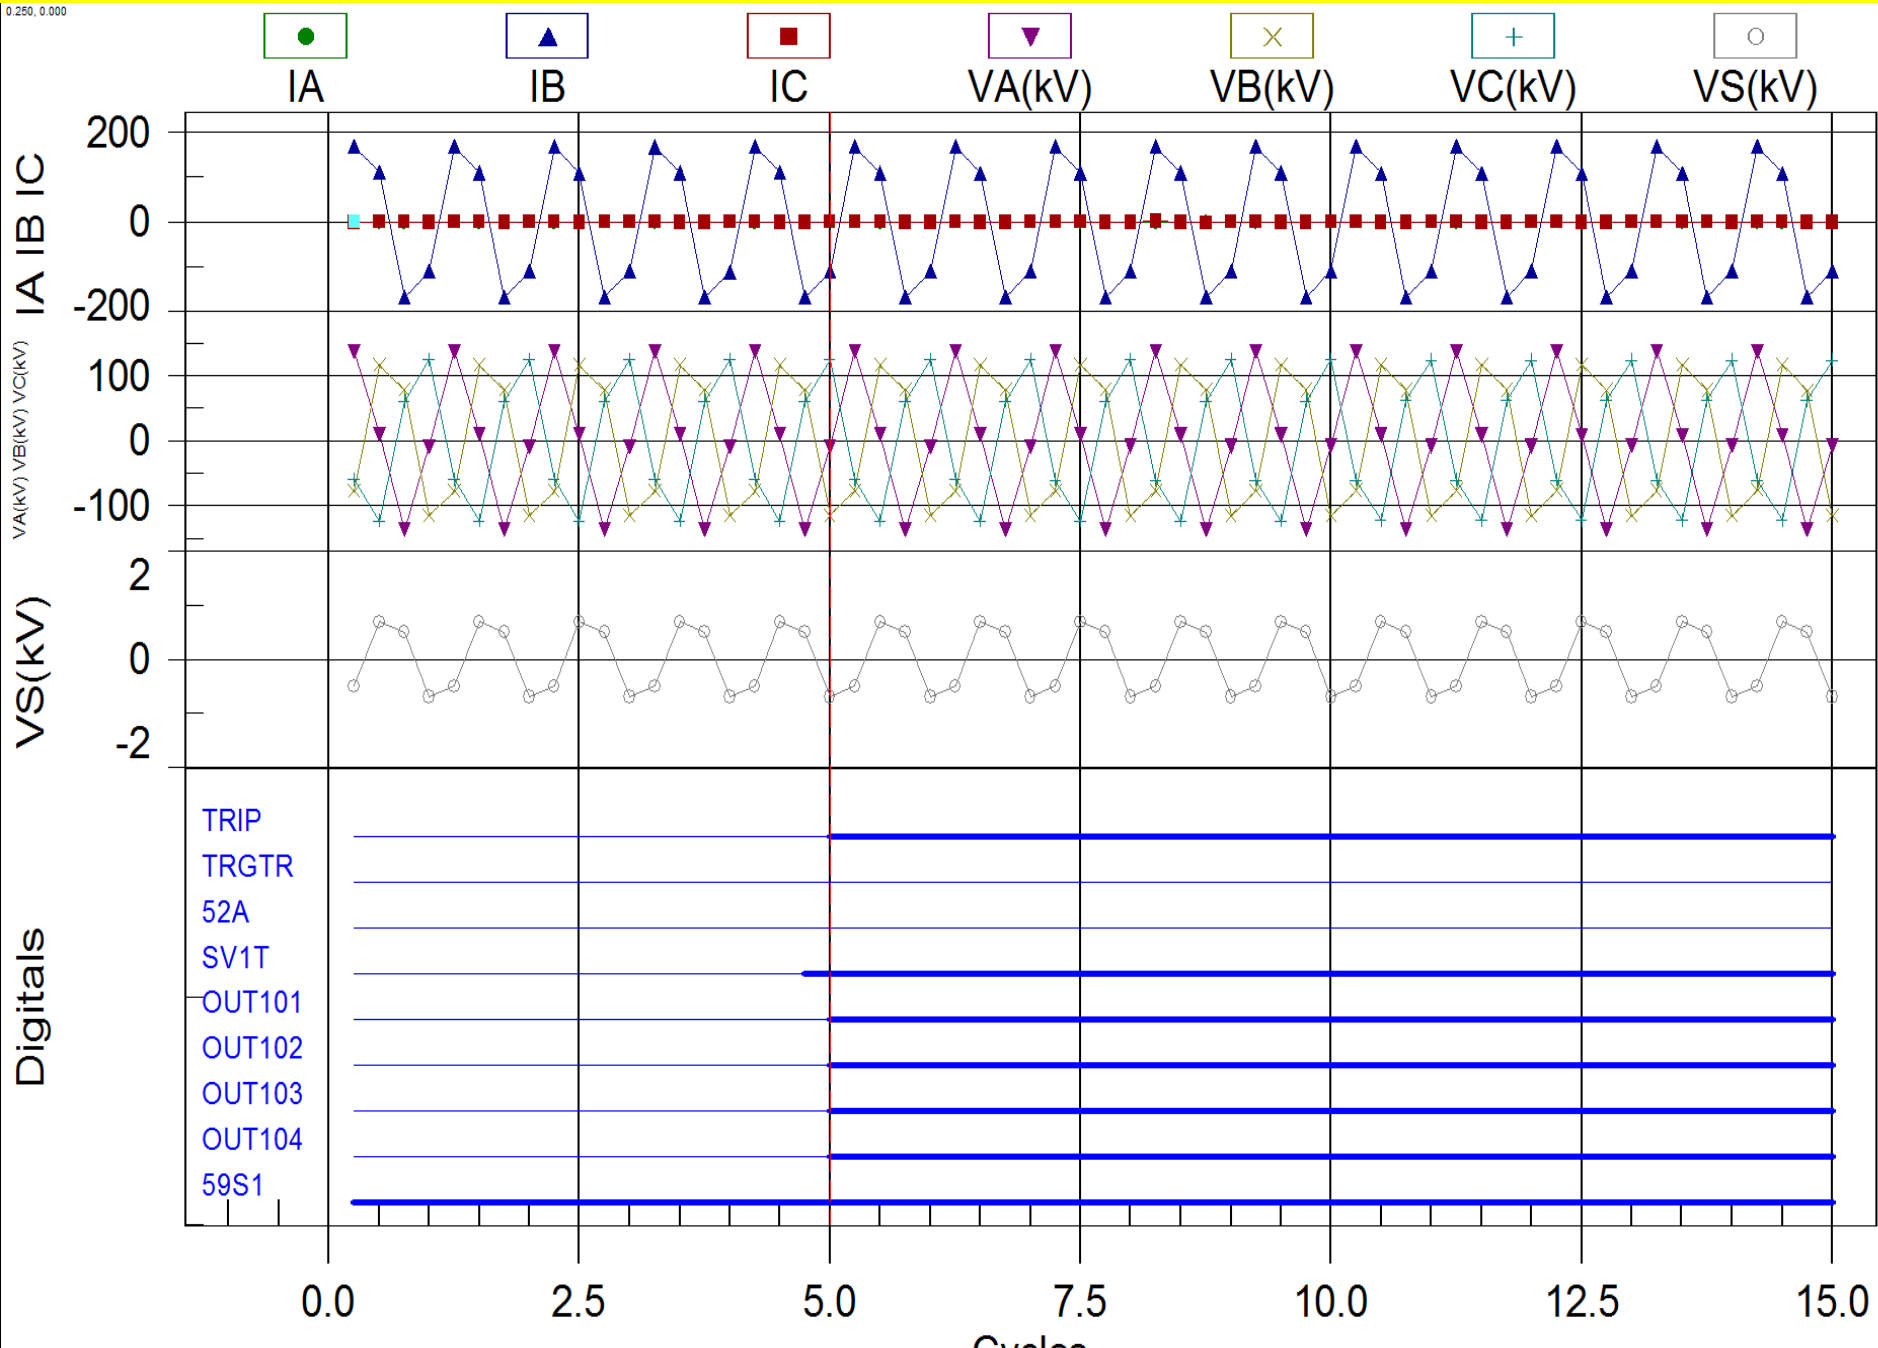
# CB 212 DEV 267-C1

FAULT VOLTAGE CB 212 DEV 267-C1 , 3VO = 3X 800V = 2400 V ,  
VS = 1100 VOLTS , VB = 139.4 KV , DIFF = 2000 VOLTS

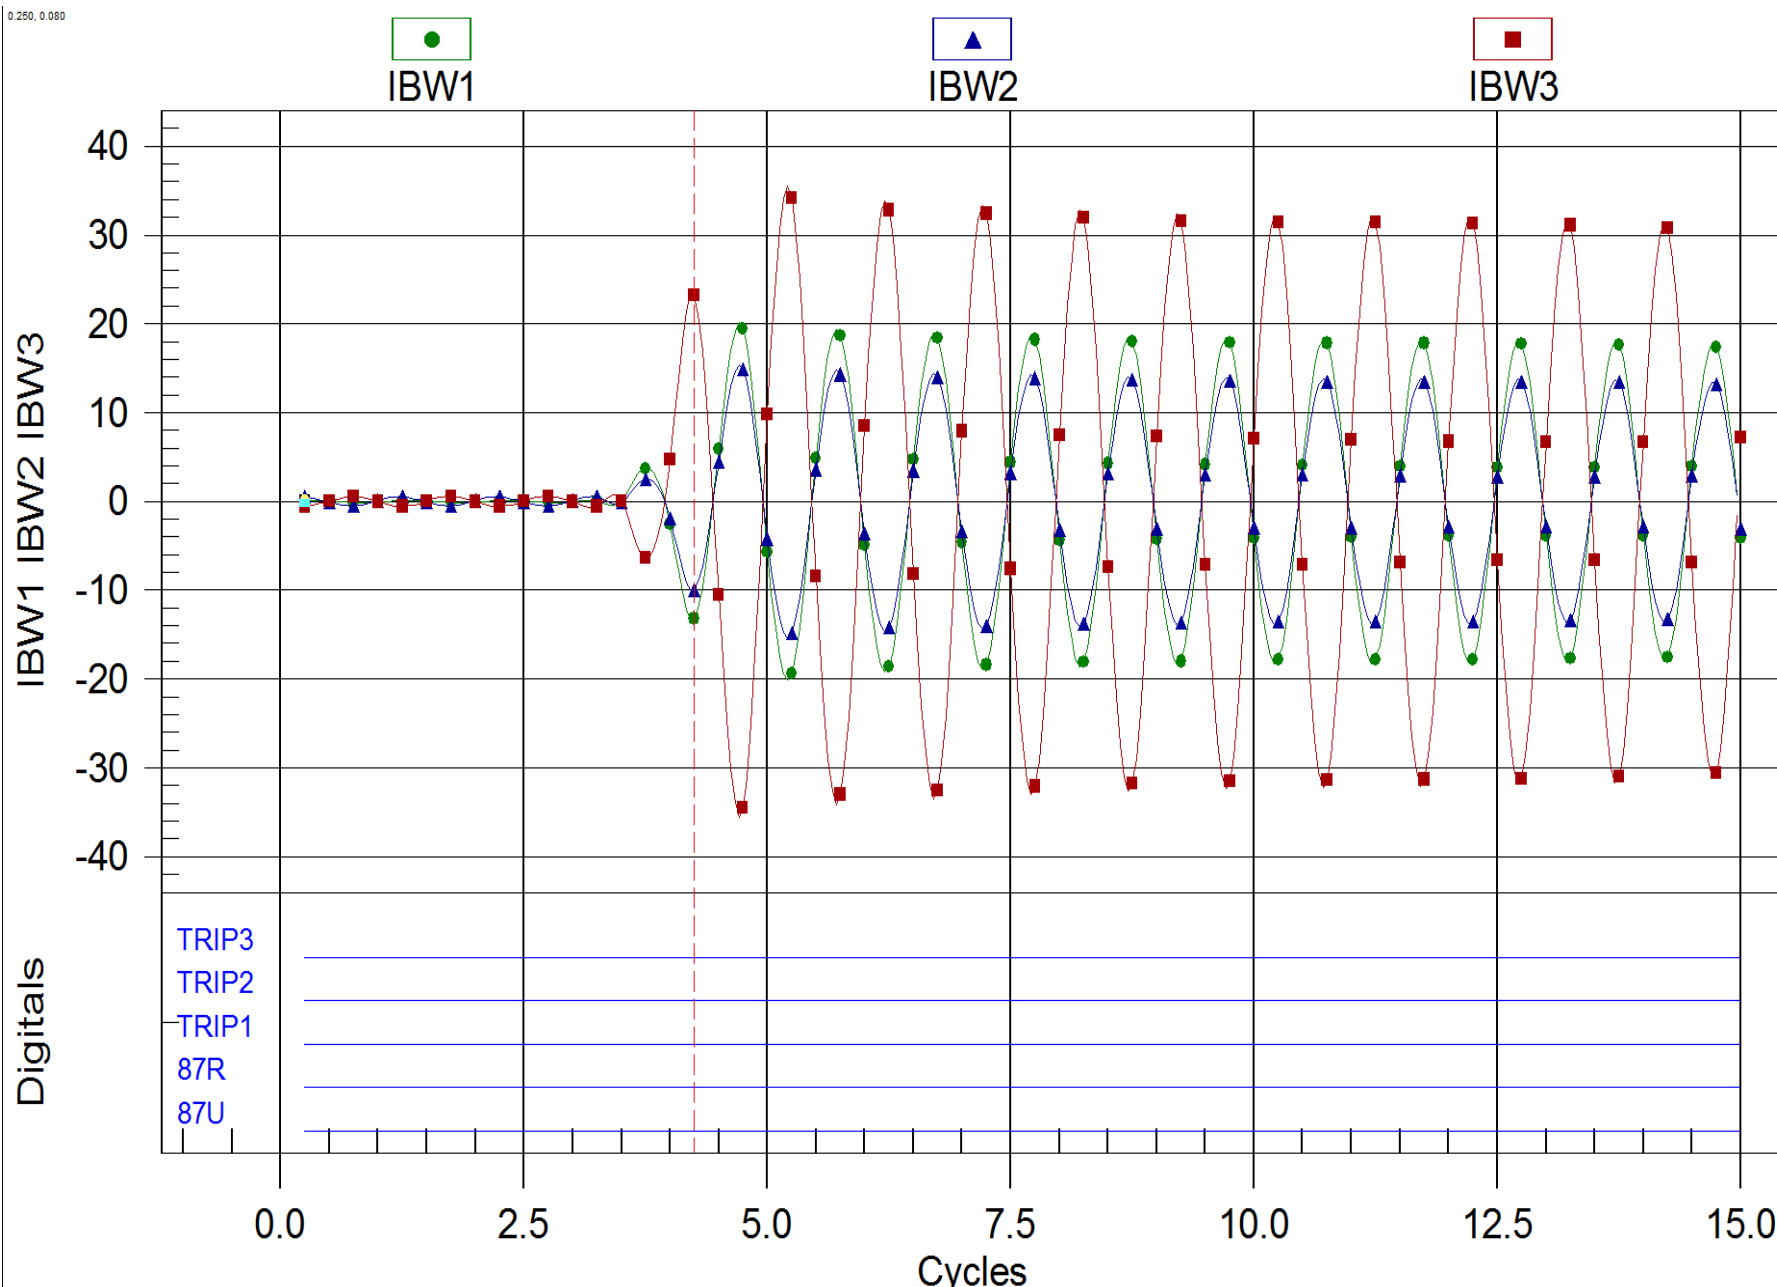
287B RELAY, CB 212 IBW3 = 36.1 X 400 CTR = 14,440 A

FAULT CURRENTS TO CAPACITOR BANK 1

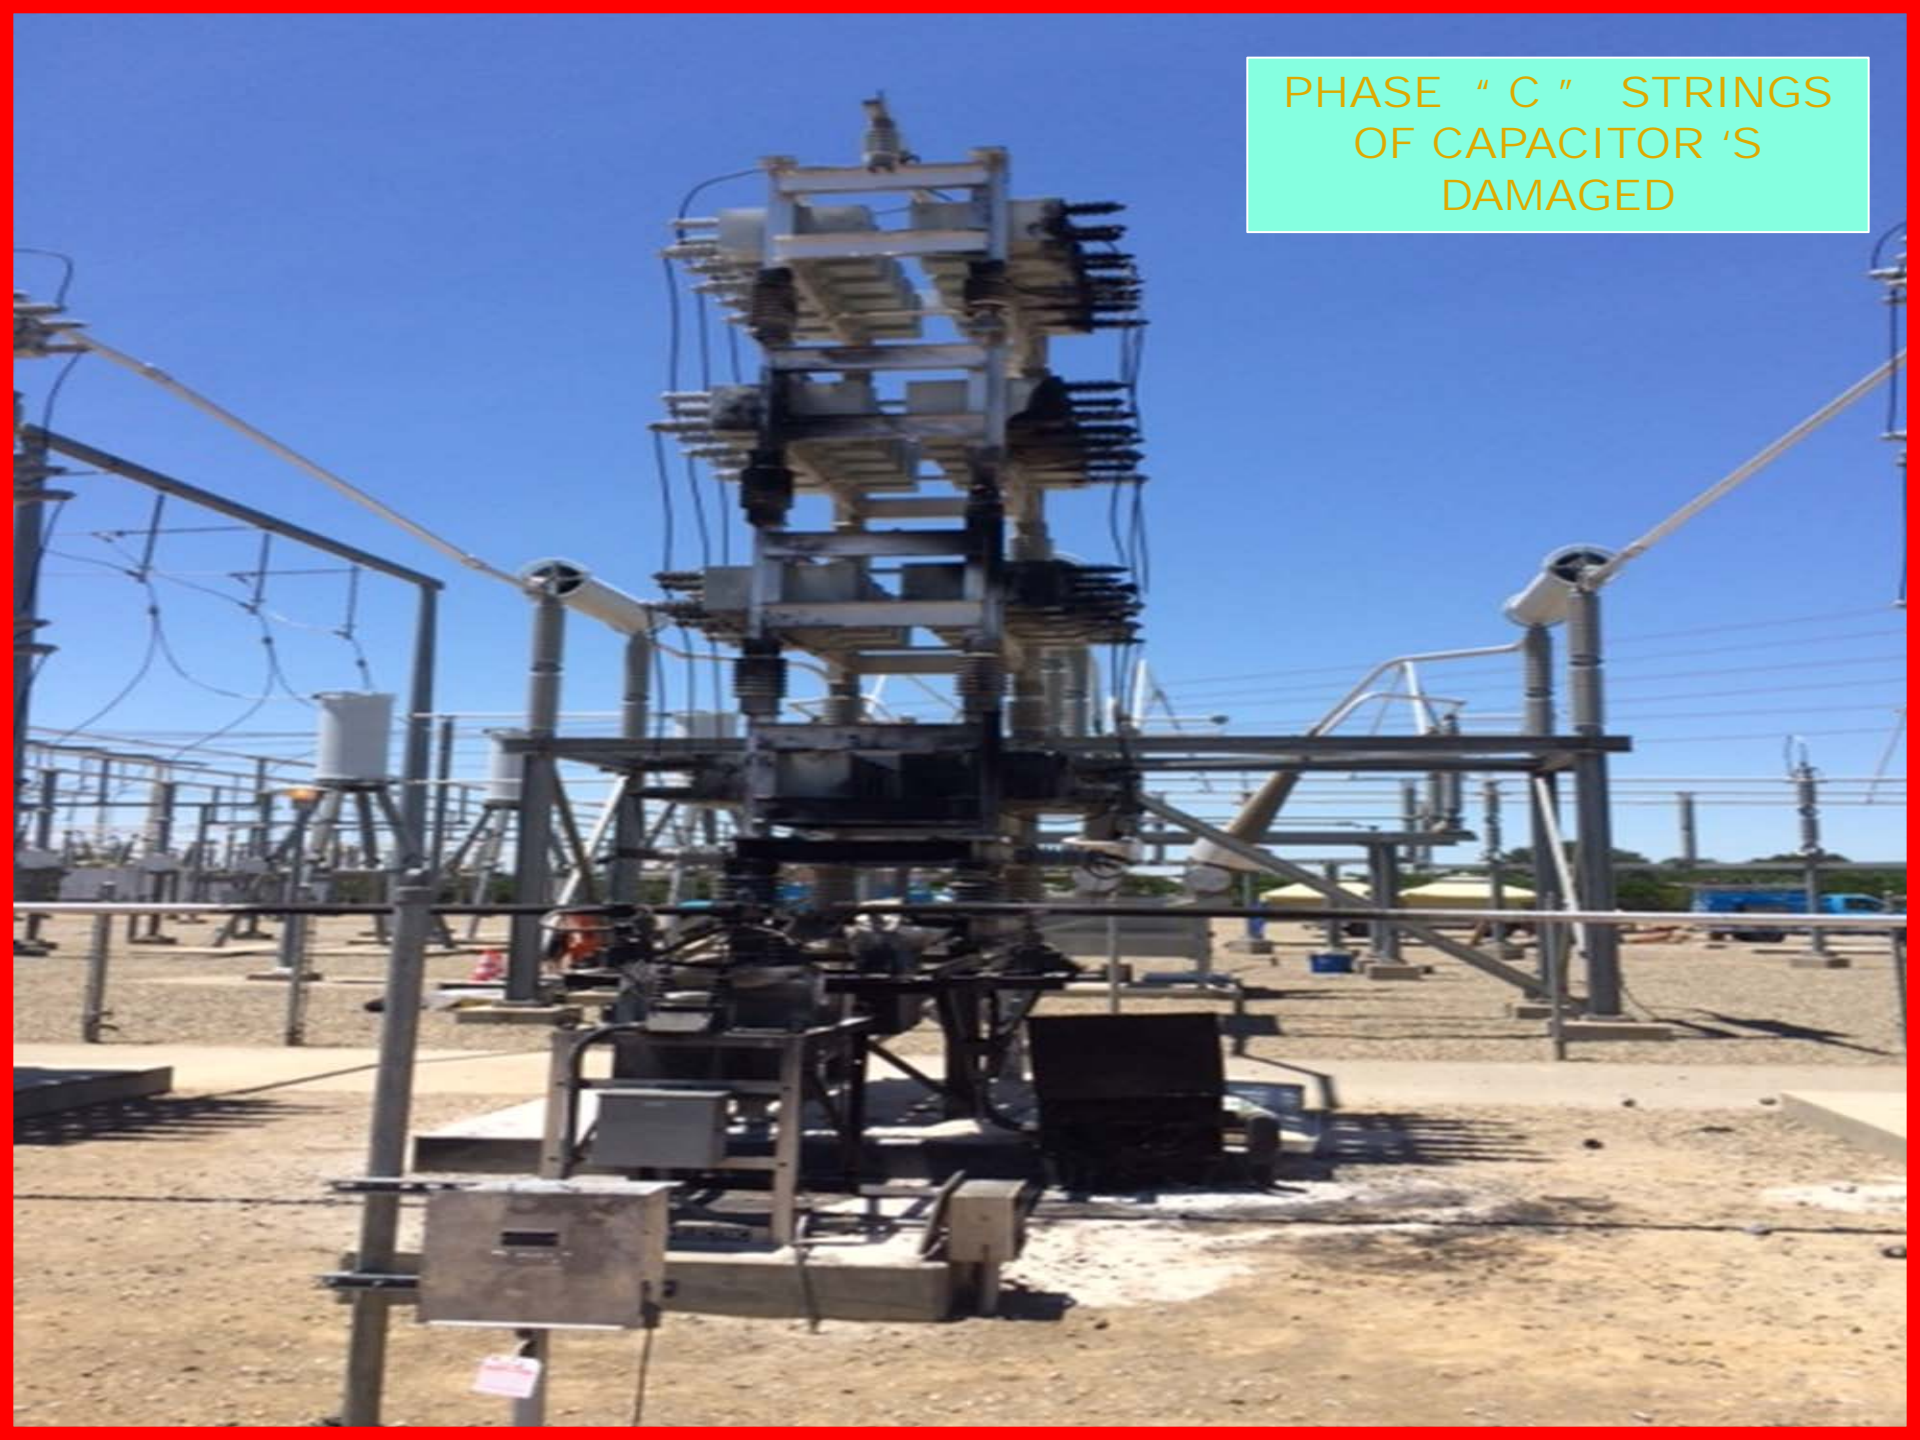
PHASE " C " STRINGS  
OF CAPACITOR 'S  
DAMAGED

LOW VOLTAGE CAPACITOR, 825 V,  
NEUTRAL POINT TO GROUND, BLOWN

PHASE "CX" LOW VOLTAGE  
CAPACITOR RUPTURED

- ❖ Replace new Phase “C” Capacitor Bank units and associated metering and relaying components. Placed on service on April 28, 2017.

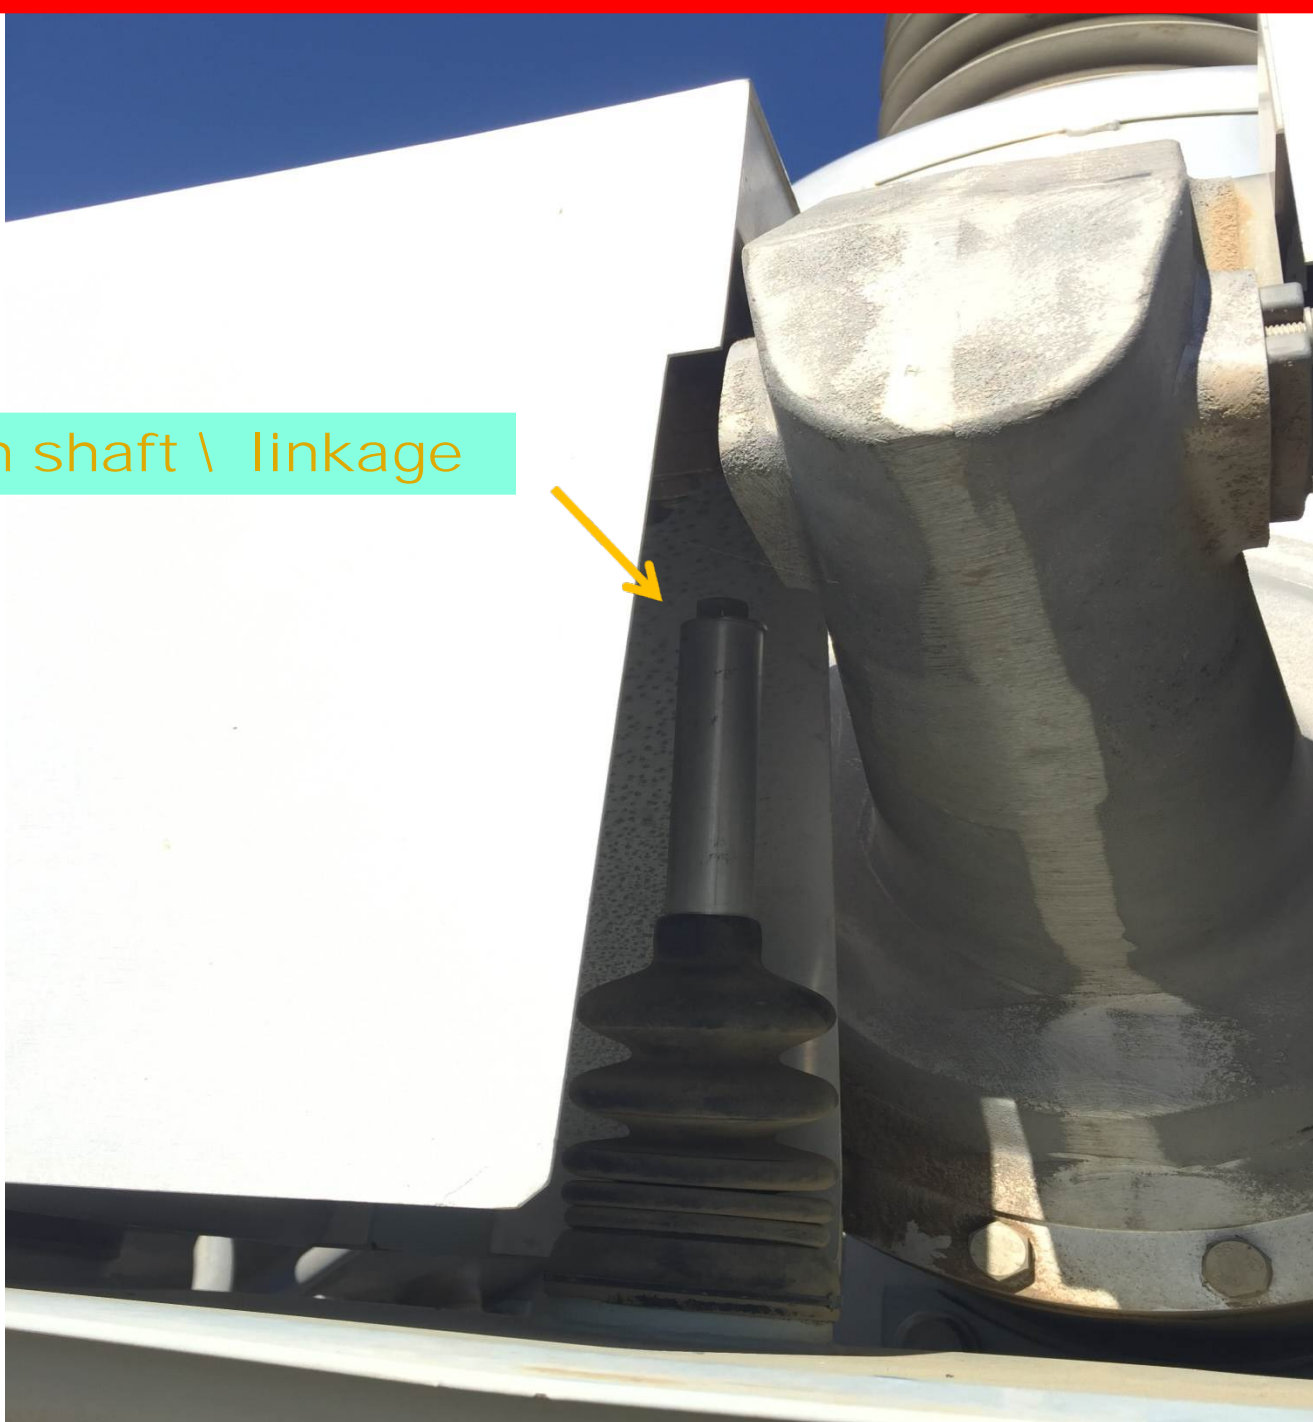
Broken  
Shaft/Linkage

Broken shaft \ linkage

- ❖ Gregg CB 212 failed on miss-adjusted push rod per manufacturer. PG&E ATS concluded, component failure on ductile overload fracture or mal-adjusted eyelet bolt in service.
- ❖ Gregg CB 572 operating linkage lever, fractured in two places yet remained in closed position on power fail trip operation. Main circuit breaker contacts successfully open as designed.
- ❖ Gregg CB 212 breaker failure relay settings were found different from issued and desired relay settings of relay database. Errant settings were traced to have changed on July 2015 in the field for unknown reasons during maintenance.

- ❖ Replace Gregg CB 212 with new breaker for Capacitor Bank application, Zero Voltage Crossing type. Completed and placed in service 4-28-2017.
- ❖ Replace Gregg CB 572 operating linkage lever from cast aluminum to aluminum bar stock.
- ❖ Replace Gregg CB 212 and CB 222 existing vintage breaker failure relay with new microprocessor breaker fail relay. Completed replacement and released new breaker fail relay for service on 4-28-2017.
