The Blimp Event of 2015

Description and Analysis of the Outages caused by a runaway blimp on PPL Electric Utilities Transmission System

Glenn Bray, PPL Electric Utilities

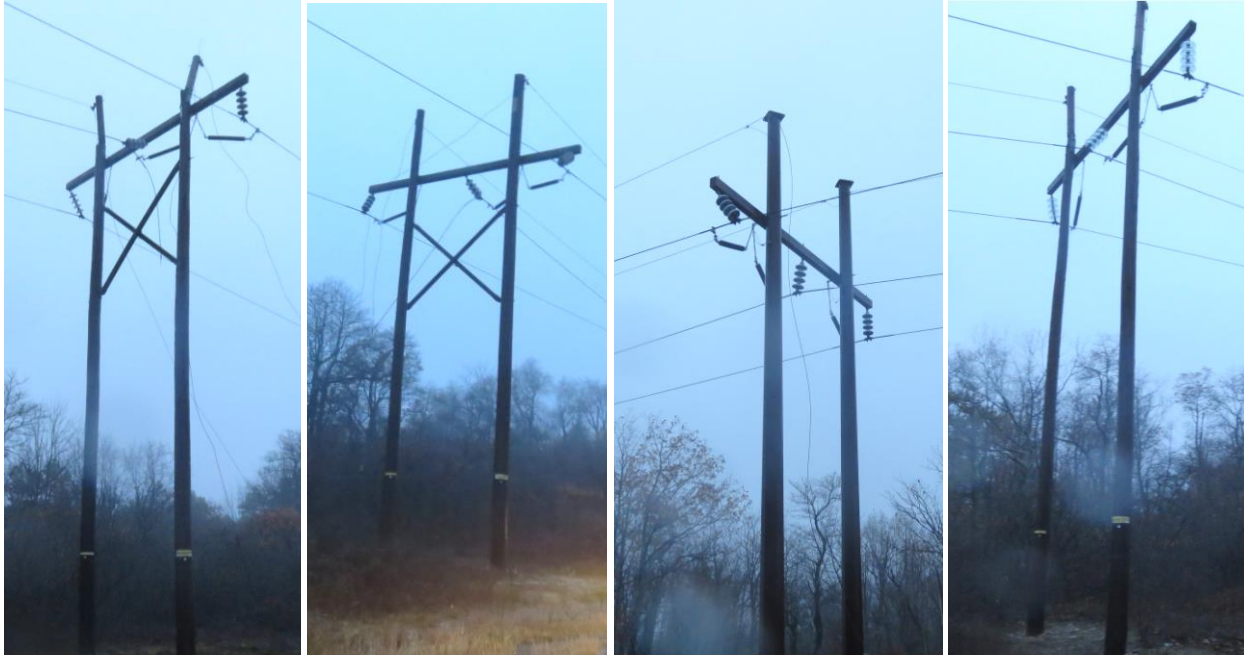
Figure 5 –Damages on Structures: 44894s55687, 44904s55715, 44868s55628, and 44879s55657

The foot patrol, performed a few hours after the operation, discovered structures with broken overhead ground wire (OHGW), conductor, and pole damage around structure 04/15 (Placemark D) on Girard Manor Tap (11.7 miles from Frackville). Helicopter patrol found nothing additional in the other patrol area for structure 79/79 (Placemark C). In order to restore power quickly, temporary repairs were made that night. The following permanent repairs were completed in July 2016 when outage conditions allowed:

- Replacement of OHGW between structures 44905s55715 and 44868s55628 (4 spans)
- Repair of the pole top damage at structure 44894s55687
- Replacement of middle phase conductor (2,800 feet) between 44905s55715 and 44894S55687

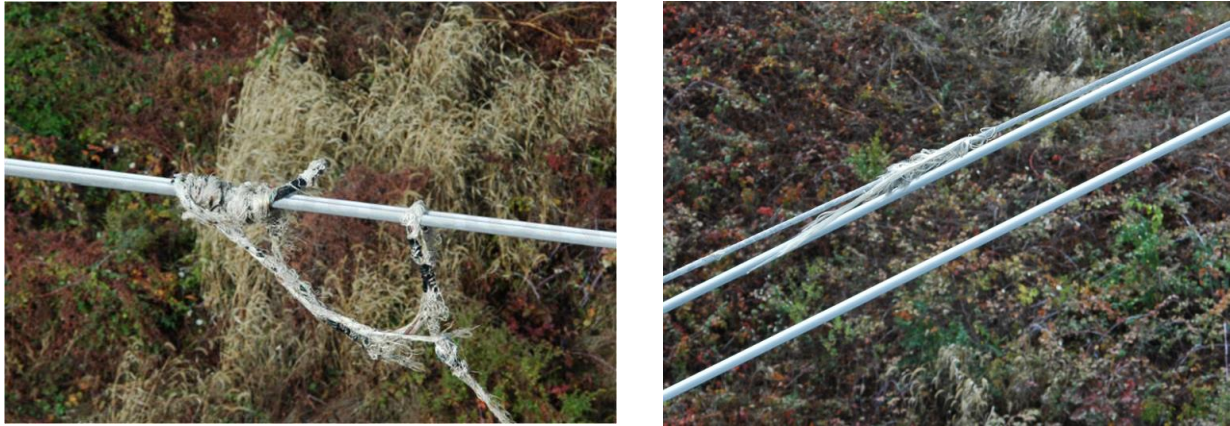
For the initial analysis, short circuit simulations were performed utilizing DFR records that were accessed remotely from both substations. The estimated fault location was 30 miles from Sunbury at structure 39049n30851 (49/51). The patrol area was from 24/79 to 21/33 (Figure 6). At 17:10 EDT, field crews reported that portions of the tether were entangled around both lines and remnants were on the ground at structure 92/30 which was 31.44 miles from Sunbury (Placemark E) as shown in Figure 7. The following day, the sections of tether from both lines were removed during the helicopter inspection.

Figure 7 - Tether entangled on Sunb-Susq conductors, 500kV on left and 230kV on right

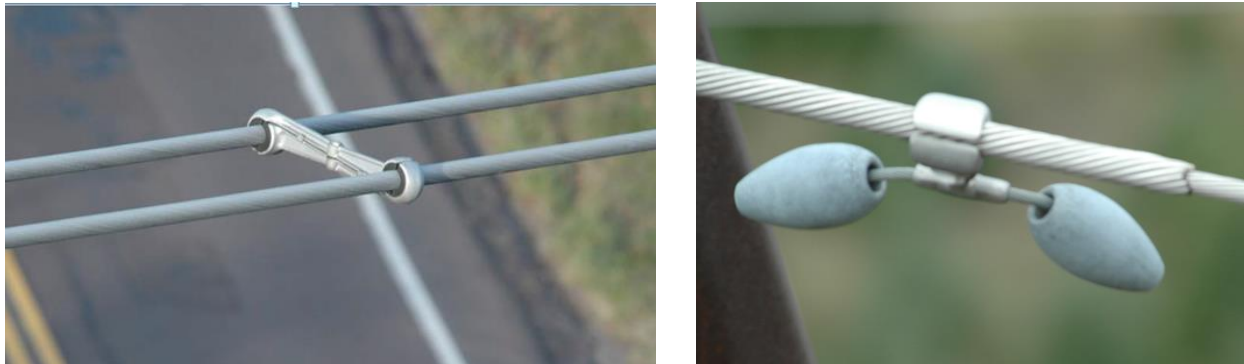
An additional helicopter visual inspection was performed on 11/1/15 which identified damage to the 500kV conductor, overhead ground wire (OHGW), and line hardware, as shown in Figures 8 and 9. Speed grip style bundle spacers moved along the conductor. Vibration dampers on both OHGWs were bent and deformed. National Electric Energy Research Testing and Applications Center (NEETRAC) performed further analysis and confirmed the damage. With the tether found on the ground and the available fault current, it is likely that arcing from the fault severed the blimp's tether.

Figure 8 – Left - Moved bundle spacer on 500kV line, Right – Deformed vibration damper on 500kV line

Permanent repairs occurred via helicopter repair crew in April 2016 during a line outage and included the following repairs to restore the line to its configuration prior to the incident:

- New bundled conductor spacers (qty 3) were installed
- OHGW vibration dampers (qty 2) were replaced
- Conductor vibration dampers (qty 6) were replaced
- Armor rod (patch rod) was installed over damaged OHGW and conductor strands

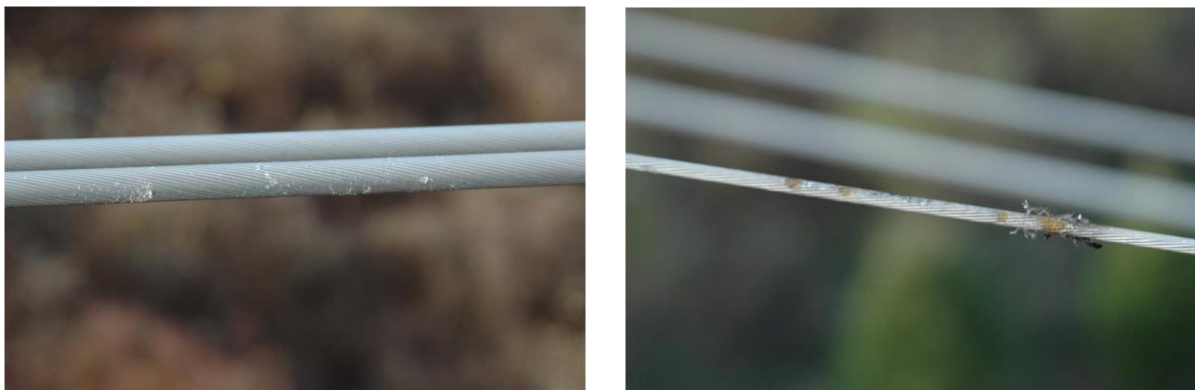
Figure 9 – Left - Conductor damage, Right – Static wire damage

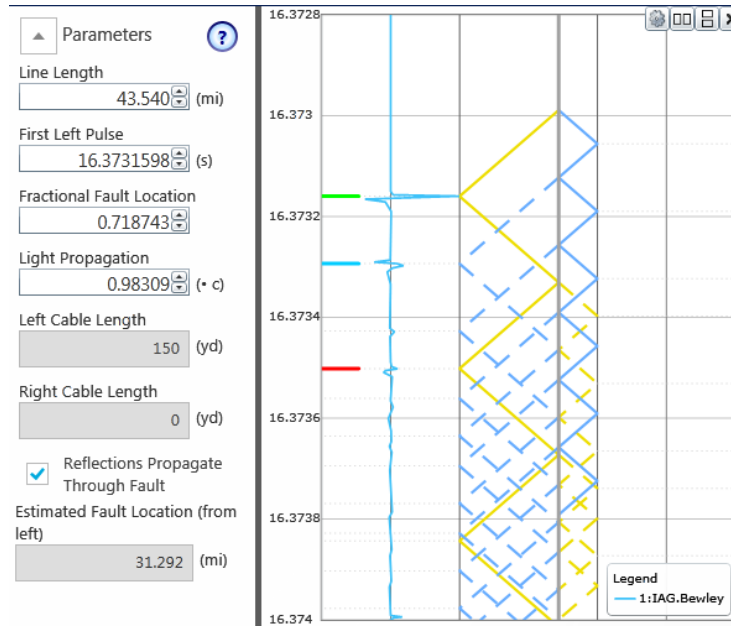
Figure 10 - Bewley diagram for Sunbury 500kV end

The Bewley diagram shows the TW propagation path along the transmission line and the reflections from the fault to Sunbury terminal (Figure 10). The fault location is represented by the vertical gray bar. The single-end TW calculation uses the time difference between the first TW from the fault and the first reflection from the fault. TW (yellow curve) launched at the fault point arrives at Sunbury, noted by the green cursor. It travels back toward the fault (gray bar), reflects back from the fault, and then returns back to Sunbury. The red cursor was aligned with the first reflection to establish the fault location. During the time interval between those two points, the TW traveled twice the fault distance. The program uses that time interval and the other parameters listed in the Bewley diagram to calculate the fault distance. Blue cursor was aligned with first full-line-traversal peak (blue curve) to refine the location which adjusted to the light propagation velocity from 0.98 to 0.98309pu.

The TW distance of 31.292 miles was within one span of the 31.44 miles fault location from Sunbury. The single-end TW calculation for other end resulted in 12.241 miles from Susquehanna. Even with the standard TW parameters utilized in the relay, the fault location values were quite good. With the standard light propagation of 0.98pu, the calculated distance was 31.194 miles.

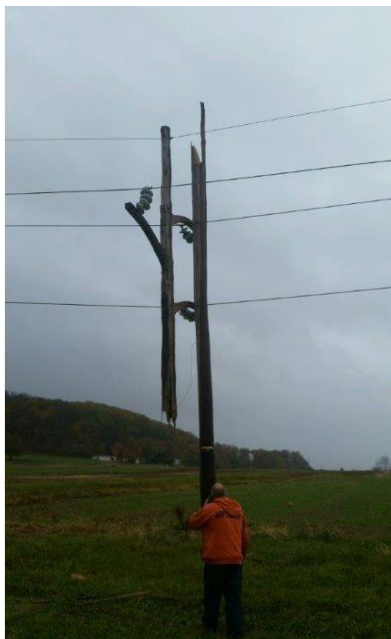
For Columbia-Scott, the foot patrol identified a broken pole at 36833n32363 (33/63), 7.6 miles from Columbia (Placemark F), as shown in Figure 12. Helicopter patrol, performed the following day, noted the broken pole identified by the ground crew; no additional findings were discovered. The broken wood pole was repaired with spare parts. The pole was replaced in early 2016.

Figure 12 –Broken Pole on Colu-Scott

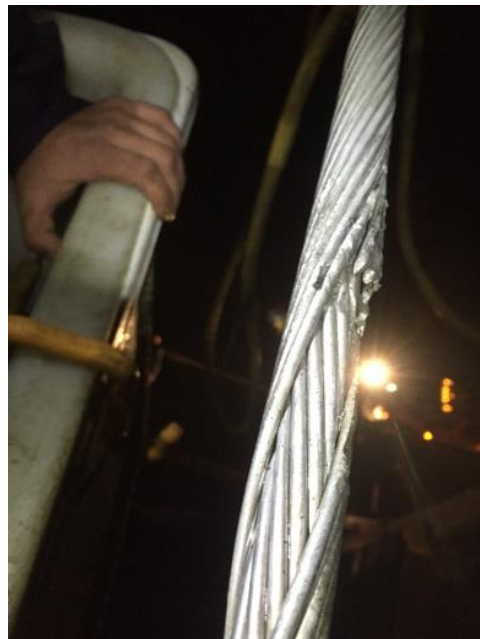
For Columbia-Berwick, foot patrol identified the static wire down on Products tap at 38528n31755 (28/55) which was 9.8 miles from Columbia and 7.8 miles from Berwick (Placemark G) as listed in Figure 11. The static wire sustained significant damage as shown in Figure 13. Helicopter patrol discovered no findings in addition to downed static wire; repairs were completed the following day. The relay event record from Berwick was retrieved weeks after the event. The relay record listed a B-phase-to-ground fault with a magnitude of 1,356A and a fault distance 9.30 miles. Short circuit simulation provided an estimated fault distance of 8.2 miles from Berwick.

Figure 13 –Static wire damage on Colu-Berw

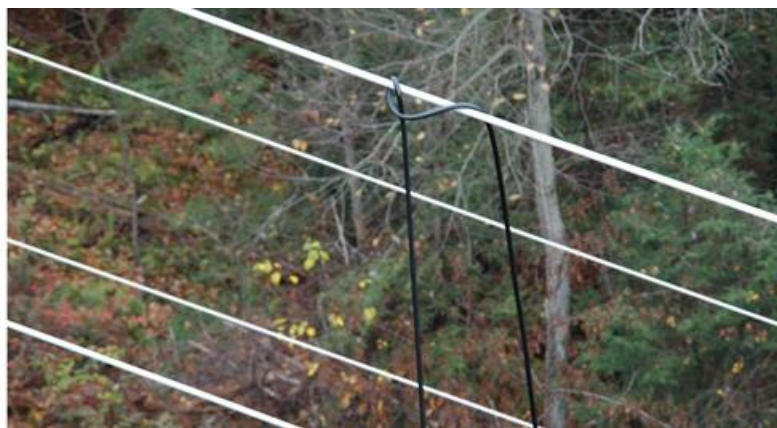
For both lines, short circuit simulation using the DFR fault values resulted in a fault distance of 8 miles from Montour substation at structure 60/28. The patrol area was from 71/17 to 84/76 (Figure 14). Helicopter patrol found a piece of the tether attached to the line extending to the ground near structure 40/97 which was 7.3 miles from Montour (Placemark H) as shown in Figure 15. No foot patrol was performed on this line.

Figure 15 - Tether hanging on Montour-Susquehanna

On 10/29/15, the helicopter removed remaining tether from the Montour-Susquehanna line and the line was returned to service at 18:27 EDT. The Montour-Susq T10 line, which was out for clearance while removing the tether on the Montour-Susquehanna line, was returned to service at 18:23.

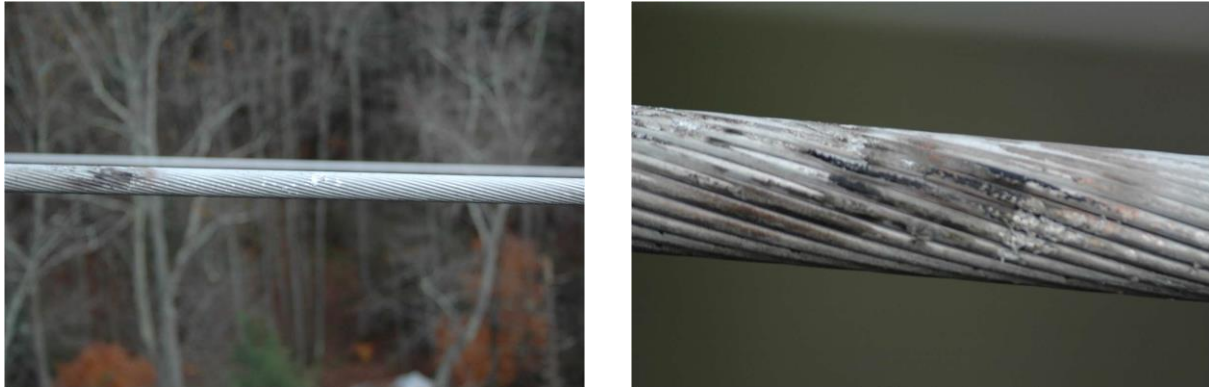
An additional helicopter visual inspection was performed on 11/01/2015 and identified evidence of conductor damage. NEETRAC noted that no damage was observed to either of the structures or the suspension hardware, but damage occurred to the conductor strands. At one place, three individual strands were significantly compromised, as shown in Figure 16. Helicopter repair crew installed armor rod (patch rod) over the damaged conductor strands during an outage in 2016.

Figure 16 – Left - Mont-Susq conductor damage, Right – Close up of the conductor’s damaged strands
