# When Load Encroachment Fails to Prevent Tripping Service to an Undersea Cable, a Wind Farm and an Island Municipality

By: Dean V. Sorensen (National Grid)

### **Abstract**

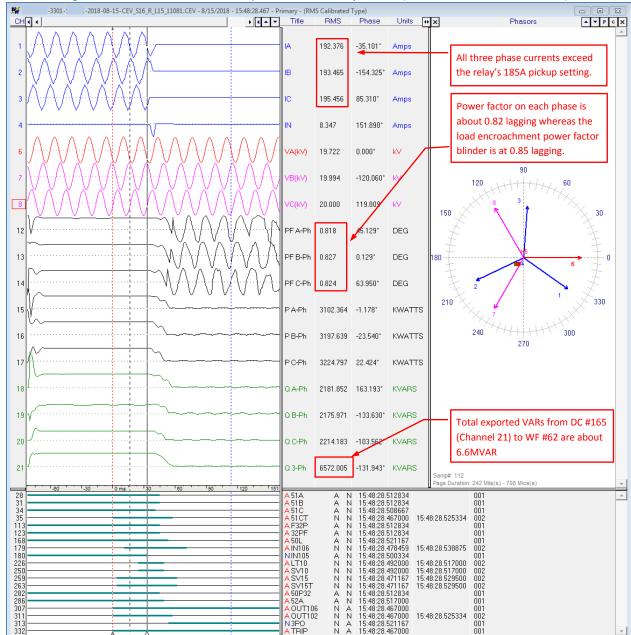
Figure 2: DC #165 3301 Line Backup Overcurrent Relay Record (Actual Event Time is 16:48:28)

A review of the backup overcurrent relay fault record (refer to *Figure 2*) shows that prefault currents were balanced with magnitudes on all three phases being just above the relay's directional overcurrent (ANSI Device 67) function pickup setting. There was no evidence of voltage depression or deviation before or after tripping. So far this does not appear to have been a fault. Since the relay's 67 function pickup setting (185A) is well below the 3301 line's 679A rating, this was also not an overload condition. With the Wind Farm being a weak source, the low pickup setting is necessary to provide sufficient fault sensitivity. Consequently, some form of torque control is necessary to provide restraint for non-fault (i.e. load) conditions. The backup overcurrent relay's load encroachment (LE) function is a common solution applied to overhead transmission and subtransmission lines so the function was applied and power factor blinders set to accommodate typical load power factor ranges (between 0.85 leading and lagging).

The oscillograph record (*Figure 2*) shows the prefault power factor on each phase to be below the 0.85 lagging power factor limit imposed by the backup overcurrent relay's load encroachment blinder. This explains why the relay tripped. Earlier DFR and relay event records recorded throughout the day showed the apparent impedance power hovered just above the relay's 0.85 lagging power factor limit for most of the day while the line current exceeded the relay's directional overcurrent element pickup setting. Tripping was just a matter of time.

- Excess VARs exported from DC #165 (Channel 21) to WF #17 suggest that the 165T1 [DC #165 to BI #160] and 160T1 [BI #160 to Wind Farm] cables were not sufficiently compensated by shunt reactors at both stations.
- The DC #165 bus voltage is right at about 1.0pu suggesting that BI #160 and the wind farm bus voltages would be higher than still. That the Wind Farm turbines tripped on overvoltage just before the 3301 line tripped, suggests the need for more aggressive shunt reactive compensation.

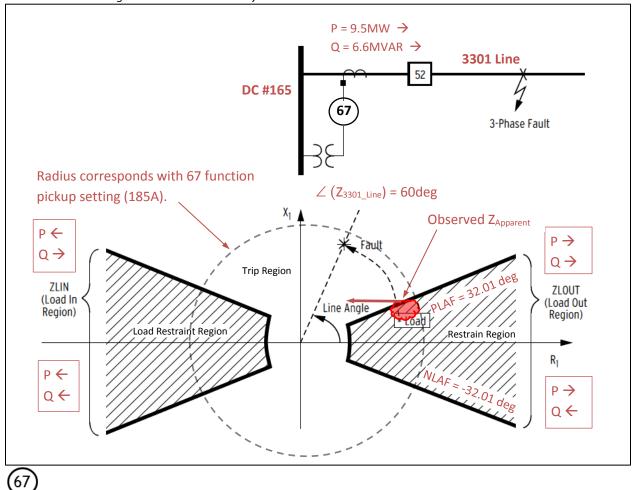
Figure 3: Overcurrent Relay with Load Encroachment Restraint Characteristic

Figure 3 illustrates what a load encroachment application looks like for a typical overhead line. Diagram annotations represent in-service relays settings and fault record measurements related to the 3301 line. Consider the load angle in Quadrant 1 (PLAF = +32deg or approximately 0.85 lagging PF). Quadrant 1 represents the condition where the DC #165 bus is exporting real (P) and reactive (Q) power towards WF #17 along the 3301 line. While the power factor limits represented by this example are typical for overhead line applications, further analysis will show them to be problematic in this instance.

The *Figure 3* base load encroachment diagram illustrates normal relay tripping for a 3-phase fault. It shows how the positive sequence apparent impedance angle follows a trajectory from within the load region towards the line's impedance angle (about 60 degrees for the 3301 line), illustrating how the load

encroachment function normally discriminates between fault current and load current. The red annotations show how the observed operating apparent impedance was just inside the load region before the tripping event. It is easy to see how excess VAR exports became problematic as exported Watts were lost.

Assuming that the Wind Farm turbines were operating at unity power factor, successive unit trips reduced exported real
power P while exported reactive power Q (sourced by the undersea 165T and 160T cable capacitance) remained constant.
Consequently, as each unit tripped the export power factor became more lagging.

So, if the power factor limits illustrated in *Figure 3* are common for overhead lines, why are they problematic for this line? The inherent capacitance (charging VARs) of the 165T and 160T undersea cables, downstream from the 3301 line, is what complicates matters. With overhead lines, charging VARs are practically negligible. Not only are undersea cable charging VARs not negligible, they represent fixed 8MVAR and 3.5MVAR shunt capacitor banks attached to the DC #165 and BI #160 buses respectively, regardless of whether wanted or not. Among other problems, the extra VARs can produce

Because the Wind Farm's power output is variable and usually less than the nameplate rating, the export of reactive power (VARs) over the 3301 line from DC #165 is largely unaffected by Wind Farm generation. When the Wind Farm turbines tripped, exported real power (MWs) literally disappeared while exported reactive power (VARs) remained unchanged –pushing the export power factor outside of allowable bounds. In *Figure 3*, this is seen as the apparent impedance following a horizontal trajectory towards the jX axis. It was discovered that Wind Farm turbines frequently trip on overvoltage conditions in response to various system events. Before this August 18 event, the next most recent occurrence of Wind Farm high voltage tripping occurred on April 5, 2018 in response to a fault on a neighboring utility's 345kV line in the greater Boston area of Massachusetts. It would appear from this analysis that the relay's load encroachment function is simply not suitable for application on this particular line.

While the load encroachment function in this particular relay is not a suitable application choice, this relay does not provide any other form of load encroachment restraint. Fortunately, another option can be leveraged. Generator interconnection protections commonly include an undervoltage restrained or undervoltage controlled overcurrent (ANSI Device 51V) function. This function leverages the expected voltage collapse that accompanies a fault. That collapse is lower than allowable normal undervoltage conditions. Coupled with directional supervision, undervoltage torque-control appears to be a better solution for the portions of the radial supply between the utility electrical power system (EPS) and the Wind Farm. Therefore, it was explored and ultimately adopted as a replacement for the relay's load encroachment torque control on the BI #160 165T line breaker. DC #165 3301 line break, and WF #17 3307 and 3308 line breakers, all looking back towards WF #62.

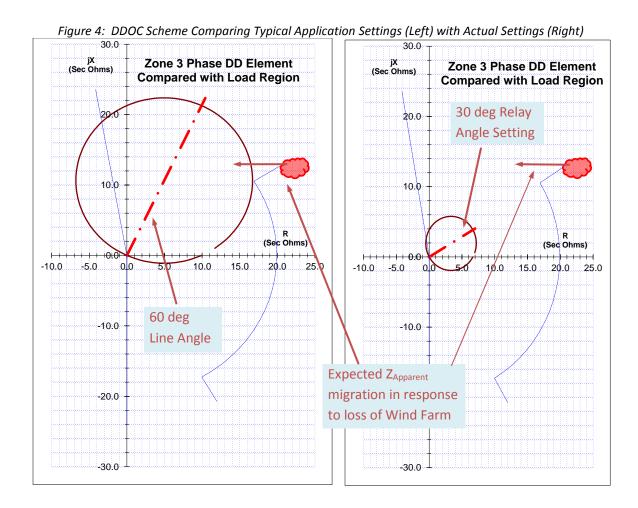
The R-X diagrams in *Figure 4* illustrates how this DDOC scheme works with respect to the migration of apparent impedance in response to loss of Wind Farm and/or BIPCo backup generation. The left diagram illustrates this migration for a typical DDOC application where the diameter of the Zone 3 characteristic is maximized to carry the highest permitted load current. It demonstrates that such migration could certainly be a source of concern. The right diagram illustrates this same impedance migration but, this time, with respect to the actual 3301 line relay settings. With the actual relay settings, the Zone 3 characteristic diameter is only large enough to accommodate required fault sensitivity. Now, the Zone 3 mho trip region is sufficiently removed from the load region so there is little risk of nuisance tripping.

This analysis raised concerns for the security of the 3301 line's multifunction line differential relay's backup overcurrent function. Since this particular multifunction differential relay does not provide a load encroachment function, a Zone 3 distance (mho) characteristic was applied as a torque control for a nondirectional overcurrent (51) function instead. This arrangement is sometimes referred to as a directional distance overcurrent (DDOC) scheme.
