Analysis of Cascading Operations for Adjacent Line Faults At National Grid

By: Yujie Irene Lu, Song Ji & Scott J. Slaski (National Grid)

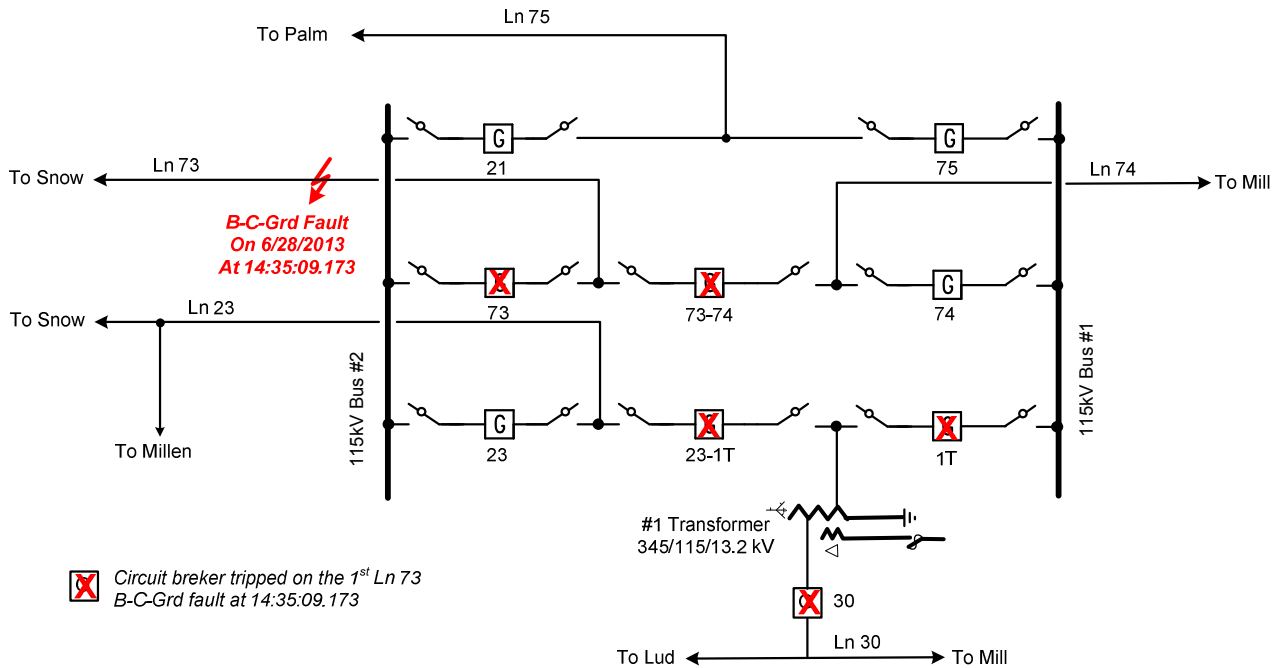
Figure 1a: Substation Carp System One Line Diagram & Breaker Status after the 1st Fault

At 14:35:09.173, a lightning stroke caused a B and C phase to ground fault on the 115kV line 73 near substation Carp. The line protection operated and tripped the breakers 73 and 73-74 correctly, which isolated the fault. Per fault records collected from the DFR at substation Carp, the fault was 1.72 miles away the station and the line 73 and breakers 73 and 73-74 were tripped in 3.5 cycles. Simultaneously the sudden pressure protection of 345/115/13.2kV #1 autotransformer also operated tripping and locking out the transformer high side 345kV breaker 30 and low side 115kV breakers 1T and 23-1T (Figure 1a).

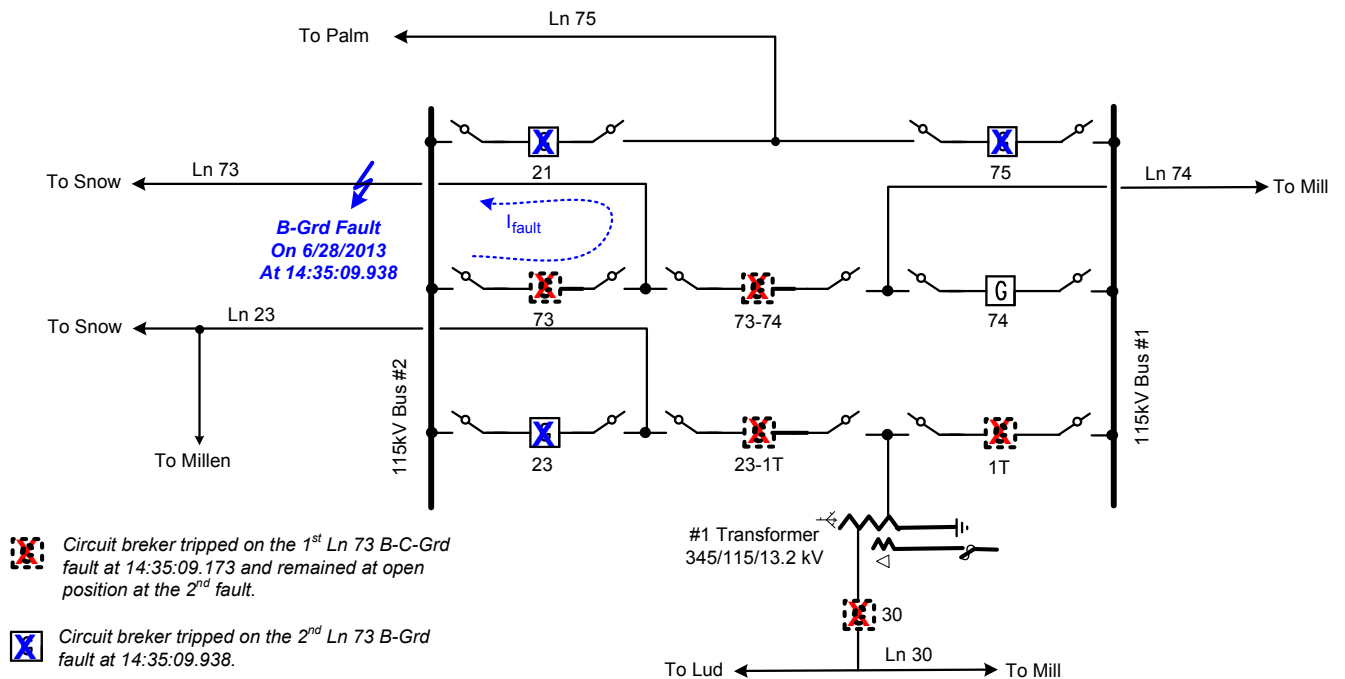
Figure 1b: Substation Carp System One Line Diagram & Breaker Status after the 2nd Fault

At 14:35:09.938, approximately 0.8 second after the first fault, the line 73 was hit again by another lightning stroke at almost the same location causing a B phase to ground fault. Although breakers 73 and 73-74 remained in the open position, the line 73 protective relay operated again on the second fault and three surrounding breakers, 23, 21 and 75, were tripped and locked out by the 73 and 74 breaker failure schemes. In addition, a direct transfer trip (DTT) signal was sent down the line 23 by the 73 breaker failure scheme tripping the customer owned Millen station offline. The only breaker that did not trip was the 74 though loss of the autotransformer and other 115kV lines left the line 74 dead. Approximately 12,700 customers at the other end of the line 73 and 23 without power (Figure 1b).

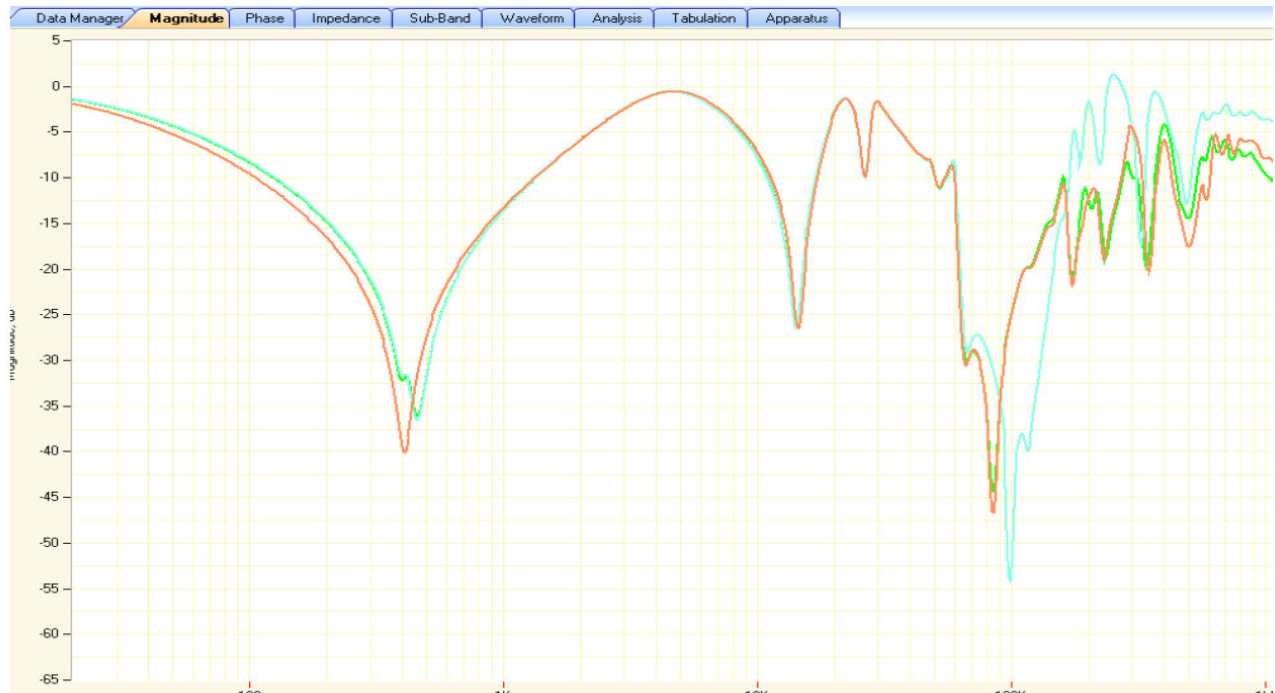
Figure 3: Doble SFRA Test Result on #1 Transformer at Carp on 7/28/2013

A transformer Sweep Frequency Response Analysis (SFRA) test was performed by Doble Engineering on July 28th, 2013 on the Carp autotransformer. Doble and National Grid concluded that there is operational and testing evidence that the fault events have caused winding movement to the Carp #1 autotransformer since the time it was manufactured and sometime during the period between 2006 and 2013. The Doble SFRA testing indicates winding movement in the 13.2kV tertiary Y1-Y2 leg. The leakage Reactance testing performed on the same day and hinted the same winding movement happened that the SFRA highlighted ^[3]. The highlighted SFRA test result from Doble is listed in Figure 3.

Figure 3 is a snapshot of the 2013 SFRA open circuit tertiary measurements for transformer T1. This snapshot reveals that there is a significant mismatch of one of the traces (light blue -Y2-Y1) when compared to typical expectation for alignment demonstrated in picture above. The deviation starts at 60 kHz and continues on up which is associated with bulk components changing location and winding geometry changing^[3].

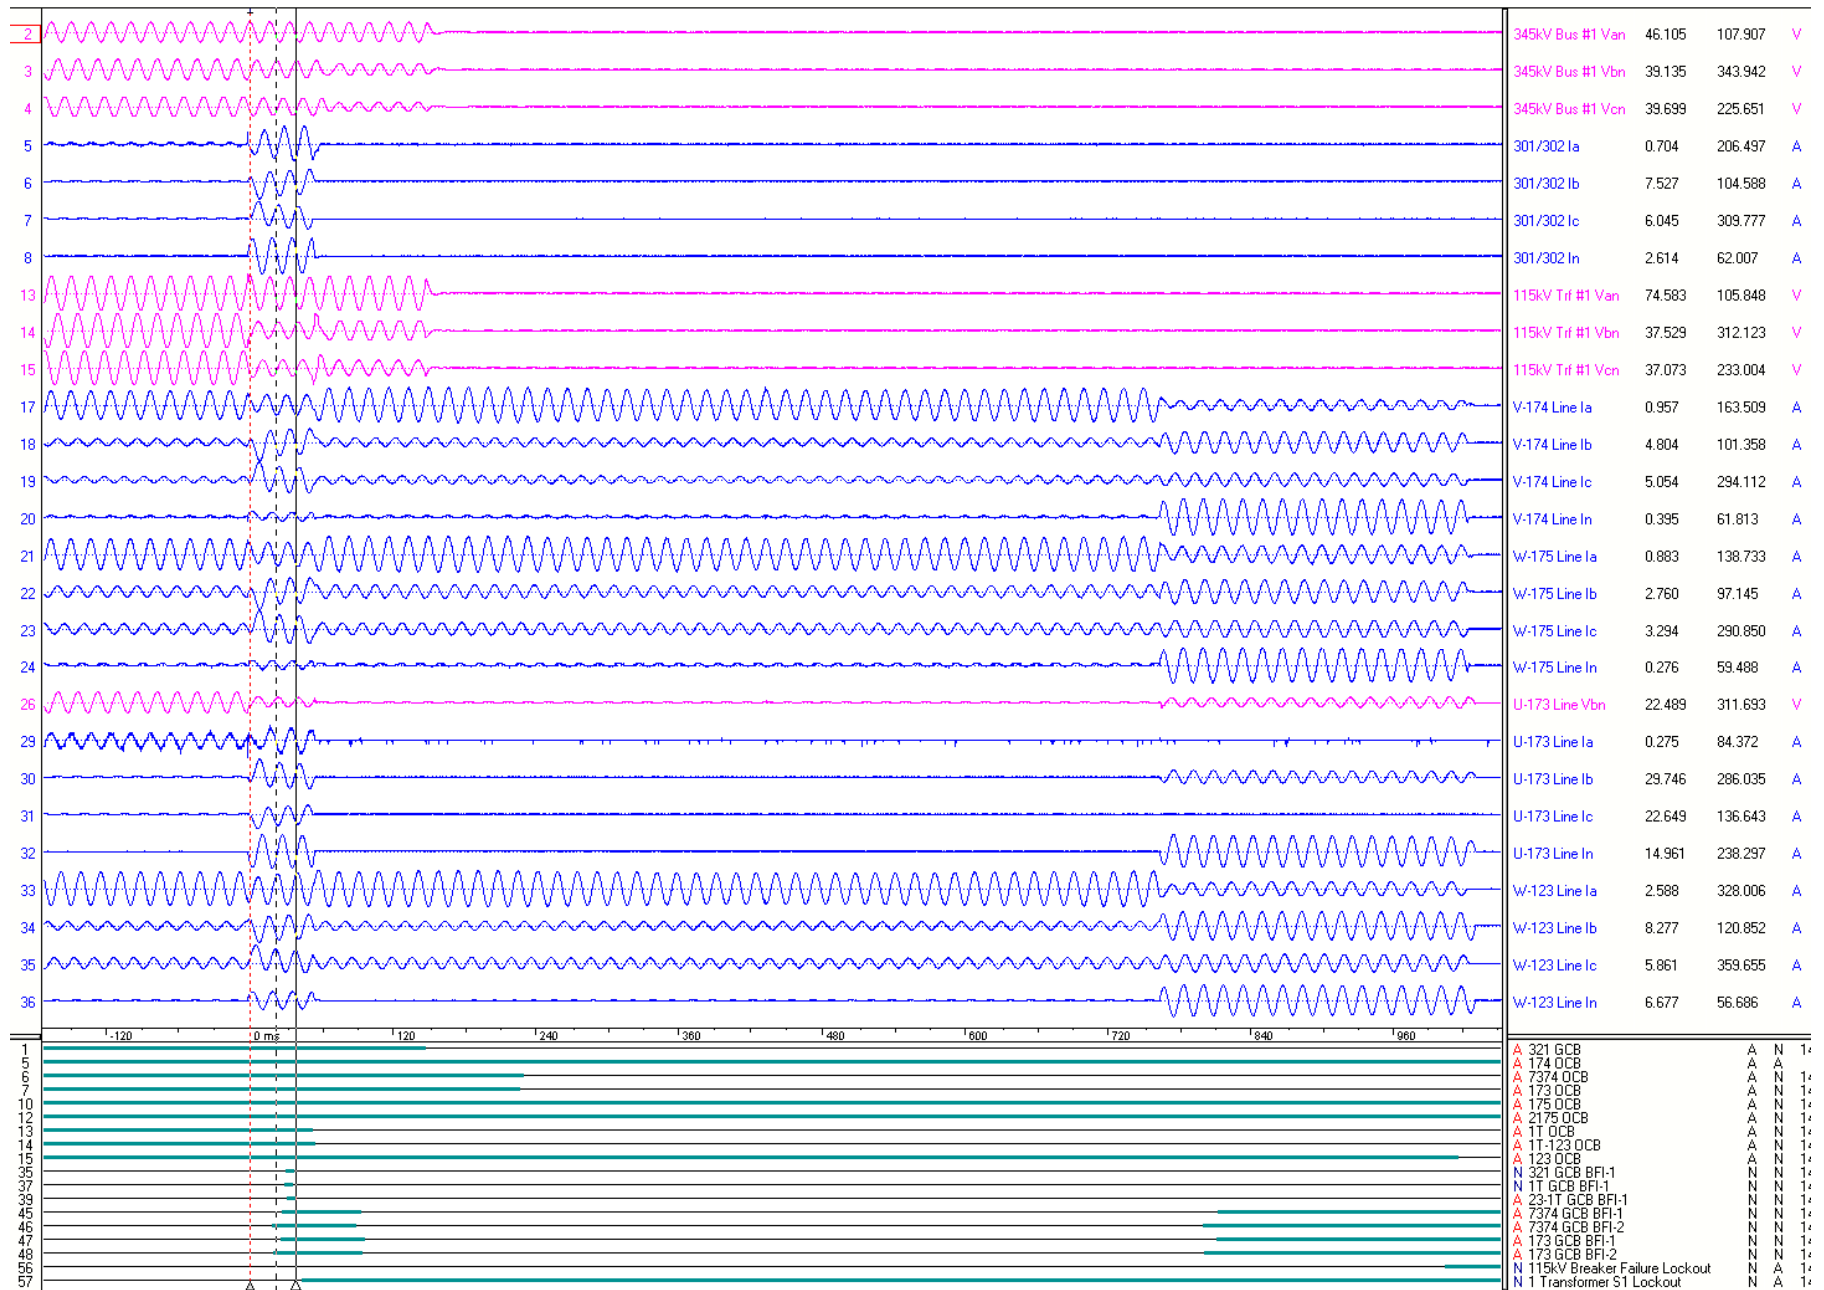
Figure 4. Carp DFR Records on Line 73 Faults on 6/28/2013, at 14:35:09.173 and 14:35:09.938

By analyzing the Carp DFR records as shown in Figure 4 on the following page, it was determined that:

- During the original line 73 fault, the line protective relay operated and tripped the breakers 73 and 73-74 correctly isolating the fault in 3.5 cycles. Both breakers remained in the open position following this trip.
- On the second lightning hit all four 115kV lines (73, 74, 75 and 23) at Carp saw B phase to ground fault current. Fault current of line 73 was out of the Carp 115kV bus toward the fault. Fault current through lines 23, 74 and 75 were only apart 40 degrees from each other but apart almost 180 degrees from the current through the line 73, i.e. the current of 23, 74 and 75 was into the bus. This finding suggested that the second fault was on the line 73 and the line 73 relay operated again. In addition, magnitude summation of the fault current of the 23, 74 and 75 is equal to the current on the 73 (Figure 5).

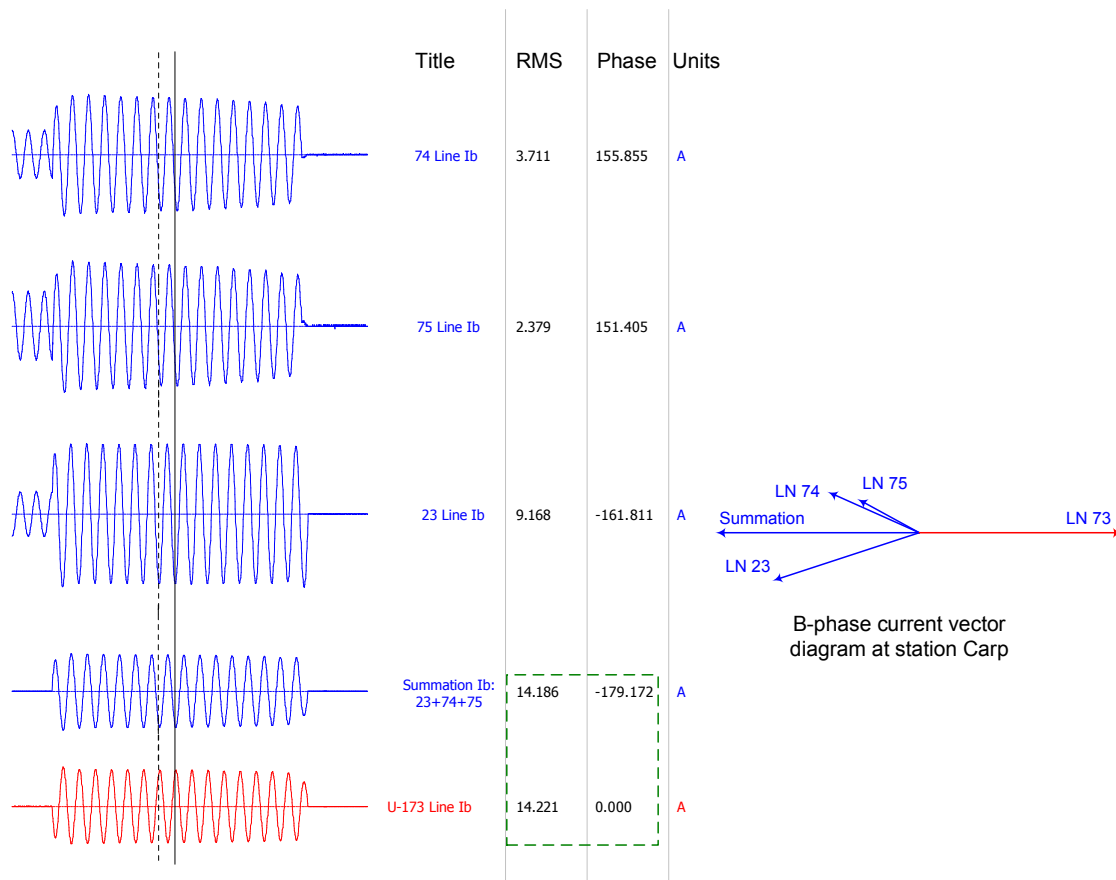
Figure 5: The B-phase current flow information during the second lightning stroke at Carp

The breakers 73 and 73-74 for line 73 were in the open position at the moment of the second line fault. How could the line 73 see the through fault current if both line breakers were open? Based on the SOE data and relay targets, it is highly suspected that the main contact insulation of the breaker 73 was experienced a dielectric breakdown by the high energy of the lightning stroke, therefore, the current did in fact feed from bus to line although physically the breaker was open at the time.

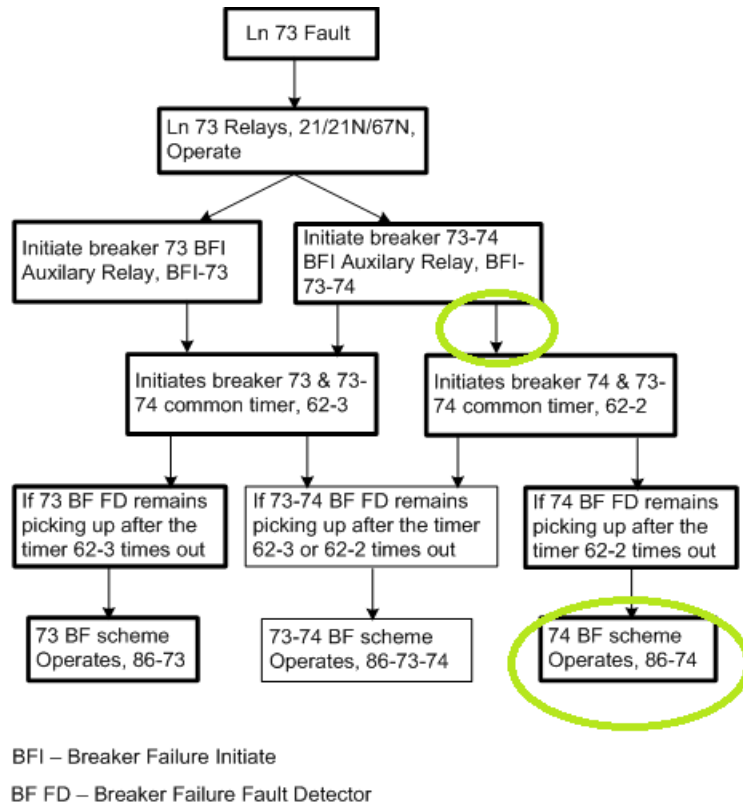
Figure 6: Operation Logic of 73 & 74 Breaker Failure Scheme at Carp during the Second Fault

Referring to the BF scheme logic illustrated below in Figure 6 and the collected target information on the 73-74 and 74 breaker failure common timer, 62-2, and the 74 breaker failure lockout relay, 86-74, it can be seen that the breaker failure scheme responded to the second fault as well because the 74 BF FD remained picked up until the second line 73 fault was isolated by the 73 breaker failure relay, which indicated why the breaker 75 was tripped at the same time as the breakers 23 and 21 opened in 15 cycles.

Through review of the 73, 73-74 and 74 breaker failure schematic drawings and relay targets captured during the line 73 faults, the reason of the 74 breaker failure operation along with the 73 breaker failure operation was discovered and traced back to incorrect cross-tripping between the 73, 73-74 and 74 breaker failure common timers, 62-3 and 62-2 (Figure 6). The design error was made while re-building part of the 115kV switchyard and modifying the 115kV breaker failure scheme from one breaker failure timer per bus to one timer per breaker in the early 2000.

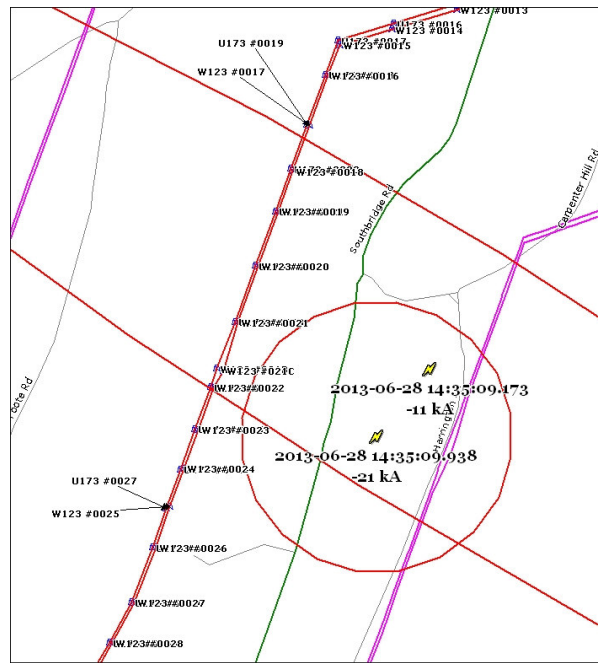
Figure 8: Lightning information from NLSN

Two thunderstorms passed over 115kV line 73 in less than 800 ms and caused two separate line faults from lightning strokes. The magnitude of lightning discharges and rough location are shown in the figure 8. It can be seen that the first and subsequent discharges are 21kA & 11kA respectively.

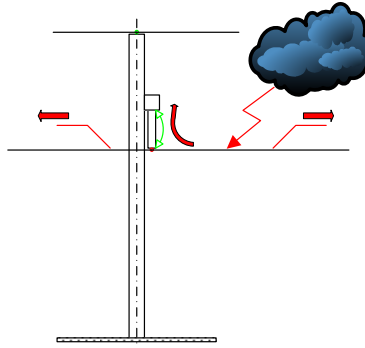
Figure 10: Direct lightning stroke on phase B conductor of line 73

Lightning strokes of low magnitudes (a few tens of kA) can bypass the overhead shield wire and can stroke directly on the phase conductor^[5]. The magnitude of second stroke was only 11kA and it was very likely the second line fault on line 73 was caused by direct lightning stroke on phase B conductor. To confirm the suspect, an EMTP simulation was performed to verify the overvoltage stress at line structure insulator and breaker 73 B-phase main contact.

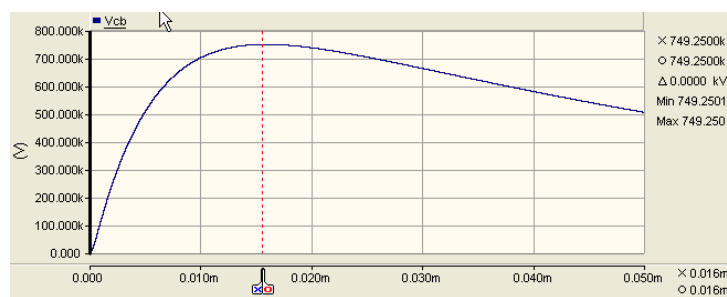
Figure 14: transient voltage on open state breaker terminal

The voltages for the insulator string at the nearest direct stroke structure and breaker 73 at substation are monitored. The simulation was performed in PSCAD to find out the voltage distribution right after the stroke. From the simulation, it can be seen that the voltage on the line side of main contact of the breaker started to rise and the voltage gradually reached to approximately the peak 750kV which exceeded the BIL of this 115kV breaker. Because there were no lightning arrestors on the line side, the high surge voltage would not be clamped. It should be also noted that the bus side of breaker was still energized with 115kV. As a result, the SF₆ gas insulation between breaker 73 B-phase contacts was broken down. The following figure 13 shows the typical interrupter of a dead tank breaker. When the fast front lightning surge arrived at the departed main contact on the line side, the very high electric fields were applied across dielectric material (SF₆ gas) between breaker contacts and a number of electrons may be suddenly excited to form the conduction path.

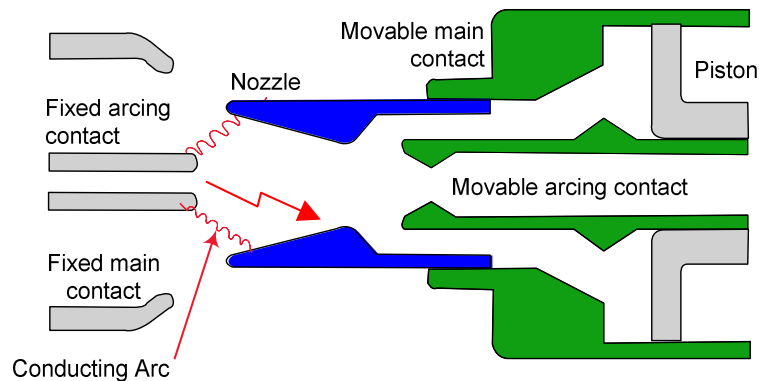
Figure 15: Interrupter of SF₆ dead tank breaker at open contact position

Most likely the arc was initially developed between fixed arcing contact and the protruded nozzle when the surge voltage exceeded breaker BIL. With the presence of initial arc, the SF₆ molecules in vicinity were further ionized and then stable arc path was formed between the breaker main contacts until the source from Substation Carp was isolated by breaker failure protections. After the arc extinguish, the decomposed SF₆ from the arc under extreme high temperature can be recombined back to SF₆.

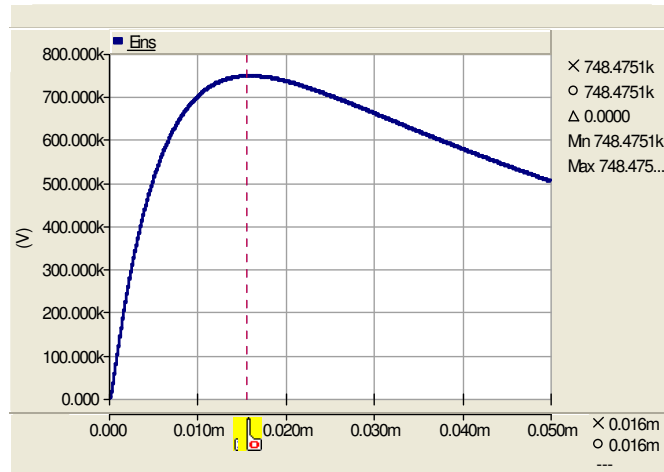
Figure 16: Voltage over insulator from the lightning stroke

The voltage on the B-phase insulator of line structure which was the nearest to the direct stroke is shown in Figure 16. The maximum strain voltage over the insulator exceeded its BIL (550kV) and flashover was expected on the insulator, resulting in the B-phase-to-ground fault.
