Analysis of POTT Scheme Operation for an External Fault

By: Yujie I. Lu and Jeffrey Pond, National Grid

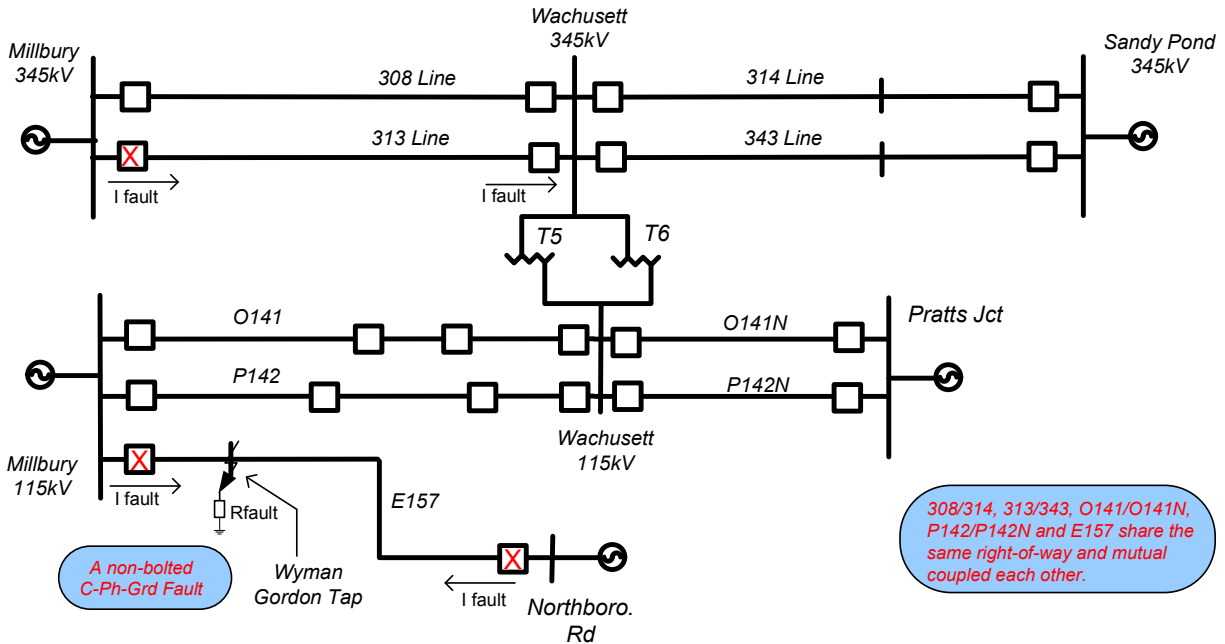
Figure 1. System One Line Diagram with E157 Line Fault

On January 11th, 2008, the national Grid Control Center reported that at 13:32:03 a lightning stroke caused a fault on the 115kV E157 Line between the Millbury and Northborough Road terminals. Simultaneously, the 345kV 313 Line operated at the Millbury terminal only. The Sequence of events are shown in Table 1 and the line configurations are shown in Figure 1. The E157 and 313 lines share a common right-of-way with three other lines. The Control Center reported that the 115kV E157 Line tripped and auto-closed correctly at both terminals, and the Millbury terminal of the 313 Line operated simultaneously to the E157 Line fault and auto-closed. Targets reported for this event are as follows:

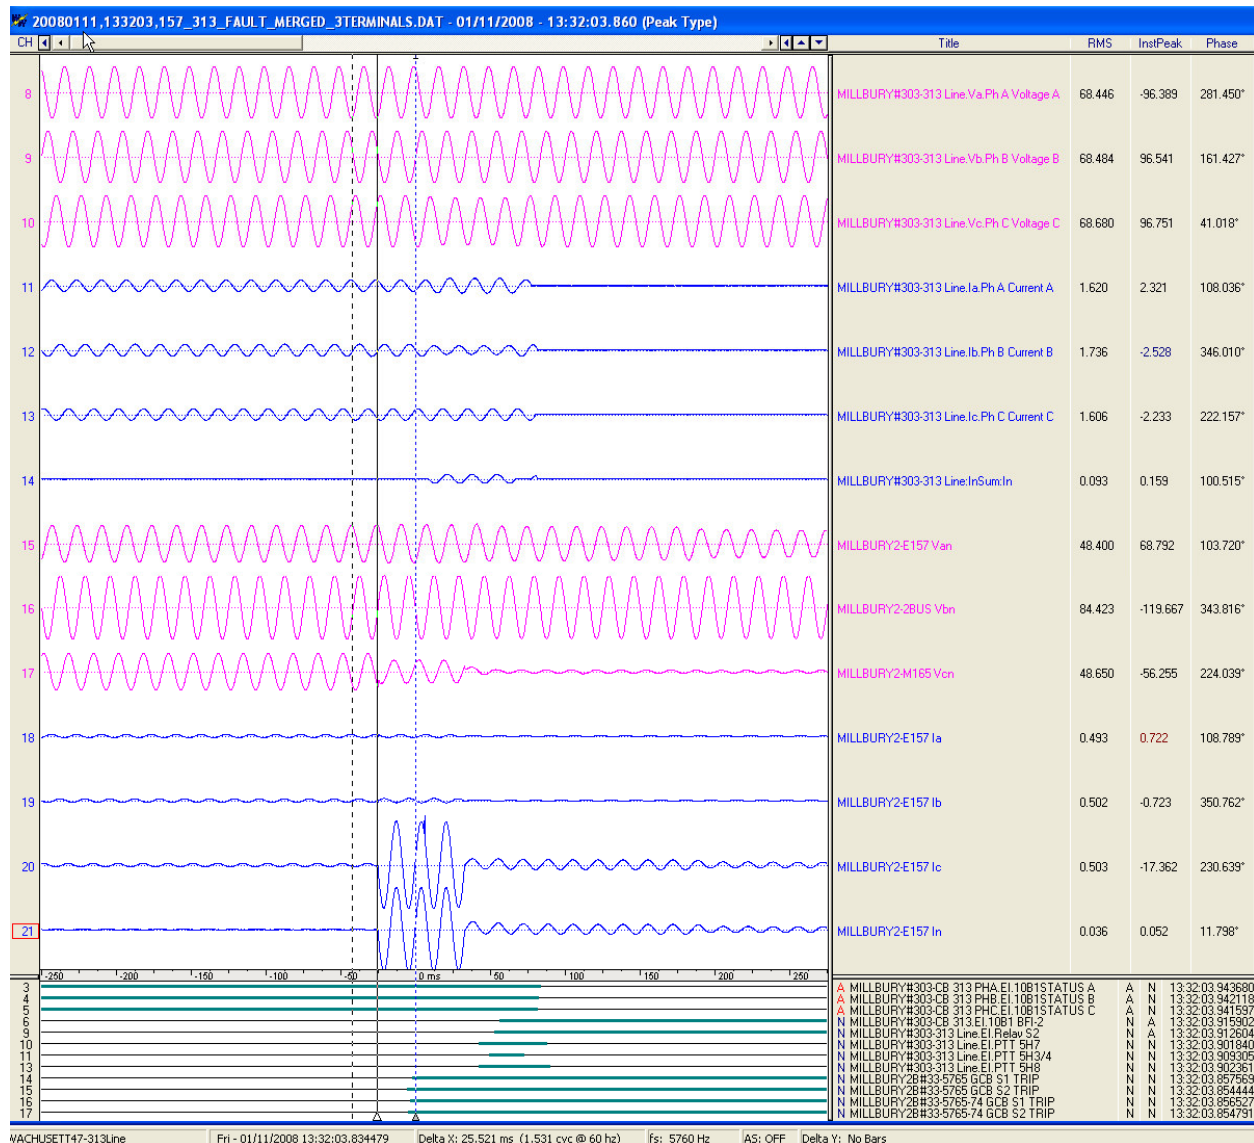
Figure 2. E157 and 313 Line DFR Waveforms at Millbury Substation at 13:32:03

The first step of the investigation was to review relay targets, Sequence-of-Events (SOE), and fault records from the digital fault recorders (DFRs) and the E157 and 313 line relays at Millbury, Northborough Road and Wachusett substations. Based on the reported targets, the SOE (Table 1) and the fault records captured by the Millbury DFRs (Figure 2) it was confirmed that a C-phase-to-ground fault occurred on the E157 Line and the E157 Line Permissive Overreaching Transfer Trip (POTT) scheme operated correctly. Review of the same record showed that no fault had occurred on the 313 Line, however, there was significant neutral current present due to the effects of mutual coupling. Review of the targets, SOE, and DFR records confirmed that the 313 Line POTT scheme operated resulting in a single-end trip of the 313 Line at Millbury 3 only. It appeared that the 313 POTT scheme operated incorrectly for this event. The investigations focus moved to identify why the 313 POTT scheme operated for the E157 fault and why was the result only a single-ended trip?

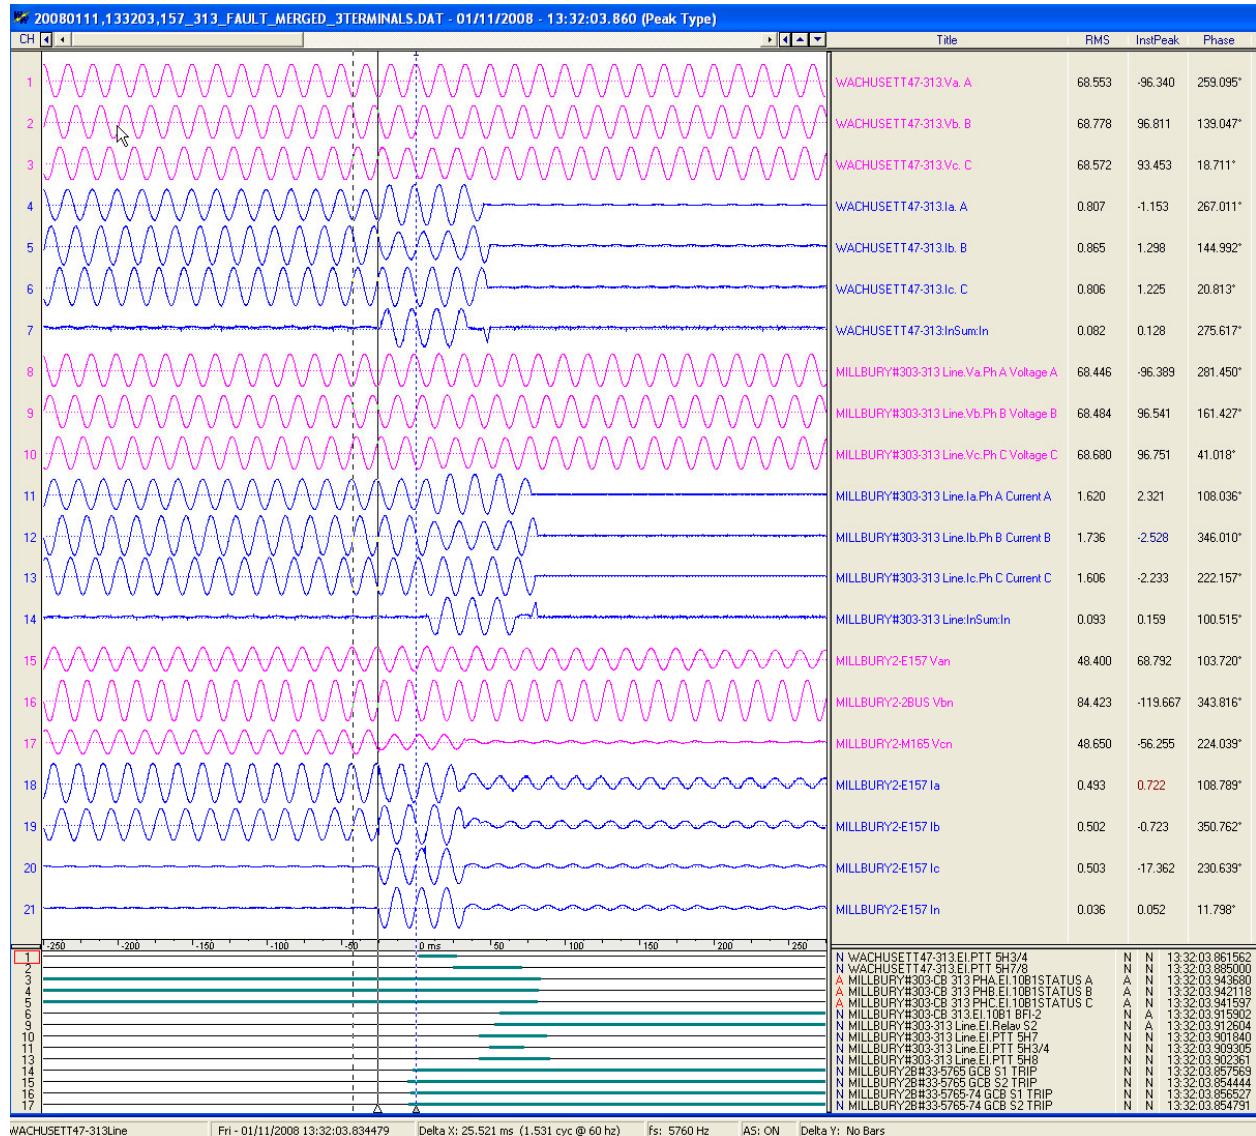
Figure 3. E157 and 313 Line DFR Waveforms at Millbury Substations and Wachusett 47 at 13:32:03

The DFR records from the Millbury substations and Wachusett 47 were reviewed. Figure 3 is a merged file of the records from the three substations for the purpose of this discussion. Analysis revealed that the 313 POTT scheme sent permissive transfer trip from Wachusett. Wachusett also received POTT and POTT was sent from Millbury and received at Millbury. Unfortunately the Waveform from the Millbury 3 DFR did not line up with the waveforms from the Millbury 2 and Wachusett 47 DFRs. Before the investigation continued the reason for the error needed to be identified. After careful analysis it was determined that the timing error existed in all devices at Millbury 3. The DFR, relays and Remote Terminal Units at all three substations are time synchronized to a local GPS receiver, yet the Millbury 3 GPS receiver was 33 milliseconds faster. Since the error was consistent it was determined that the GPS receiver was the most likely cause of the error and before the analysis continued the time needed to be adjusted in the DFR and Relay records related to this event from Millbury 3. Figure 4 shows the DFR

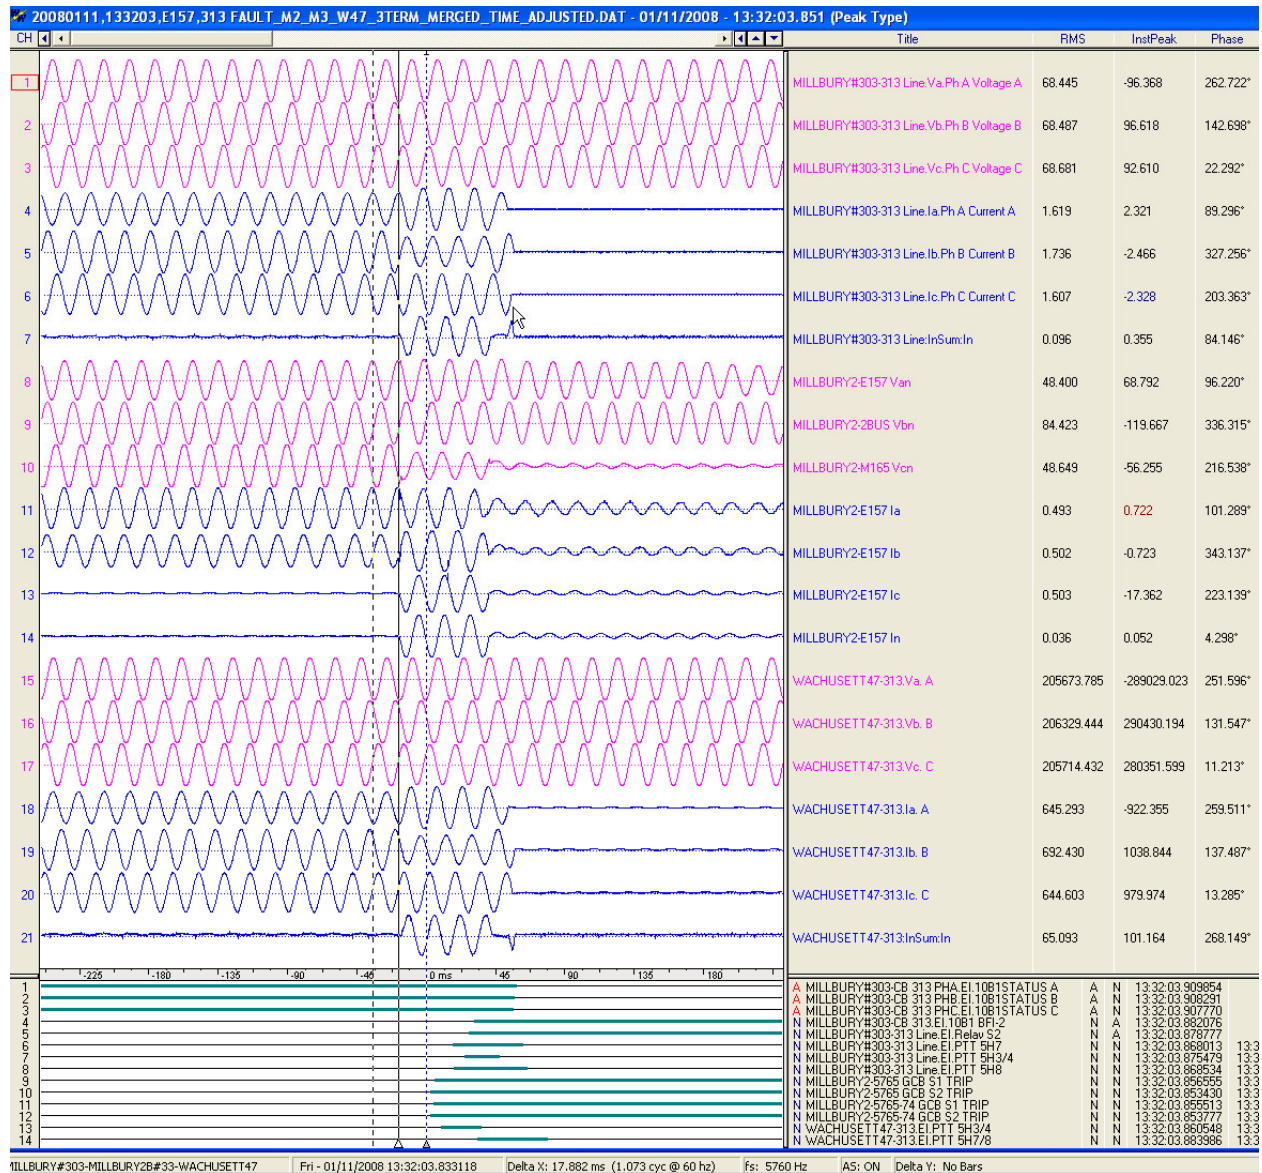
Figure 4. Time Adjusted 313 Line DFR Waveforms from Millbury 3 and E157 and 313 Line at Millbury Substation and Wachusett 47 at 13:32:03

waveforms with Millbury 3 time adjusted. The time adjusted waveforms provide a better snapshot of what occurred during the event and it is clear that POTT was sent and received to allow a high-speed trip.

Millbury operated and sent a permissive input signal (PT) to Wachusett. However, in the meantime, the fault records also indicated that a PT signal was received at Millbury (Figure 4). Upon receiving the PT signal, the permissive tripping condition was met and, consequently, the 313 terminal at Millbury was allowed to operate by the POTT scheme.

The analysis team did not immediately recognize the timing discrepancy at the Millbury 3 terminal. An error of 33 milliseconds is significant and impacts the investigation. Not realizing the error could have resulted in an incorrect determination of the mis-operations cause.

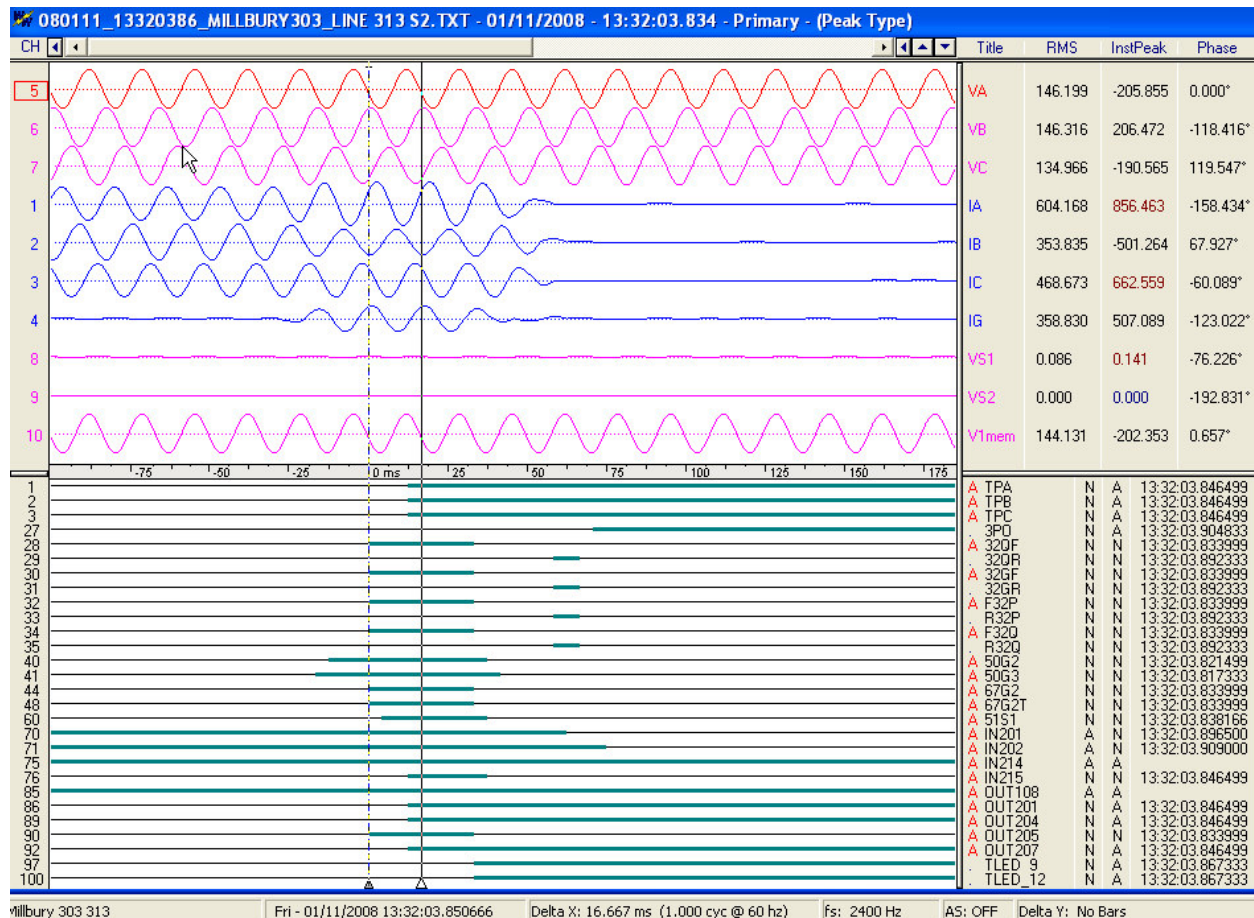
Figure 5. 313 Line POTT Scheme Relay Fault Record at Millbury Substation at 13:32:03

Comparing the relay fault records for the 313 POTT relay at Millbury 3 (Figure 5) and at Wachusett 47 (Figure 6) and the associated relay settings it was noticed that, at the trigger point, the magnitude of the reverse-looking ground overcurrent element (67G3) at Wachusett 47 was higher than the pre-set pickup level and so the overcurrent element (50G3) of the 67G3 picked up, while the negative-sequence polarized reverse-looking directional element (32GR) did not assert solidly but was right on the edge of operating, in other words, it was toggling between a logic ONE and logic ZERO. As compared with the 32GR, the logic status of the 63G3 was toggled also. As a result, the current reversal element, 67G3, failed to block the received Permissive Trip signal at Wachusett 47 and it echoed back to Millbury 3 (see Figure 7 & 8 for detailed logic). At this point, it was determined that the single-ended POTT operation at Millbury was due to the failure of the negative-sequence polarizing for directional control to assert at Wachusett. The investigation team now focused on determining why the negative-sequence elements associated with the directional control failed to assert.

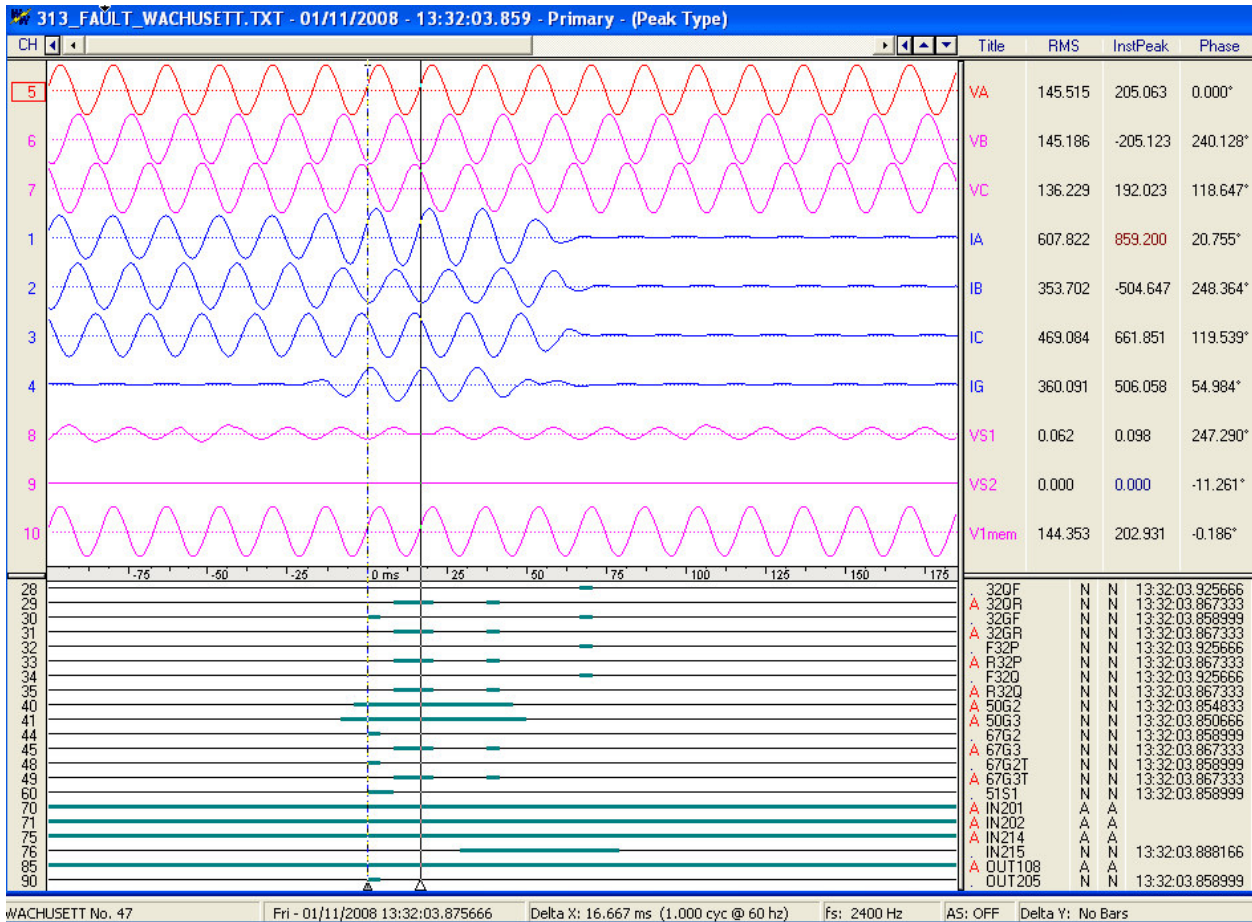
Figure 6. 313 Line 313 POTT Scheme Relay Fault Record at Wachusett Substation at 13:32:03

1. The 3I2 detected by the 50RP is the same as the setting of the 50RP, i.e. it is on the edge of assert or de-assert, even though it has been set at the minimum tap to provide maximum sensitivity. Therefore, it is a possible root cause factor in preventing the 32GR element from picking up.
2. Per the manufacturer definition, $a2 = I2/I1 = (200/3) / 669 = 0.0997$, which is 0.003% smaller than the setting of the a2 element, therefore, it was determined to be a root cause factor in preventing the 32GR and the 67G3 elements from picking up. Consequently, the current reversal element, 67G3, failed to pickup resulting in the scheme failure to block the received PT signal inhibiting the signal from being echoed to the remote end.

The above discovery quantitatively proved that the root cause of the single-end POTT operation at Millbury was due to a lack of negative-sequence current, although only 0.03% lower than the pre-set threshold, for the directional control of the current reversal blocking during the E157 fault at Wachusett.

The E157 and 313 lines share a common right-of-way with several other lines; therefore there is a significant mutual coupling effect in this area. In order to improve the security of the POTT scheme, and, prevent any parallel line fault from causing an operation on the Permissive Overreaching Transfer Trip (POTT) scheme for external faults, the Echo logic application for the 313 Line was disabled. A review of other lines in the area resulted in the disabling of the ECHO logic in POTT schemes on an additional seven transmission lines.

As a result of the investigation a recommendation to re-evaluate the use of the Echo applications in POTT schemes was made. The determination was that there are cases where the Echo feature could provide needed protection system dependability. However, the use of Echo logic in POTT schemes should be evaluated carefully for each transmission line application as an improper application affects protection system security.

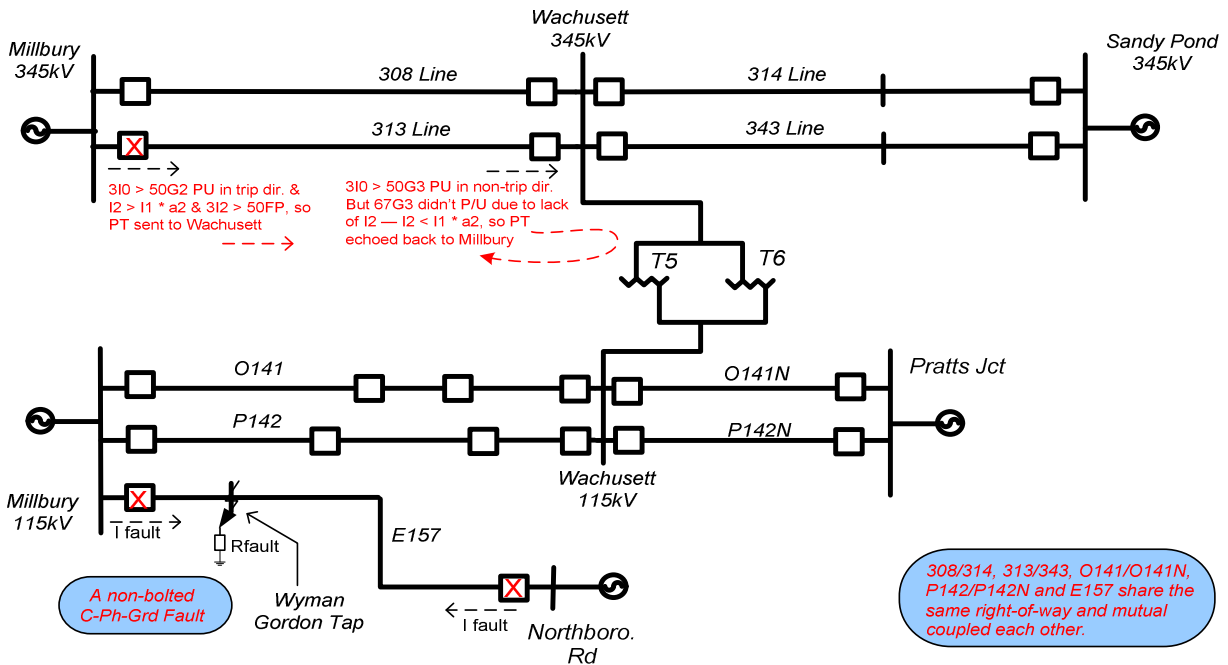
Figure 7. E157 Fault with Response of 313 Echo Logic at Wachusett

The 313 POTT scheme was set utilizing the relay Echo Logic, with Current Reversal Blocking control, to “echo” the received Permissive Trip (PT) signal to the initiating terminal. As per the manufacturer design, the echo with current reversal logic functions if a reverse fault has not been detected by the reverse-looking elements (phase and ground Zone 3, Z3P and Z3G, and ground overcurrent, 67G3, for this application) before a received PT signal is echoed back. To avoid zero-sequence mutual coupling effect, negative-sequence polarizing is used for directional control on the ground elements used for this application. The following diagrams (Figure 7 & 8) illustrate how the echo with current reversal and the negative-sequence directional control logic works.

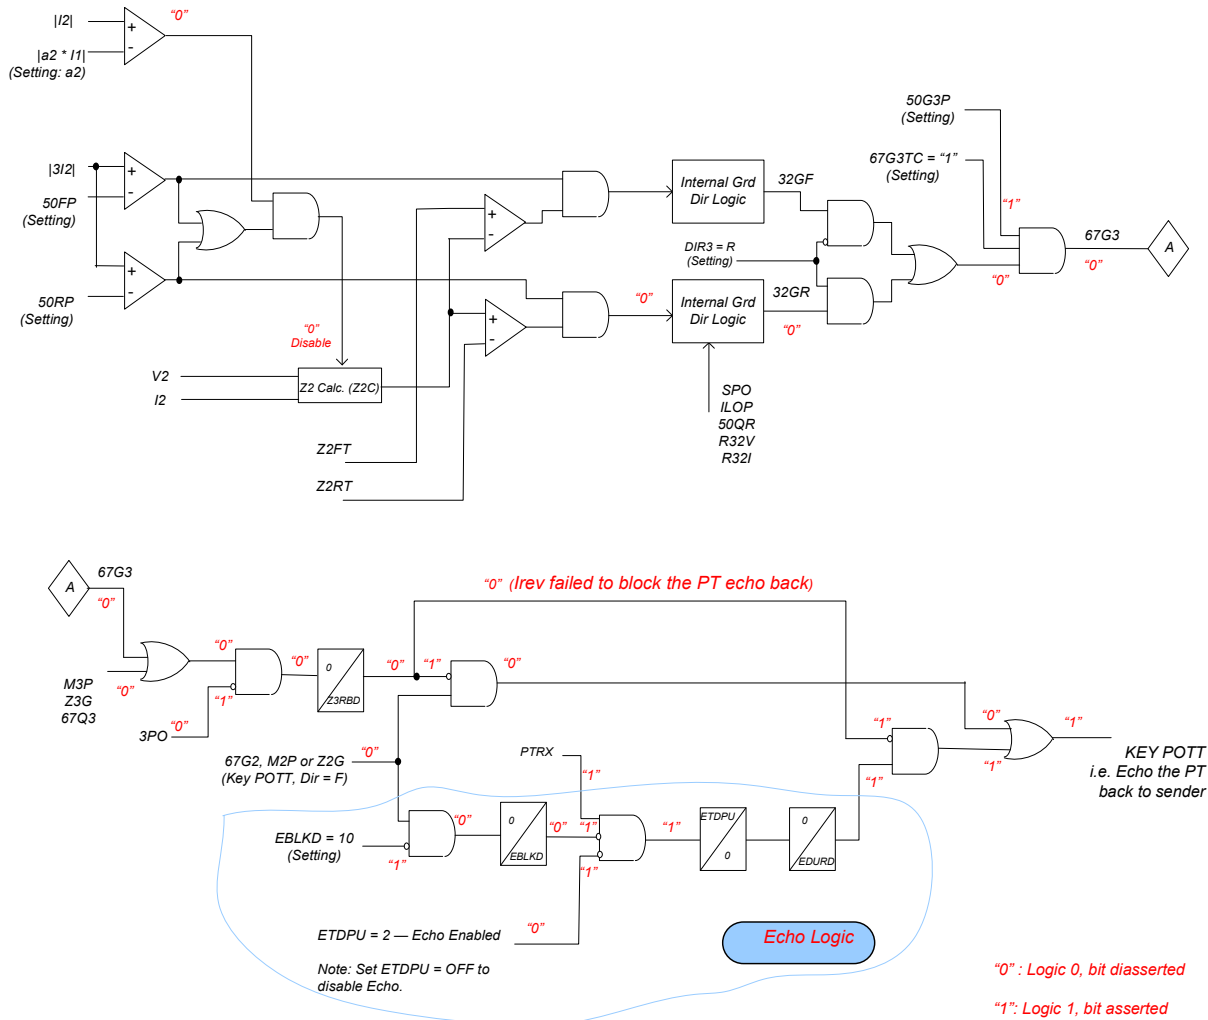
Figure 8. Echo with Current Reversal and Negative-Sequence Directional Element Logic

Following a review of the relay echo and directional control logic shown in Figure 8, at Wachusett, it was determined the following elements could prevent the negative-sequence polarizing for directional control to assert if not set properly.

- Reverse Direction Negative-Sequence Current Detector, 50RP (3I2) – Set the pickup threshold at 0.25/200 amperes (i.e. set at the minimum. tap), or
- Positive-Sequence Restraint Factor, I2/I1, a2 – Set at 0.1 (a typical setting), or
- Zero-Sequence Restraint Factor, I2/I0, k2 – Set at 0.2 (a typical setting)
