Diagnosis of Protection Misoperations Due to Mutually-Coupled Transmission Lines

By Terry T. Bowman
Duke Energy

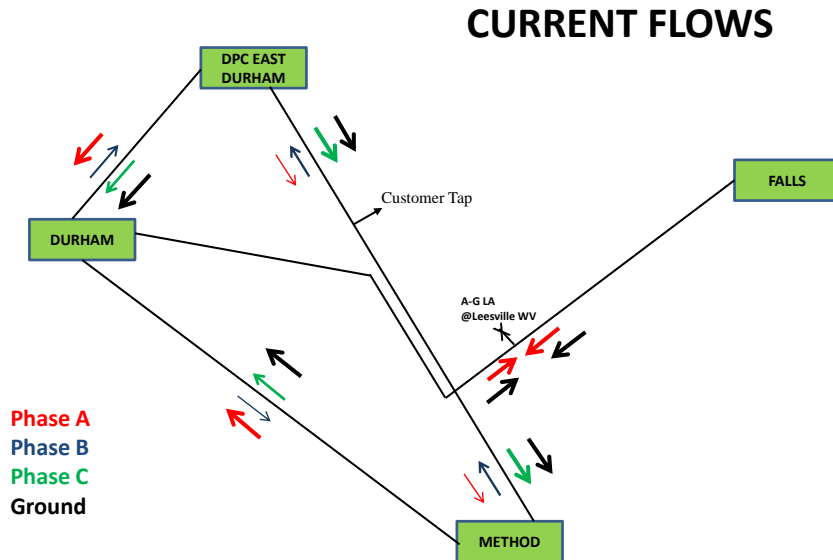
Figure 2 shows the power system configuration for this example. Initial pre-fault power flow was from the DPC East Durham terminal toward the Method terminal.

As expected for the A-G fault on the Durham – Falls 230kV line, DFR data indicated that I_A (denoted by red arrows) and I_G (denoted by black arrows), flowed toward the fault from both terminals. At the same point in time, a large magnitude of I_C (denoted by green arrows) and I_G flowed from the DPC East Durham terminal and into the Method terminal. During the fault, I_B (denoted by blue arrows) reversed direction.

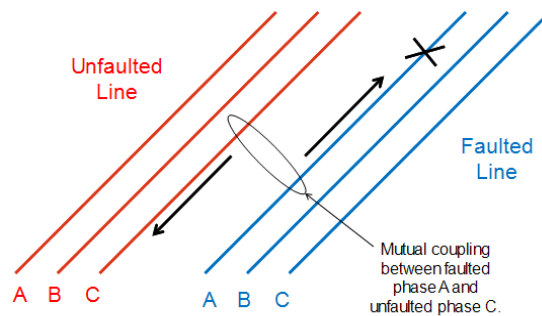
Figure 3
Orientation of Conductors

Figure 3 shows the physical orientation of the unfaulted line with respect to the faulted line in the area where the two lines are routed in parallel. Since the degree of mutual coupling is a function of the physical separation between the conductors involved, it would be expected that phase C of the healthy line would be most impacted and that phase A of the healthy line would be least impacted. As indicated by the size of the arrows in Figure 2, this was the case.

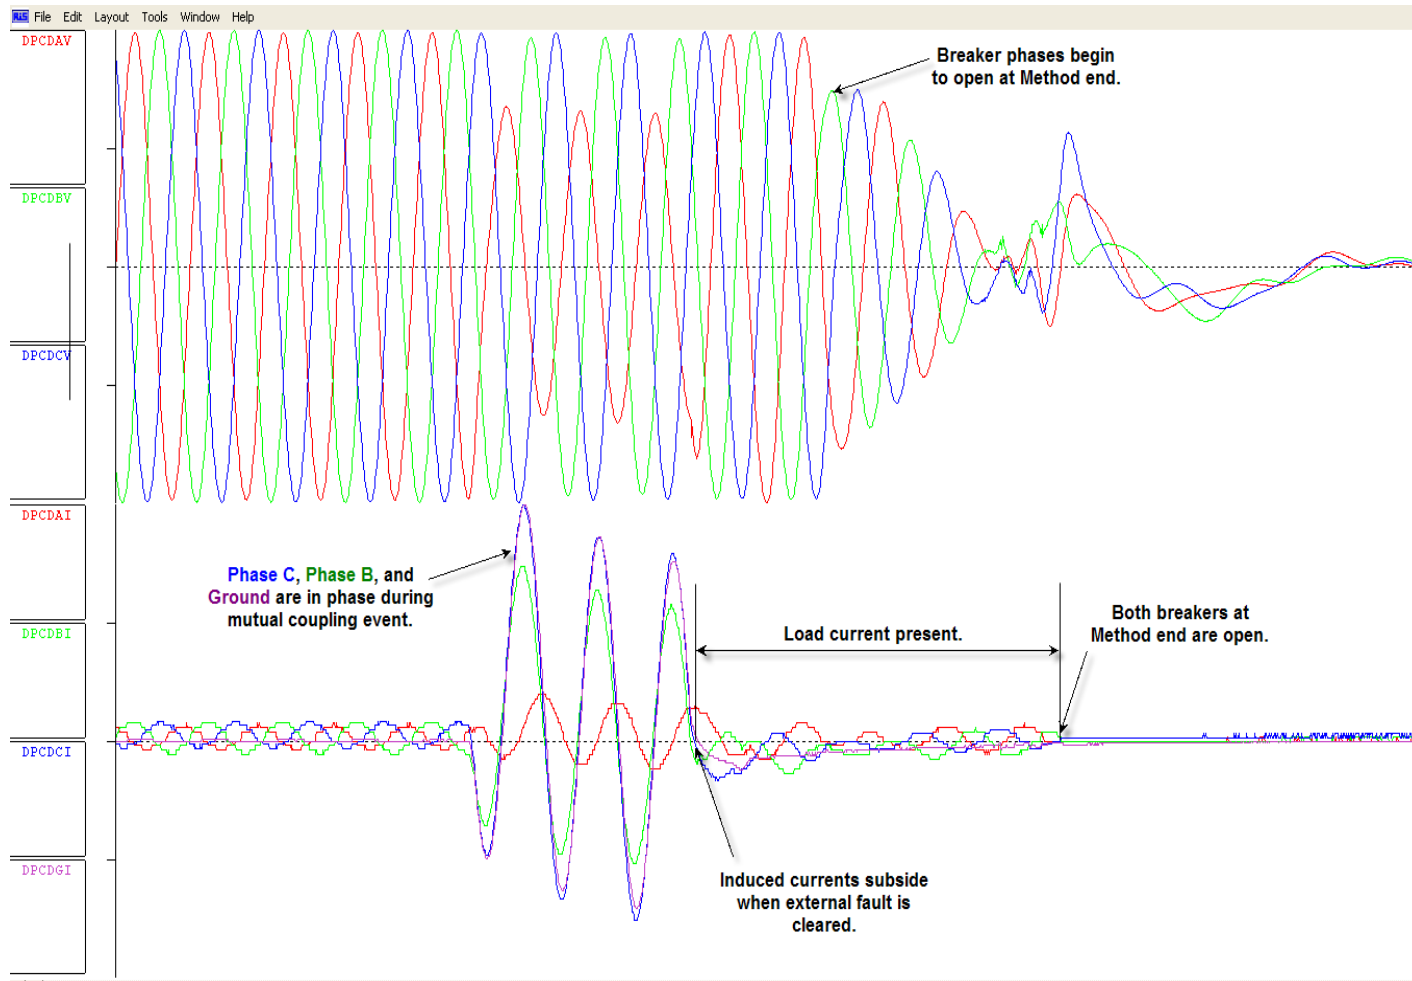
Figure 4
 DPC East Durham Terminal at Method 230kV Substation

Figure 4 shows DFR data recorded at the Method 230kV Substation during the event. Several noteworthy observations can be made from this DFR screenshot including:

1. The induced currents were present for three cycles.
2. Load current was present for at least two cycles after the large current subsided. This indicated the fault was cleared by breakers external to the line.
3. I_C and the residual current were in phase and very near the same magnitude. I_B was nearly in phase with I_C and the residual current but smaller in magnitude. I_A was much smaller in magnitude and lagged the other currents by approximately 80 degrees. The magnitude and phase relationship of the currents were consistent with their physical proximity to the faulted phase.

4. I_B experienced a current reversal during the event.
5. V_C and V_B were not significantly depressed during the event as would be expected given the increased magnitudes of I_B and I_C . Rather, V_A was substantially depressed due to the phase A-to-ground fault on the other line. As shown in Figure 2, the Method Bus is electrically connected to the faulted line through the Durham 230kV Bus.

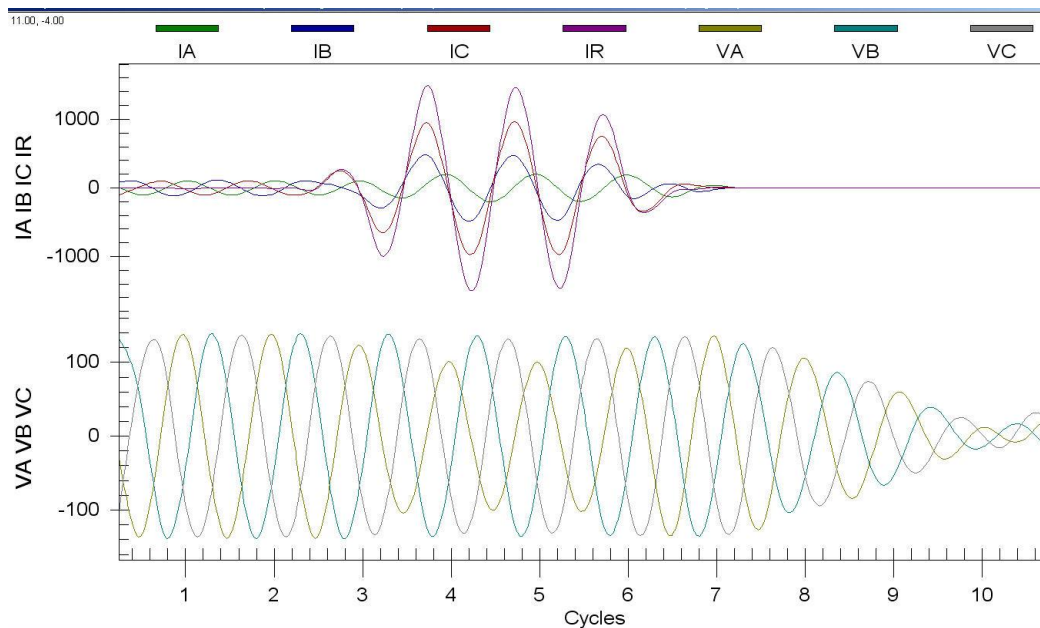
Figure 5 shows event data from a digital relay located at the DPC East Durham terminal. The following observations can be made:

1. The induced currents were present for three cycles, same as at the Method end.
2. As noted with the Method terminal, I_C and the residual current are in phase and close in magnitude. I_B is nearly in phase with I_C and the residual current, but smaller in magnitude. I_A is much smaller in magnitude and lags the other currents by approximately 80 degrees.

3. I_B experienced the same current reversal during the event as experienced on the Method end.
4. V_B and V_C did not experience significant depressions during the event as expected given the large magnitudes of I_B and I_C . V_A experienced a significant depression during the event due to the large I_A on the faulted Durham-Falls 230kV line. As shown in Figure 2, the DPC East Durham bus is electrically connected to the faulted line through the Durham 230kV Bus.

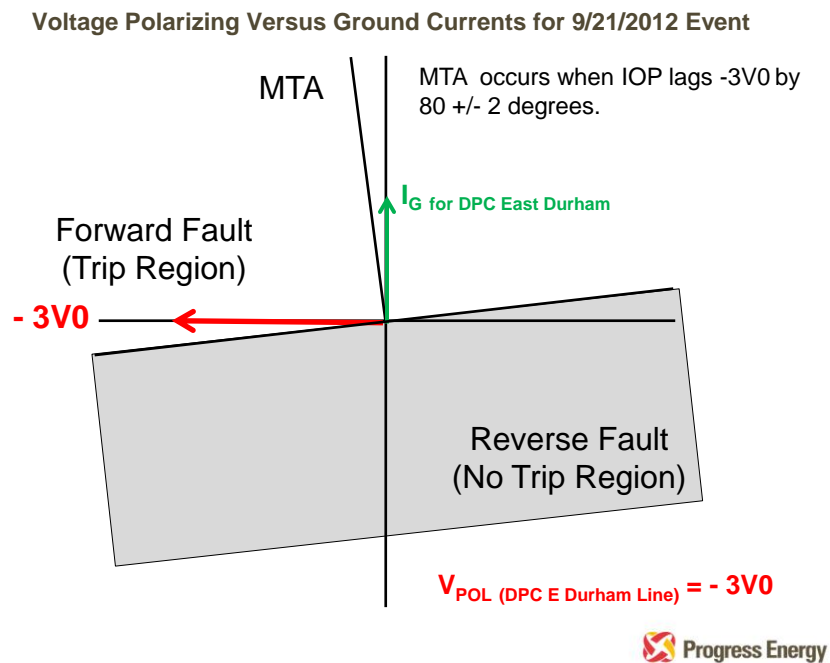
Figure 6
Polarizing for DPC East Durham Terminal at Method 230kV Substation

Unfortunately, the DFR channel monitoring the polarizing current was not functional at the time of this event. Consequently, the relationship of line residual current to polarizing current is not known. Figure 6 shows the relationship between $-3V_0$ and $3I_0$.

Figure 6 shows that the residual line current lagged $-3V_0$ by approximately 90 degrees. Since Maximum Torque Angle (MTA) for the CLPG relay occurs when $3I_0$ lags $-3V_0$ by 80 degrees, the relay determined that the fault was in the forward direction. This was an incorrect determination by the relay since it has already been established that the ground current was flowing in the reverse direction (i.e., toward Method).

1. Perform configuration review of transmission lines that have the potential to experience mutual coupling and revise fault impedance model - The configuration of transmission lines should be reviewed to determine where and for what distance the lines are routed in parallel. Mutual impedances should be calculated for lines that are routed in parallel (e.g., on same structure or in common right-of-way) for a significant percentage of their total line lengths. A criterion of 10% or more is suggested as a starting point. The fault impedance model should be revised to reflect the mutual impedances between the subject lines. Per Reference 1, mutual impedances should not be distributed evenly along the line. Rather, the mutual impedance should be modeled where the line sections are in parallel. This may necessitate dividing the line into several segments.

2. Review and revise relay settings - The settings of relays that utilize zero-sequence quantities (ground distance relays and directional ground relays) should be reviewed using the revised fault model data and new settings implemented as appropriate.

3. Replace relays that utilize zero-sequence polarizing with digital relays that utilize negative-sequence elements to determine direction – As described previously, mutual coupling events can significantly impact the relationship between the induced ground current and the zero-sequence polarizing quantities. The phase reversal of the zero-sequence polarizing quantities can lead to misoperations in carrier blocking schemes. An effective solution is to replace the zero-sequence polarized relays with digital relays that utilize negative-sequence elements to establish direction (References 1 and 2). As described earlier, negative-sequence quantities are relatively insensitive to mutual coupling events. Figure 7 shows data recorded by a digital relay located at the misoperating terminal of a different line during a mutual coupling event in which the primary carrier blocking scheme misoperated. The digital relay provides backup protection, and its event reporting was triggered by operation of the primary protection.

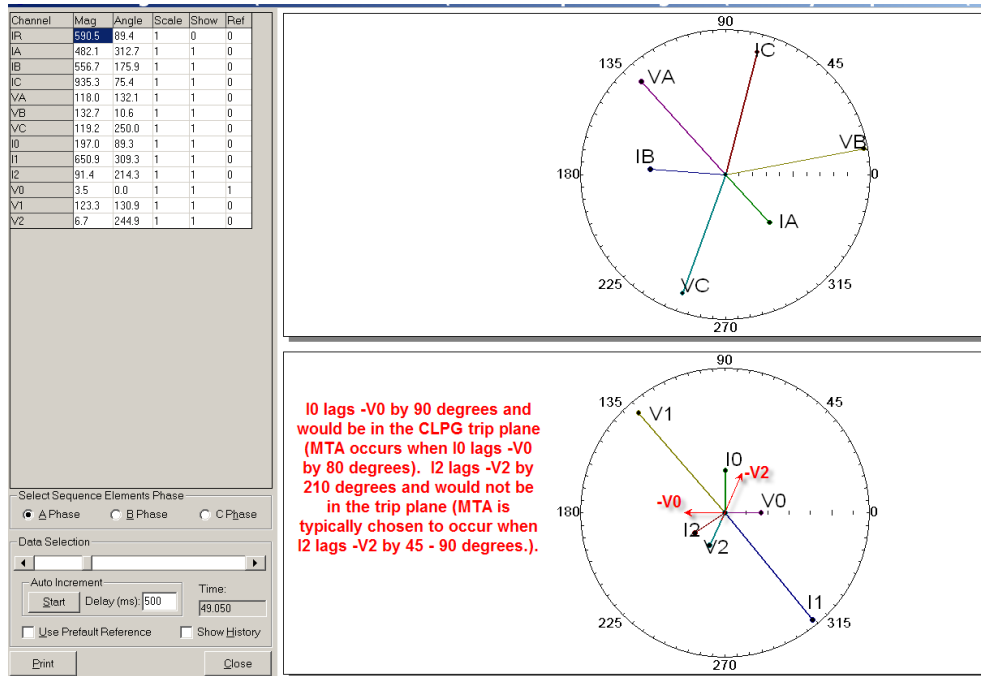
Polarizing for the Misoperating Terminal During a Different Mutual Coupling Event

The carrier blocking scheme utilizes a GE CLPG relay, a zero-sequence polarized electromechanical relay. In this actual scenario, the ground current was flowing into the bus and should have been interpreted by the directional ground relay as being in the reverse direction. However, Figure 7 shows that the induced ground current ($3I_0$) was lagging the polarizing voltage ($-V_0$) by 90 degrees. The $-V_0$ phasor has been added for clarity. Since MTA for the CLPG relay occurs when the operating current lags $-3V_0$ by 80 degrees, the induced ground current would incorrectly appear as a forward fault to the relay. This figure also shows the relationship between I_2 and V_2 as captured by the digital relay. The $-V_2$ phasor has been added for clarity. This digital relay, which utilizes a negative-sequence impedance algorithm derived from V_2 and I_2 to determine direction, correctly determined the ground current as being in the reverse direction.

A traditional negative-sequence polarized relay would also have correctly determined the induced ground current to be in the reverse direction; the MTA for relays that utilize negative-sequence polarizing is typically chosen to occur when I_2 lags $-V_2$ by the line impedance angle (45-90 degrees, depending on the relay characteristic angle of the relay per Reference 3). As seen in Figure 7, I_2 lags $-V_2$ by 210 degrees and is roughly 180 degrees from the MTA. Consequently, a traditional negative-sequence polarized relay would not have misoperated for this mutual coupling event.
