## **Disturbance/Misoperation Analysis at OG&E**

Oklahoma Gas & Electric utilizes many traditional methods and newer synchrophasor technology as a practical tool to locate disturbances and solve real world operating problems.

By Austin White and Shawn Jacobs, Oklahoma Gas & Electric

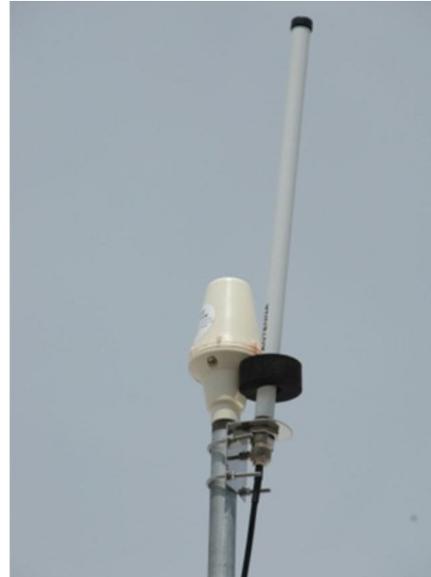
**Figure 10 – Interference from a close RF source can jam GPS reception**

Identification of failing equipment doesn't necessarily need to be limited to the power system assets. There have been many observations of problems with the GPS clocks that serve as the precise time reference to substation IEDs. GPS problems are usually pretty easy to spot in the PMU voltage angle data. It has been noted that a 3G data radio antenna mounted adjacent to the GPS antenna will very effectively jam the GPS signal. Fortunately, the STAT frame in the PMU stream shows when the PMU is in sync. It is advised to use the STAT frame data in any event detection algorithms to avoid using bad data.

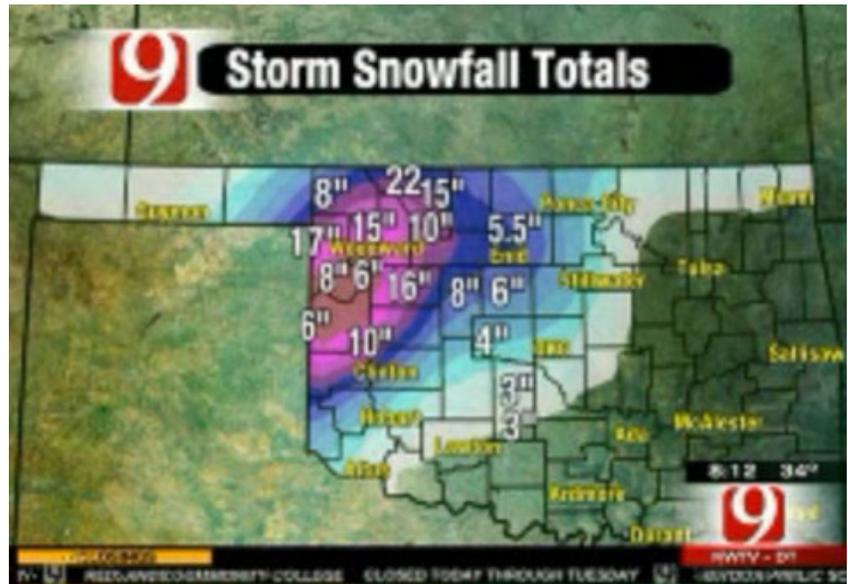
Figure 20 – Major Winter Storm Event

A severe winter storm moved into northwest Oklahoma on February 25, 2013 dumping as much as 22 inches of heavy wet snow as shown in Figure 20. Numerous line outages occurred during the storm, which progressed throughout the day. With synchrophasor data, the utility was able to see the system weaken as lines locked out. The following figures show the progression of the event with voltage angles in northwest Oklahoma referenced to Oklahoma City.
