A Comparative Study on Cost Savings Offered by Traveling Wave System Fault Locators over Traditional Distance Relays for Long Distance Transmission Lines

*Authors: Jonathan M. Trejo – System Protection & Control Engineer, El Paso Electric Company
David Cole – Technical Applications Specialist, Qualitrol*

This paper describes the deployment of a double ended traveling wave method of fault location, its benefits over existing impedance schemes and its contribution to remedial works described in four case studies.

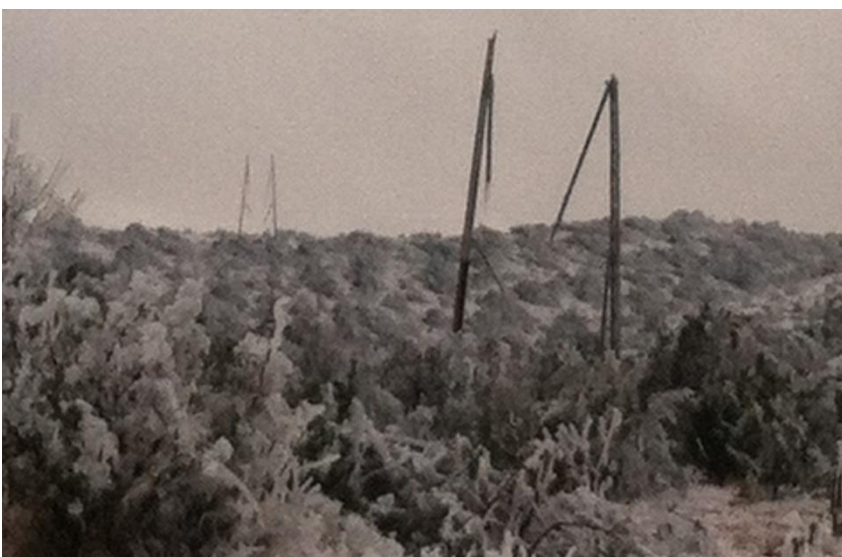
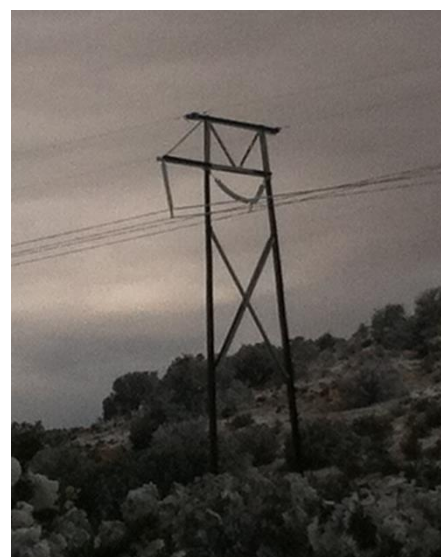
The 345kV transmission line from Amrad to Eddy County Substations is 125 miles long. A traveling wave distance to fault result after a line trip in 2013 placed the fault 58 miles from Amrad. On arrival the crews found significant damage due to a severe ice storm, 103 structures had collapsed or were damaged over a length of 16.7 miles. See Figure 6. This fault was not hard to find but the speed in obtaining the result and the faith the crews had in the accuracy meant teams were on scene in the minimum time.

Figure 6 – Broken Structures due to Ice Storm

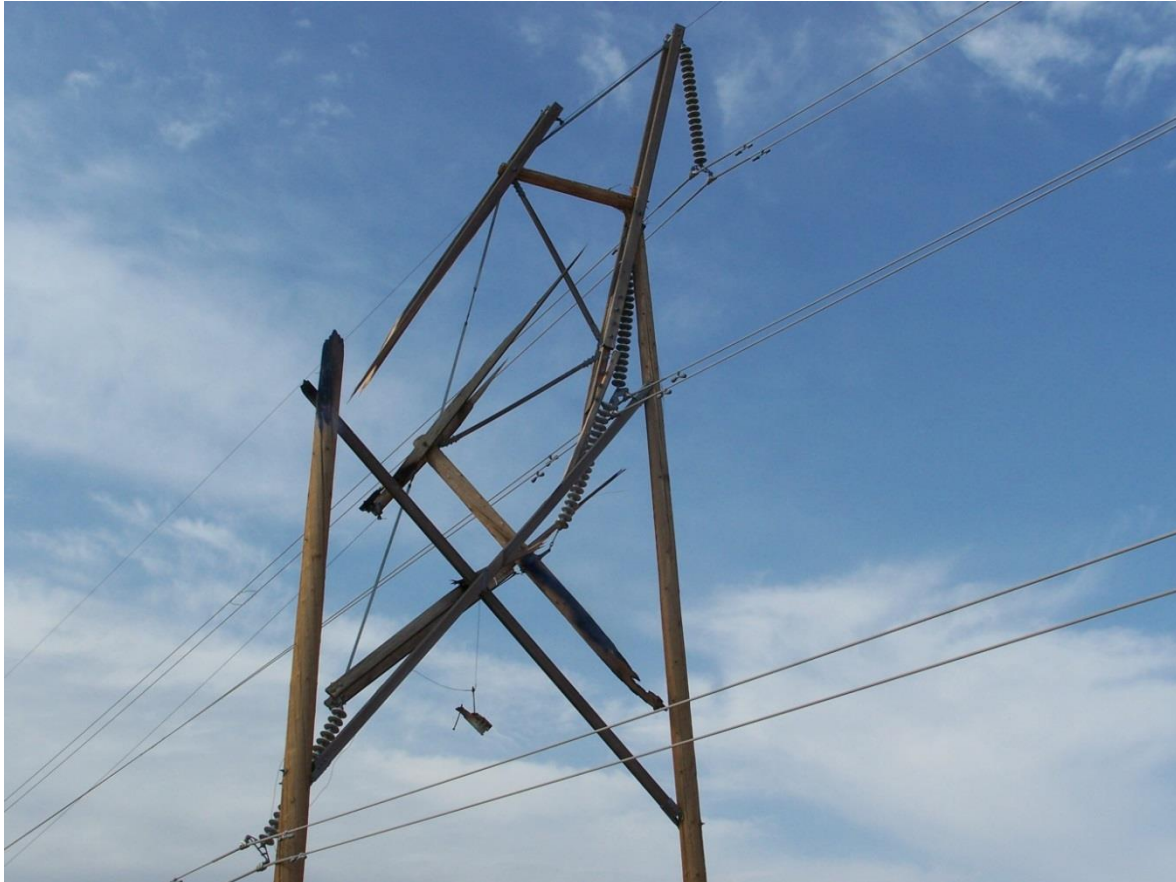
The 345kV transmission line from Arroyo to West Mesa Substation was built in 1968 and is 201 miles long. A traveling wave distance to fault result after a line trip in April 2016 placed the fault 53 miles from Arroyo. On arrival the crews found significant damage to a structure damaged by fire as shown in Figure 7.

Fig 7 Structure Collapse Due to Fire Damage

After similar incidents and further examination it was discovered that the fire was caused by the heating of the pole mounted earth wire from induced current due to increased loading on the line. After nearly 50 years in service the weathered poles were drier and more susceptible to burn. The staples used to clamp the earth wire had also worked loose resulting in further arcing. A design alteration to hold the earth wire away from the pole using stand-off supports was implemented on 1500 structures as shown in Figure 8.

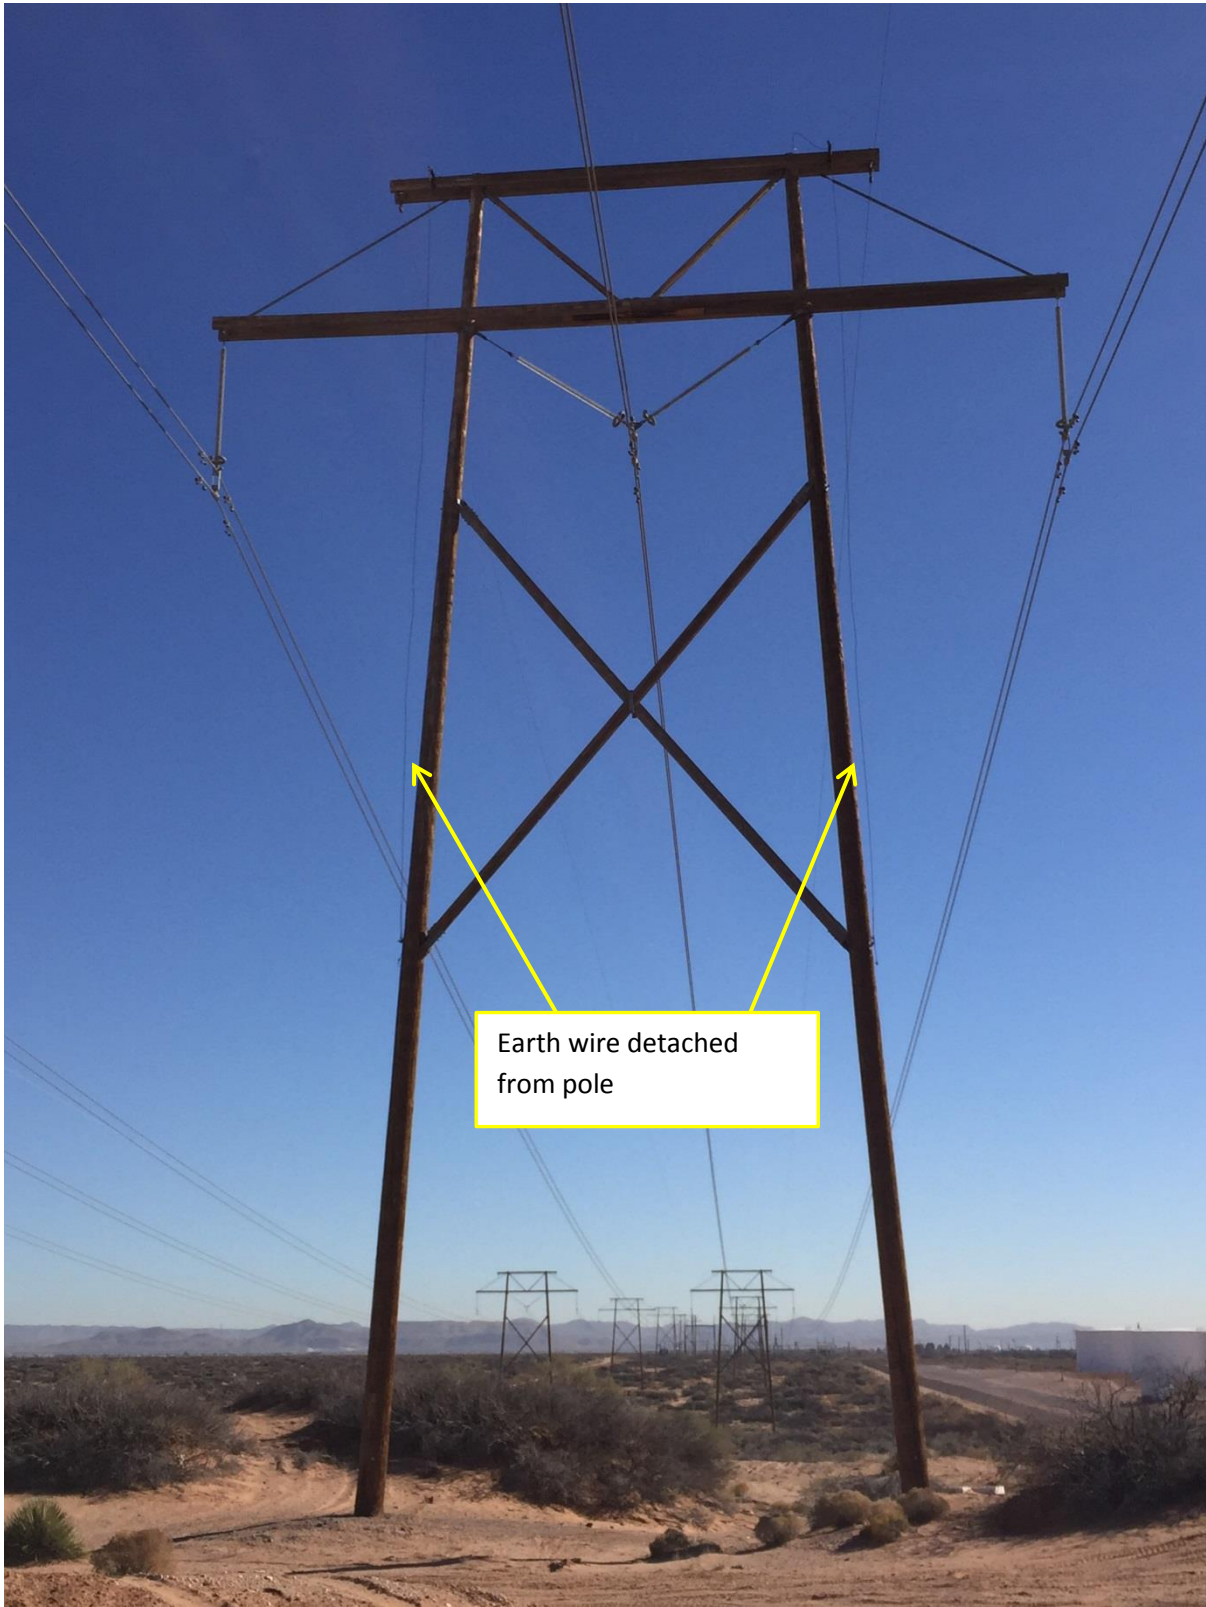
Figure 8 Design Upgrade on Earth Wire

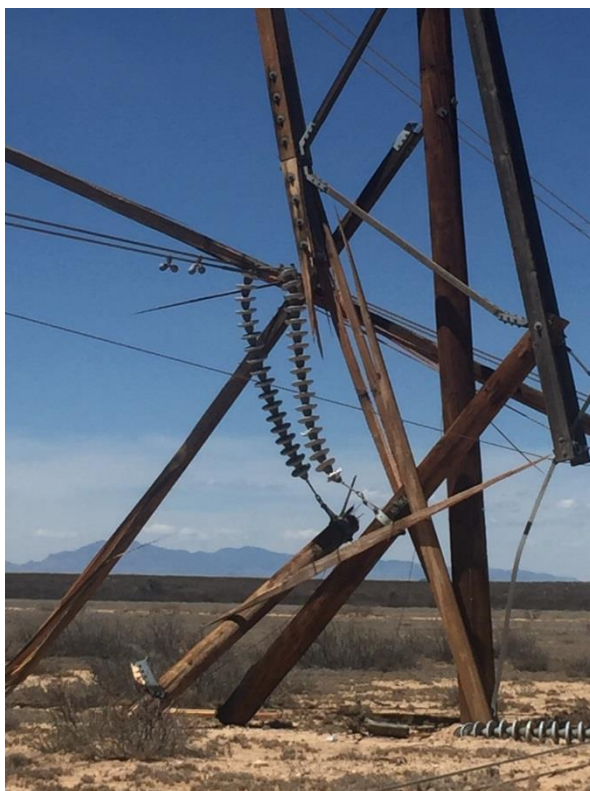
During the remedial work program the traveling wave system successfully located other fire damaged structures keeping the outage time down to a minimum. See Figure 9. An impedance result from one of these events placed the fault site 30.8 miles from Arroyo substation when the actual distance, as defined by the traveling wave system, was 50.1 miles. Without the traveling wave result it would have taken several days to find the site using a 4 person patrol crew.

Figure 9 Other Fire Damaged Structures

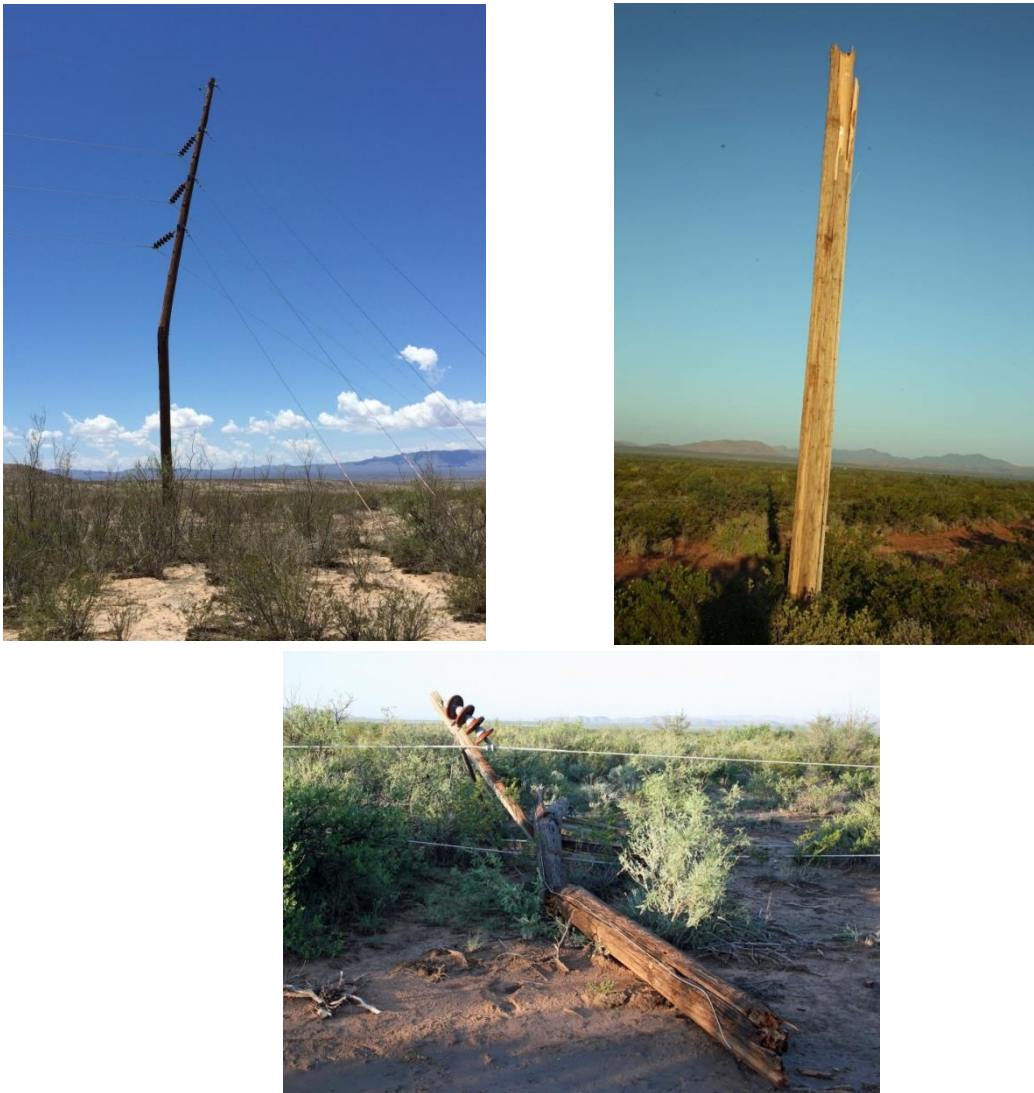
This line section has been subject to high winds in recent years. Up to 10 momentary trips per year were recorded plus some permanent faults when damage to the structure occurred. Some examples of severe structure damage are shown in Figure 10.

Figure 10 - 69KV Structures Damaged by High Wind Speeds

After several similar operations it was decided to replace the wooden structures with steel at a rate of about 100 structures per year.
