Analysis of 115kV circuit switcher damage during a normal switching operation

Song Ji, Yujie Irene Lu, Dan Hasenwinkel, Joshua Joseph - National Grid USA

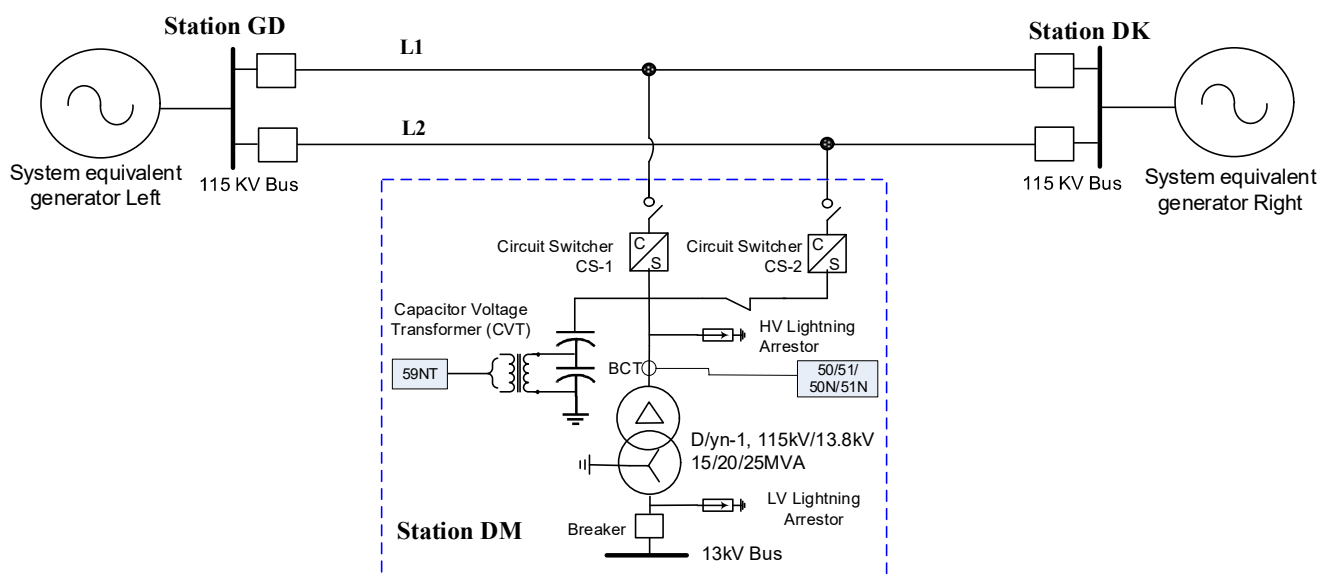
The simplified regional system one line is shown in Figure 1. 115kV lines L1 and L2 run parallel between source stations GD and DK located in western New York. The distribution station DM is tapped from line L1 & L2 through 115kV circuit switchers CS-1 and CS-2 respectively. Several other stations are tapped from these lines to supply normally closed sub-transmission loops or radial distribution stations.

Figure 1: the simplified regional system one line

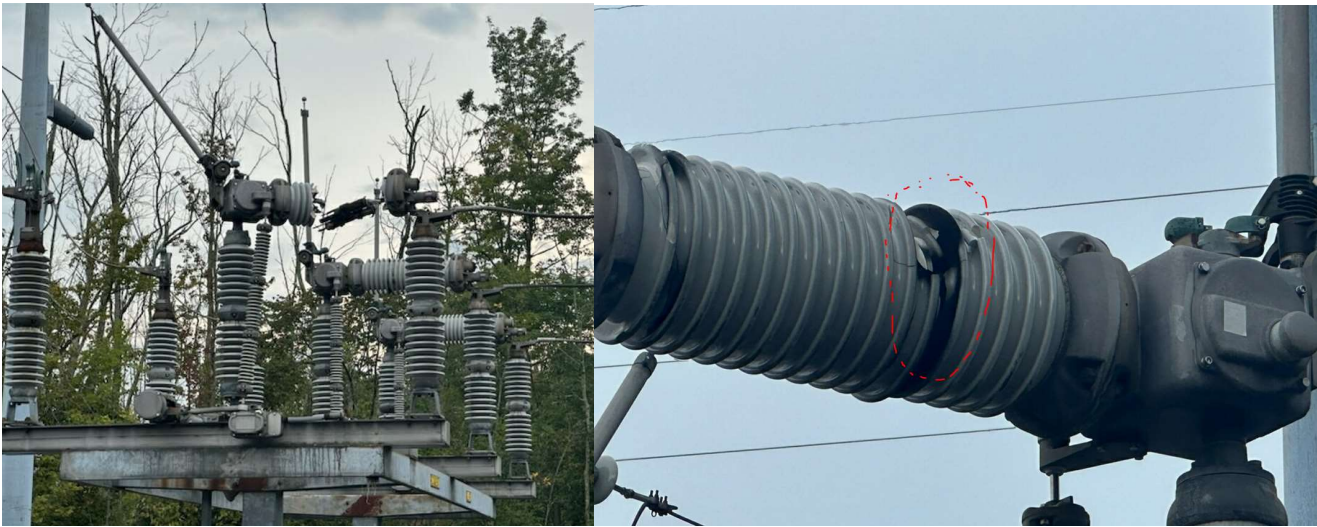
Fifty (50) minutes later, the traveler arrived at station DM and found the 115kV circuit switcher CS-1 was on fire with severely damaged A & B phase interrupters as shown in Figure 2. The traveler managed to restore the station from line 2 through circuit switcher CS-2.

Figure 2: the damaged 115kV circuit switcher CS-1 and cracked housing on B-phase interrupter

The damaged circuit switcher CS-1 was manufactured in 1974 with 2000A continuous current rating. As shown in Figure 2, the outmost phase interrupter (A-phase) exploded and the middle phase (B-phase) interrupter insulating housing has a large crack. This implied that the huge internal gas pressure must be present inside of the interrupter and the pressure was caused by the heat. As the current rating of CS-1 is 2000A, to generate such heat, the magnitude of the flowing current through CS-1 would be much more than 2000A if the damage was caused by the current. However, there was no triggered events & records on line L1 relays and DFRs at source station GD & DK. The damage must be due to other reason.

Based on the damage pictures in Figure 2, it was most likely that circuit switcher CS-1 was not fully engaged in the closed position, which was also the trigger of ferroresonance and will be discussed later. The discharge arcing from the longitudinal voltage across phase A & B interrupter was the cause of the damage.

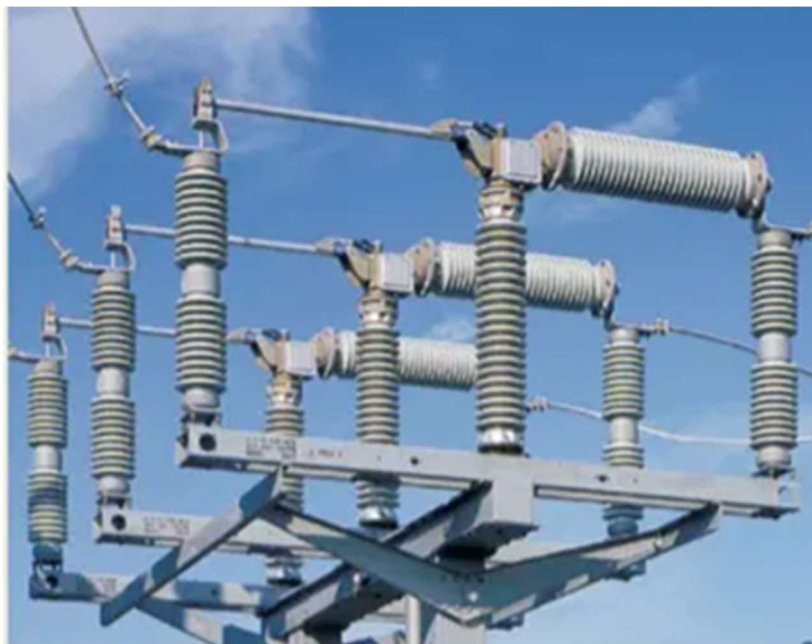
The circuit switchers at station DM have a horizontal interrupter design configuration with an integral vertical break disconnect switch.

Figure 6: Horizontal interrupter circuit switcher with integral vertical disconnect switch

The SF6 filled interrupters are installed on vertical post insulators, therefore the housing of interrupters cannot be maintained at ground potential and window CTs can't be installed around the interrupter housing. In the event of a circuit fault, the interrupter is instructed to clear the circuit, the disconnect opens to establish visible air gap. On a closing operation, the disconnect closes before the interrupter does.

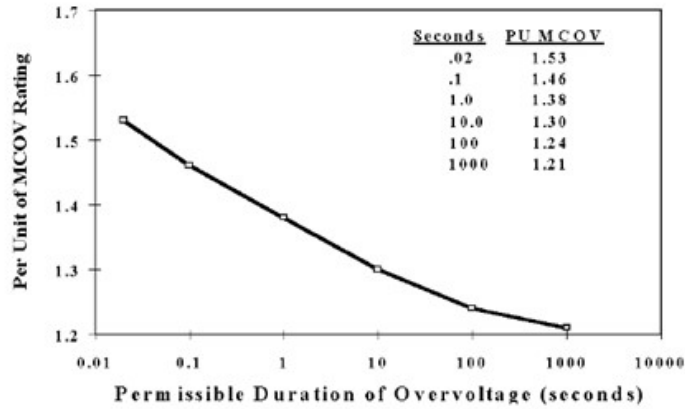
manufacturer can provide a time curve showing the temporary power-frequency overvoltage without damages. The typical overvoltage capability curve is shown in Figure 8:

Figure 8: Typical 60-Hz Temporary Overvoltage Capability for Metal Oxide Arresters [1]

If TOV exists and exceeds the withstand curve, the large amount of heat would be generated in the housing and the surge arrester is susceptible to thermal damage. The reported surge arrester failures at station DM were most likely caused by the long duration of overvoltage from ferroresonance presence following the switching.

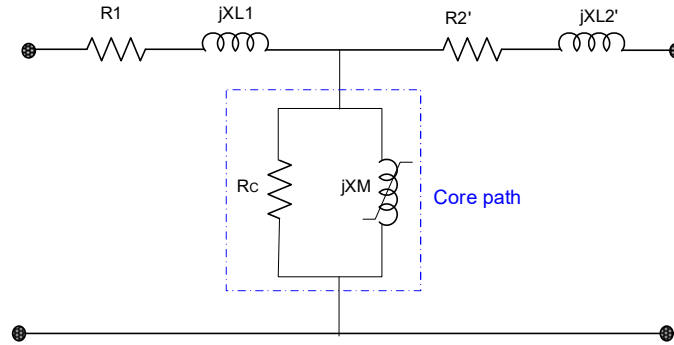
Considering the winding ohmic losses, hysteresis and eddy current losses in the core, the transformer circuit can be represented in a classical T-model shown in Figure 10.

Figure 10: the classical T-model of two-winding transformer

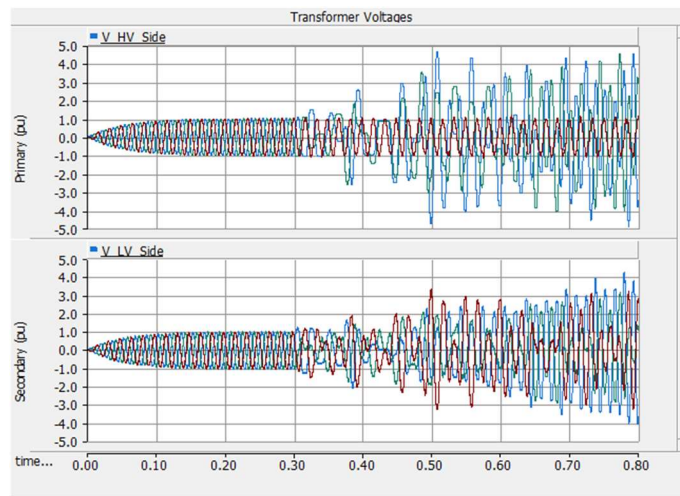
The ferroresonance simulations were performed with and without transformer LV side loading. The no loading simulation results are shown in Figure 15 & 16.

Figure 15: Transformer HV & LV terminal voltages during ferroresonance event

The transformer did experience temporary overvoltage from ferroresonance. The long duration exposure to such overvoltage is detrimental to the insulation of electrical equipment and would adversely impact the lifespan and performance of the affected equipment. The localized ferroresonance may not have any influence at the remote source station. The same simulation was performed with loadings added to the transformer and no ferroresonance appeared.

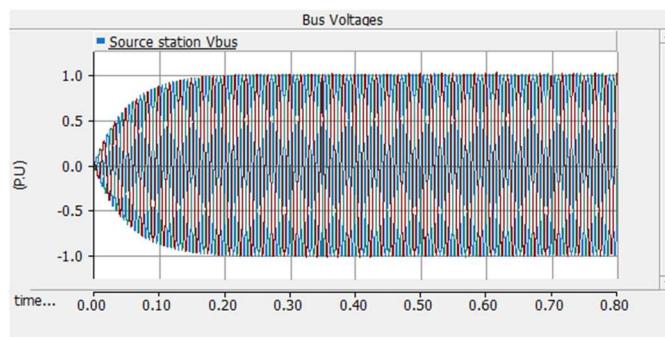
Figure 16: Source station bus voltages
