**A SERIES OF UNFORTUNATE EVENTS: FAULT DISTURBANCE
ANALYSIS OF 345KV LINE TERMINAL BUS INSULATOR FAILURES AND
A “HANDTOOL-INDUCED” BREAKER FAILURE EVENT ON NORTHEAST
UTILITIES’ TRANSMISSION SYSTEM**

**By: Dominick Fontana, John Ferraro, Frank Flavin
Northeast Utilities System**

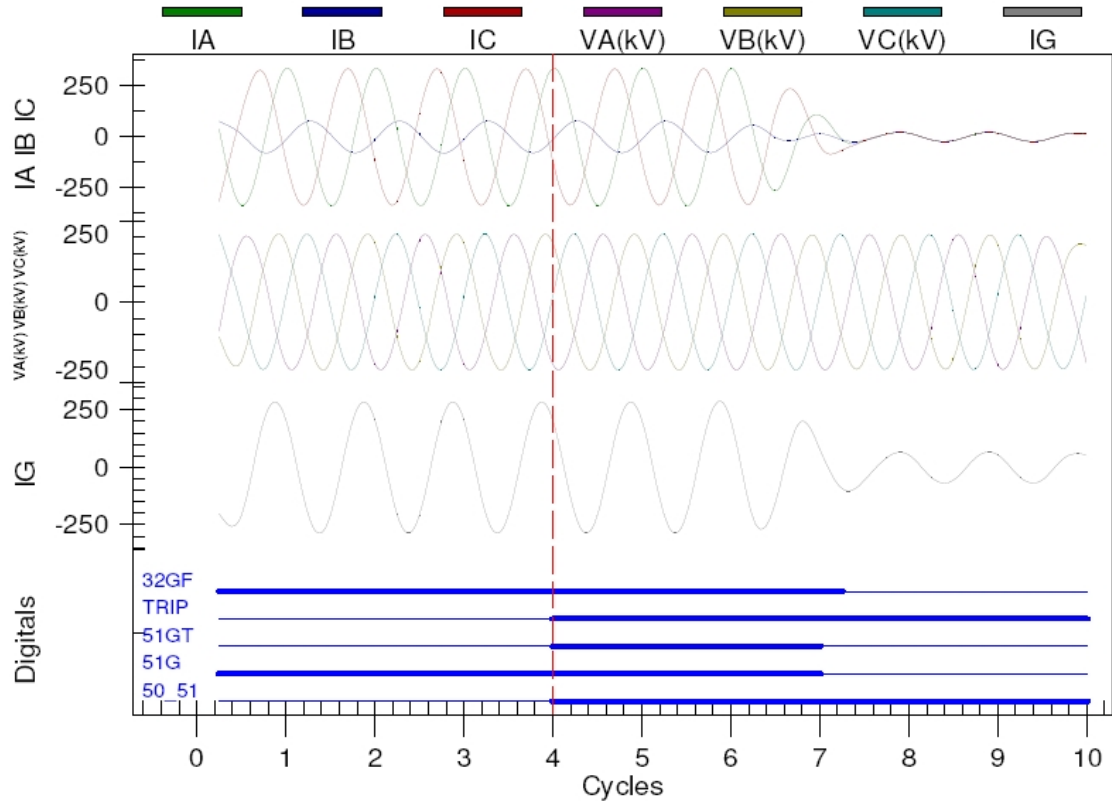
**Figure 2: Primary Relay Record for First Trip at N. Bloomfield
Time - 1:20:15.253**

Test personnel traveled to the North Bloomfield substation and found a primary relay target indicating ground directional overcurrent trip (element 51G made directional by 32GF), but it was not immediately obvious what physically had tripped the terminal (see Figure 2 for primary relay plot). Our Massachusetts Test supervisor was able to observe remote Manchester currents on the primary relay at Ludlow, and direct personnel to the Manchester terminal. It would be a few hours before test personnel visited the Manchester terminal and discovered the culprit (see Pictures 1 thru 3). They observed that the A phase line terminal bus horizontal standoff insulator had broken, allowing the bus to separate away from the line terminal without touching another phase or ground. The North Bloomfield primary relay responded to the neutral current created by the unbalanced phase currents.

We questioned why was it that only the remote North Bloomfield terminal tripped for this condition. A review of the relay settings revealed that the North Bloomfield relay was set more sensitively than the other terminals due to the fact that this terminal is a weak source. The North Bloomfield relay was set for 240A, while the other 2 terminals were set for 600A. Roughly 290A of neutral current flowed from the North Bloomfield terminal for a time period sufficient for the timer to time out. Reviews of the relay record at Manchester indicated that the neutral current exceeded 600A for short time intervals, but never long enough for the timed element to trip (see figure 4). Overall we considered this a correct and desired relay operation.

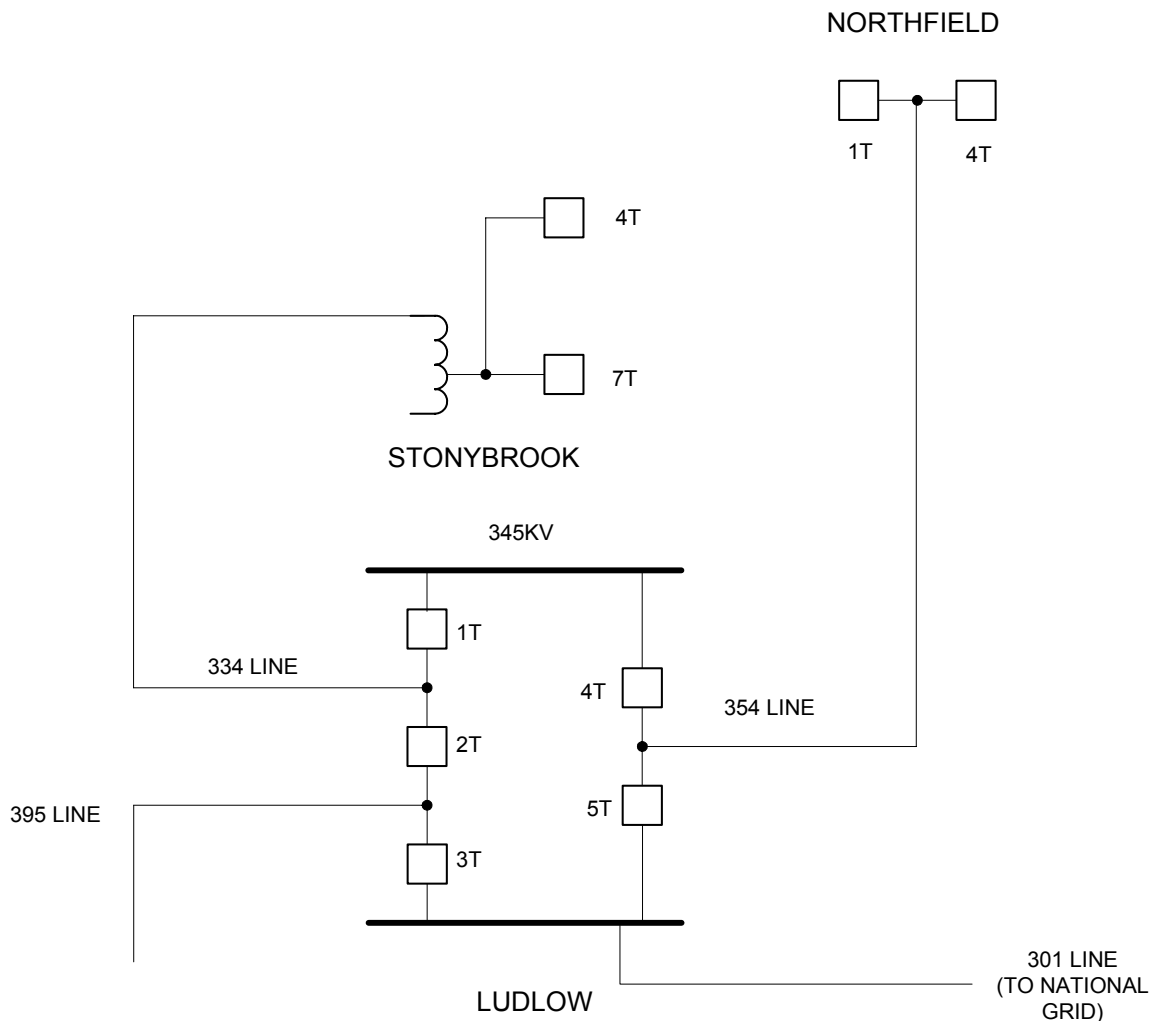
Figure 5: The 334 and Adjacent 354 Line at Ludlow

The 334 line is a short 2-terminal line with terminals at Ludlow and Stonybrook Massachusetts (see figure 5 below). Stonybrook is a merchant generating station, and no relay or DFR records were available from this end of the line. The line is protected by early vintage static and electromechanical relays, with a DCB scheme over power line carrier for primary protection and an audio tone POTT scheme over phone lines for backup. The Ludlow to Northfield 354 line was also involved in this event and was at the time protected by the same relay schemes as the 334 line. The relays and communications systems on the 354 line have since been replaced by modern digital equipment.

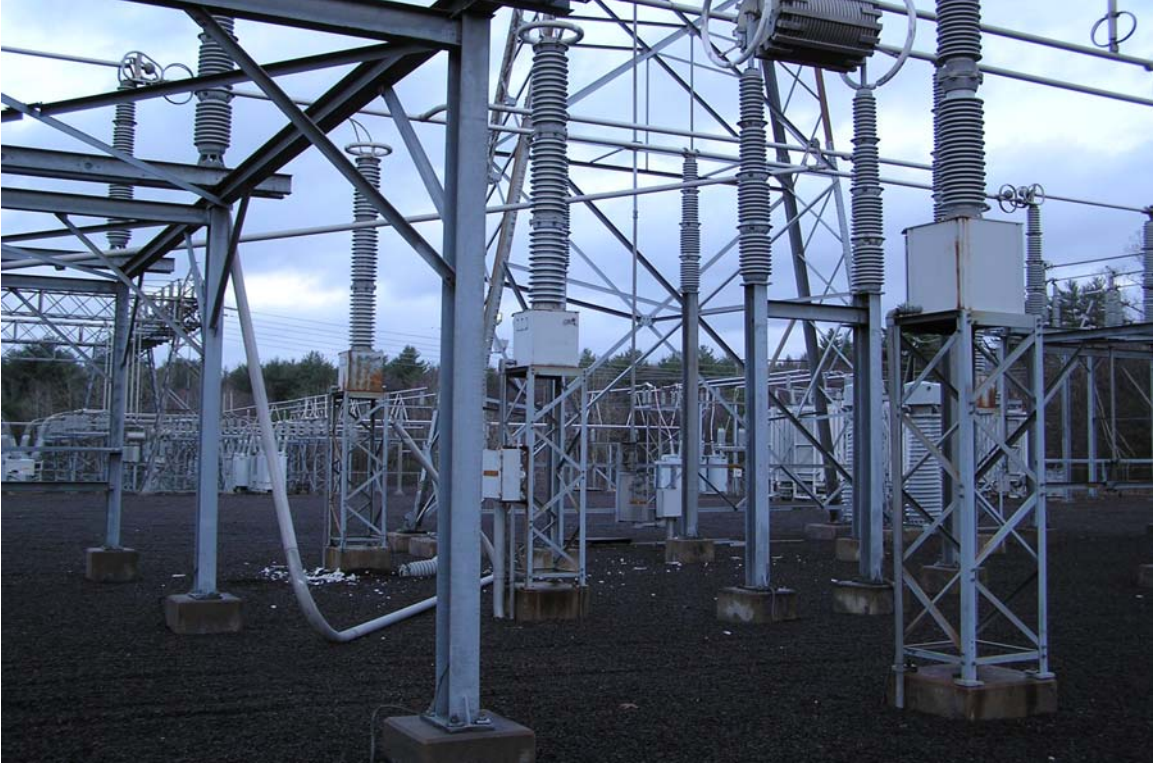
Picture 4: Ludlow 334 Line Bus on Ground

The damage that occurred at Ludlow as a result of the insulator failure was more severe than what had happened at Manchester on the 395 line. This time, the bus came crashing down to the ground in 2 pieces, coming in contact with grounded and live equipment/structures along the way (see pictures 4 thru 6 below). We considered relay operations on the 334 line to be correct and desired, but operations on the 354 line were incorrect and undesired.

The mechanism of failure in all of these bus events was determined to be cracking due to moisture accumulating within the insulator and freezing. Picture 11 shows ice that had formed on a healthy insulator. There are 24 sets of these insulators located at 10 stations across the NU system. Needless to say, all are currently scheduled for replacement.

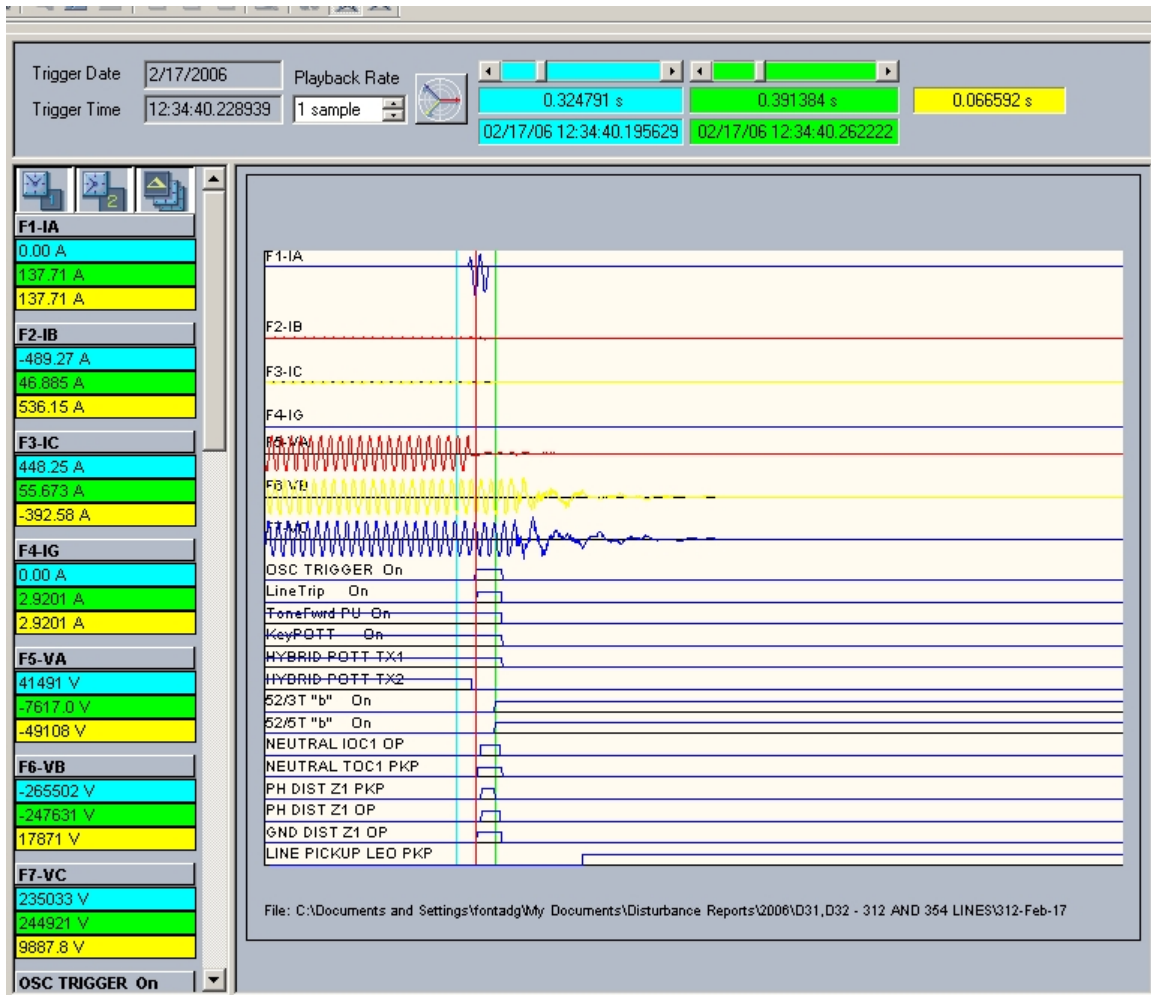
Figure 11: Northfield Backup Relay Record for 312/393 Line Event

The backup relay record for the initial fault is shown in figure 11.

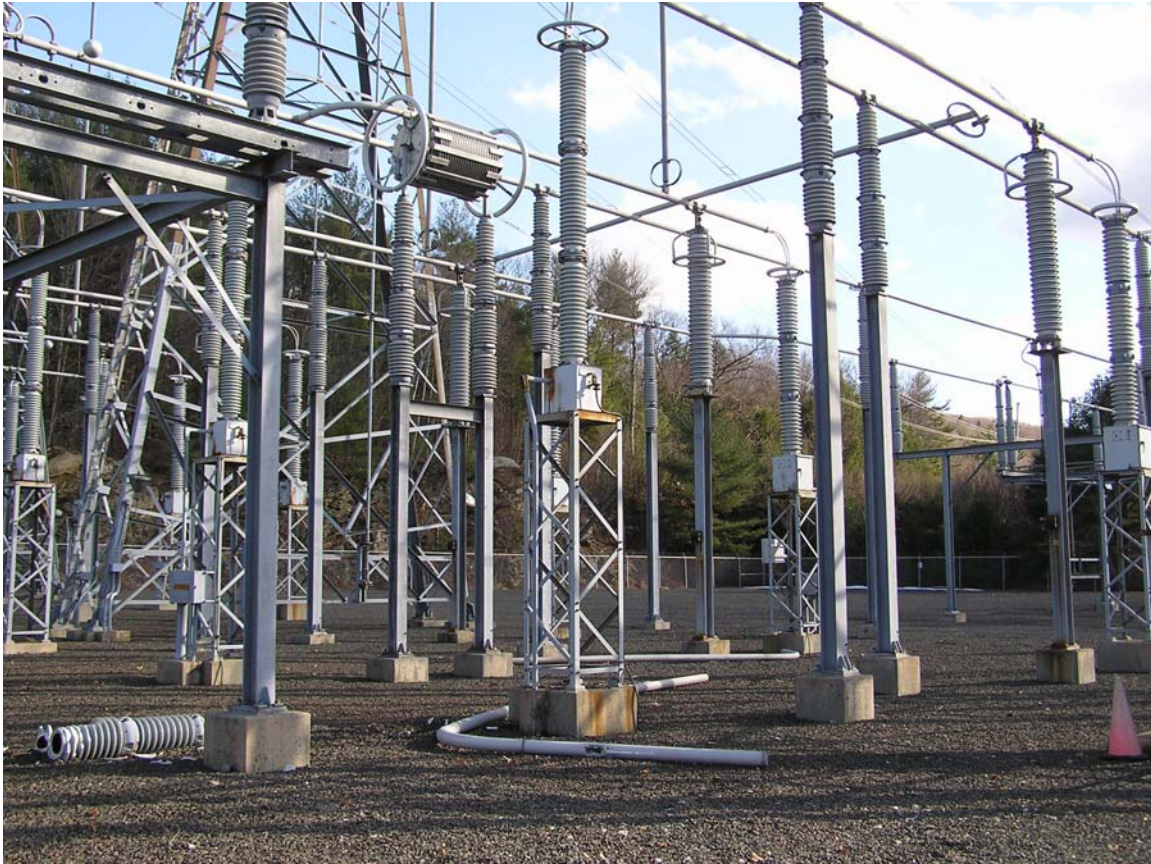
Picture 7: Northfield 312/393 Line Terminal Following Bus Insulator Failure

When we examine the attached picture (picture 7) that was taken after the fault occurred, we can see that the bus indeed broke away from the terminal and came to rest on what were then de-energized lower A, B and C phase line terminal busses. When the bus initially fell, it created a phase A to ground fault only on the Northfield side of the open. Since Alps and Berkshire relays did not show any targets for this initial fault, these terminals could only have been transfer tripped by the backup relay at Northfield (in accordance with standard NU practice).

With phase A was now open at Northfield, and the fallen bus resting squarely across the lower busses, the reclose at Alps should have closed into a phase B to C fault.
