Analysis of Selected Motor Event and Starting Reports

Derrick Haas, Jason Young, and Ryan McDaniel, *Schweitzer Engineering Laboratories, Inc.*

This paper investigates several real-world events with data from both motor starting reports and event records. The data demonstrate the value of having devices capable of recording motor data during starts and fault events and of capturing and reviewing such data for the purpose of determining root cause. Lessons learned are shared to help in troubleshooting motor problems and to avoid potential misoperations in motor protection.

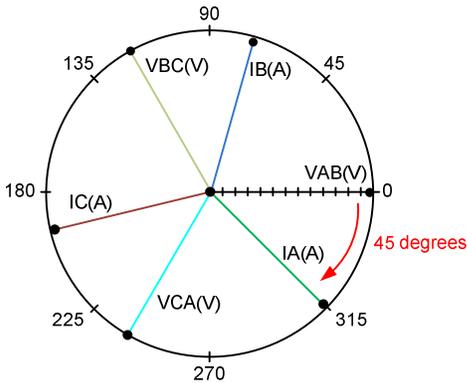
Fig. 6. Motor start phasor relation

In April 2010, a 375 hp motor suffered an unbalance trip while starting. It was assumed that two current transformer (CT) secondary wires were rolled going to the relay. Therefore, the A- and C-phase wires were swapped in an attempt to correct the assumed problem, and the motor was started again. Despite the wiring change, once again, the relay tripped on unbalance. Assuming the wrong wires had been swapped, the B- and C-phase wires were rolled and the motor was started for a third time, and the relay tripped on unbalance for the third time.

The motor was applied to an ACB system. Fig. 6 shows the phasor relation from the initial trip. As expected, the phase current lags the phase-to-phase voltage by approximately 45 degrees.

Because a motor draws approximately six times its full-load amperes during a start, it is common for the CTs to experience some saturation. Therefore, unbalance elements should not be set to operate instantaneously because they can operate on false unbalance quantities that result from CT saturation. It is important to remember that the threat of damage posed by negative-sequence currents is thermal in nature. Therefore, equipment will not be damaged instantaneously.

One reference recommends that a definite-time element operating on negative-sequence current be set at 1.5 A secondary with a 4-second delay to ride through the saturation that can occur during a start. This setting ensures the security of the element [5].

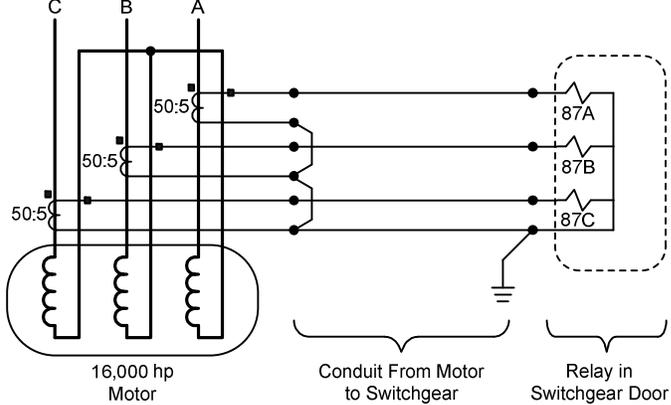
Fig. 8. Simplified three-line diagram

In November 2010, a 16,000 hp motor tripped during starting from a current differential fault. The particular motor installation made use of a self-balancing differential scheme. This scheme is applied where access to all six motor leads is available. A simplified three-line diagram of the installation is shown in Fig. 8.

When the relay and primary equipment are tested and appear to be functioning as expected, the next logical place to check is the secondary wiring. After the insulation to ground on the secondary wiring was checked, two wires were found to have developed short circuits to ground. The locations of the ground faults are shown in Fig. 11. Both were located in the metallic conduit between the switchgear and the motor location. All wiring in this metallic conduit was replaced.

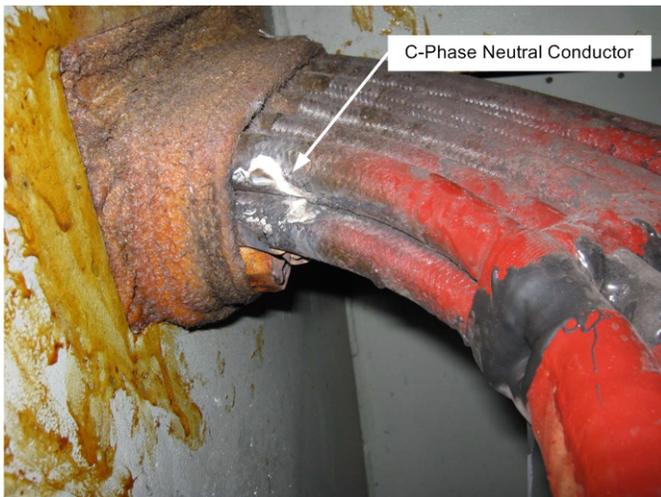
Fig. 29. Side view of the incoming and neutral conductors

Based on the fault current values seen during the event, closer inspection was given to the source side of the stator winding. This includes the junction box where the phases are landed on the motor terminals. The two conductors in the foreground are paralleled neutral conducts, and these show a sign of possible arcing (see Fig. 29). The two paralleled conductors just behind are the C-phase incoming conductors.

Closer inspection was required to see if there was some arcing on the incoming phases. This physical evidence of a fault is very near the differential flux-balancing CT and at a point where the neutral and source to the stator are very close to each other. Fig. 30 shows a top view of the conductors.
