# Analysis of the Plant Gorgas Breaker Failure

By: Jerrod B. Moll, Alabama Power

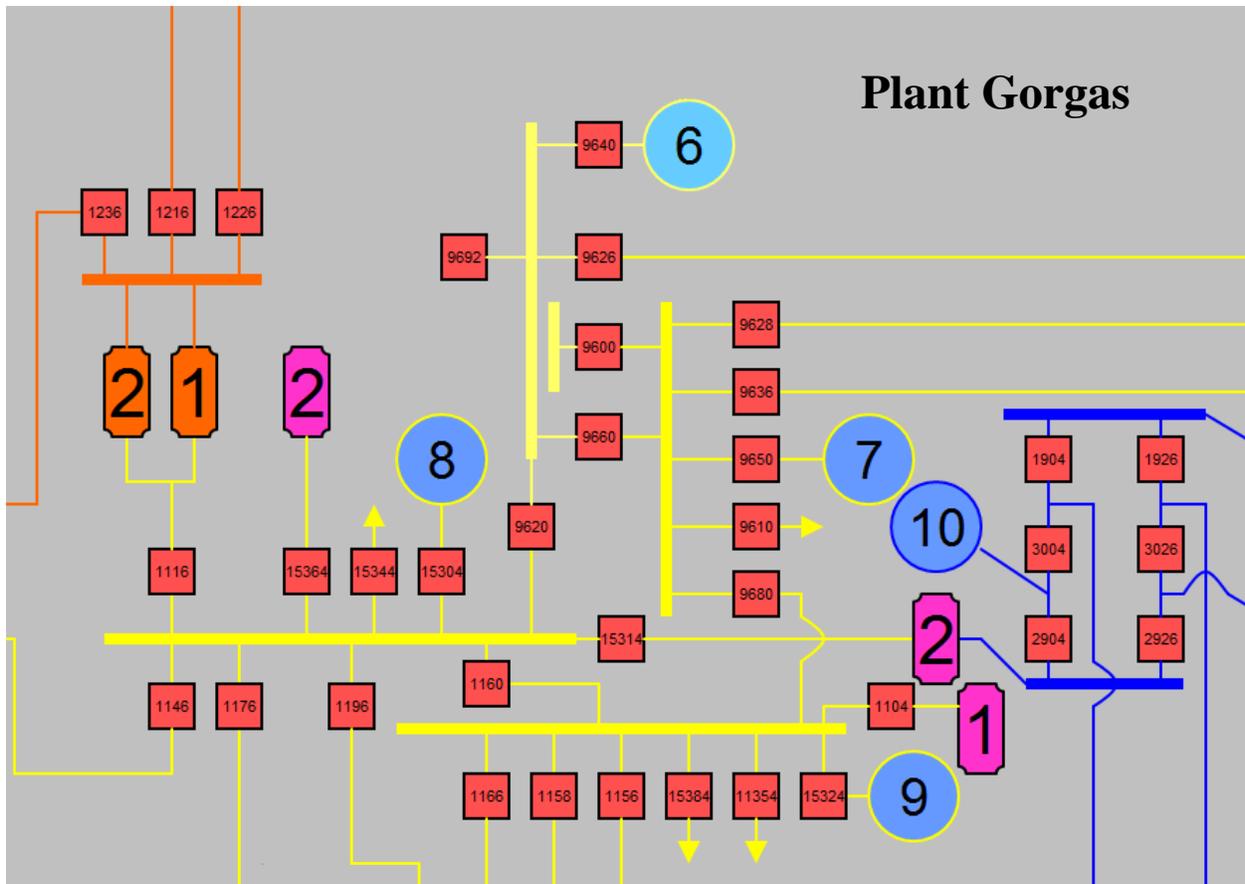
Figure 1: Plant Gorgas Single Line Diagram

On June 16<sup>th</sup> 2008, Plant Gorgas was bringing Unit #6 online when suddenly the Unit Breaker failed catastrophically. This initial failure caused Bus #2, and two 115KV lines to trip. When the Unit Breaker failed it sprayed oil onto the Bus Tie Breaker causing it to be engulfed in flames. The Bus Tie Breaker fault started a chain reaction of buses, lines, generating units, and transformers tripping in and around Plant Gorgas. Under normal circumstances the Bus Tie Breaker fault should have taken out Bus #3, Unit #7, and two 115KV lines. We had to utilize Digital Fault Recorder (DFR) event records and field personnel observations to recreate what actually happened that night and to investigate why the Bus Tie Breaker fault did not clear as designed. In all we had twenty seven transmission lines trip (2 - 46KV, 15 - 115KV, 4 - 161KV, and 2 - 230KV), twenty two distribution substations out, and seven generating units offline (1315 MW's). This paper will show the events that took place on Jun 16<sup>th</sup>, 2008 and how we ended up recreating the event using DFR event records and field personnel observations.

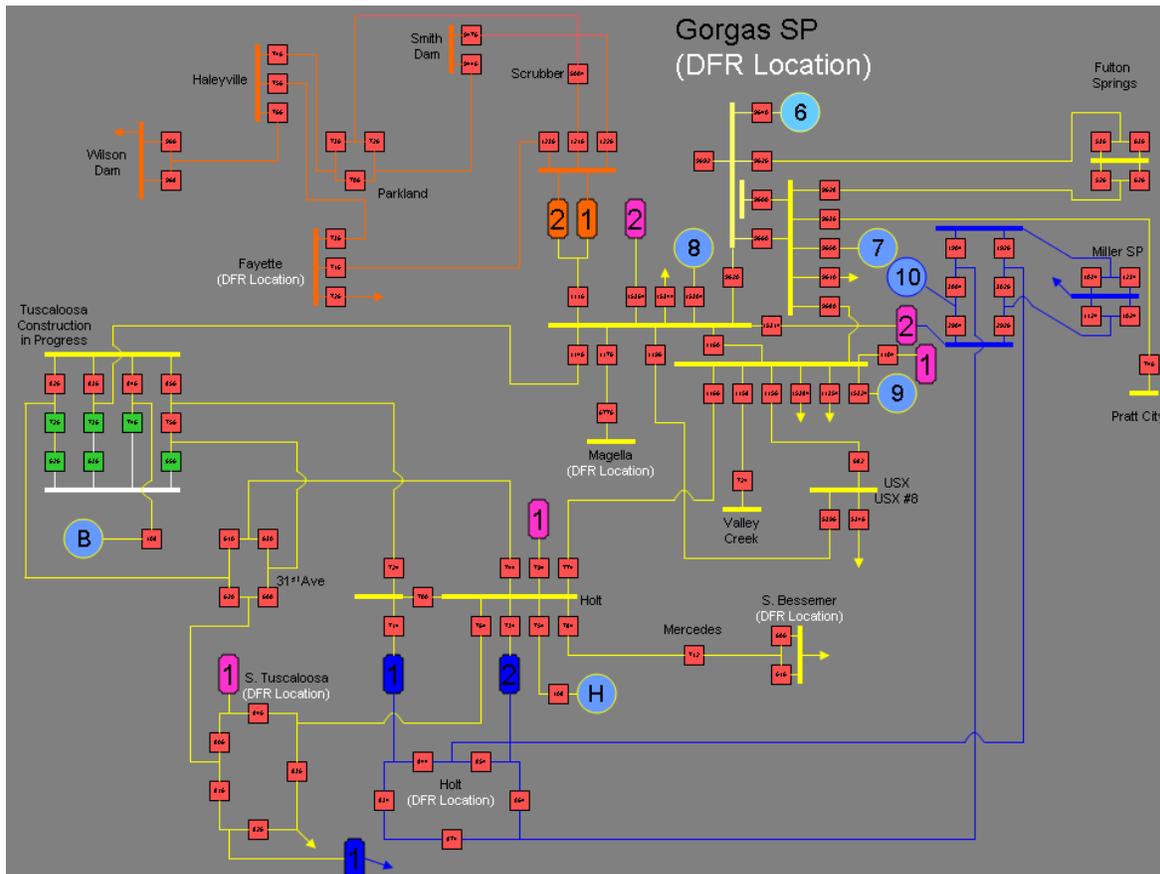
Figure 3: Event Area Single Line Diagram w/ DFR Locations

To begin the analysis of this event it was determined that we had to gather all the DFR event records to create a sequence of events of what happened because the EMS times of all the operations were proven to not be accurate. Our EMS system scans every six seconds so the time reported could be off by as much as 12 seconds. Also due to the magnitude of the fault the RTU's at Plant Gorgas failed or lost communication. Each DFR location is equipped with a network connection to transfer data from the substation to the centralized data storage at Alabama Power's corporate headquarters. Once a DFR creates an event record it is automatically transferred within fifteen minutes. Unfortunately the DFR's at Plant Gorgas lost communication during the event and only transferred two sets of records and deleted the remaining records when it thought it had transferred the event records successfully. There were five other DFR's that captured event records for the event and they were spaced out across the transmission system which provided a different "look" at the event.

All the DFR's were connected to a GPS Clock, which gave them all the same reference point, so they could be combined and examined to discover the true sequence of events.
