Knoxville 161-kV Substation Bus Insulator Failures and Corresponding Ground Problems

Timothy L. Burgess
Chattanooga Transmission

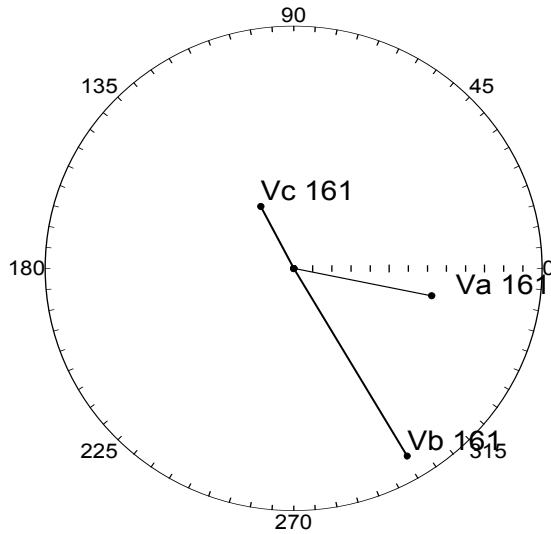
Figure 8: Voltage Vectors at t = 6 cycles on 9/14/2000

Because the fault type seemed to evolve with time, the voltages were examined at 2 times; 6 cycles and 14 cycles from the start of the fault record (Figures 8 and 9). (Prefault A-Phase voltage was used as the reference).

In analyzing the above vector data, V_{a161} or V_{ag} was dissected into two components; V_{an} and V_{ng} (see *Applied Protective Relaying* - Westinghouse, Chapter 2, Section IV.B.2). First V_{ng} was calculated:
